September 21, 2022

Alberta Transportation
2nd Floor, 803 Manning Road N.E.
Calgary, Alberta
T2E 7M8

**CON0022161 Southern Region GRMP Instrumentation Monitoring
Site S003; H22:16 km 9.9 Cochrane
Section C – 2022 Spring Readings**

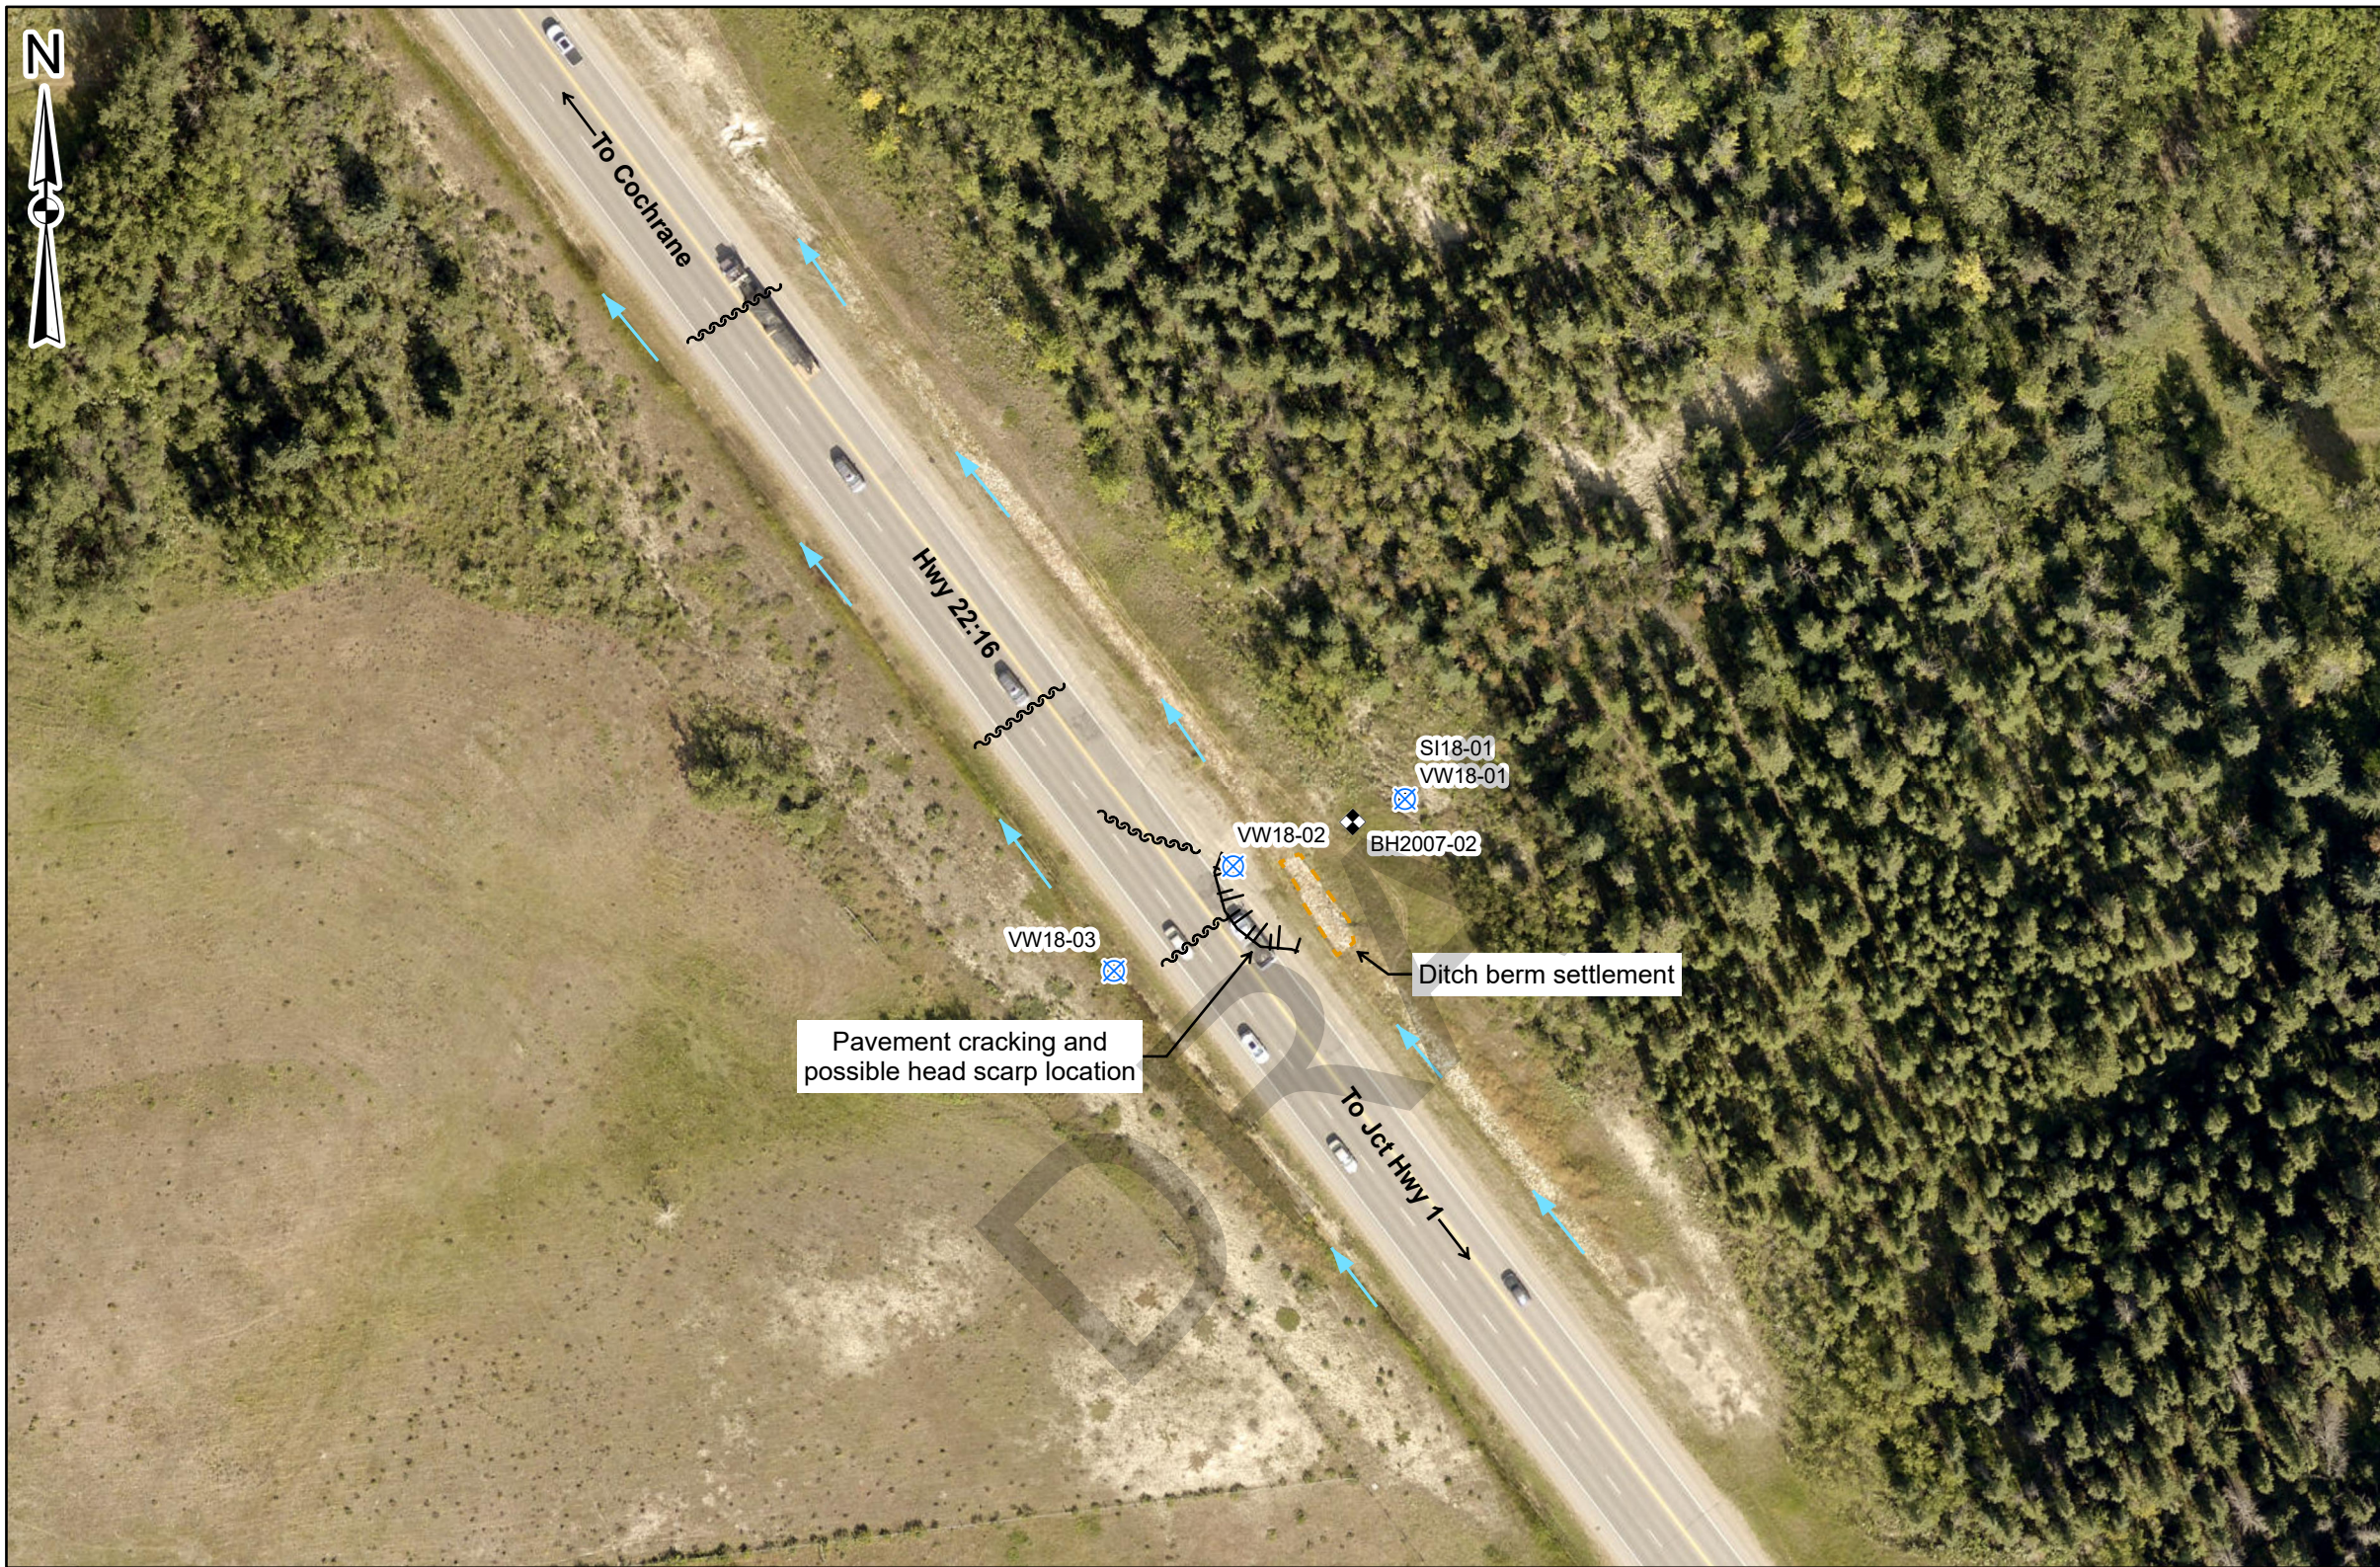
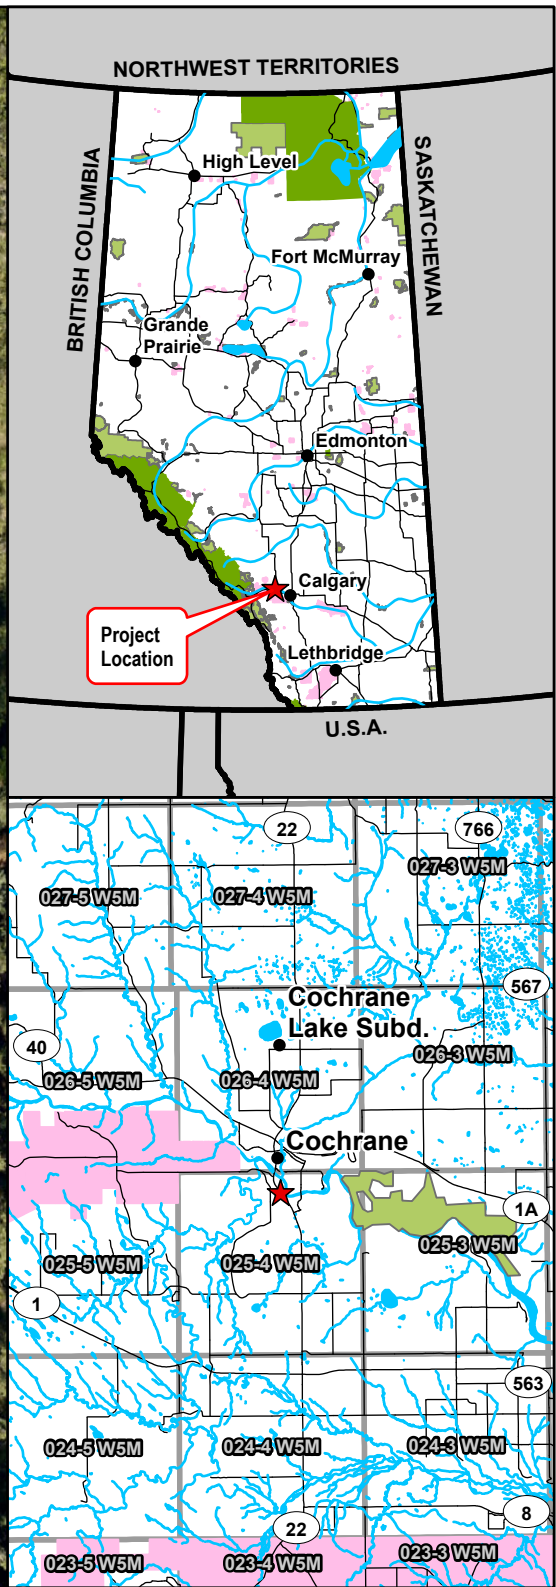
SCALE 1:1,000 PROJECT No. A05116A03 FIG No. 1

The geohazard at the S003 site consists of a landslide along the south slope of the Bow River valley. The landslide encroaches approximately 3 m into the northbound lane of Hwy 22:16. Previous remedial actions at this site include construction of a ditch berm (date unknown) in the northeast (northbound lane) ditch to reduce surface water runoff from discharging onto the landslide. However, in late-2020, ongoing movement of the slide area had caused settlement of the ditch berm such that ditch flows were directed onto the slide area.

A H-pile-wall design was completed by KCB in late-2021. This design also includes repair of the ditch berm. A draft tender has been prepared by KCB (Tender No. 20856), but it has not yet been released by AT for bidding. Construction is anticipated to begin in 2023.

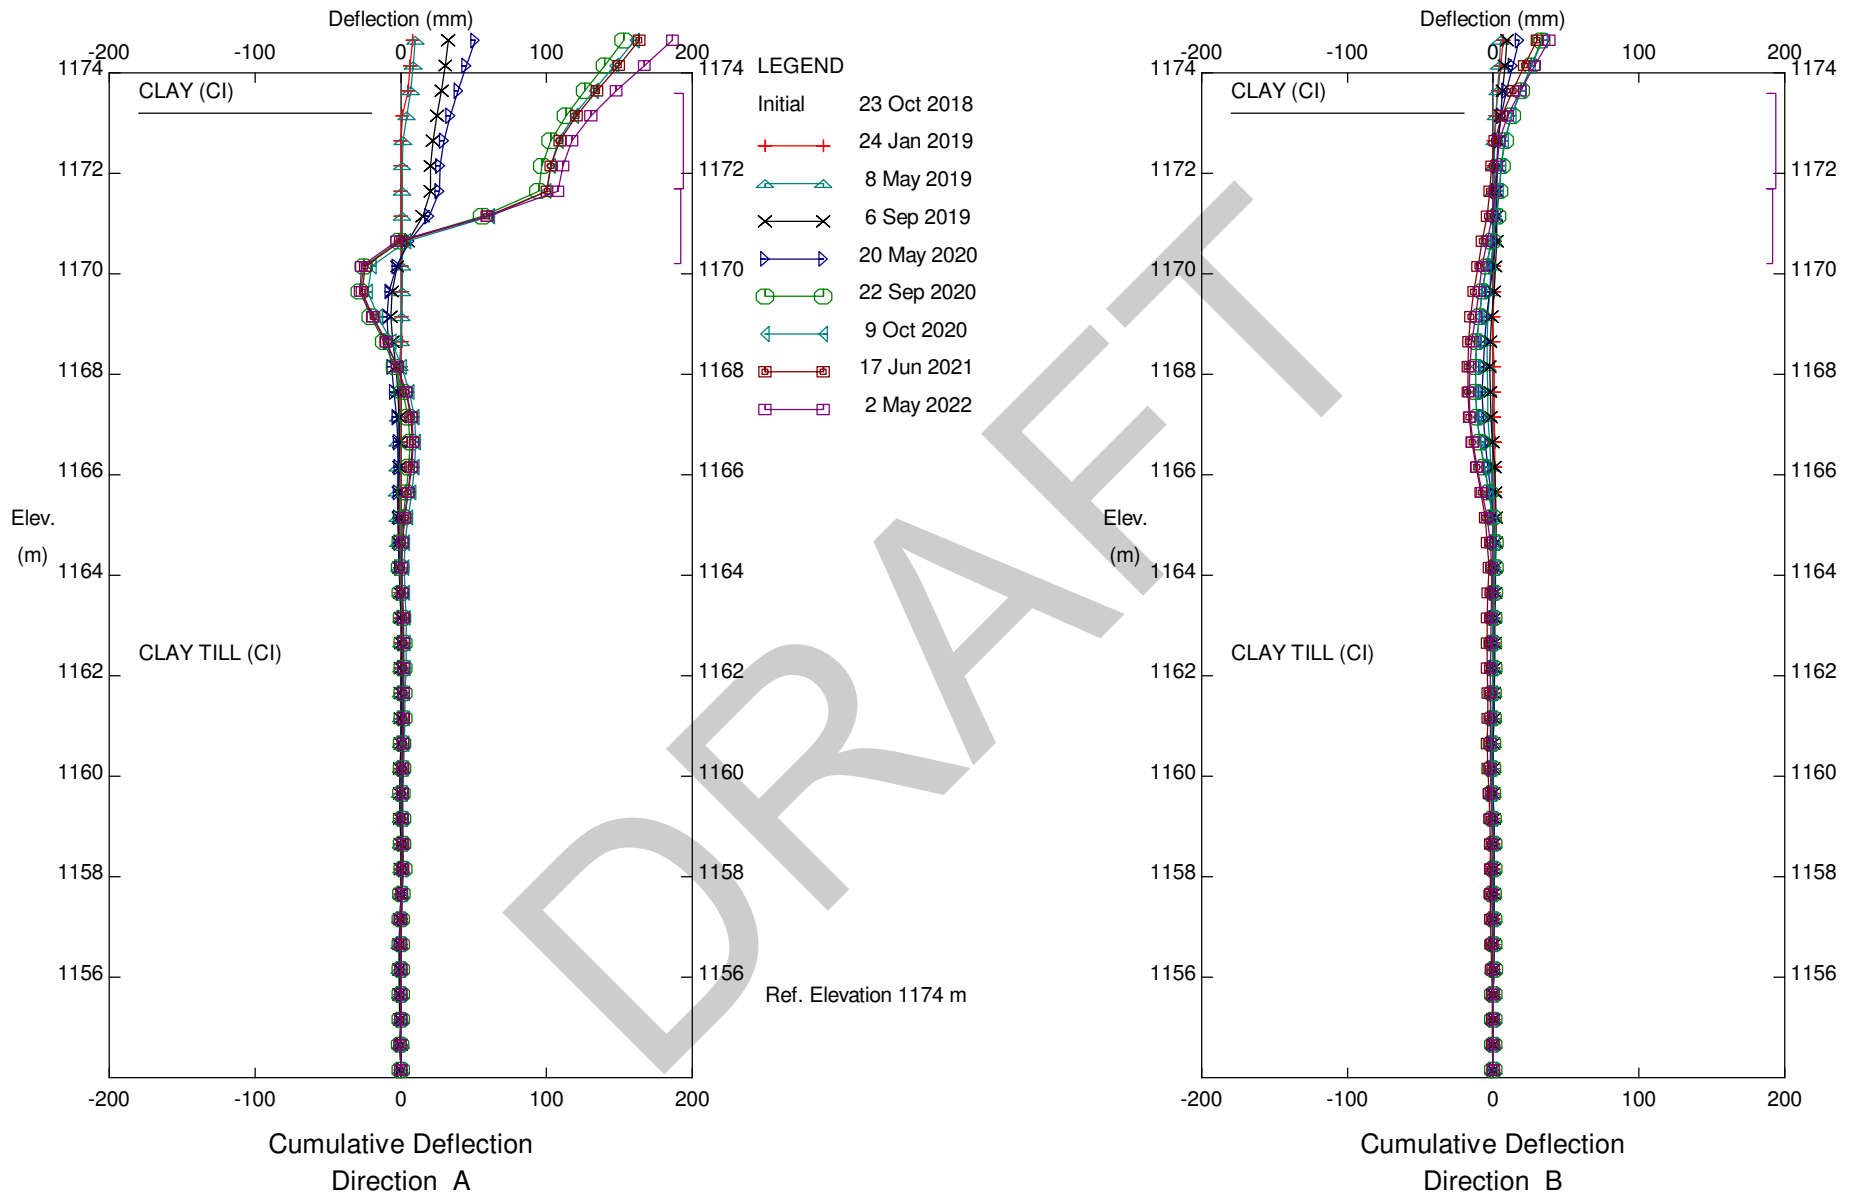
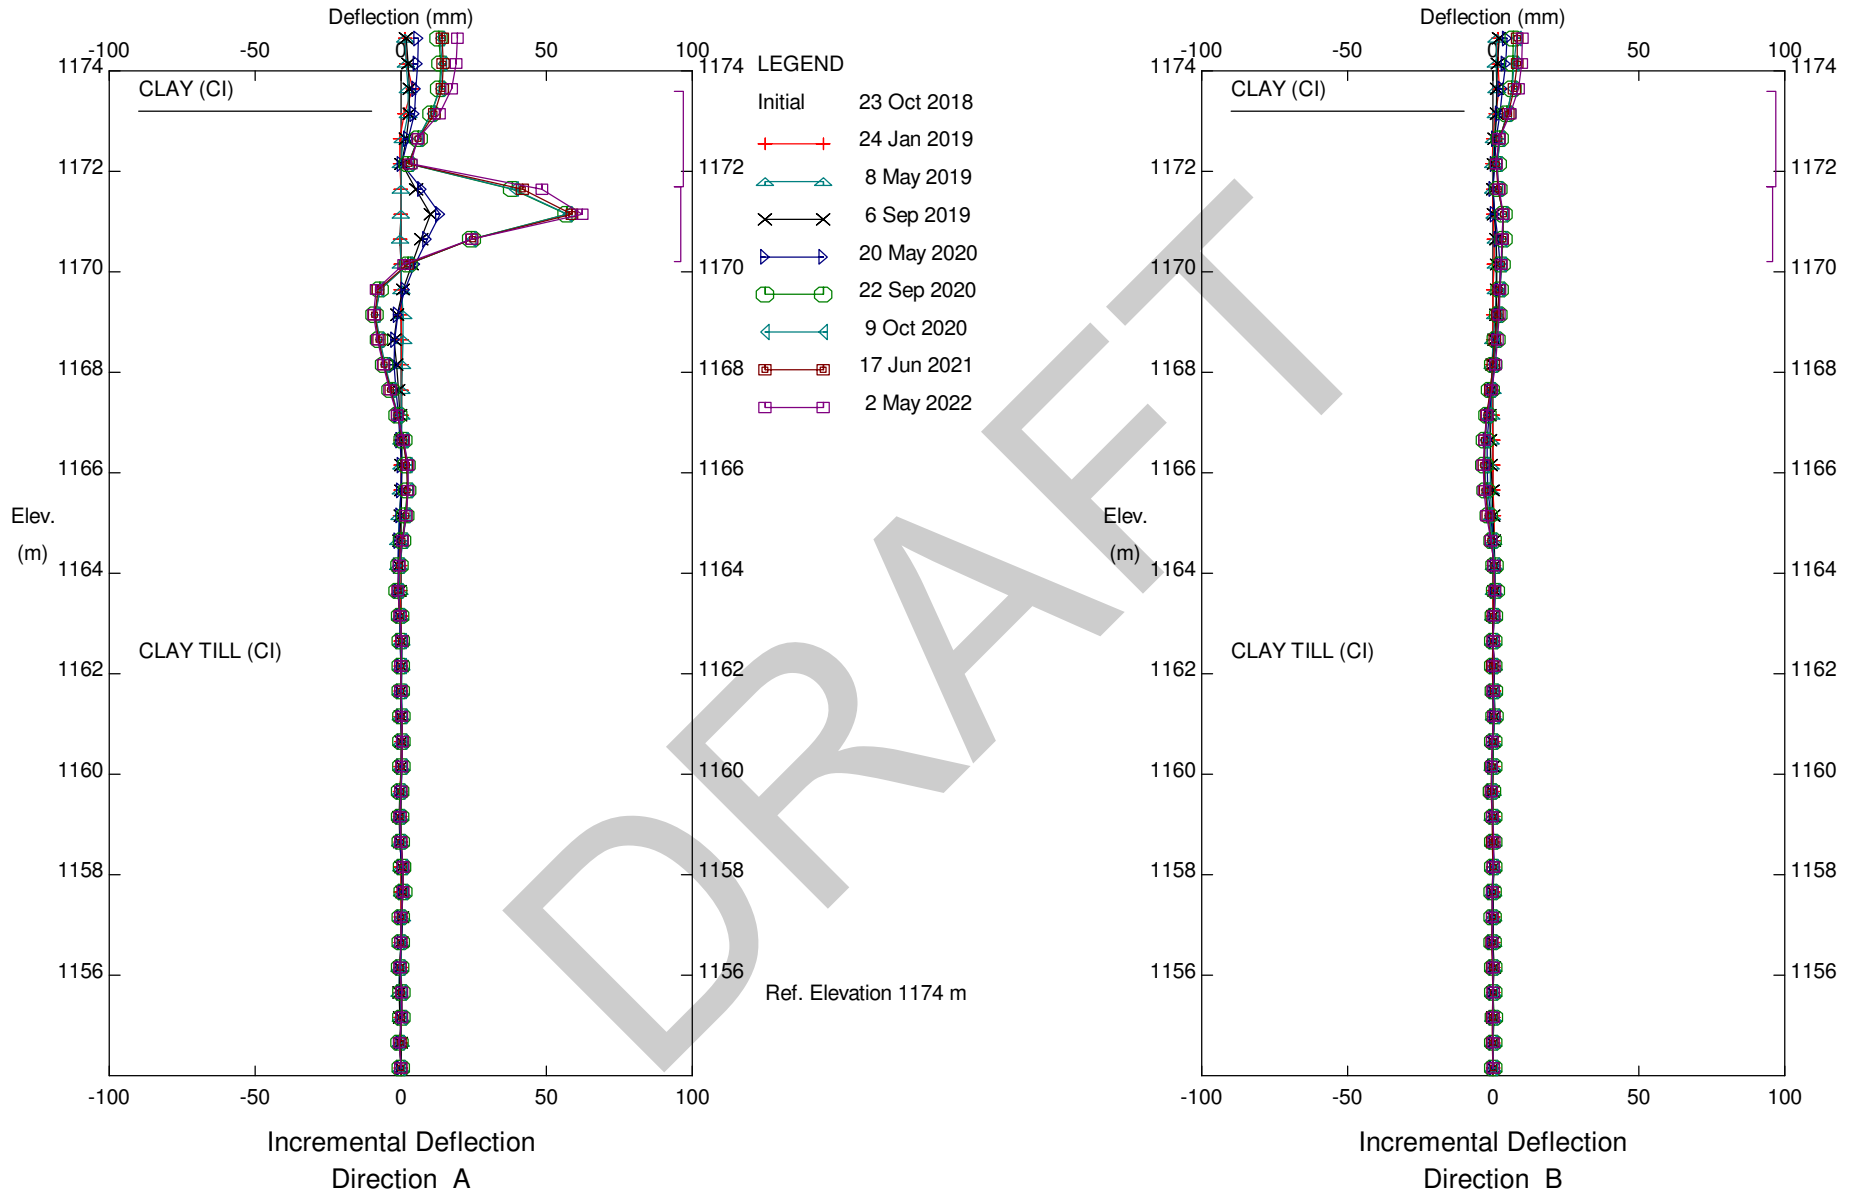
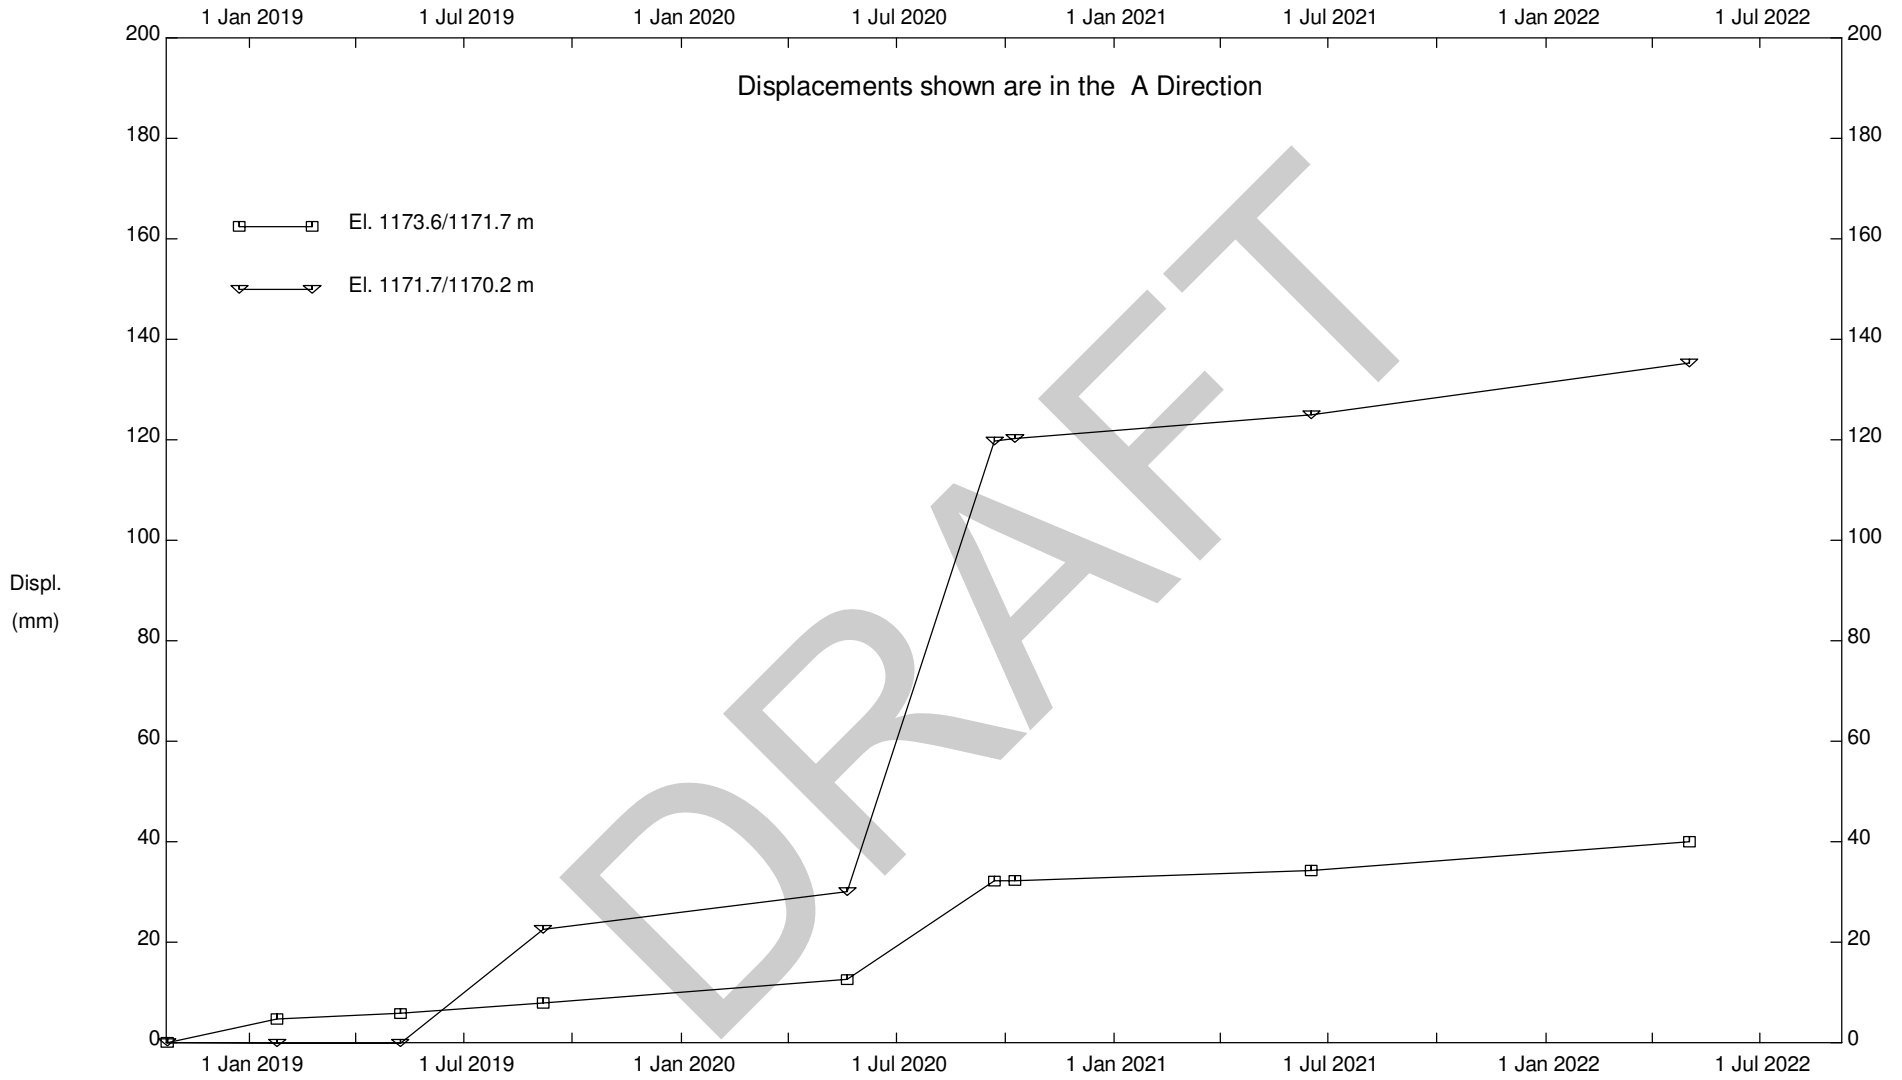
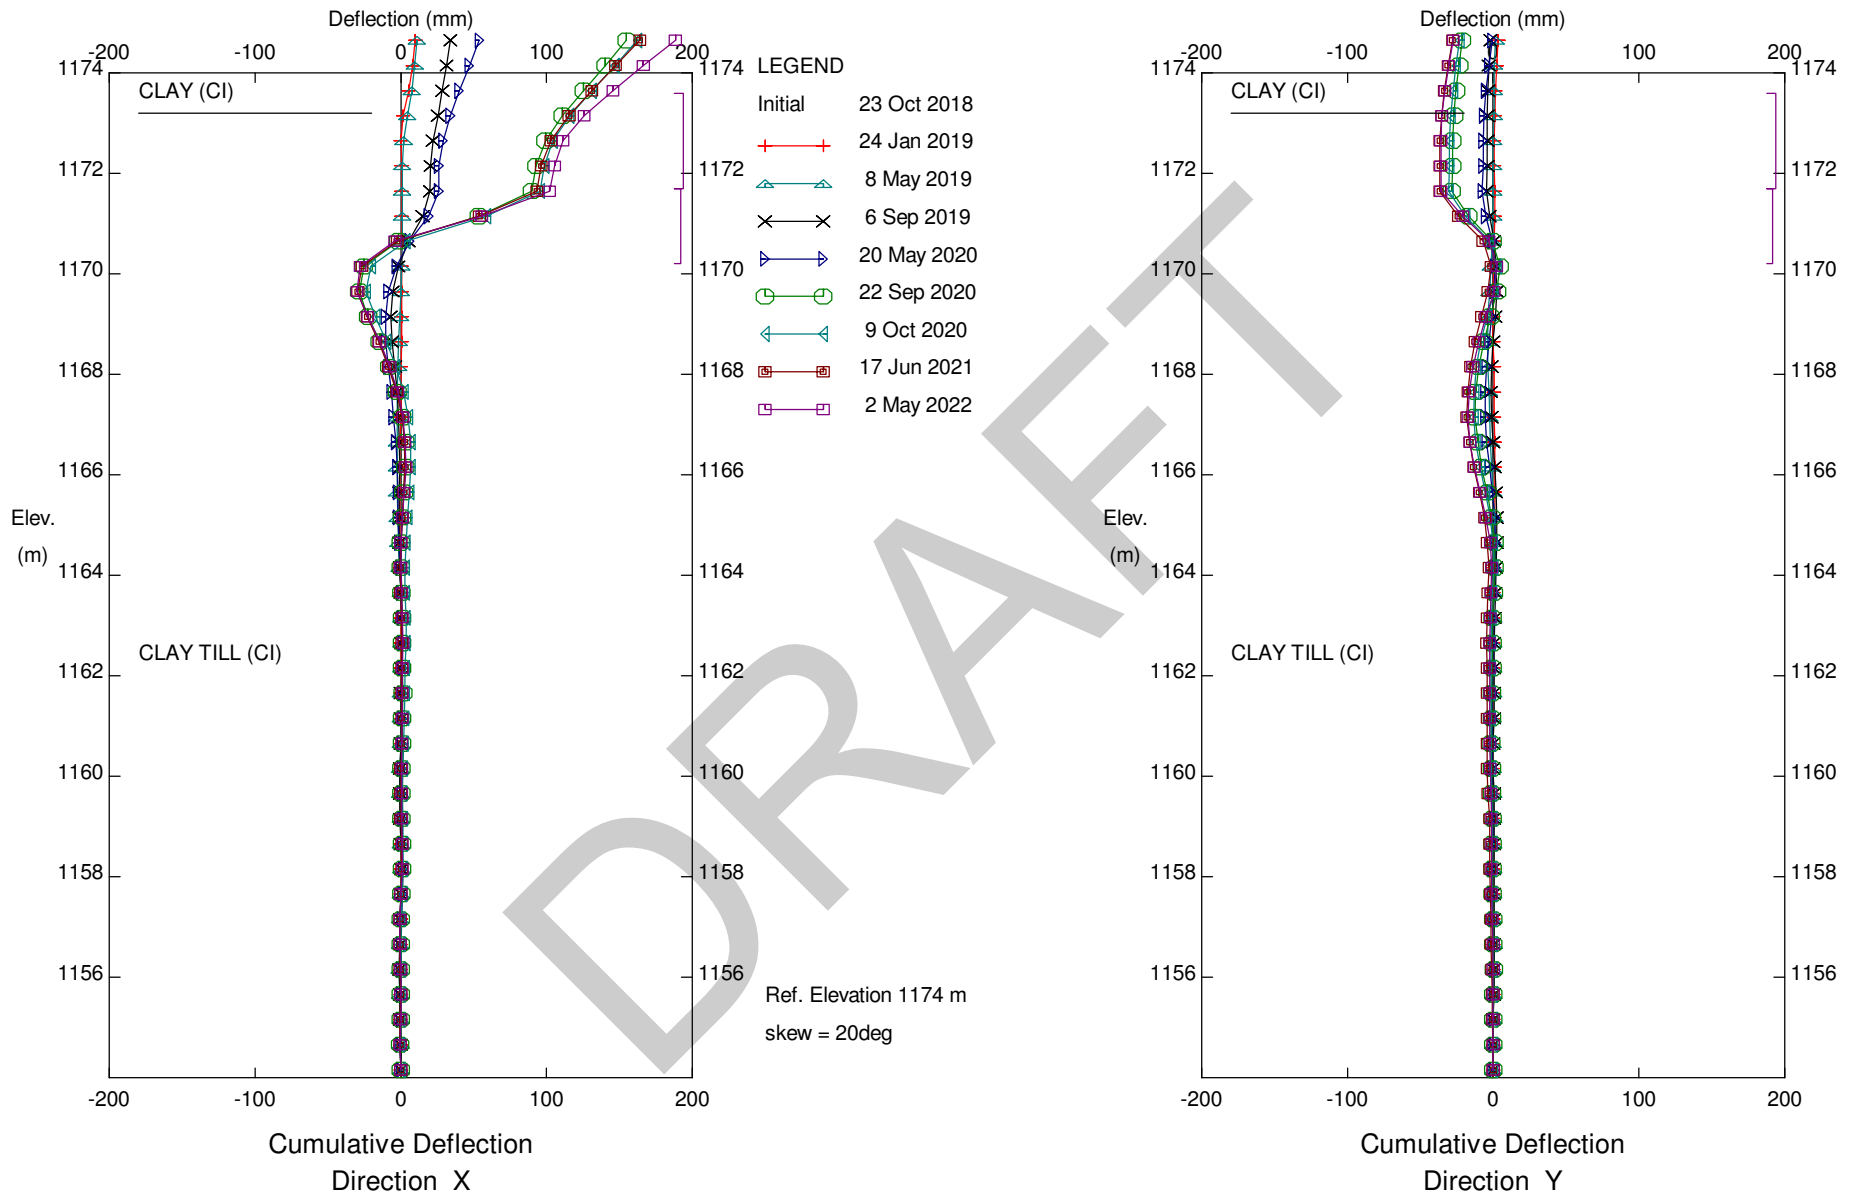
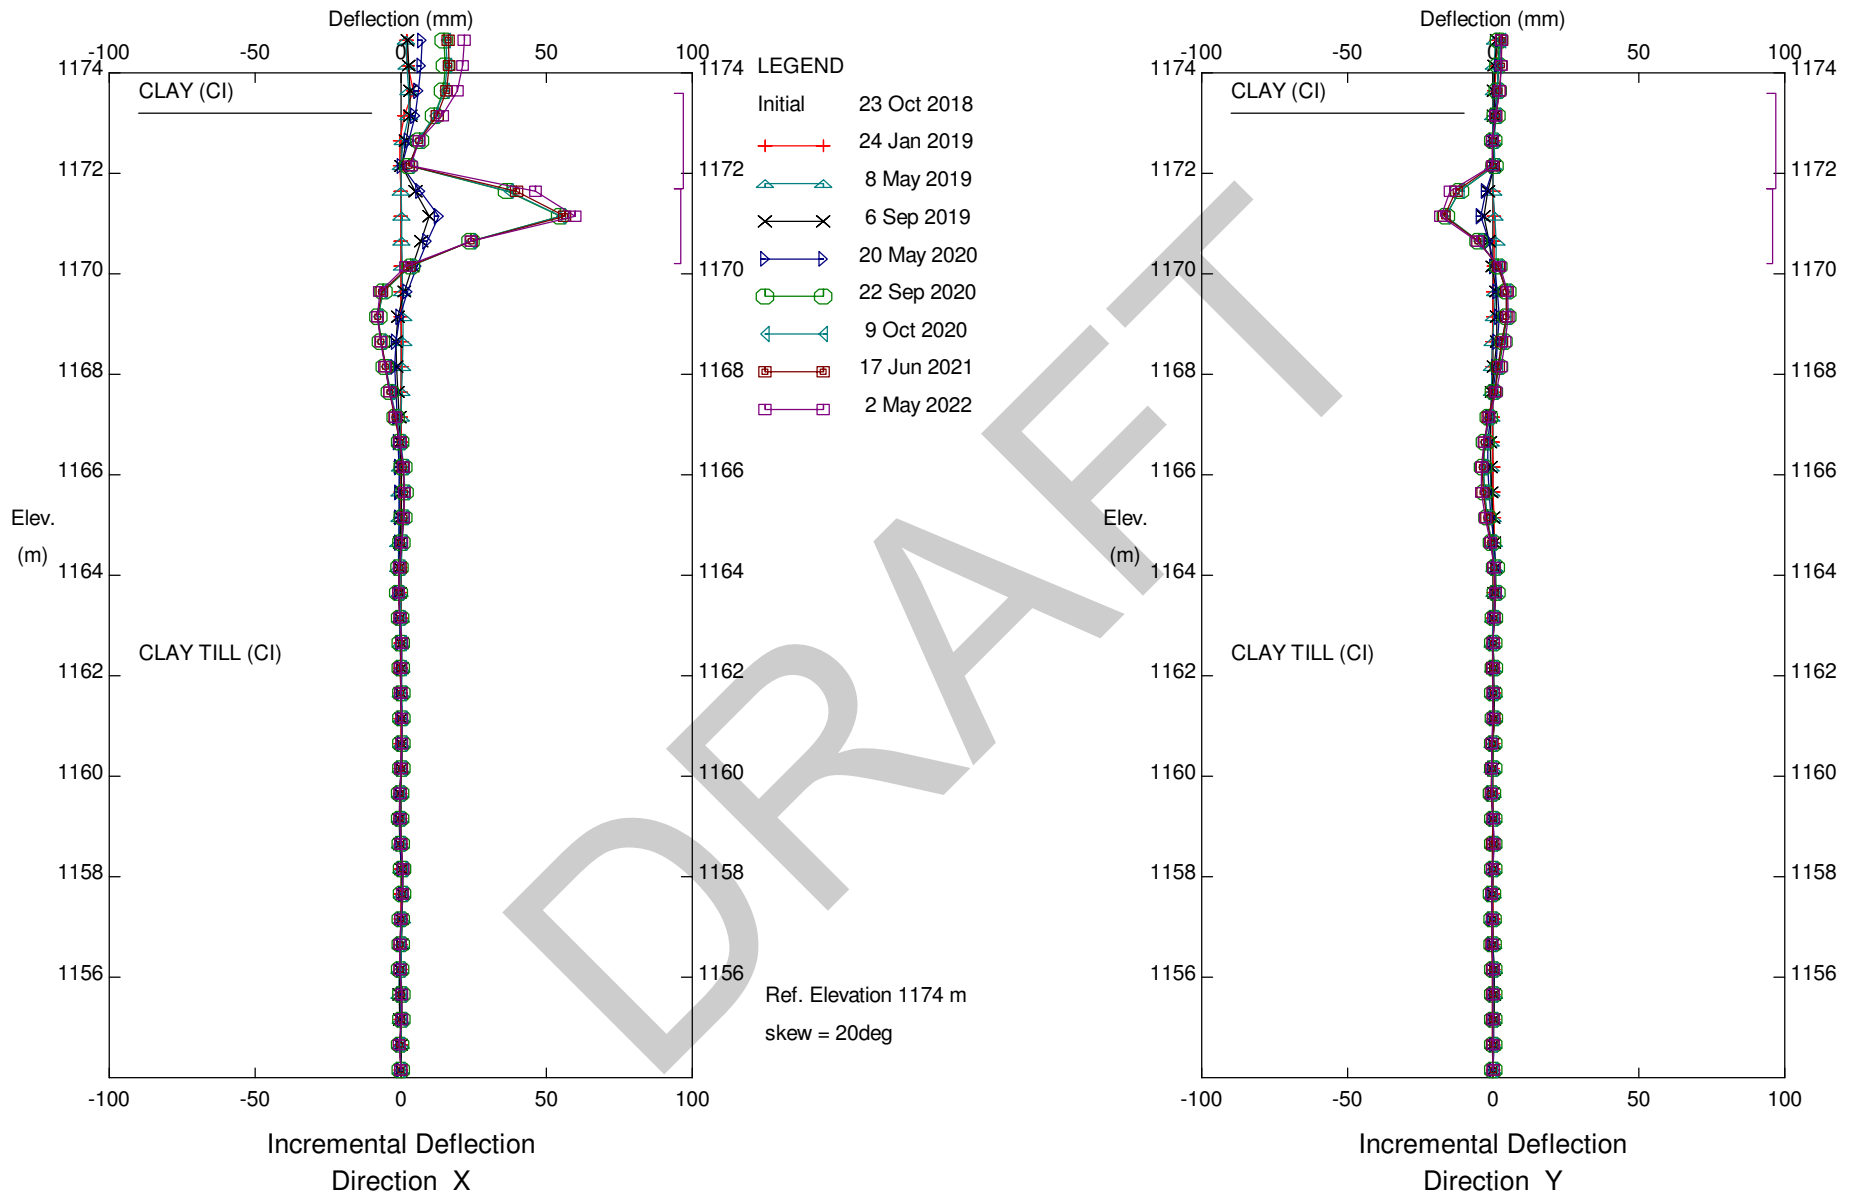
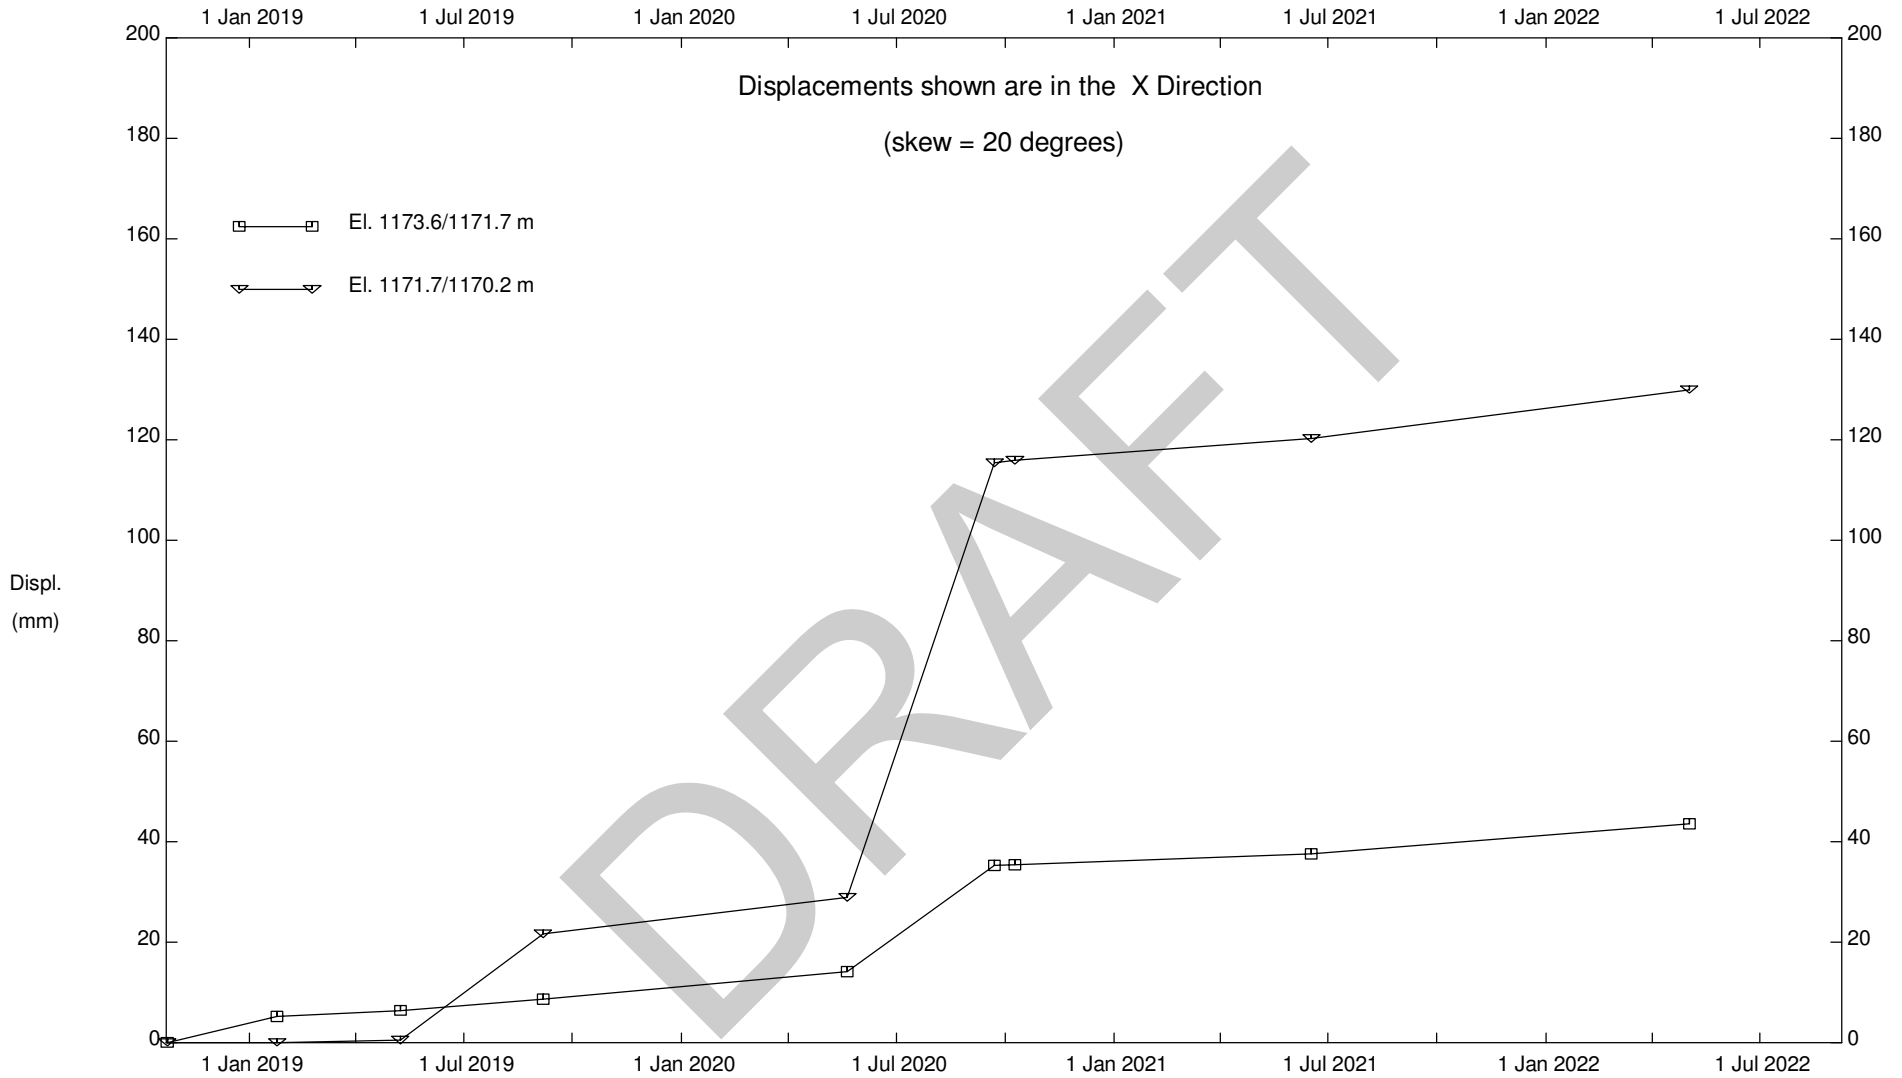
S003; H22:16, Cochrane, Inclinator SI18-01

Distributed movement is being recorded in SI18-01 from ground surface to an approximate depth of 2.3 m below ground surface (approximately El. 1173.6 m to El. 1171.7), and possible discrete movement between 2.3 m and 3.8 m (approximately El. 1171.7 m to El. 1170.2). The casing also appears to be settling or buckling between an approximate depth of 3.8 m and 8.8 m as discussed below. SI18-01 is located near the middle of the slide on the downslope side of the highway.

The settlement or buckling observed in SI18-01 (from approximately 3.8 m and 8.8 m below ground surface) could be an indication that the instrument is poorly grouted with a possible grout void. The readings along this segment also do not stabilize, which further indicates a possible issue with the grout or damage to the casing. The movements of the slide mass and interpretation of the SI data is complicated by the potential for settlement or buckling of the SI casing in the poorly grouted casing segment.

The rate of movement recorded in SI18-01 has been relatively steady (approximately 3 mm/year to 11 mm/year) since the fall 2020 reading. However, last year and the spring of 2021 were relatively dry (see monthly precipitation data on piezometer plots in Appendix I). During the previous periods of wet weather in 2019 and 2020, the rate of movement had increased to approximately 4 mm/year and 62 mm/year, respectively. Increased movement may occur again in response to prolonged or heavy rainfall, resulting in higher groundwater conditions, especially now that the ditch berm has settled and has reduced capacity to divert surface water flows away from the slide area.

Approximately 160 mm of cumulative movement has been recorded in SI18-01 since installation. We expect this instrument may shear soon. SI18-01 was installed to support design of a H-pile wall and drainage improvements to mitigate the impacts of the slope movement on Hwy 22:16. The H-pile wall design is complete, and the tender is waiting for release. If the SI becomes unreadable or unreliable, readings can cease, and monitoring can be conducted on pavement surface deformations until the H-pile wall and drainage improvements are constructed.

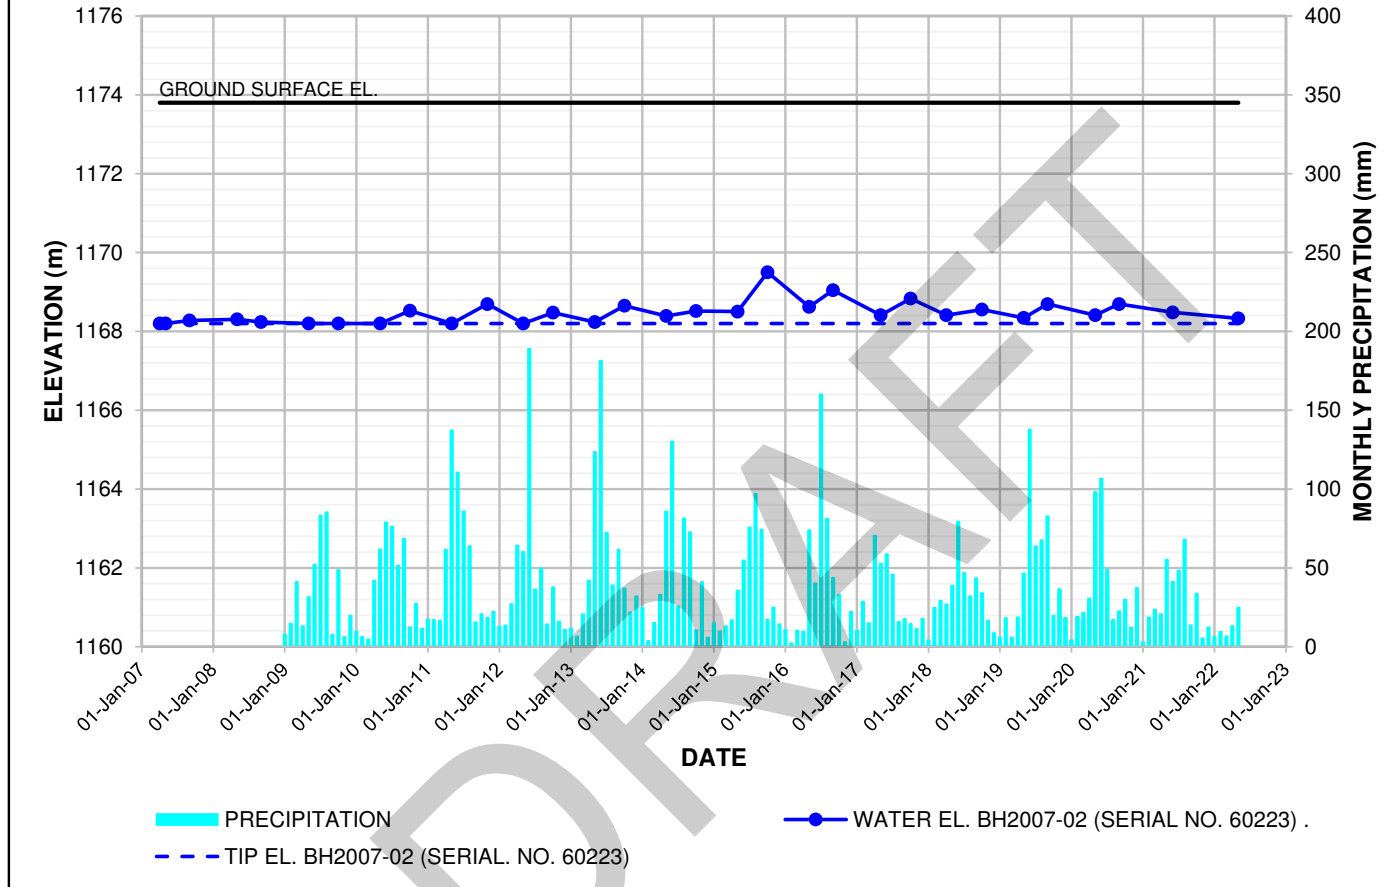
BH2007-02 (SERIAL NO. 60223)

Water levels recorded in BH2007-02 (Serial No. 60223) fluctuate seasonally (with the spring readings being lower than fall readings) from approximately 4.3 m to 5.6 m below ground surface.

Between May and July 2022, the above-ground tubing for BH2007-02 was damaged and the tip for the instrument was missing. KCB will replace the tip during the fall 2022 readings, and assess if the instrument is still operable.

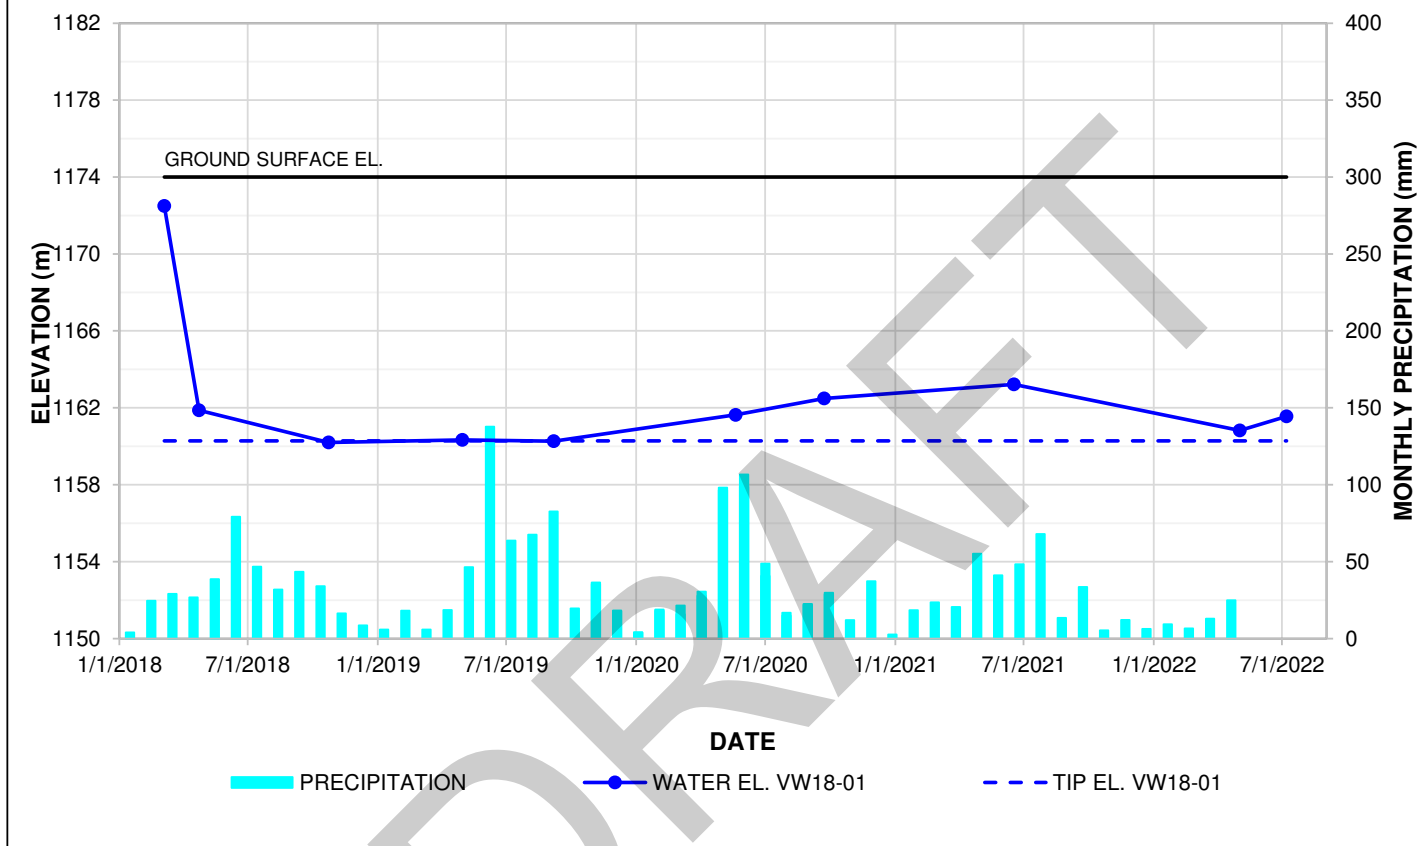
VW18-01 (SERIAL NO. 1800200)

The initial readings for the VWP (VW18-01 through VW18-03) were taken immediately following grouting operations, and KCB believes that the initial water levels recorded in the VWPs were artificially high due to grouting. Water levels recorded in these instruments decreased up to 12 m within a month of installation.

Excluding the first reading, water levels recorded in VW18-01 (located within the slide mass, downslope from the highway) have varied from 8.8 m and 12.0 m below ground surface, and water levels in VW18-02 (located within the slide mass, on the east shoulder of the highway) have varied from approximately 7.7 m and 10.1 m below ground surface. These water levels are below the depth of movement recorded in the SIs (between ground surface and 4.0 m below ground surface). The data indicates slide movements are like in response to periods of increased precipitation when surface water infiltrates into the top few meters destabilizing the slope.

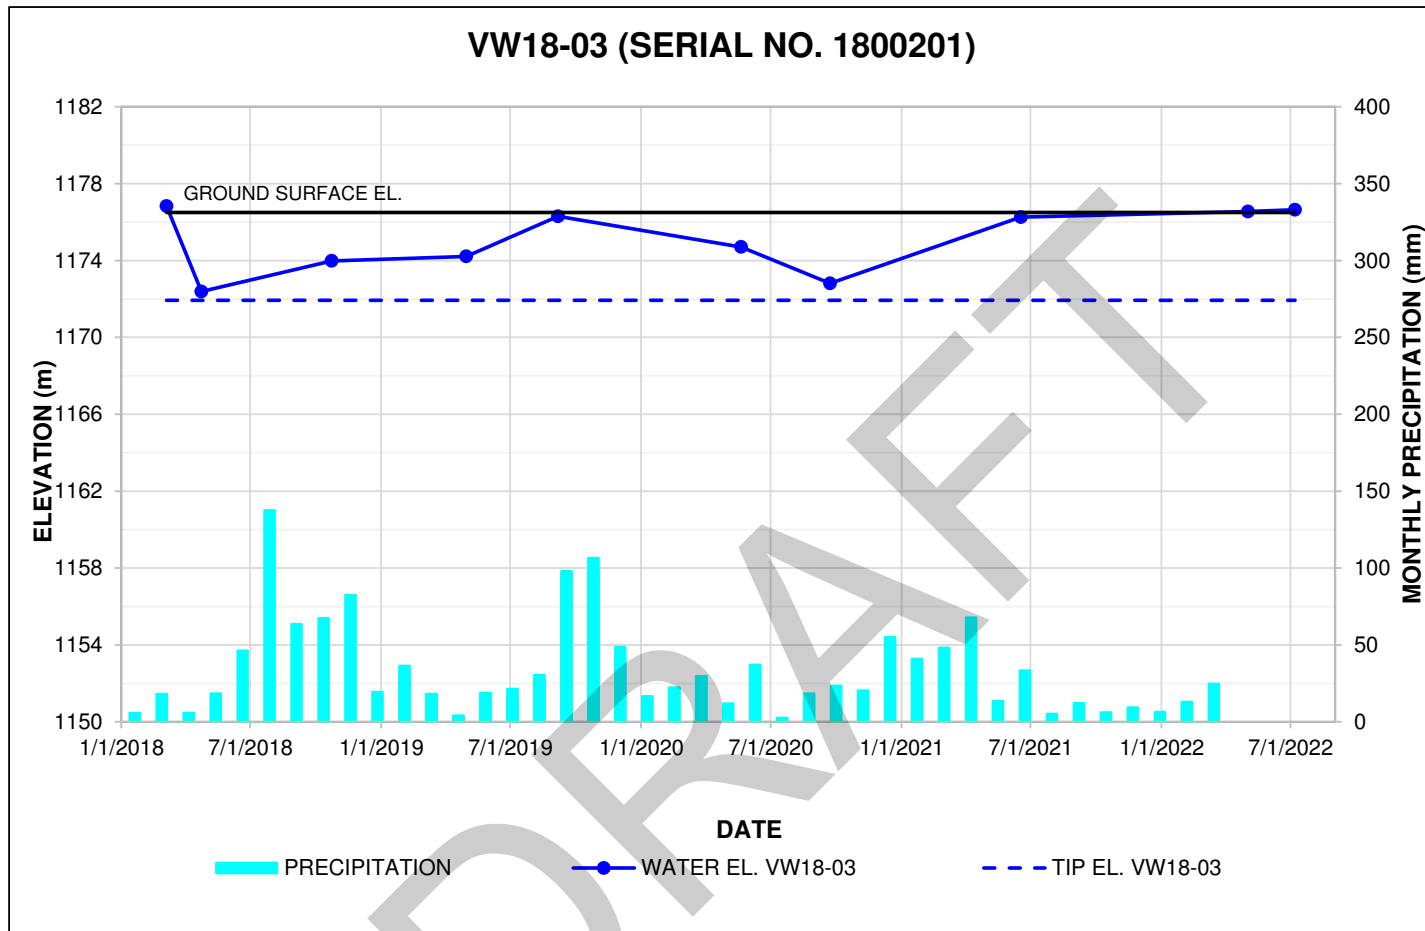
VW18-03 (SERIAL NO. 1800201)

Water levels recorded in VW18-03 (located in the west highway ditch) have been near ground surface (± 0.1 m) since June 2021. Periods of increased water levels were recorded in 2019, 2021, and 2022 and can most likely be attributed to periods of increased precipitation.
