November 29, 2024

CON0022161 Southern Region GRMP Instrumentation Monitoring
Site S003; H22:16 km 9.9 Cochrane
Section C – 2024 Fall Readings

PROJECT SOUTHERN REGION GEOHAZARD RISK MANAGEMENT PROGRAM		
TITLE Site Plan S003 - Cochrane Hwy 22:16, km 9.875		
SCALE 1:1,000	PROJECT No. A05116A03	FIG No. 1

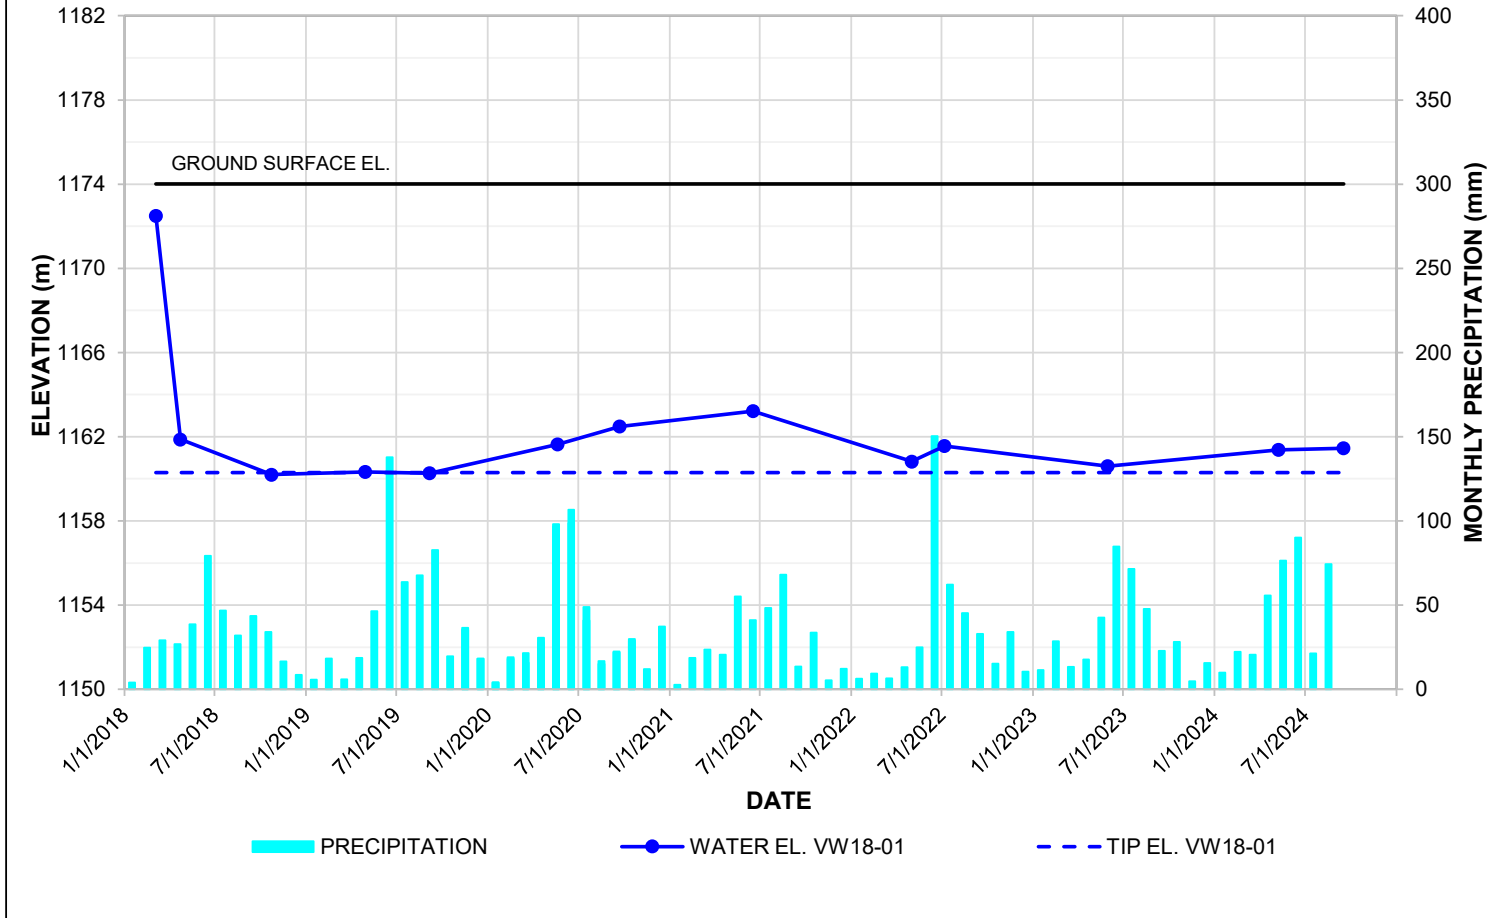
VW18-01 (SERIAL NO. 1800200)

The initial readings for the VWP (VW18-01 through VW18-03) were taken immediately following grouting operations, and KCB believes that the initial water levels recorded in the VWPs were artificially high due to grouting. Water levels recorded in these instruments decreased up to 12 m within a month of installation.

Excluding the first reading, water levels recorded in VW18-01 (located within the slide mass, downslope from the highway) have varied from 8.8 m and 13.4 m below ground surface, and water levels in VW18-02 (located within the slide mass, on the east shoulder of the highway) have varied from approximately 7.7 m and 10.1 m below ground surface. These water levels are below the depth of movement recorded in the SI (between ground surface and 4.0 m below ground surface). The data indicates slide movements are likely in response to periods of increased precipitation when surface water infiltrates into the top few meters, destabilizing the slope.

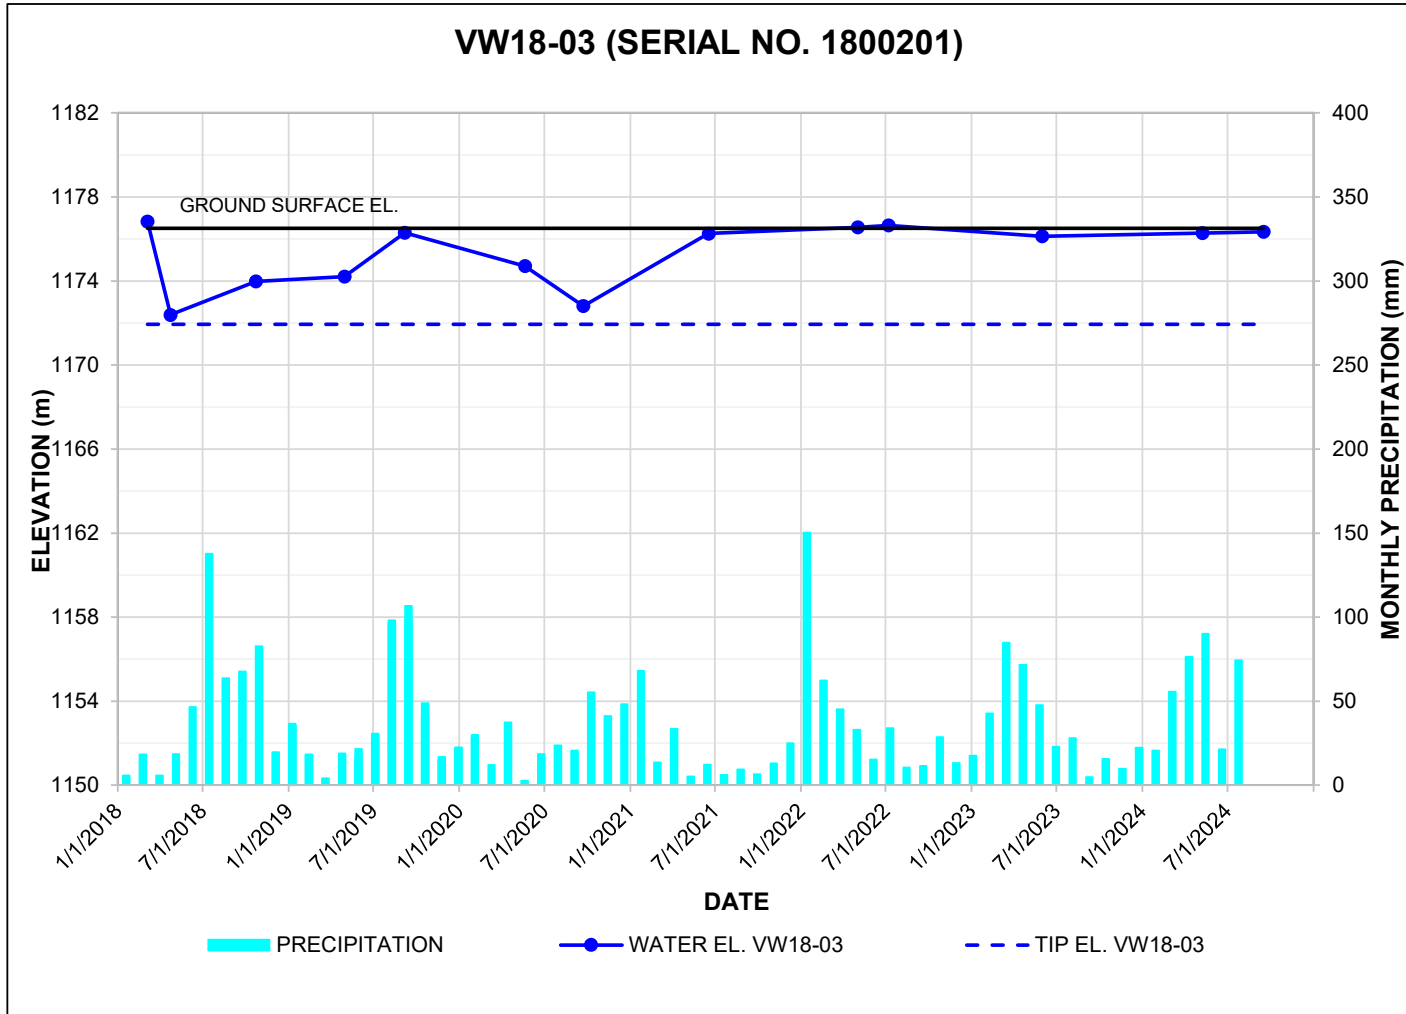
VW18-03 (SERIAL NO. 1800201)

Water levels recorded in VW18-03 (located in the west highway ditch) have been within 0.4 m of ground surface since 2021. The fall 2024 was recorded at 0.2 m below ground surface. Rainfall data past August 31, 2024 was not available at the time of writing this report, further discussion on how the piezometers respond to increased rainfall will be discussed in subsequent reports once the data is available.

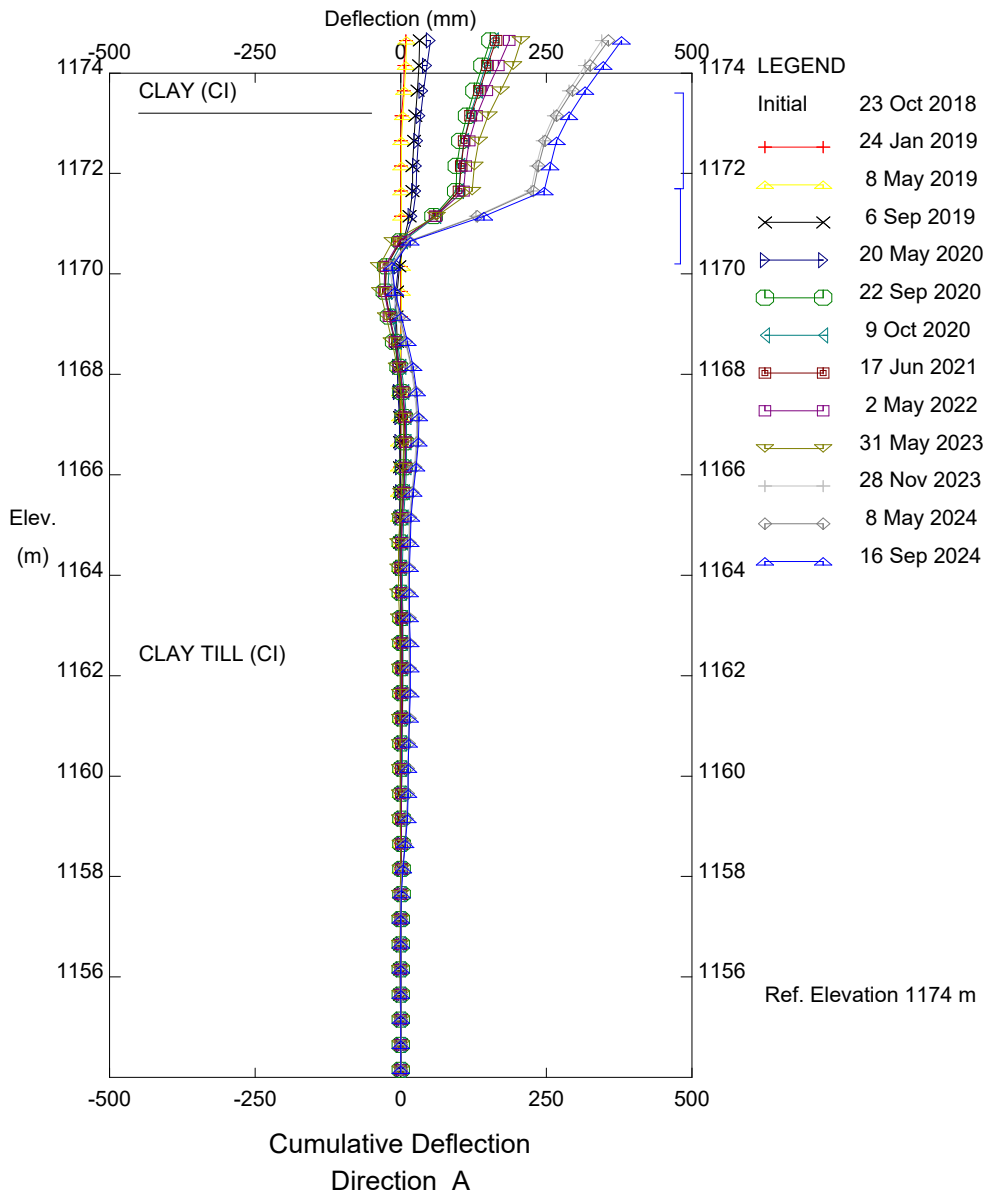
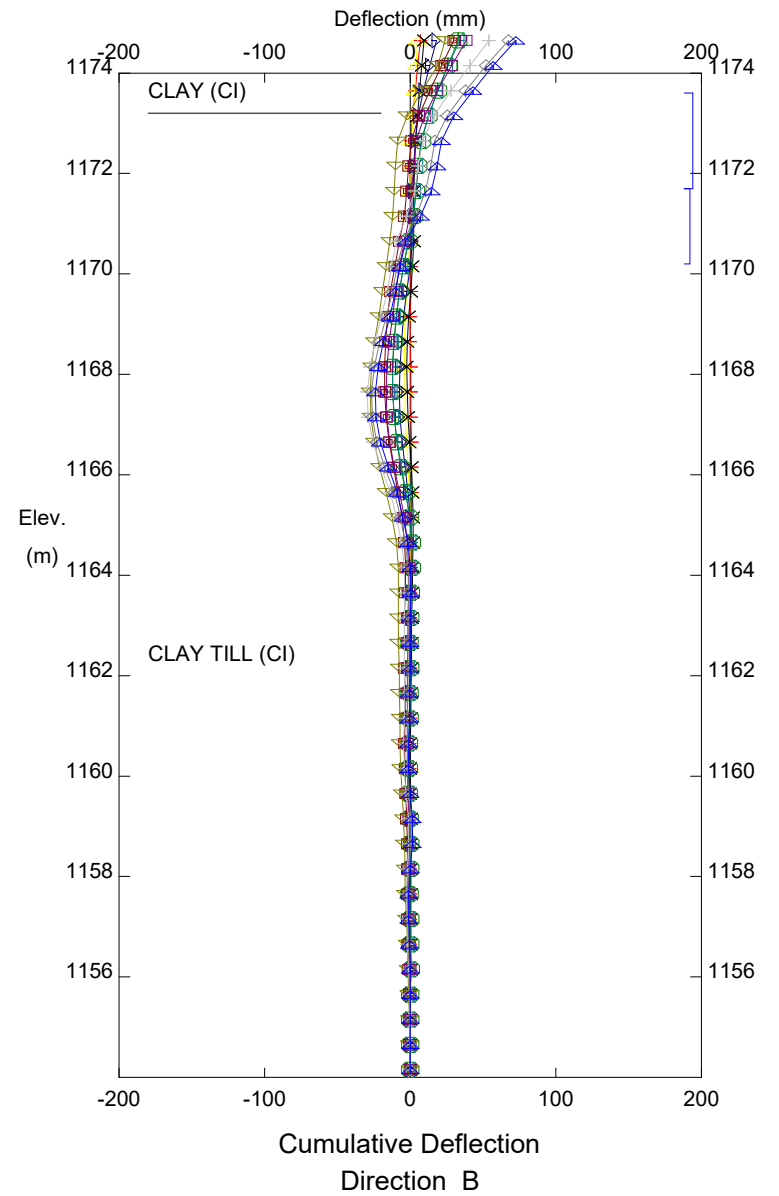
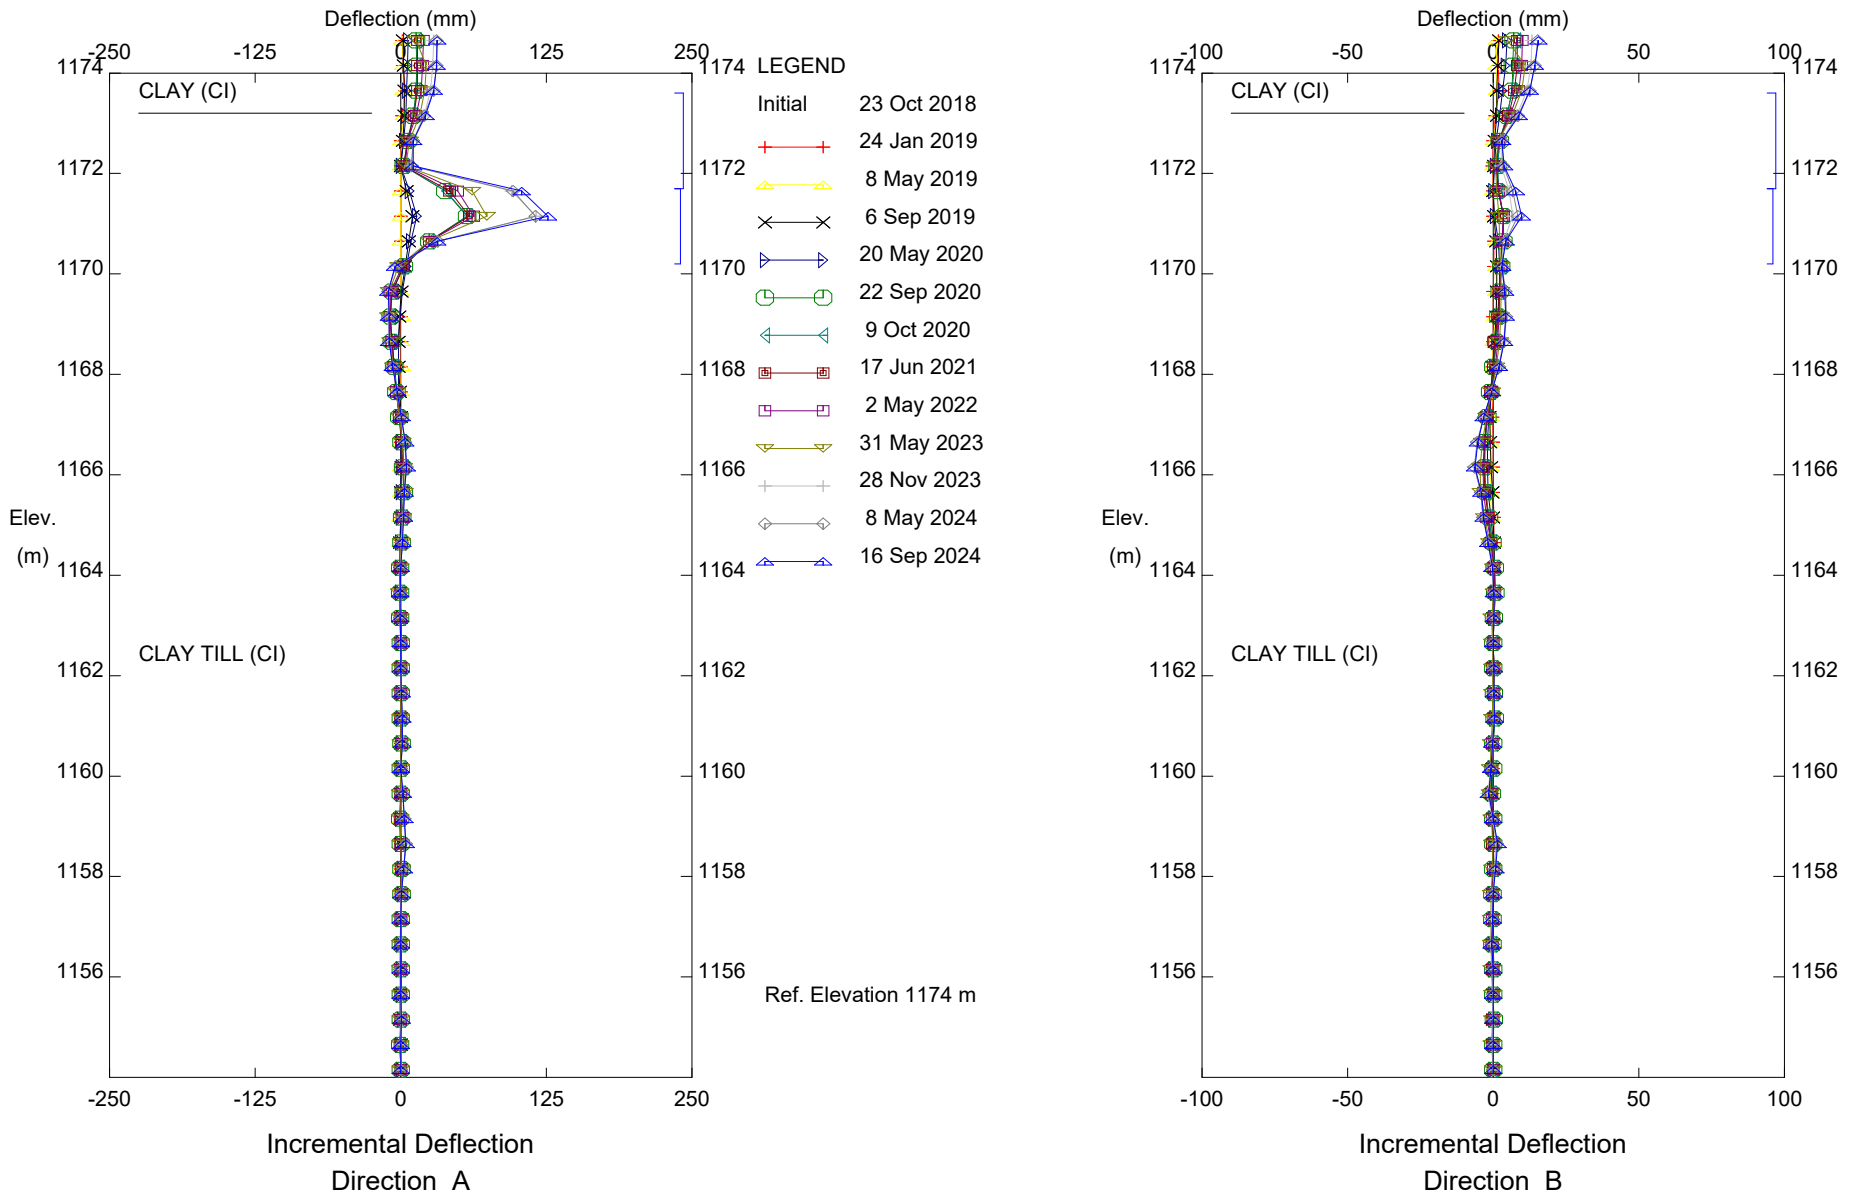
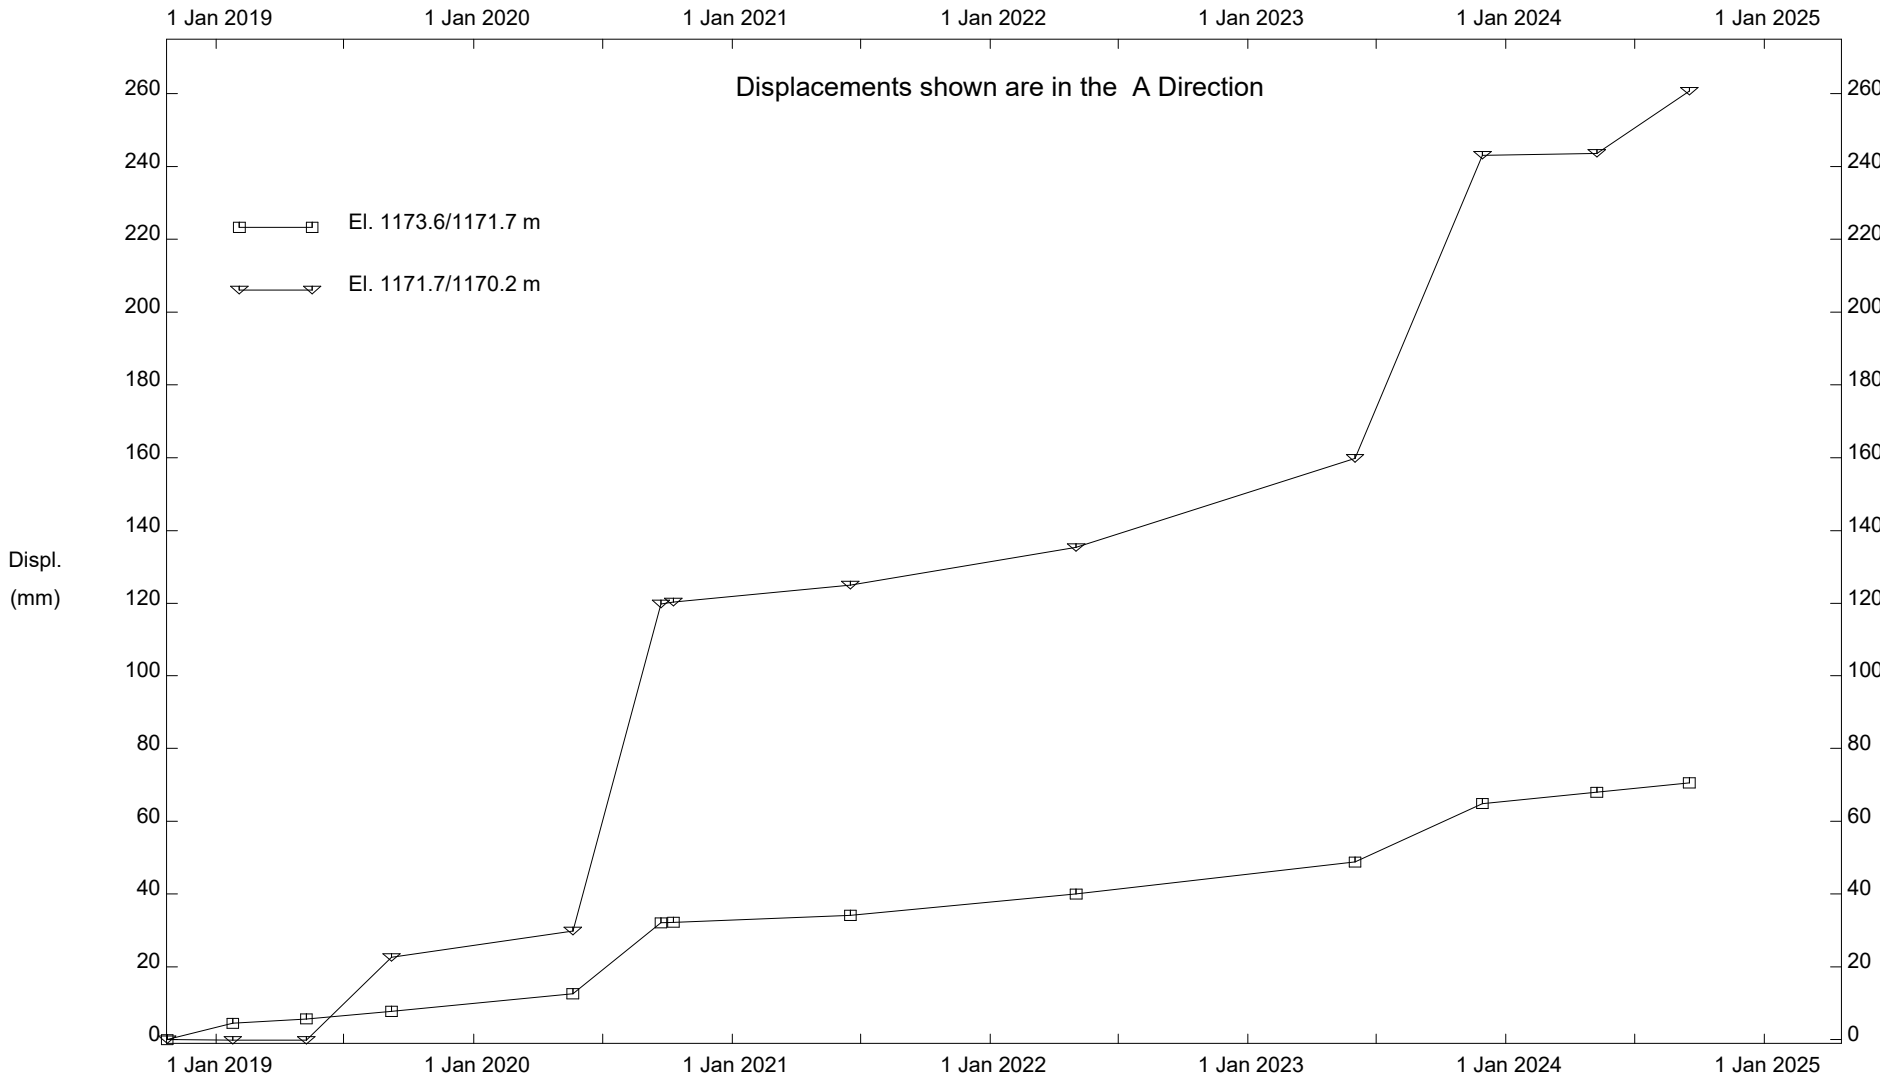
S003; H22:16, Cochrane, Inclinometer SI18-01
 Alberta Transportation

Distributed movement is being recorded in SI18-01 from ground surface to an approximate depth of 2.3 m below ground surface (approximately El. 1173.6 m to El. 1171.7), and possible discrete movement between 2.3 m and 3.8 m (approximately El. 1171.7 m to El. 1170.2). The casing also appears to be settling or buckling between an approximate depth of 3.8 m and 8.8 m as discussed below. SI18-01 is located near the middle of the slide on the downslope side of the highway.

The settlement or buckling observed in SI18-01 (from approximately 3.8 m and 8.8 m below ground surface) could be an indication that the instrument is poorly grouted with a possible grout void. The readings along this segment also do not stabilize, which further indicates a possible issue with the grout or damage to the casing. The movements of the slide mass and interpretation of the SI data is complicated by the potential for settlement or buckling of the SI casing in the poorly grouted casing segment.

Approximately 331 mm of cumulative movement has been recorded in SI18-01 since installation from a depth of 3.8 mbgs to ground surface. We expect this instrument may shear soon. SI18-01 was installed to support the design of an H-pile wall and drainage improvements to mitigate the impacts of the slope movement on Hwy 22:16.

Approximately 104 mm of movement was measured in SI18-01 between the spring 2023 reading and the reading taken post pile wall construction (November 2023) from a depth of 3.8 mbgs to surface. During construction, survey monitoring pins installed downslope of the pile wall measured horizontal movement up to 67 mm in the downslope direction in the slide zone at surface. This movement is believed to be due to added weight on the slope during pile installation from the piling rig, potential excess pore pressures in the slope due to pile installation and vibrations due to pile installation.

Cumulative movement in SI18-01 between the November 2023 (post construction) and the spring 2024 readings measured an additional 4 mm of cumulative movement in the upper 3.8 m. An additional 20 mm of cumulative movement was measured between spring 2024 and fall 2024 in the upper 3.8 m.

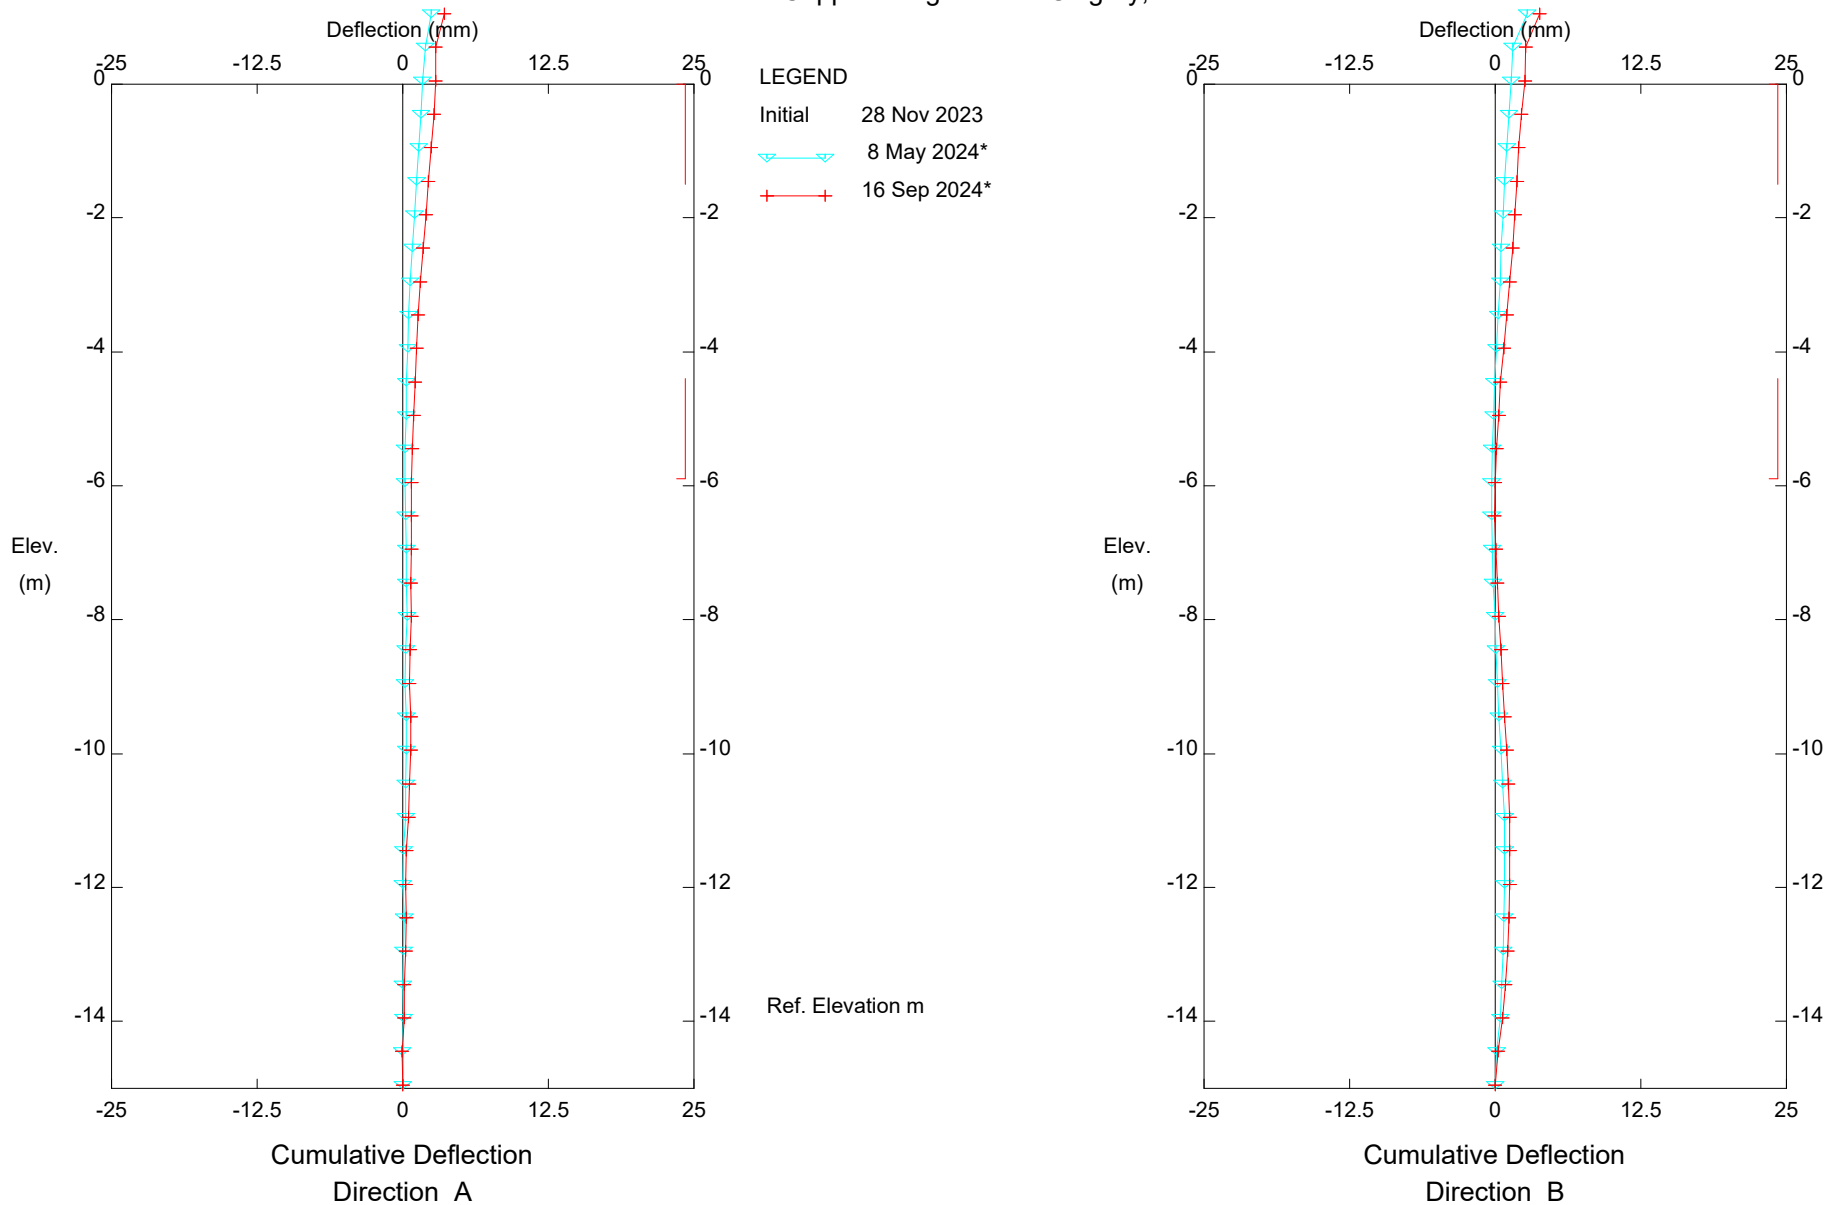
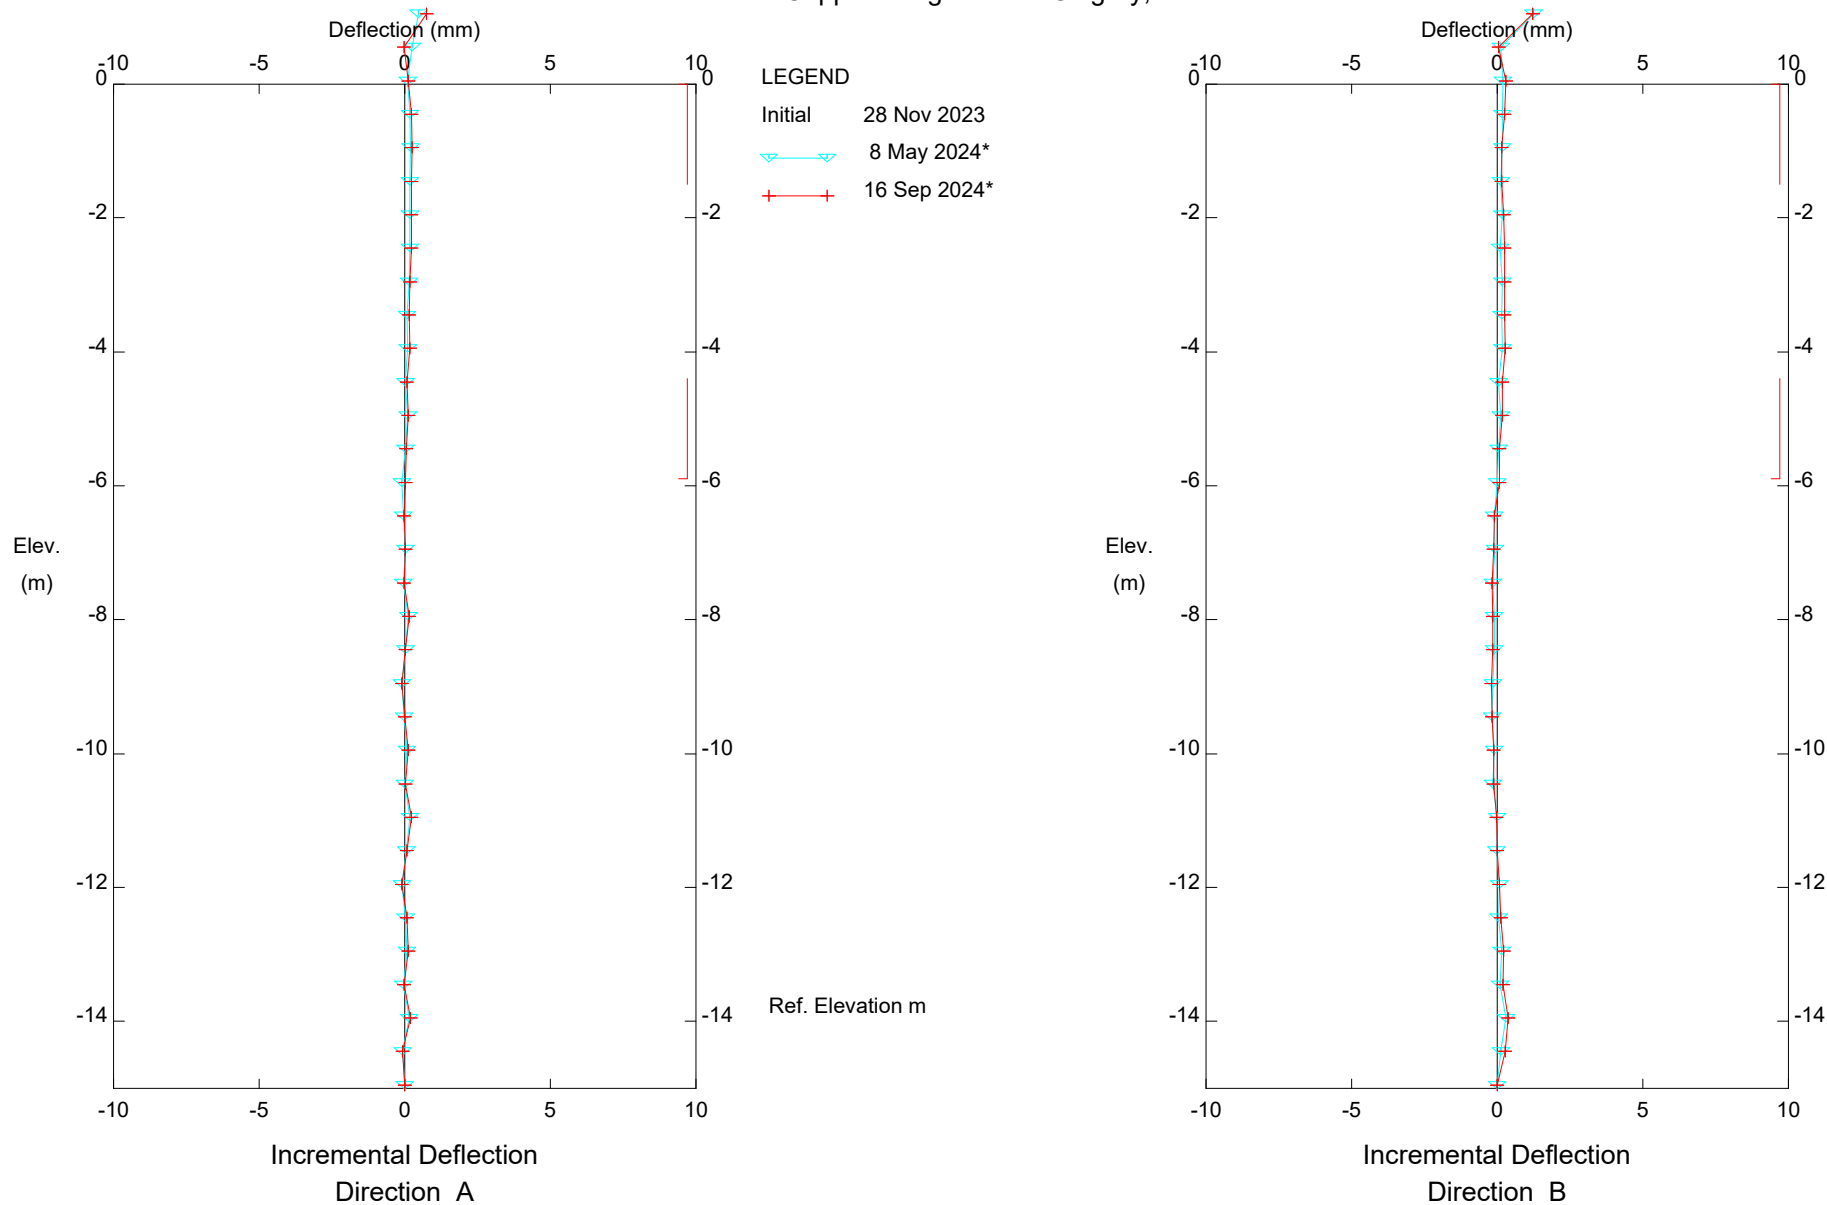
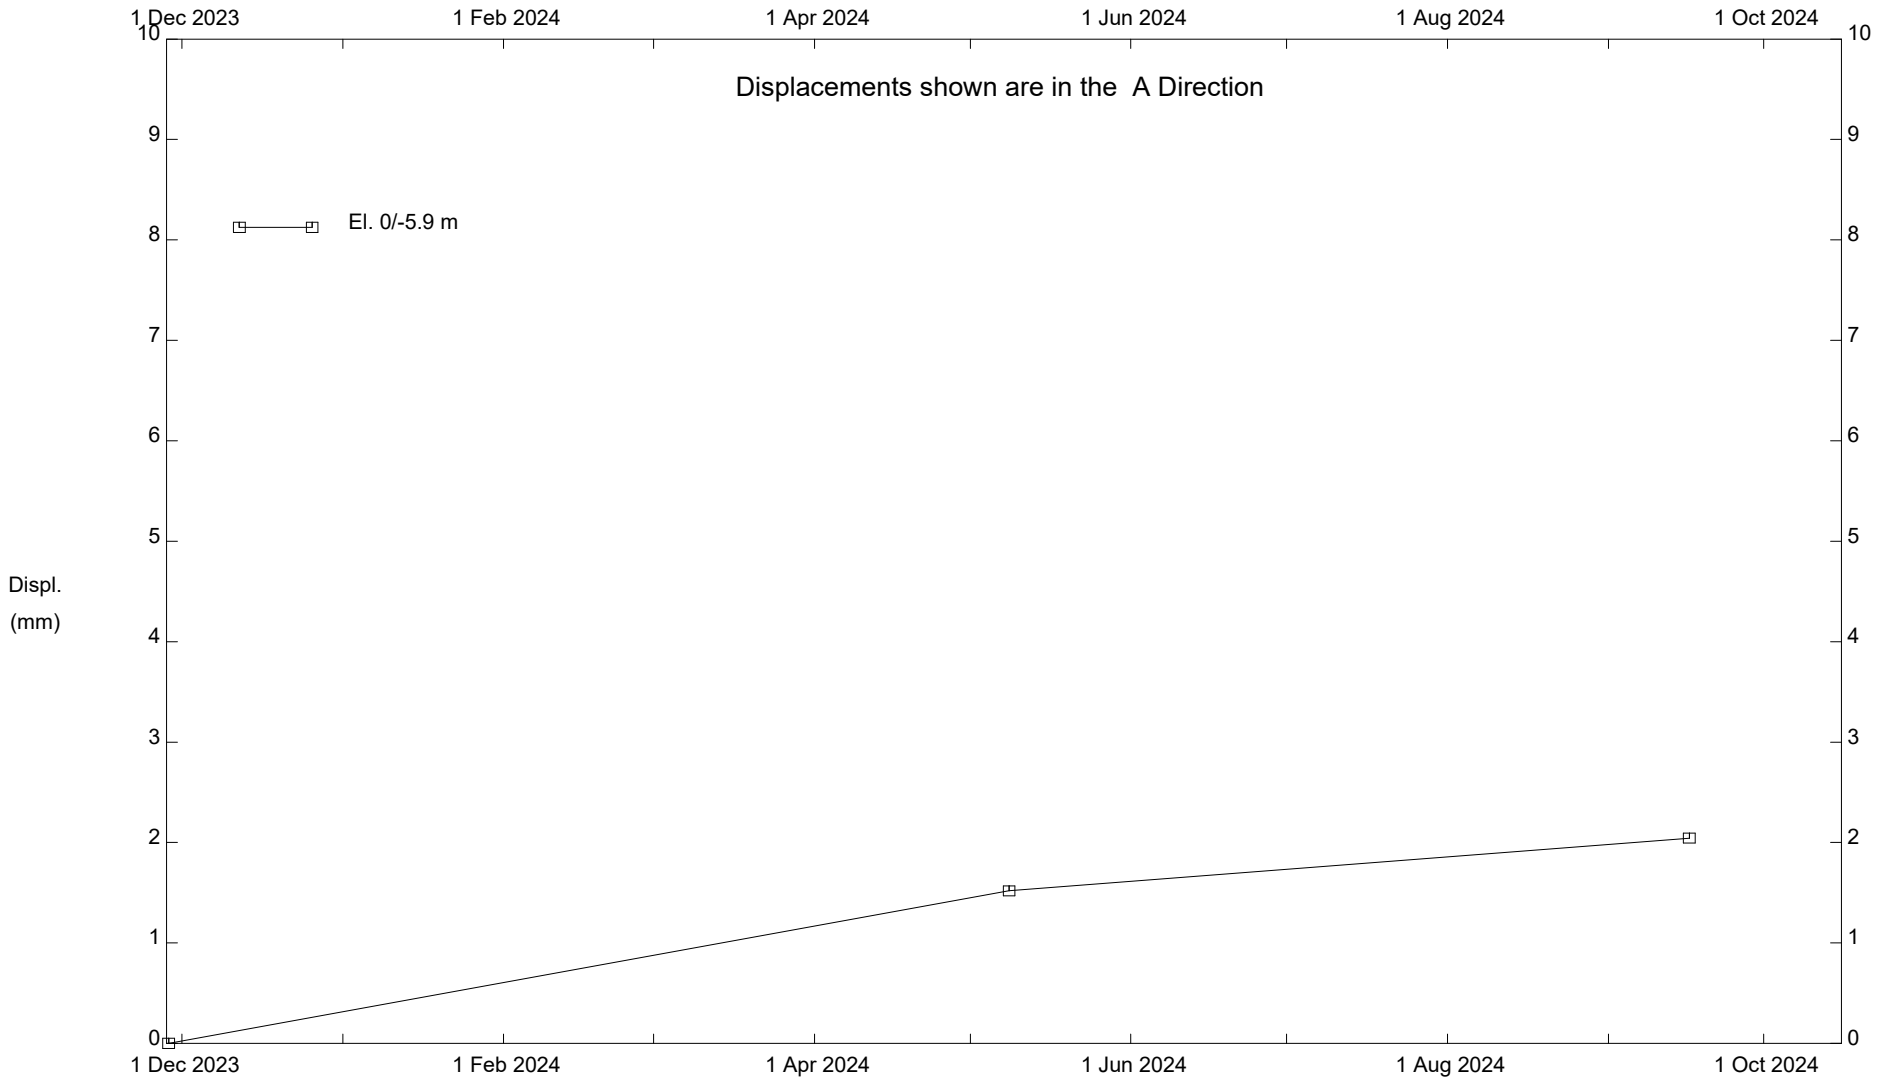
Cochrane, Inclinator 23-01

Distributed movement has started to be recorded in the SIs installed in the pile wall (SI23-01, SI23-02, and SI23-03) in the top 4 m to 6 m below ground surface, indicated that the pile wall has begun to take load from the slide mass.

The four SIs installed during construction were initialized in November 2023 once construction was completed. The new SIs were installed inside the H-Pile flanges in steel channels and backfilled with sand. Small amounts of distributed movement (up to approximately 2.5 mm) are starting to be measured in the top 4 to 6 mbgs in SI23-01, SI23-02 and SI23-03, indicating that the pile wall has begun to take load from the slide mass. Additional readings will be needed to provide further interpretation of the pile wall movement as it continues to take load from the slide mass. Readings taken since installation in SI23-04 have had poor data quality and have been re-read several additional times to try and get consistent readings. The issue with SI23-04 will need to be investigated further as the readings to date do not have consistent check sum values, resulting in displacement plots that are unable to be interpreted.
