November 29, 2024

CON0022161 Southern Region GRMP Instrumentation Monitoring
Site S003; H22:16 km 9.9 Cochrane
Section C – 2024 Fall Readings

PROJECT SOUTHERN REGION GEOHAZARD RISK MANAGEMENT PROGRAM		
TITLE Site Plan S003 - Cochrane Hwy 22:16, km 9.875		
SCALE 1:1,000	PROJECT No. A05116A03	FIG No. 1

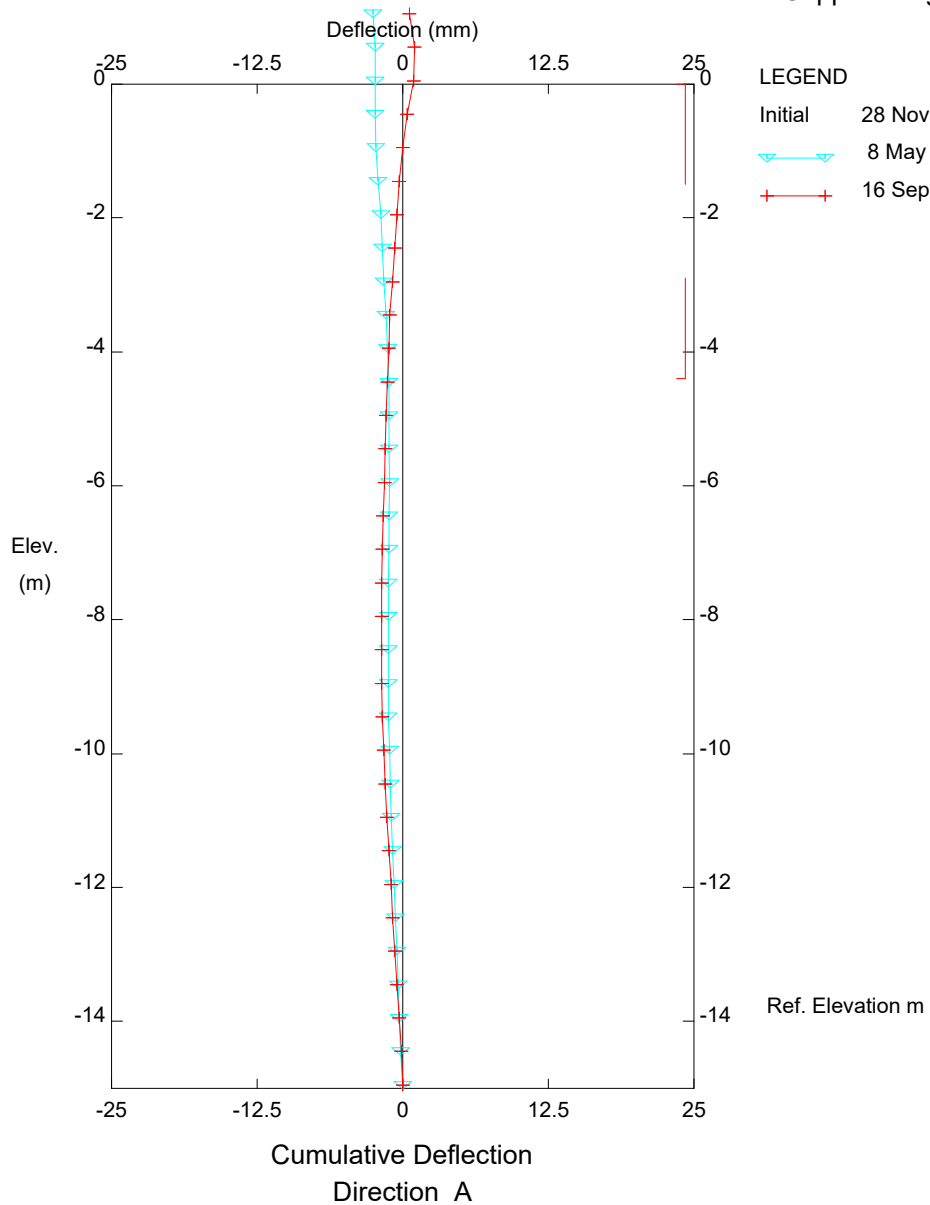
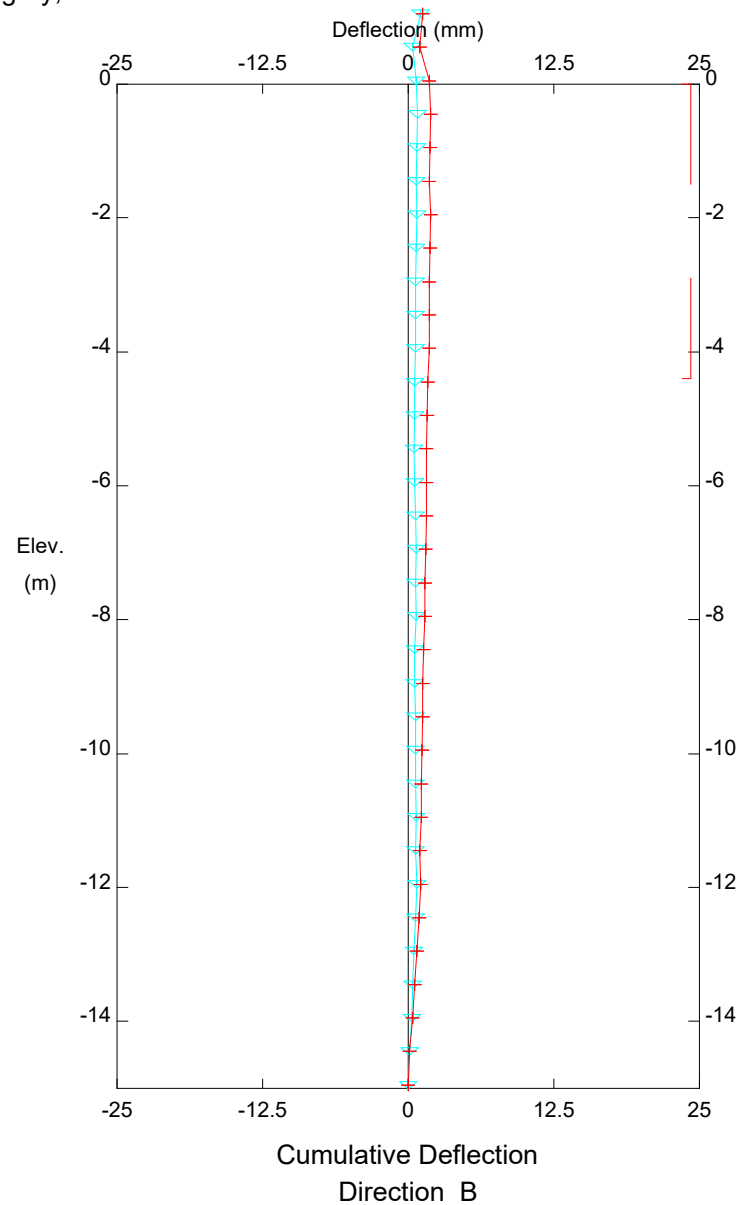
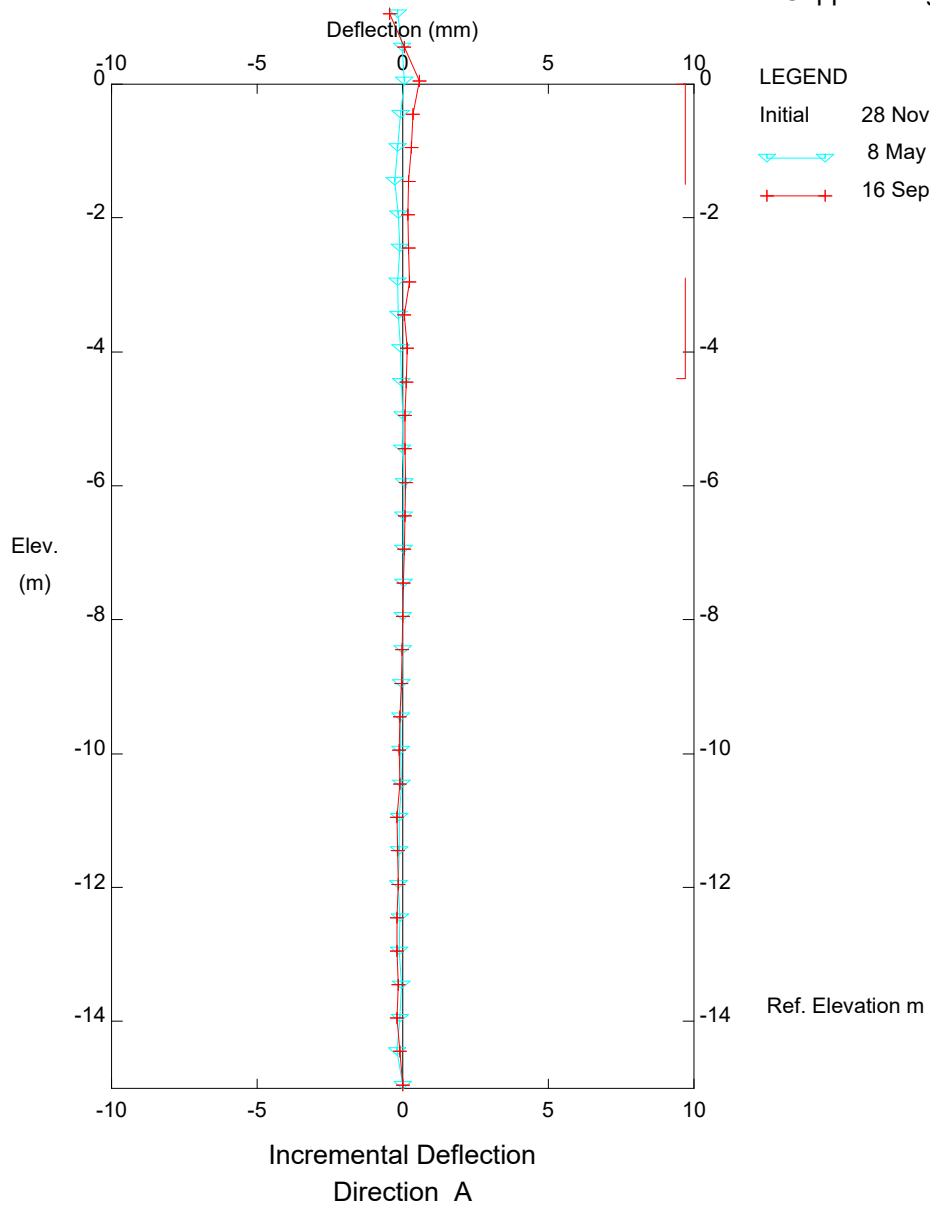
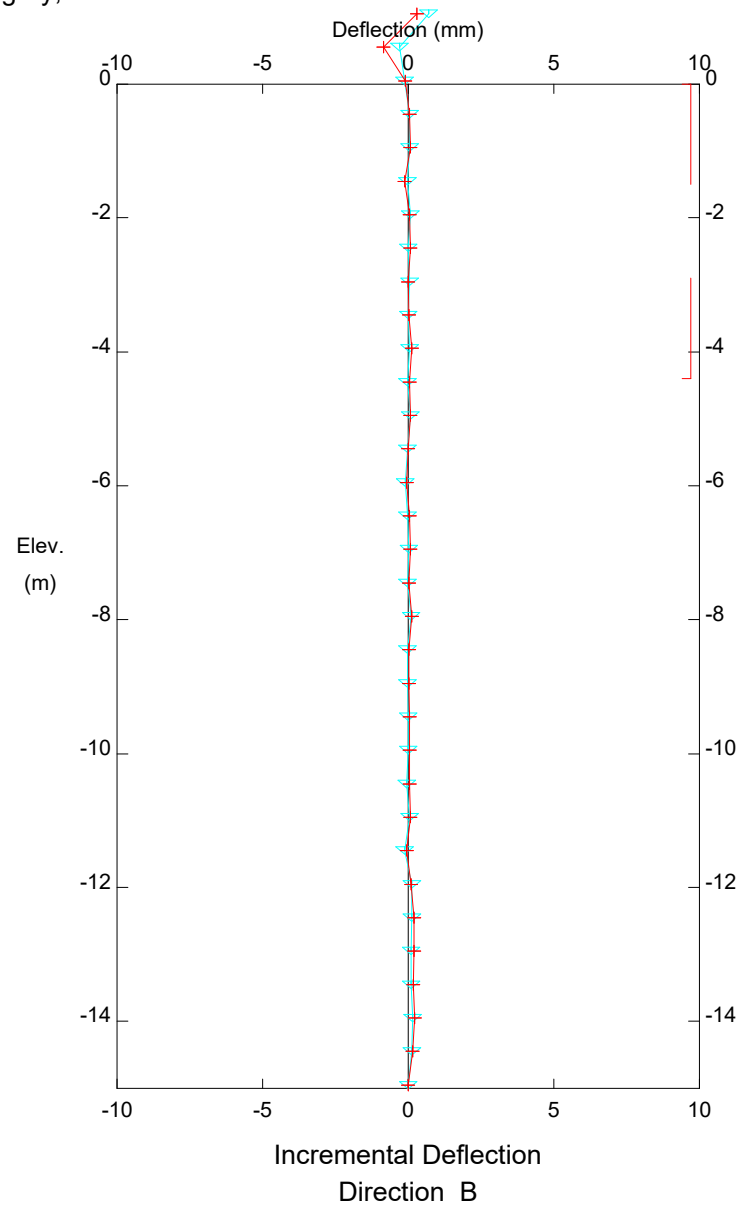
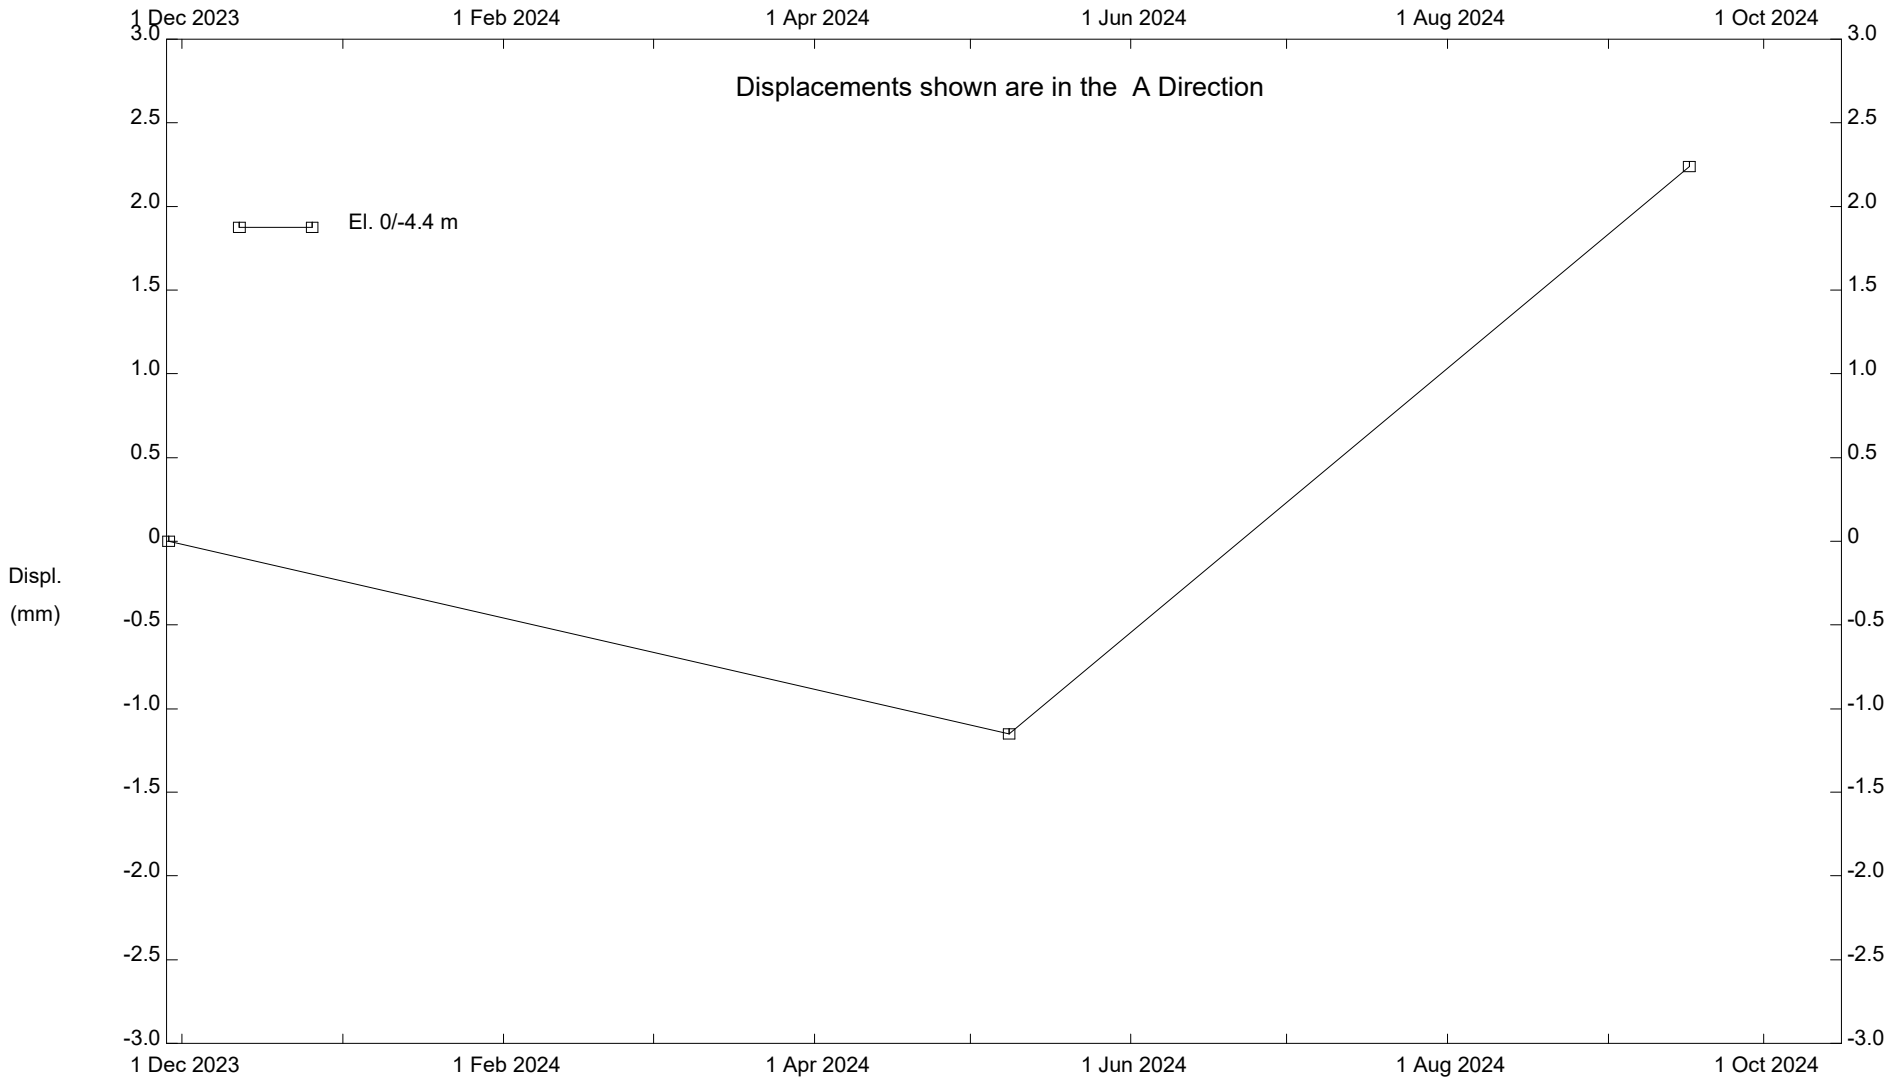
Cochrane, Inclinator 23-02

Distributed movement has started to be recorded in the SIs installed in the pile wall (SI23-01, SI23-02, and SI23-03) in the top 4 m to 6 m below ground surface, indicated that the pile wall has begun to take load from the slide mass.

The four SIs installed during construction were initialized in November 2023 once construction was completed. The new SIs were installed inside the H-Pile flanges in steel channels and backfilled with sand. Small amounts of distributed movement (up to approximately 2.5 mm) are starting to be measured in the top 4 to 6 mbgs in SI23-01, SI23-02 and SI23-03, indicating that the pile wall has begun to take load from the slide mass. Additional readings will be needed to provide further interpretation of the pile wall movement as it continues to take load from the slide mass. Readings taken since installation in SI23-04 have had poor data quality and have been re-read several additional times to try and get consistent readings. The issue with SI23-04 will need to be investigated further as the readings to date do not have consistent check sum values, resulting in displacement plots that are unable to be interpreted.
