SITE NUMBER AND NAME: S003 Cochrane		HIGHWAY & KM: 22:16, 9.875	PREVIOUS INSPECTION DATE: June 8, 2020	INSPECTION DATE: May 27, 2024
LEGAL DESCRIPTION: 06-34-025-04 W5M	NAD 83 COORDINATES: UTM Northing Easting 11 5672104 676003		RISK ASSESMENT: PF: 1 CF: 4 TOTAL: 4	
AVERAGE ANNUAL DAILY TRAFFIC (AADT): 28340 (north), 22460 (south) (Ref. No. 70000075)			CONTRACTOR MAINTENANCE AREA (CMA): 28

PRIMARY SITE ISSUE: Slope instability affecting northbound lane, approximately 3 m into northbound lane. Landslide appears to be related to seepage and deeper instability located downslope.

PROJECT SOUTHERN REGION GEOHAZARD RISK MANAGEMENT PROGRAM		
TITLE Site Plan S003 - Cochrane Hwy 22:16, km 9.875		
SCALE 1:1,200	PROJECT No. A05116A03	FIG No. 1

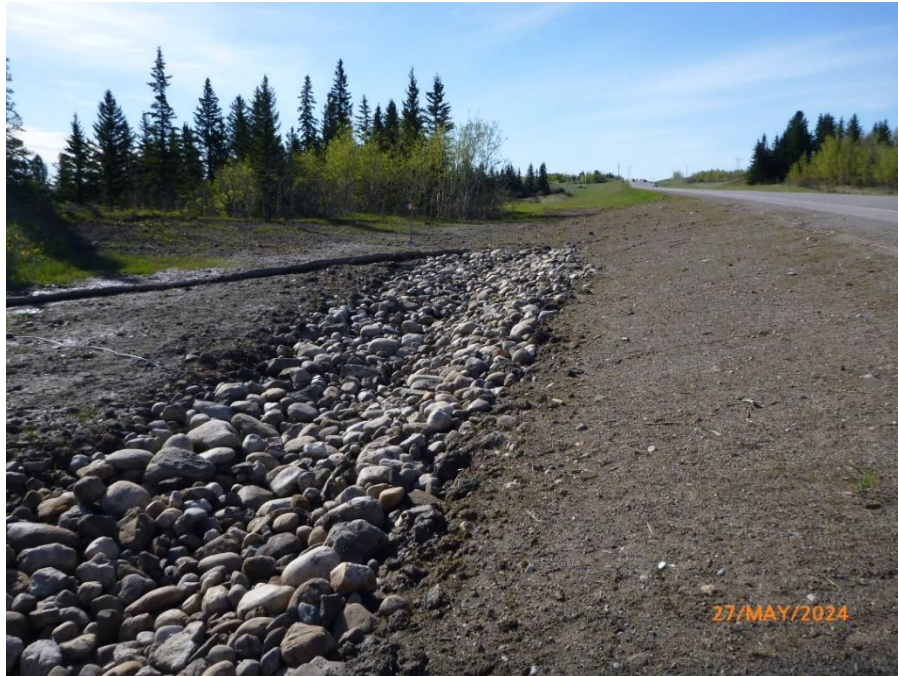
Photo 1 South end of the project area with the ditch reinstated with riprap. Photo was taken facing southeast on May 27, 2024.

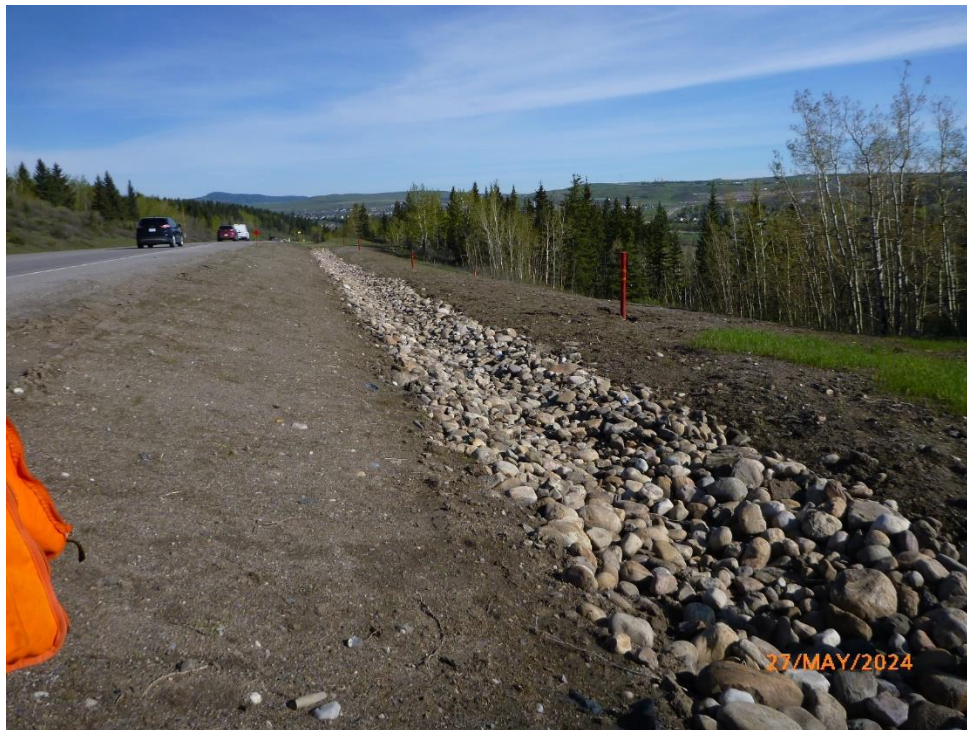
Photo 2 North end of the project area with the ditch reinstated with riprap. Pile wall installed downslope of ditch. Photo was taken facing northwest on May 27, 2024.

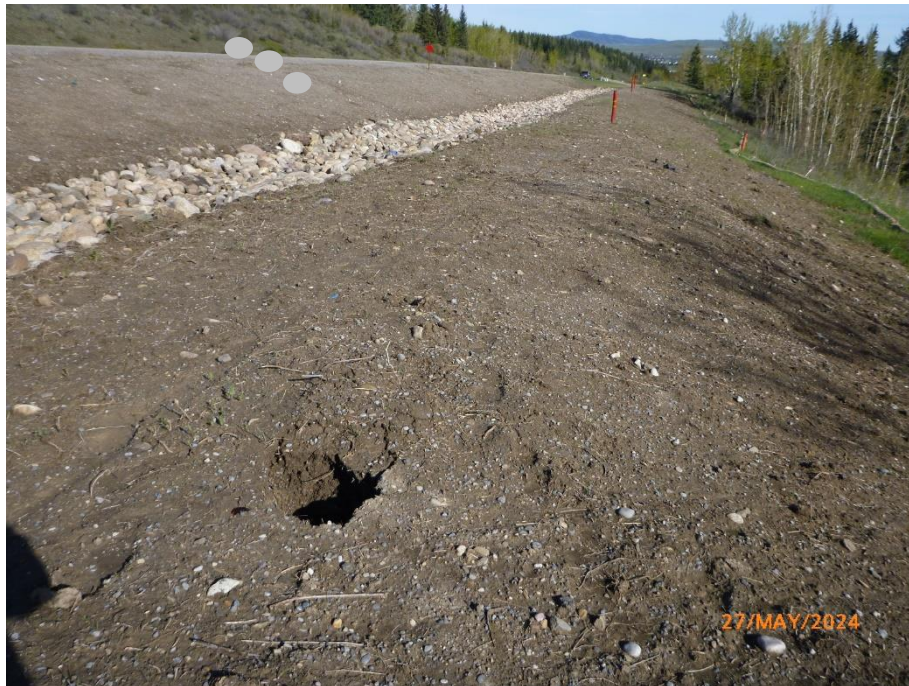
Photo 3 Some voids forming in the pile flanges due to backfill settlement. Photo was taken facing northwest on May 27, 2024.

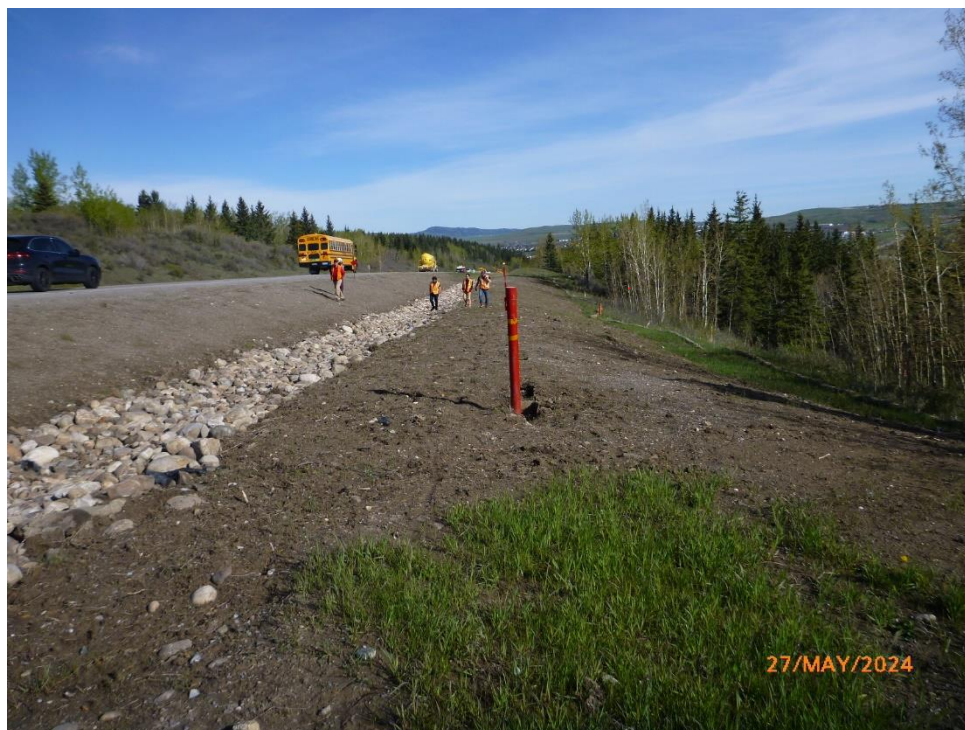
Photo 4 Pile wall alignment. Some voids forming in the pile flanges due to backfill settlement. Photo taken facing north on May 27, 2024.

The slope inclinometers should continue to be read in the spring and fall annually to measure pile wall movement as it takes up load and begins to stabilize the slope.

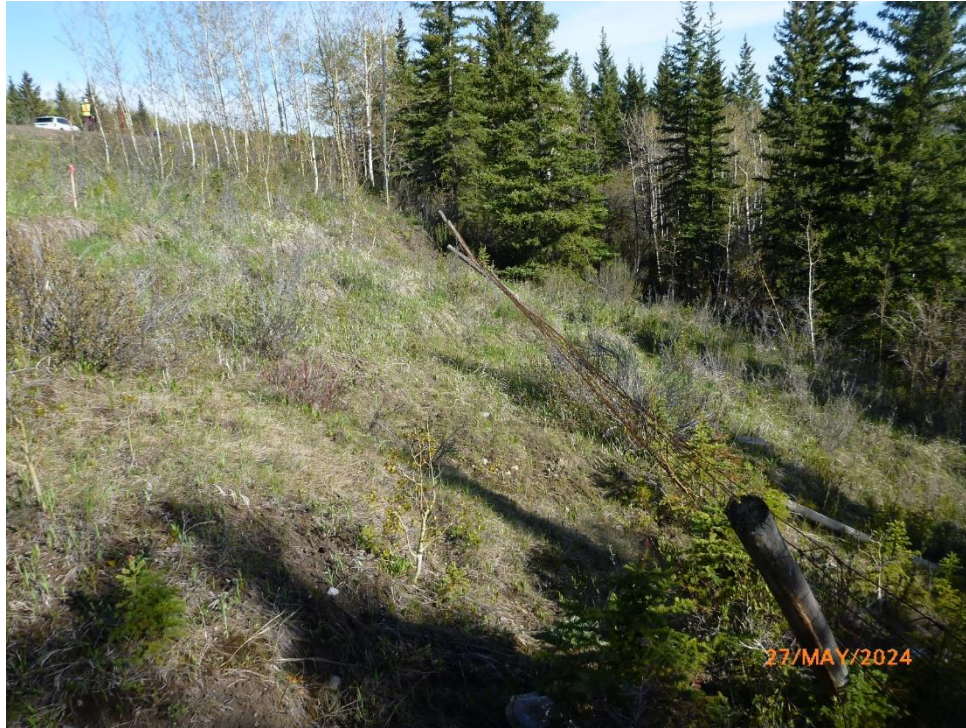
Fence across slide zone is deflected, undermined, and tipped over by slope movement.

Photo 5 Downslope of the pile wall. Fence knocked over from slope movement. Photo taken facing north on May 27, 2024.
