July 10, 2024

Alberta Transportation and Economic Corridors
2nd Floor, 803 Manning Road N.E.
Calgary, Alberta
T2E 7M8

CON0022161 Southern Region GRMP Instrumentation Monitoring
Site S003; H22:16 km 9.9 Cochrane
Section C – 2024 Spring Readings

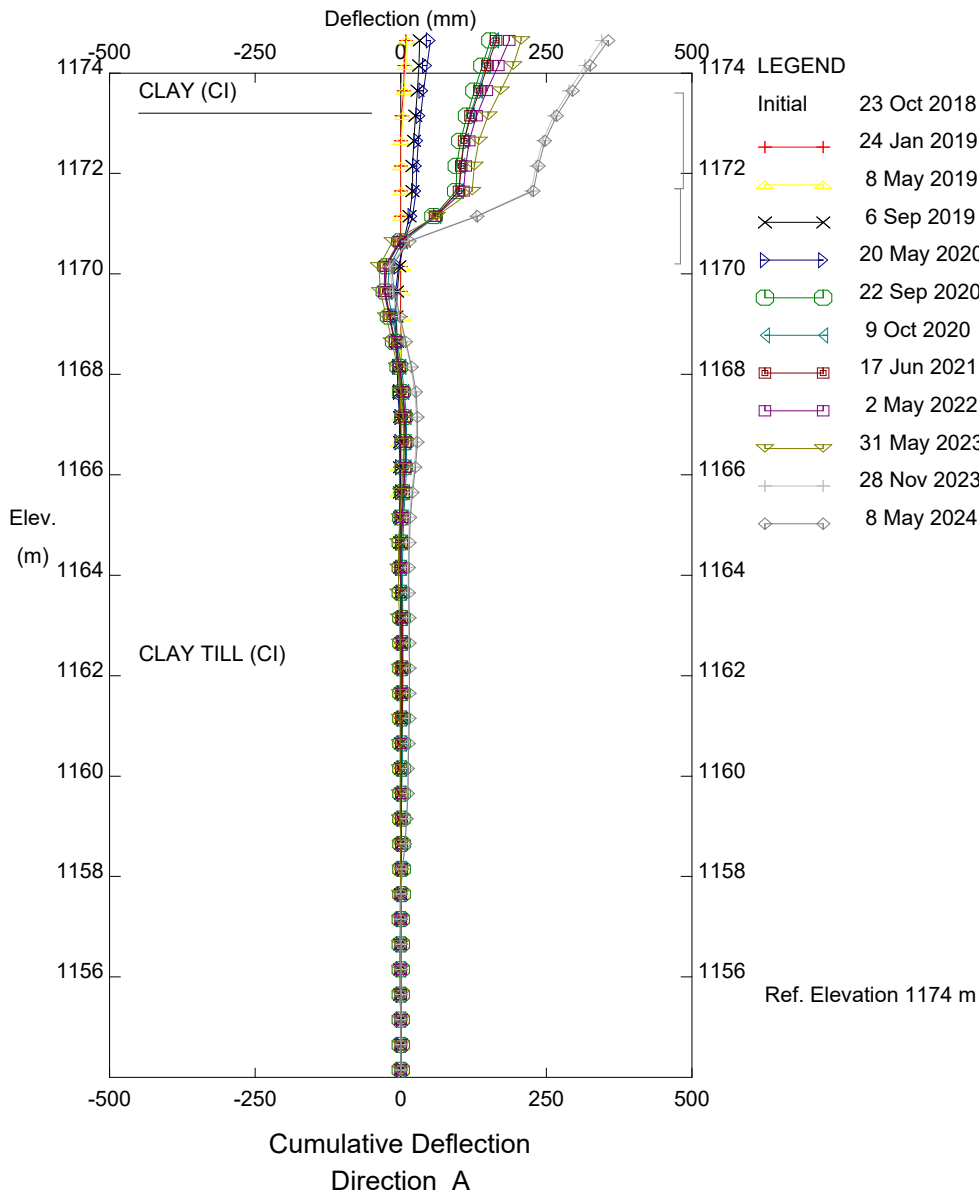
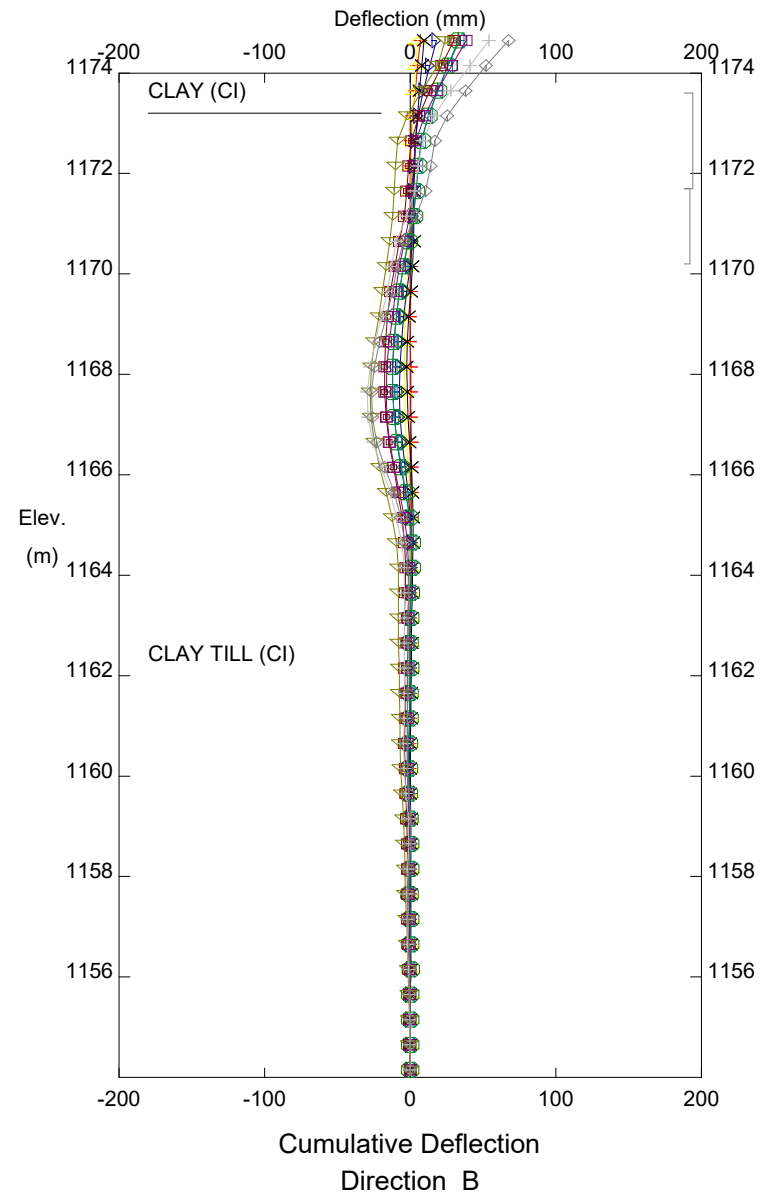
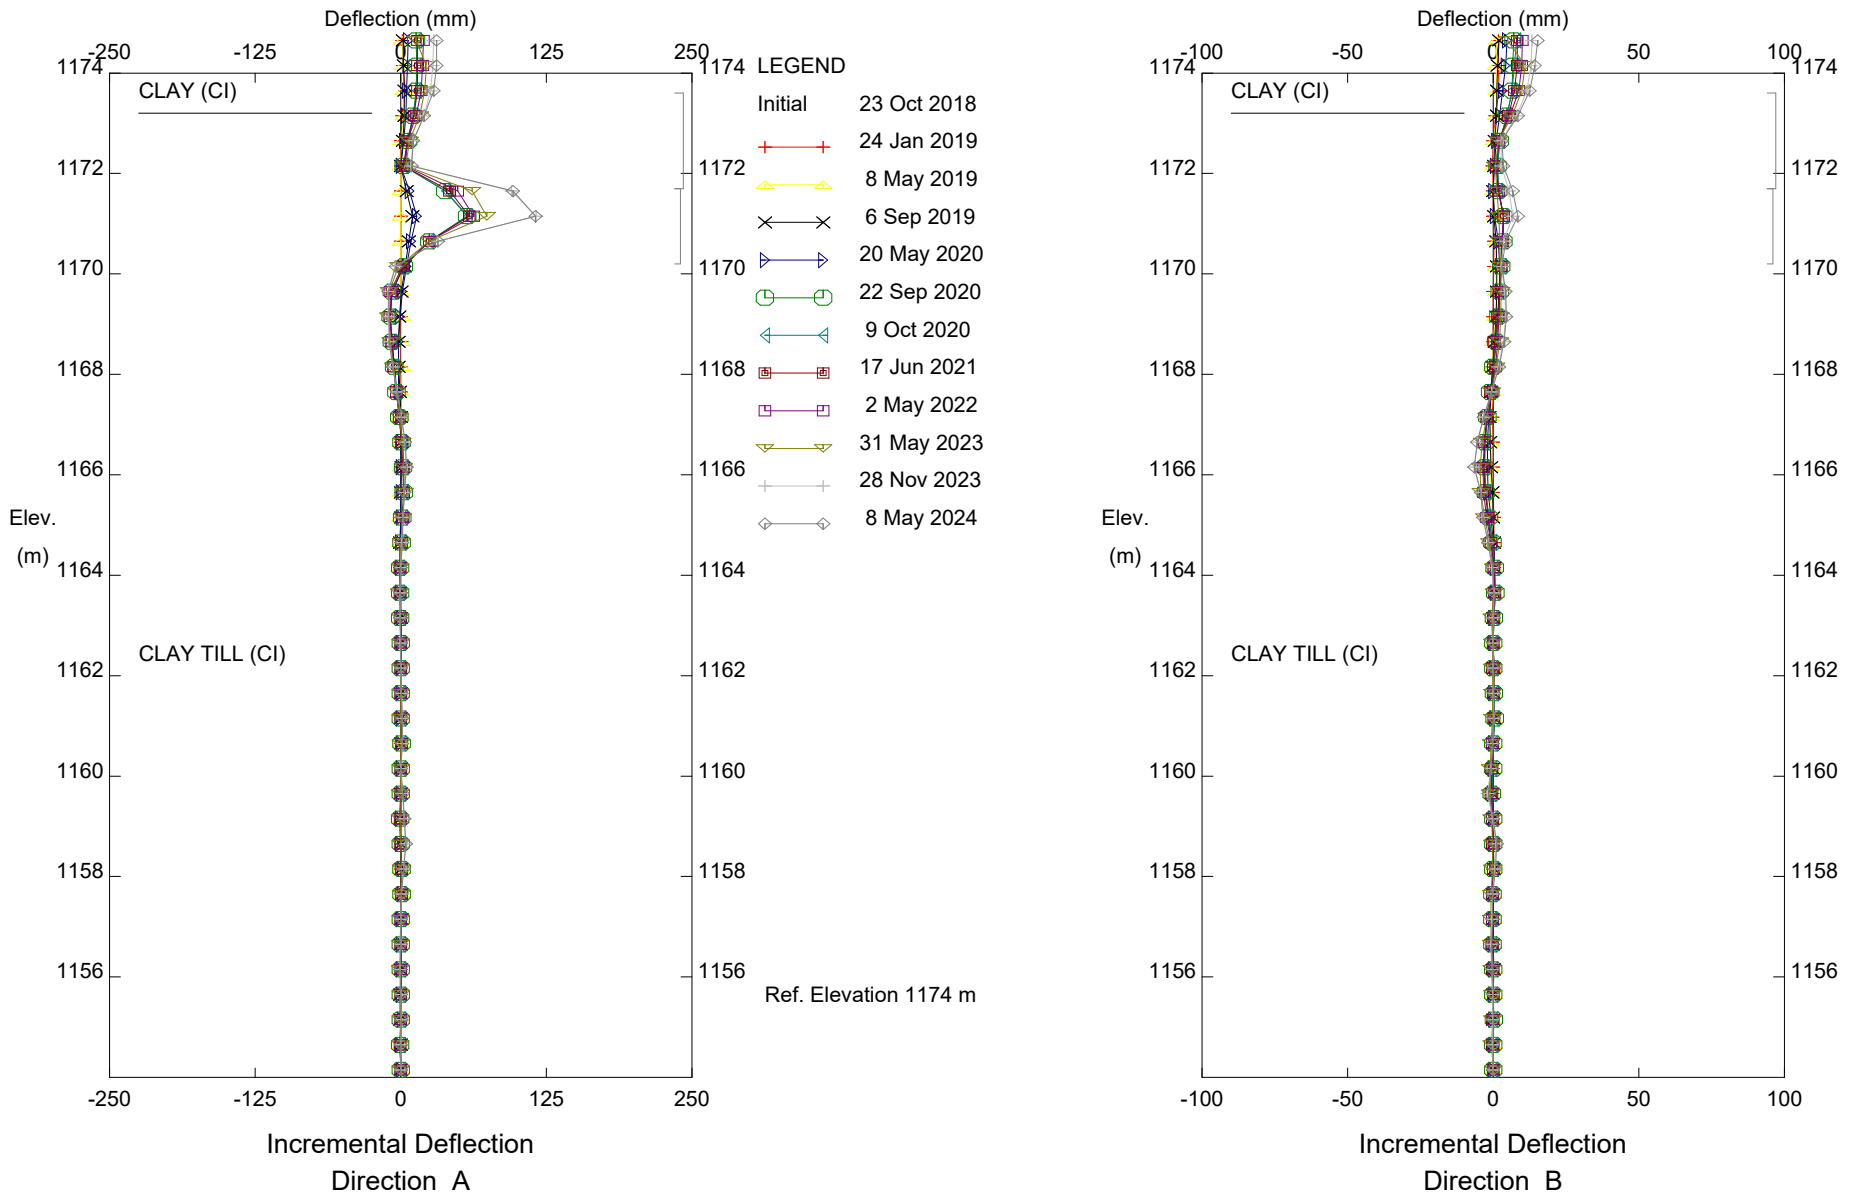
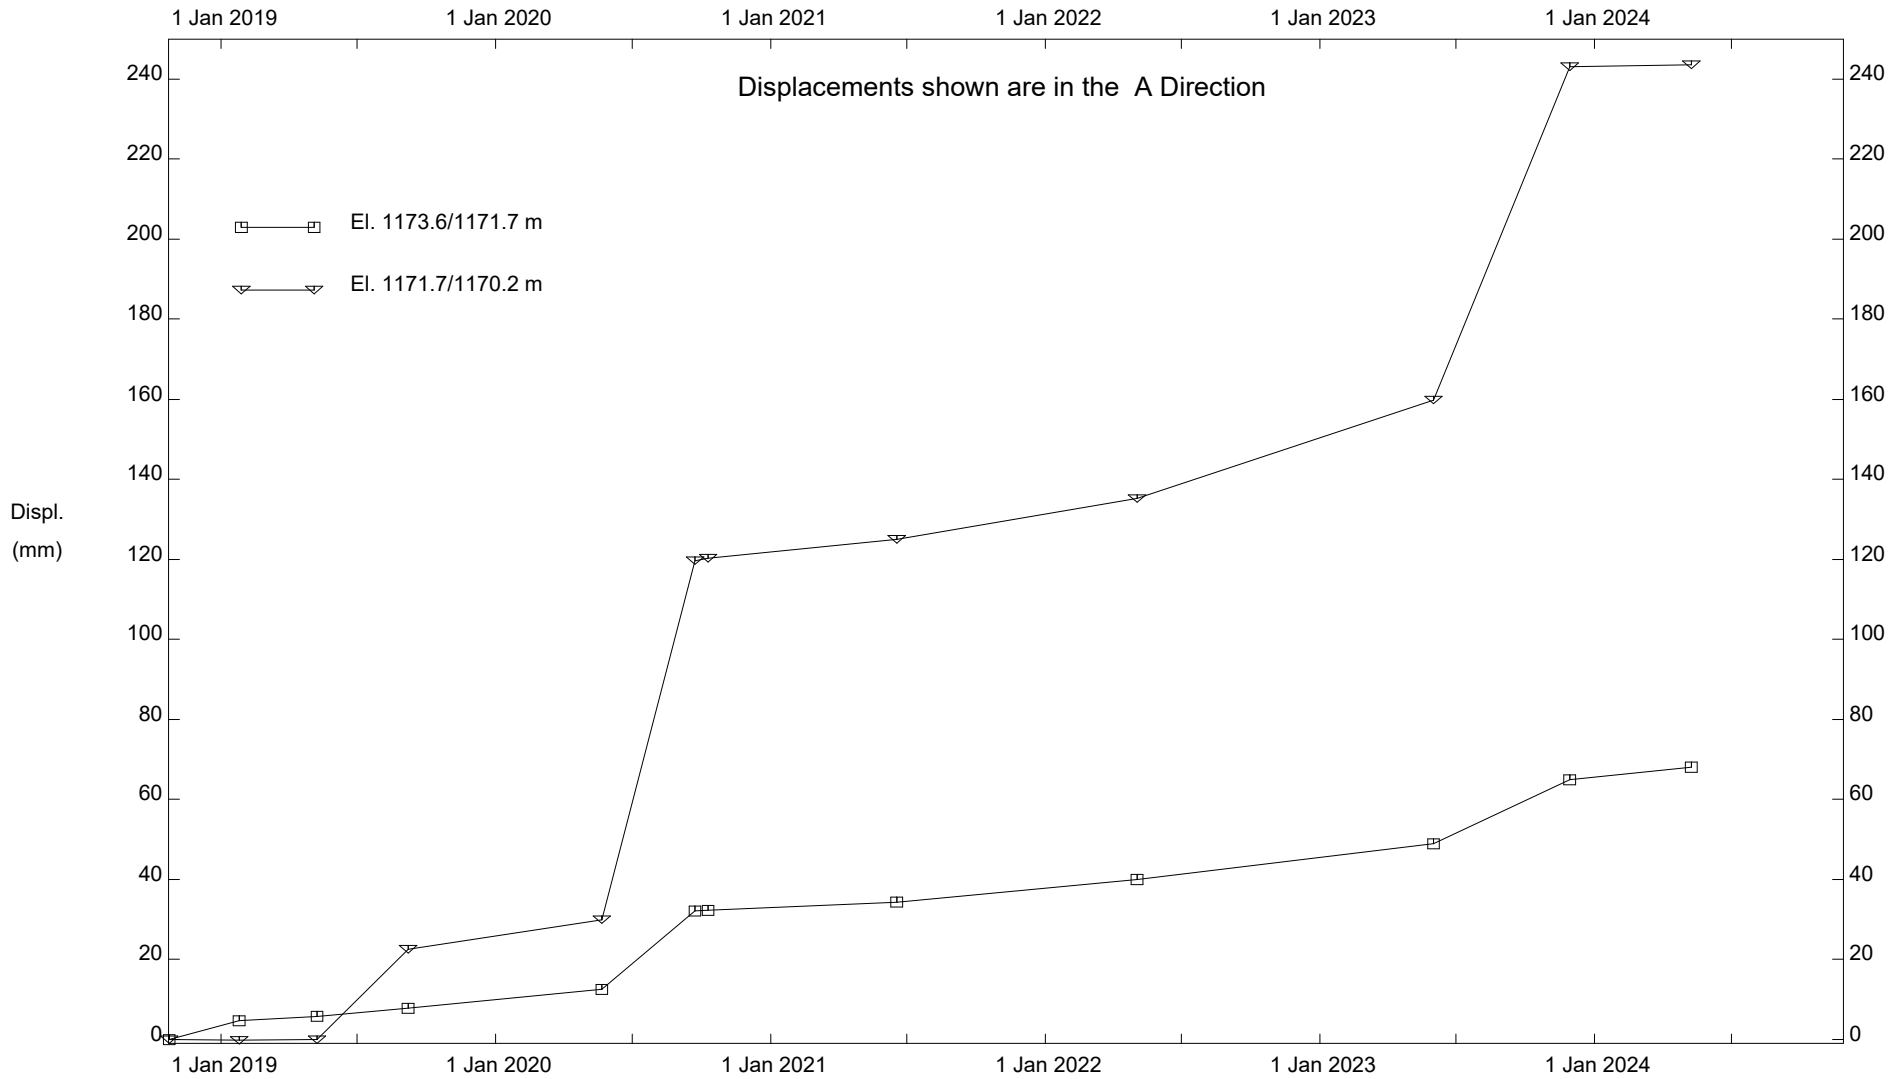
S003; H22:16, Cochrane, Inclinator SI18-01
 Alberta Transportation

Distributed movement is being recorded in SI18-01 from ground surface to an approximate depth of 2.3 m below ground surface (approximately El. 1173.6 m to El. 1171.7), and possible discrete movement between 2.3 m and 3.8 m (approximately El. 1171.7 m to El. 1170.2). The casing also appears to be settling or buckling between an approximate depth of 3.8 m and 8.8 m as discussed below. SI18-01 is located near the middle of the slide on the downslope side of the highway.

The settlement or buckling observed in SI18-01 (from approximately 3.8 m and 8.8 m below ground surface) could be an indication that the instrument is poorly grouted with a possible grout void. The readings along this segment also do not stabilize, which further indicates a possible issue with the grout or damage to the casing. The movements of the slide mass and interpretation of the SI data is complicated by the potential for settlement or buckling of the SI casing in the poorly grouted casing segment.

Approximately 311 mm of cumulative movement has been recorded in SI18-01 since installation from a depth of 3.8 mbgs to ground surface. We expect this instrument may shear soon. SI18-01 was installed to support the design of an H-pile wall and drainage improvements to mitigate the impacts of the slope movement on Hwy 22:16.

Approximately 104 mm of movement was measured in SI18-01 between the spring 2023 reading and the reading taken post pile wall construction (November 2023) from a depth of 3.8 mbgs to surface. During construction, survey monitoring pins installed downslope of the pile wall measured horizontal movement up to 67 mm in the downslope direction in the slide zone at surface. This movement is believed to be due to added weight on the slope during pile installation from the piling rig and potential excess pore pressured in the slope due to pile installation.

Cumulative movement between the November 2023 and the spring readings measured an additional 4 mm of cumulative movement in the upper 3.8 m.

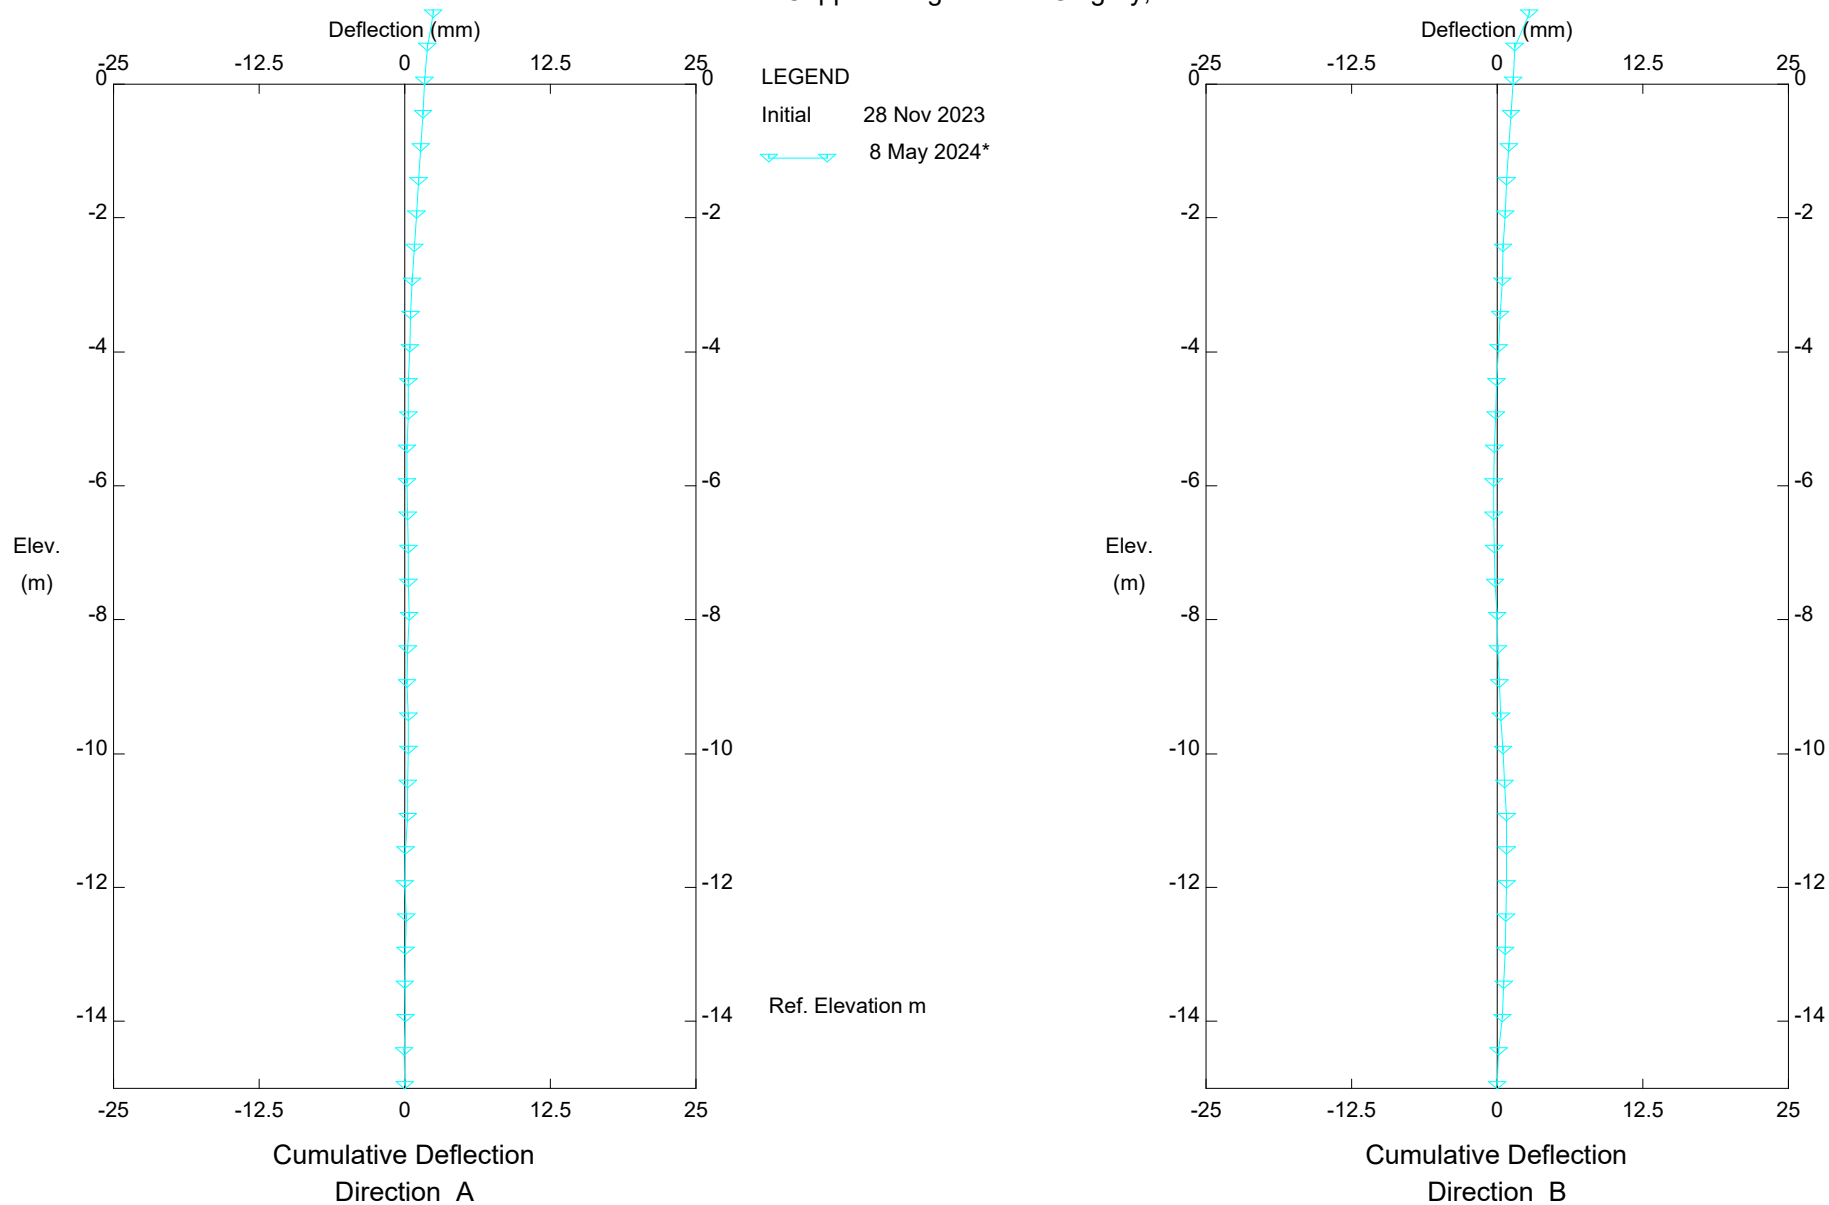
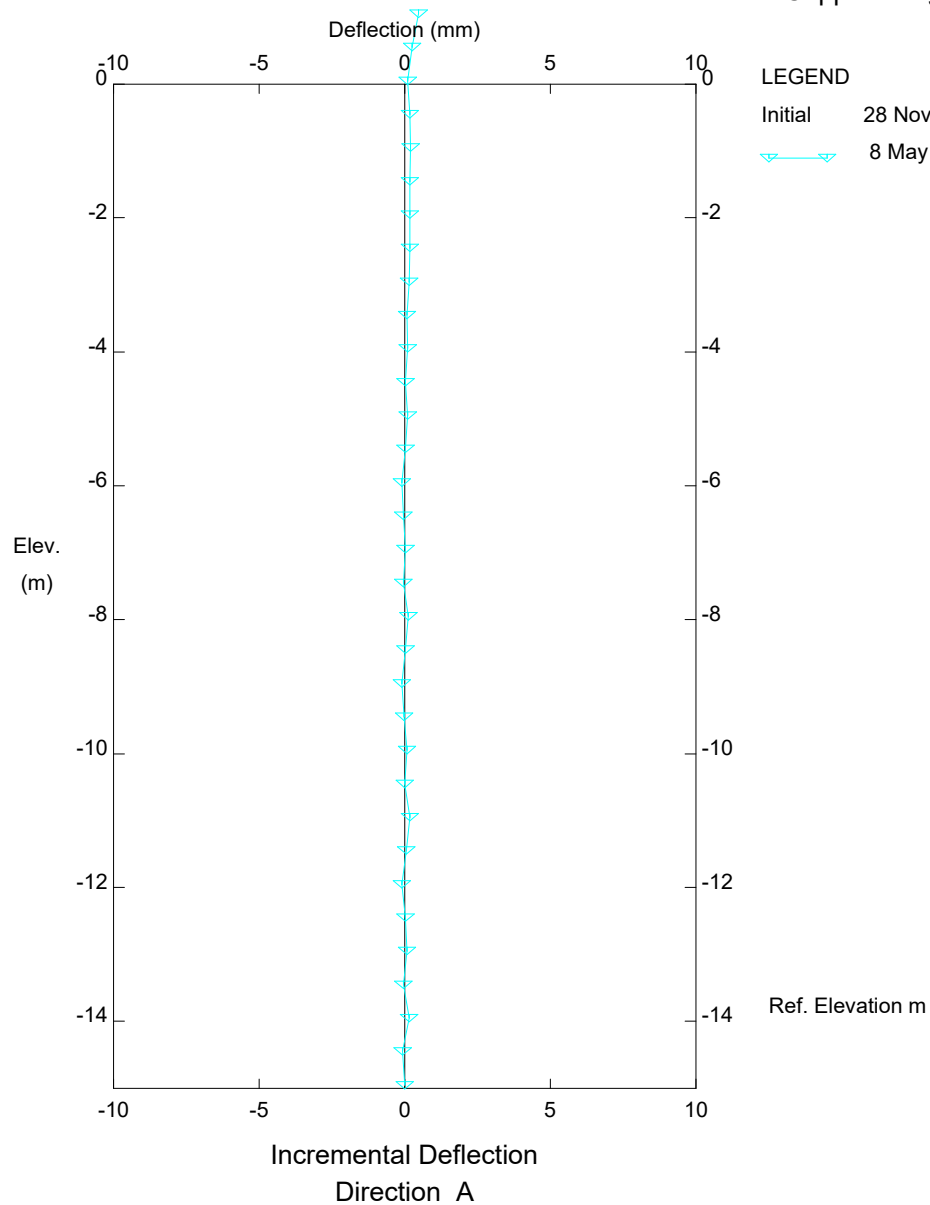
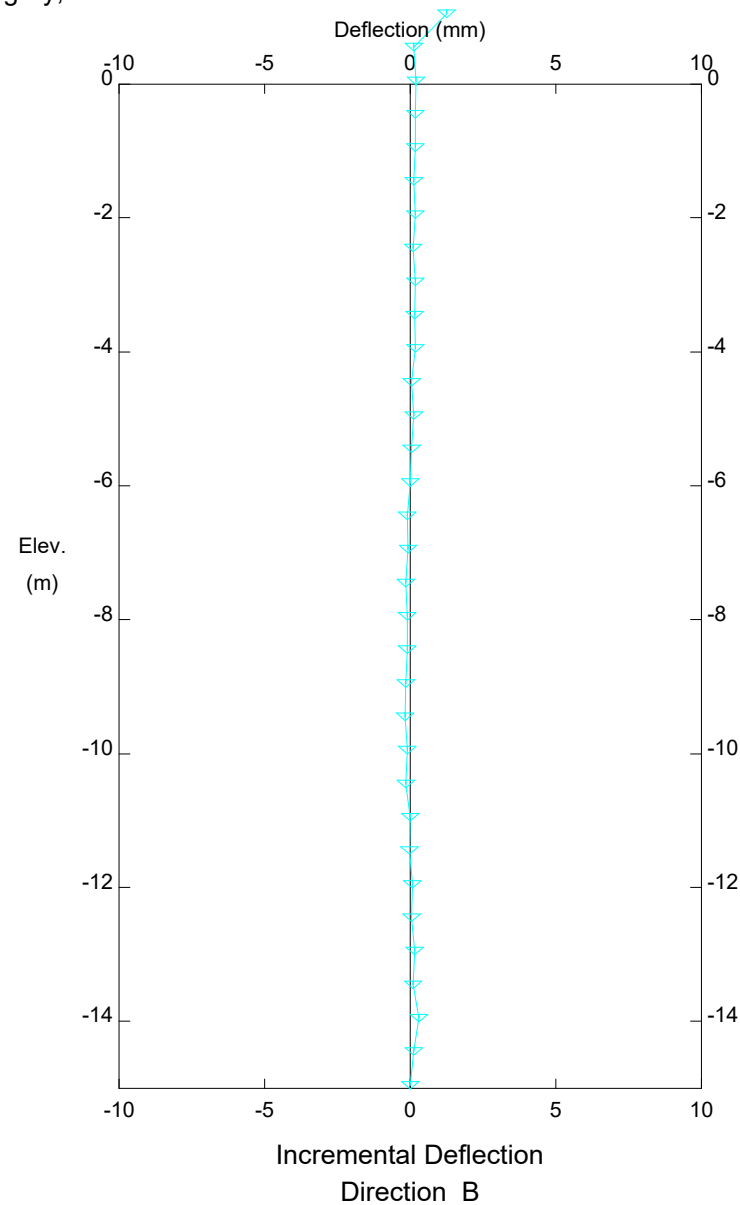
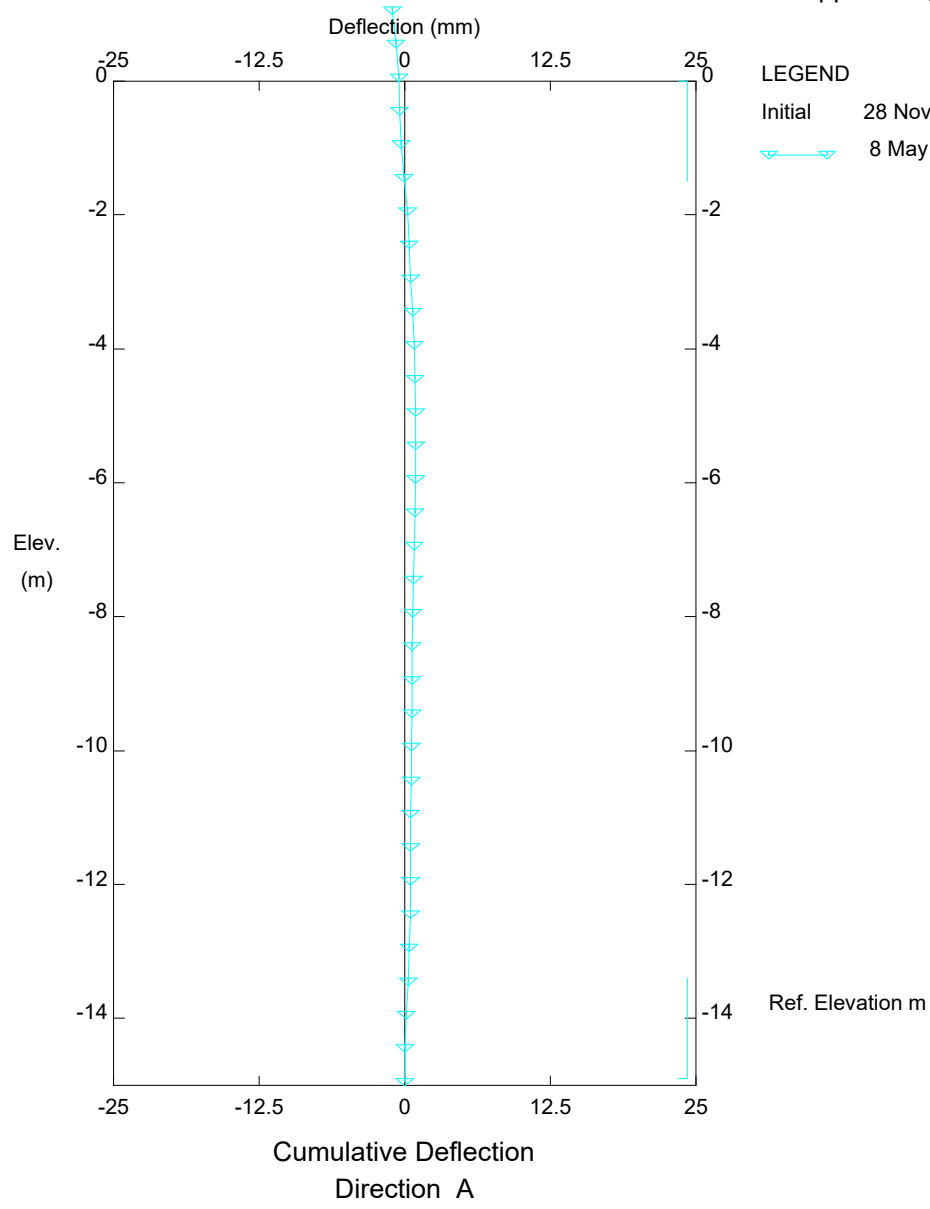
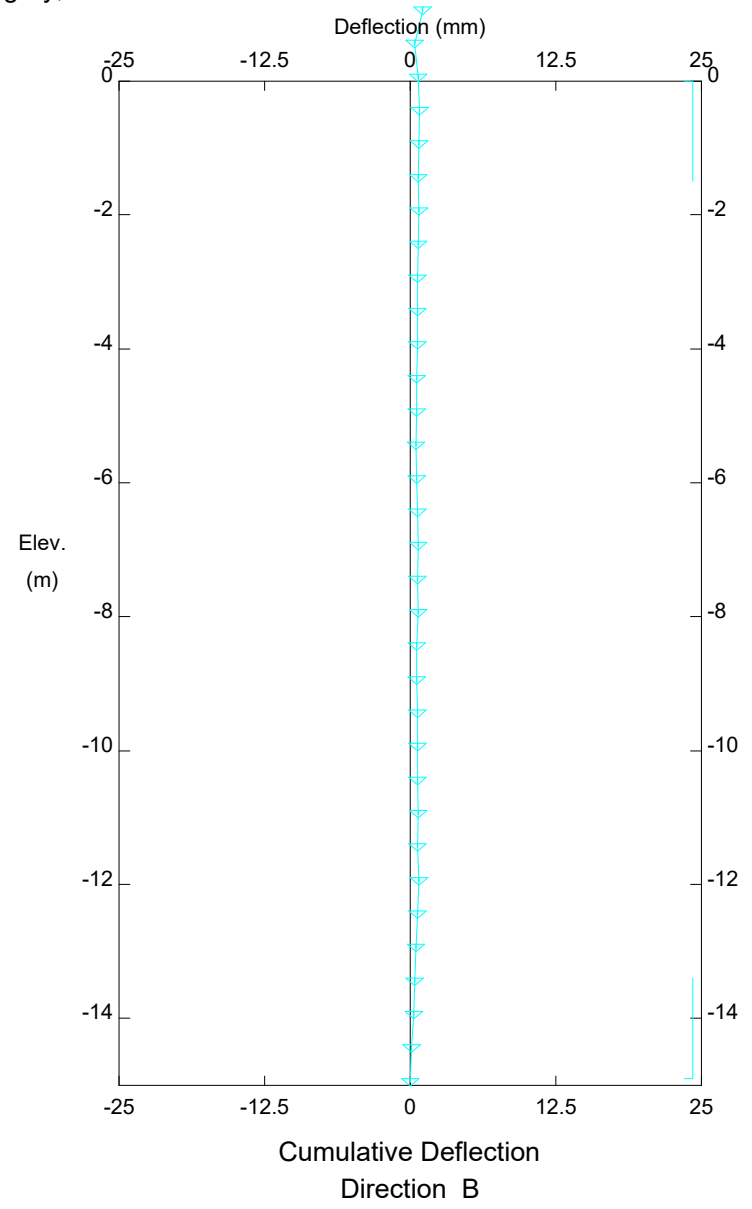
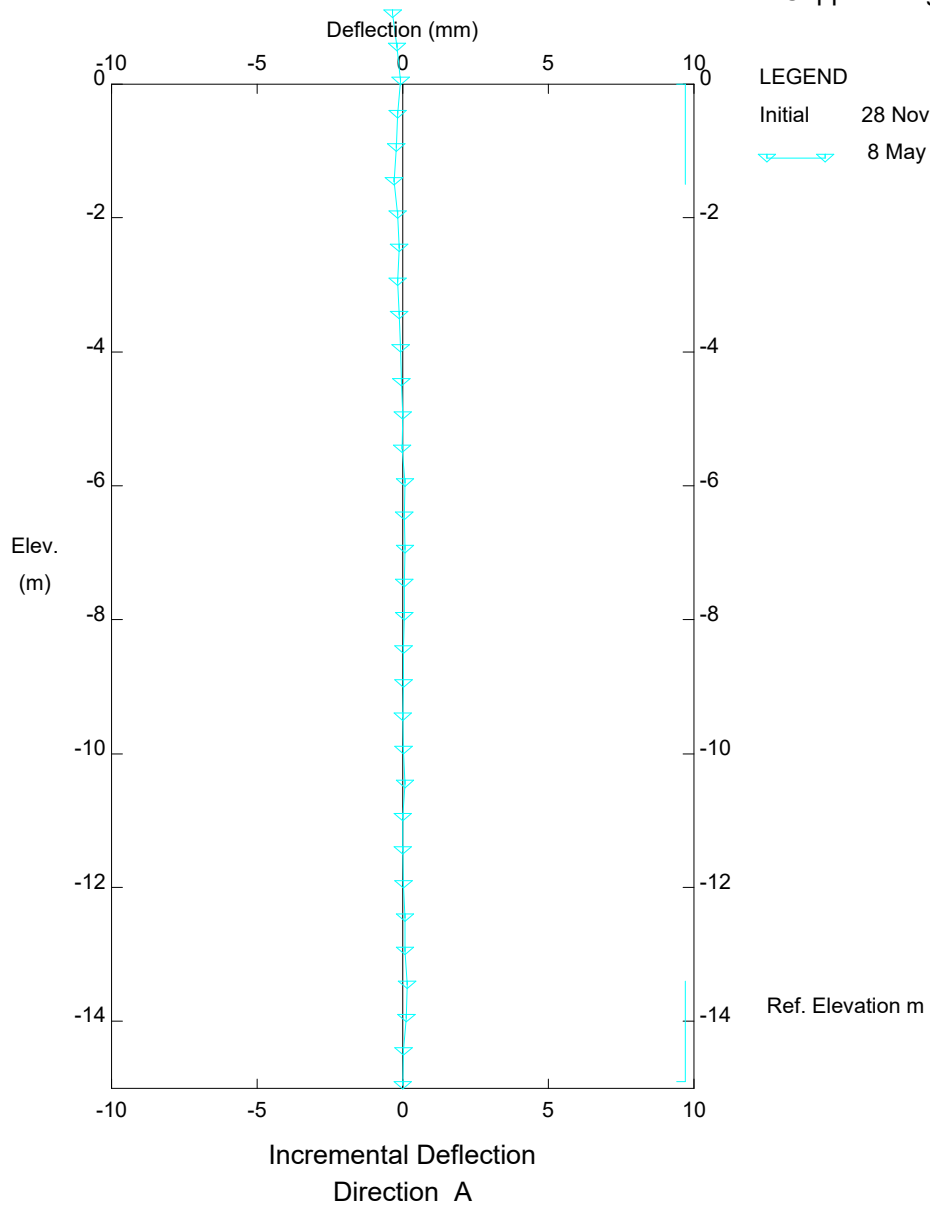
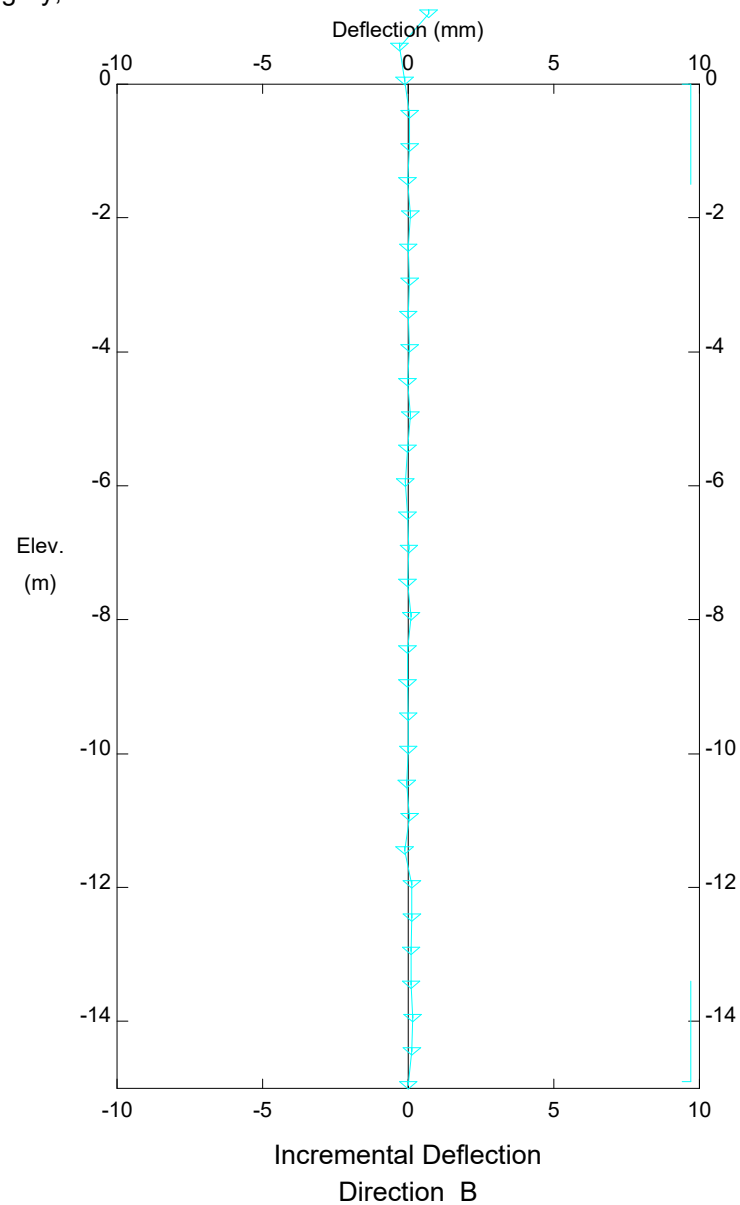
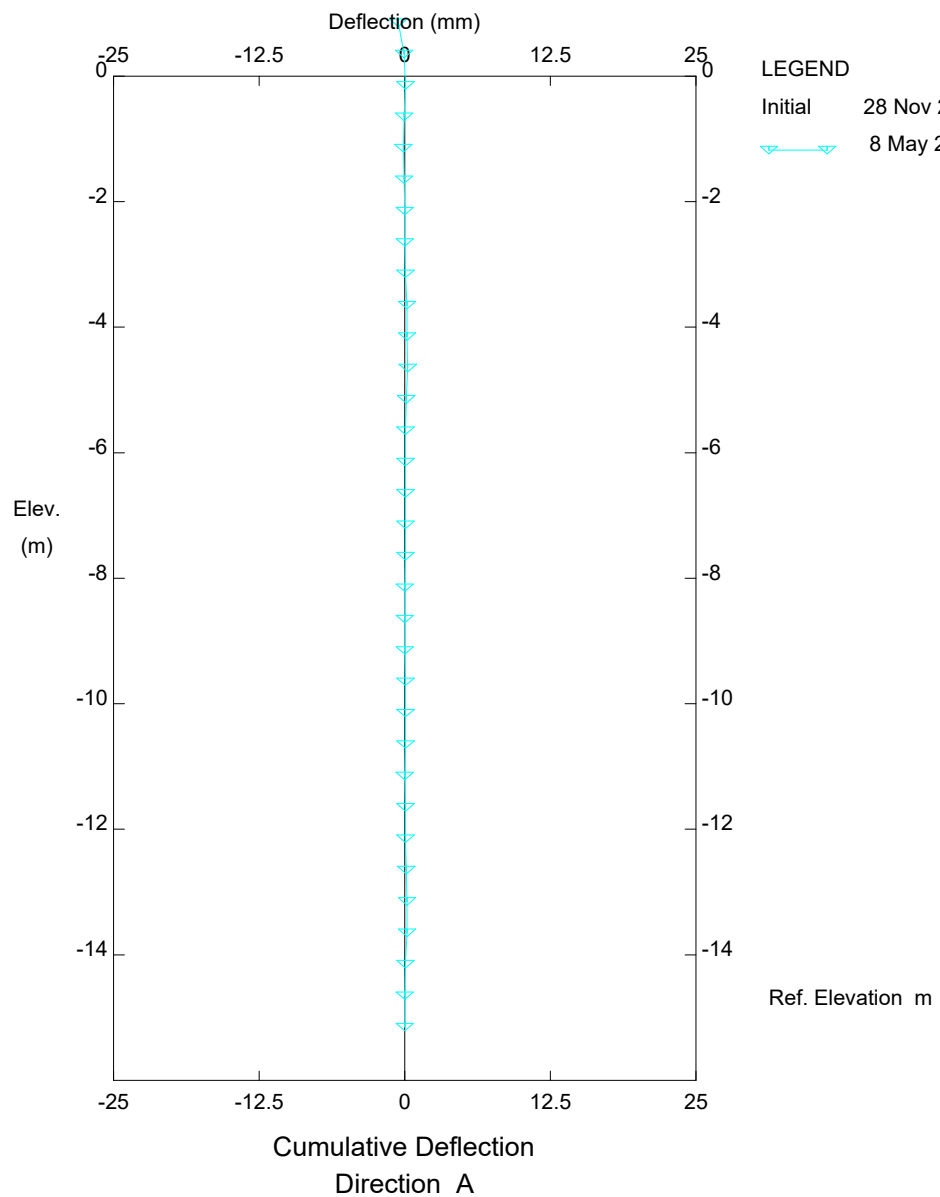
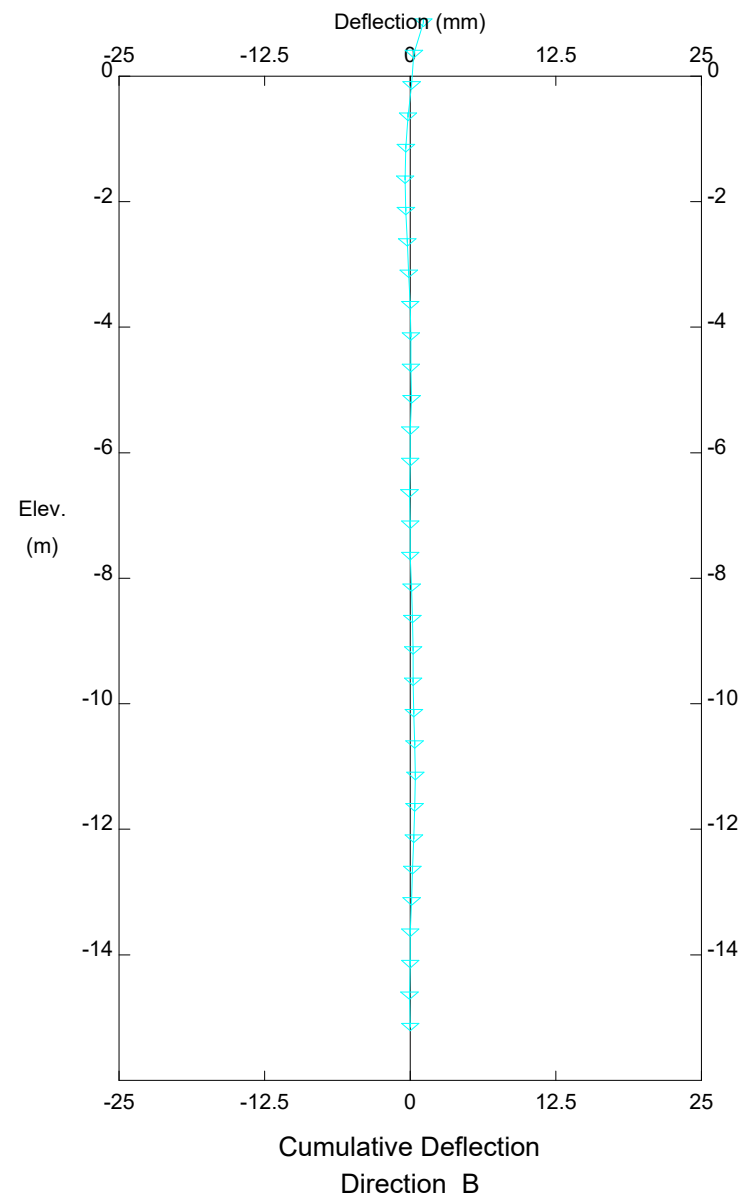
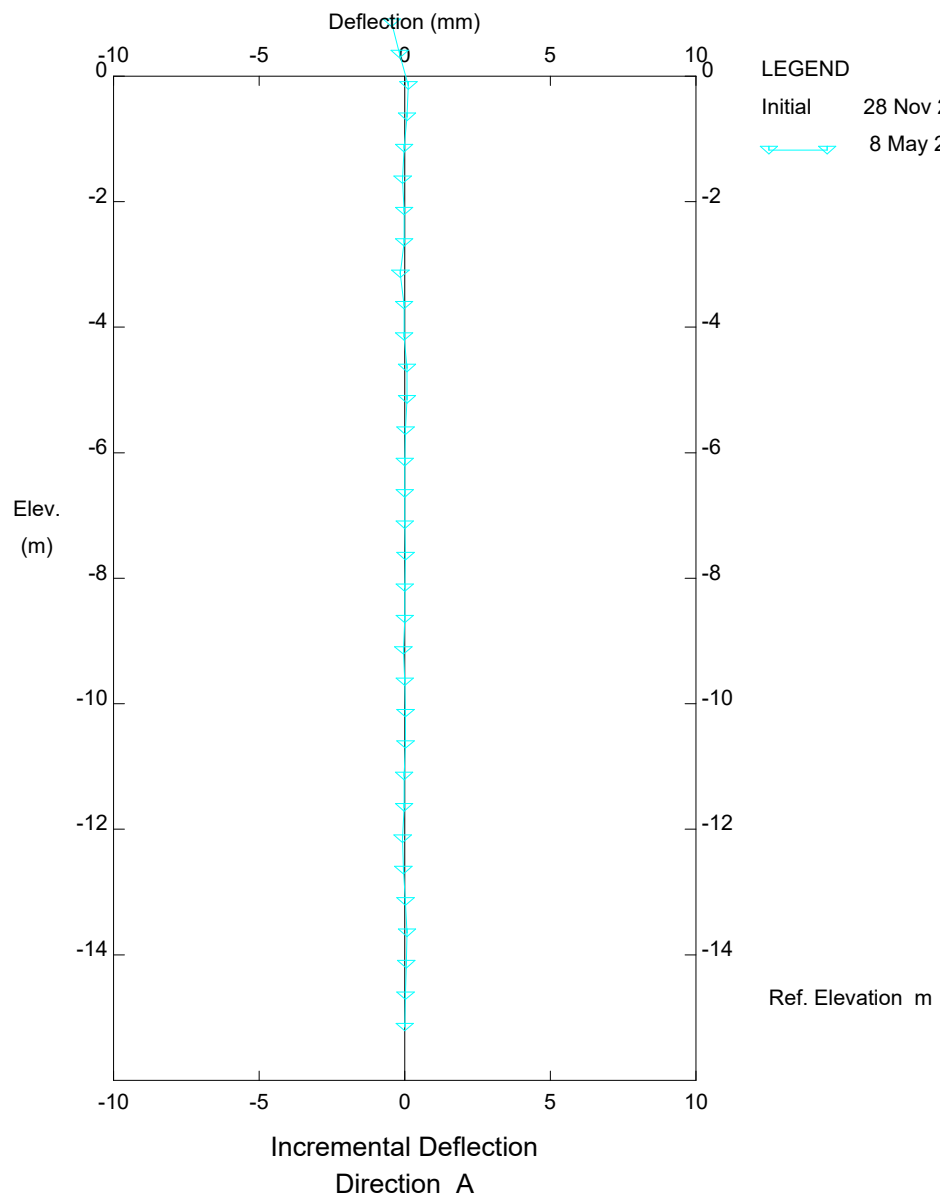
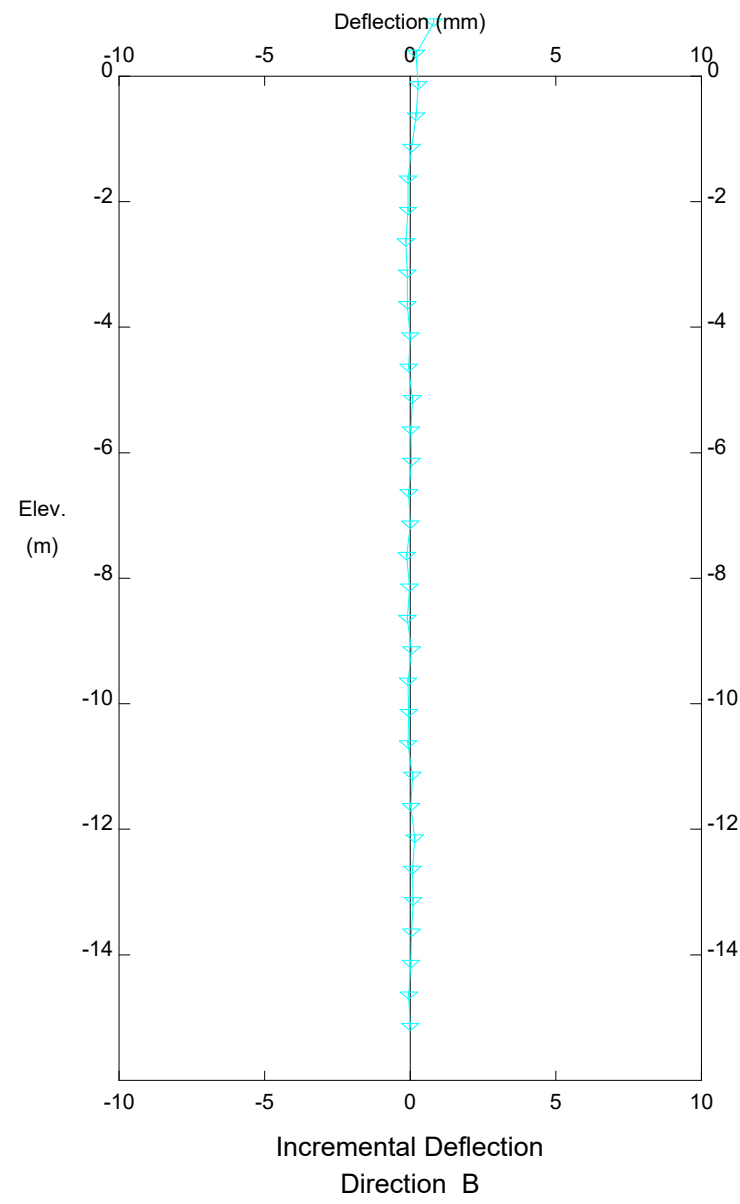
The four installed during construction were initialized in November 2023 once construction was completed. The new SIs were installed inside the H-Pile flanges in steel channels and backfilled with sand. No discernible movement was measured in the new SIs. Additional readings will be needed to provide further interpretation of the pile wall movement as it begins to take load from the slide mass. Readings taken since installation in SI23-04 have had poor data quality and have been re-read several additional times to try and get consistent readings. The issue with SI23-04 will need to be investigated further as the readings to date do not have consistent check sum values, resulting in displacement plots that are unable to be interpreted.

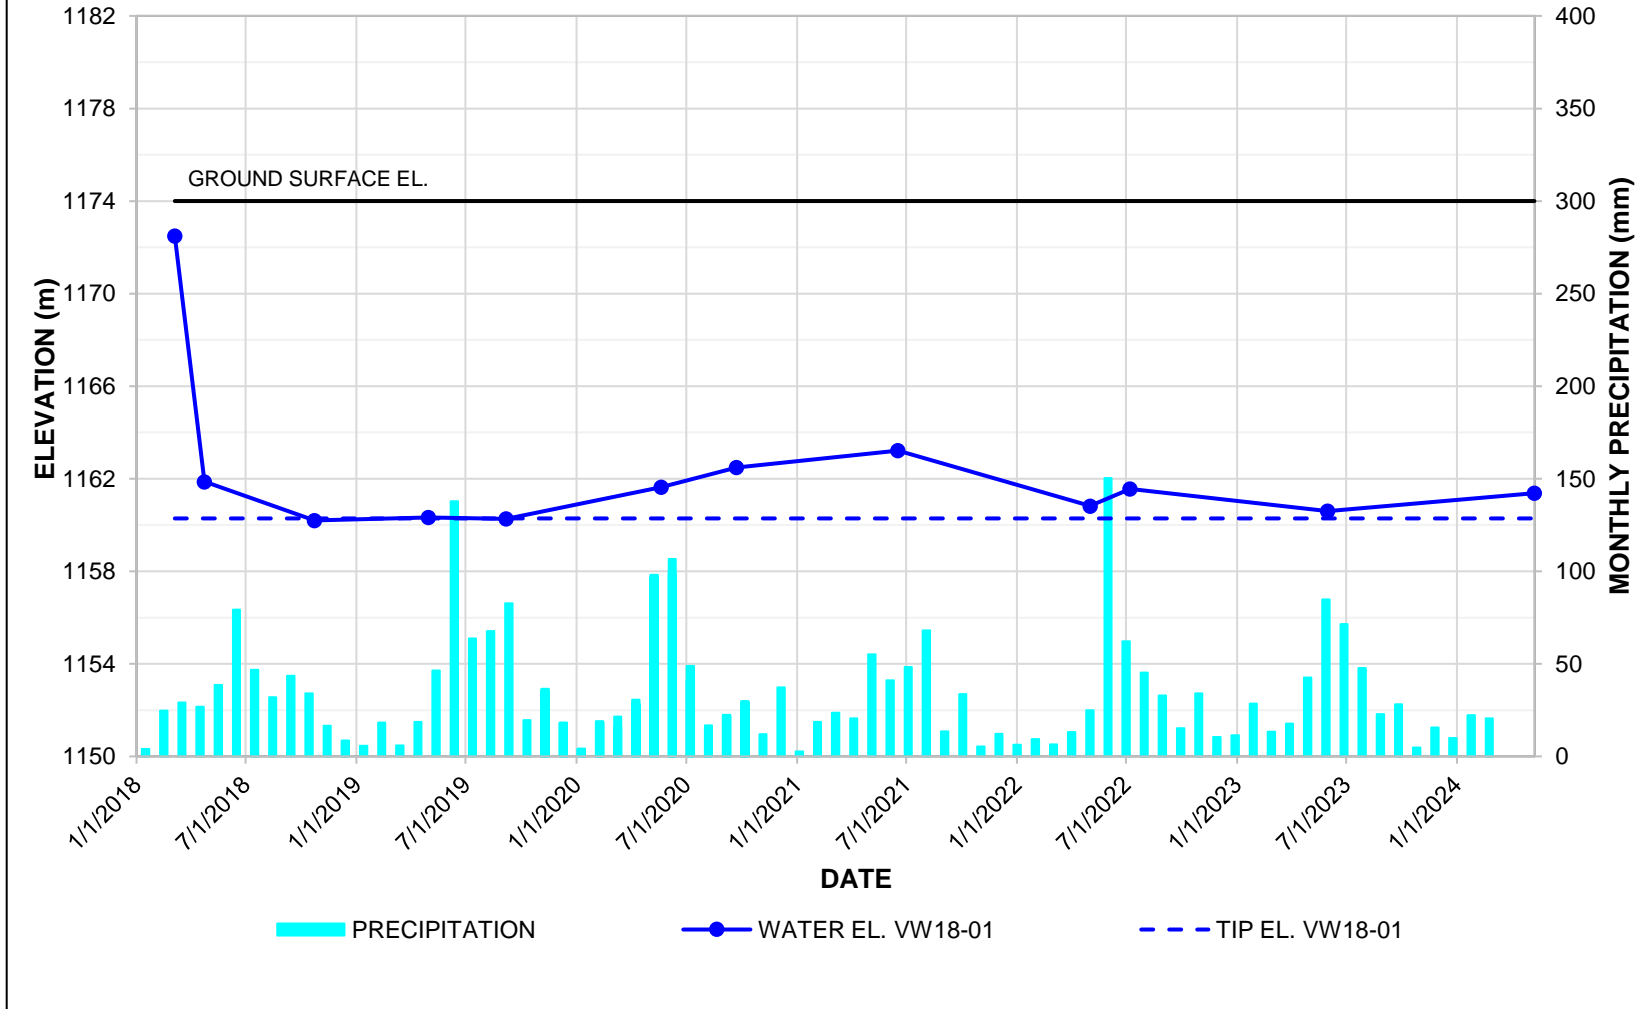
VW18-01 (SERIAL NO. 1800200)

The initial readings for the VWPs (VW18-01 through VW18-03) were taken immediately following grouting operations, and KCB believes that the initial water levels recorded in the VWPs were artificially high due to grouting. Water levels recorded in these instruments decreased up to 12 m within a month of installation.

Excluding the first reading, water levels recorded in VW18-01 located within the slide mass, downslope from the highway) have varied from 8.8 m and 13.4 m below ground surface, and water levels in VW18-02 (located within the slide mass, on the east shoulder of the highway) have varied from approximately 7.7 m and 10.1 m below ground surface. These water levels are below the depth of movement recorded in the SI (between ground surface and 4.0 m below ground surface). The data indicates slide movements are likely in response to periods of increased precipitation when surface water infiltrates into the top few meters, destabilizing the slope.
