July 10, 2024

Alberta Transportation and Economic Corridors
2nd Floor, 803 Manning Road N.E.
Calgary, Alberta
T2E 7M8

CON0022161 Southern Region GRMP Instrumentation Monitoring
Site S003; H22:16 km 9.9 Cochrane
Section C – 2024 Spring Readings

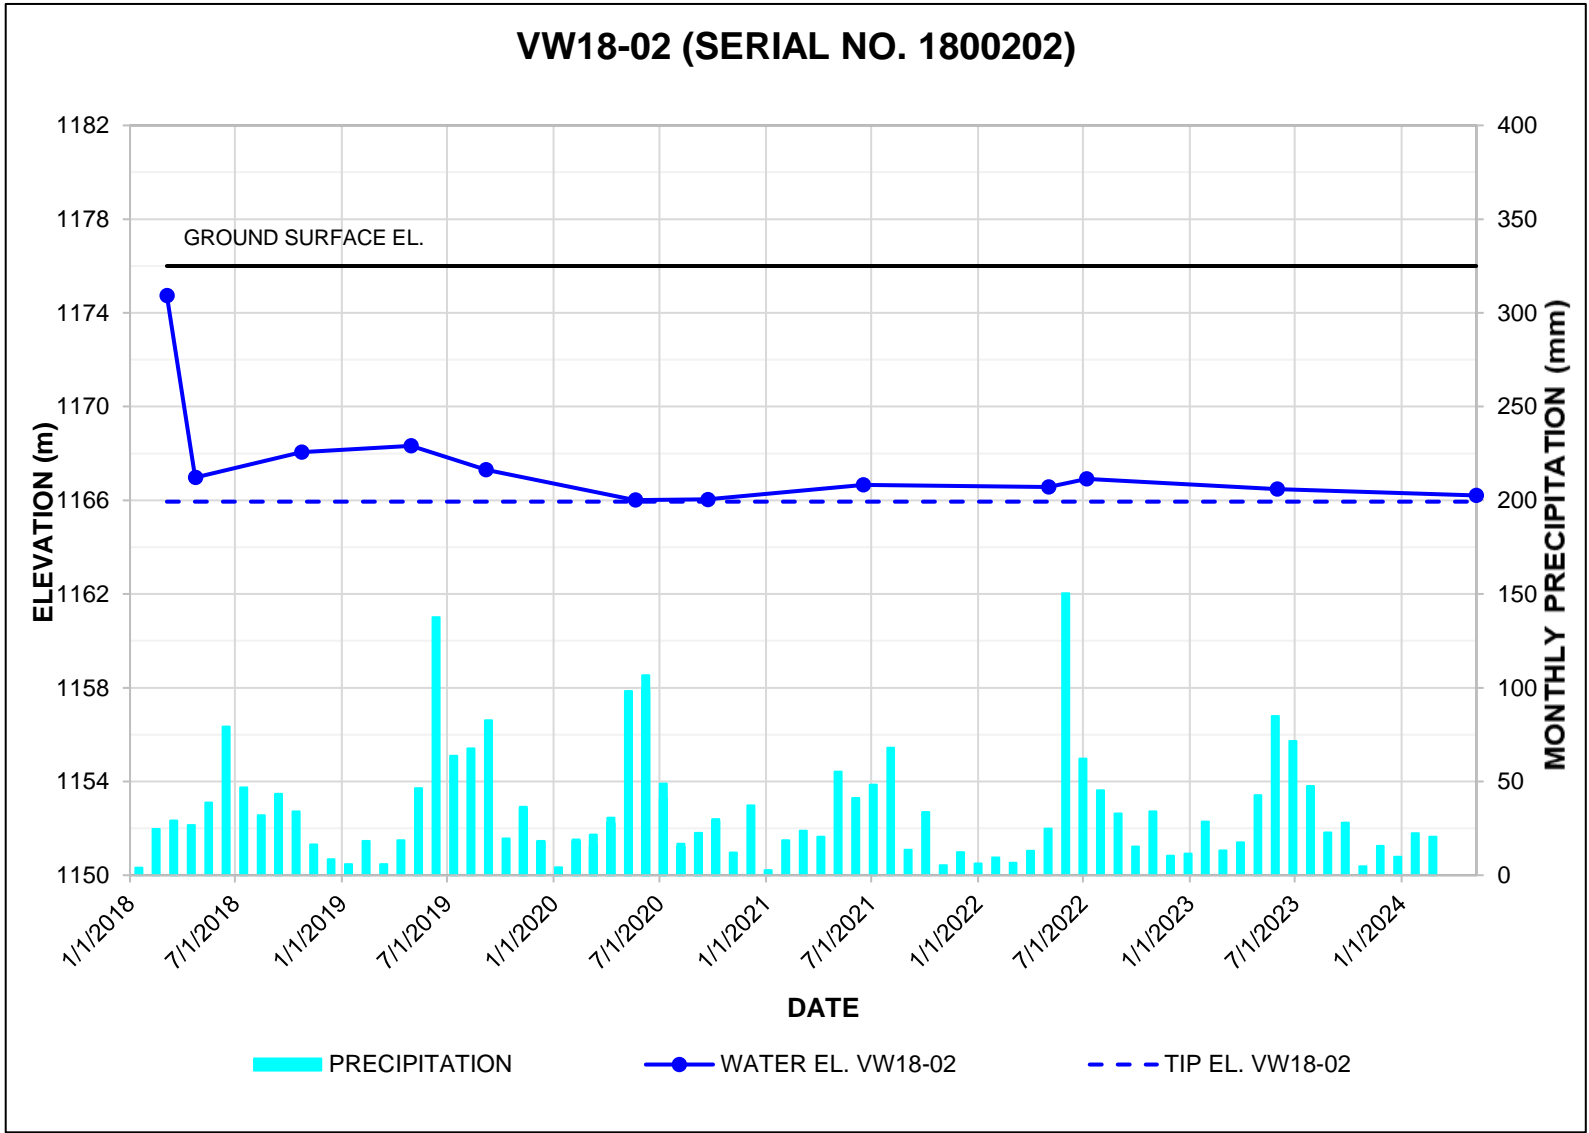
VW18-02 (SERIAL NO. 1800202)

Excluding the first reading, water levels recorded in VW18-01 located within the slide mass, downslope from the highway) have varied from 8.8 m and 13.4 m below ground surface, and water levels in VW18-02 (located within the slide mass, on the east shoulder of the highway) have varied from approximately 7.7 m and 10.1 m below ground surface. These water levels are below the depth of movement recorded in the SI (between ground surface and 4.0 m below ground surface). The data indicates slide movements are likely in response to periods of increased precipitation when surface water infiltrates into the top few meters, destabilizing the slope.

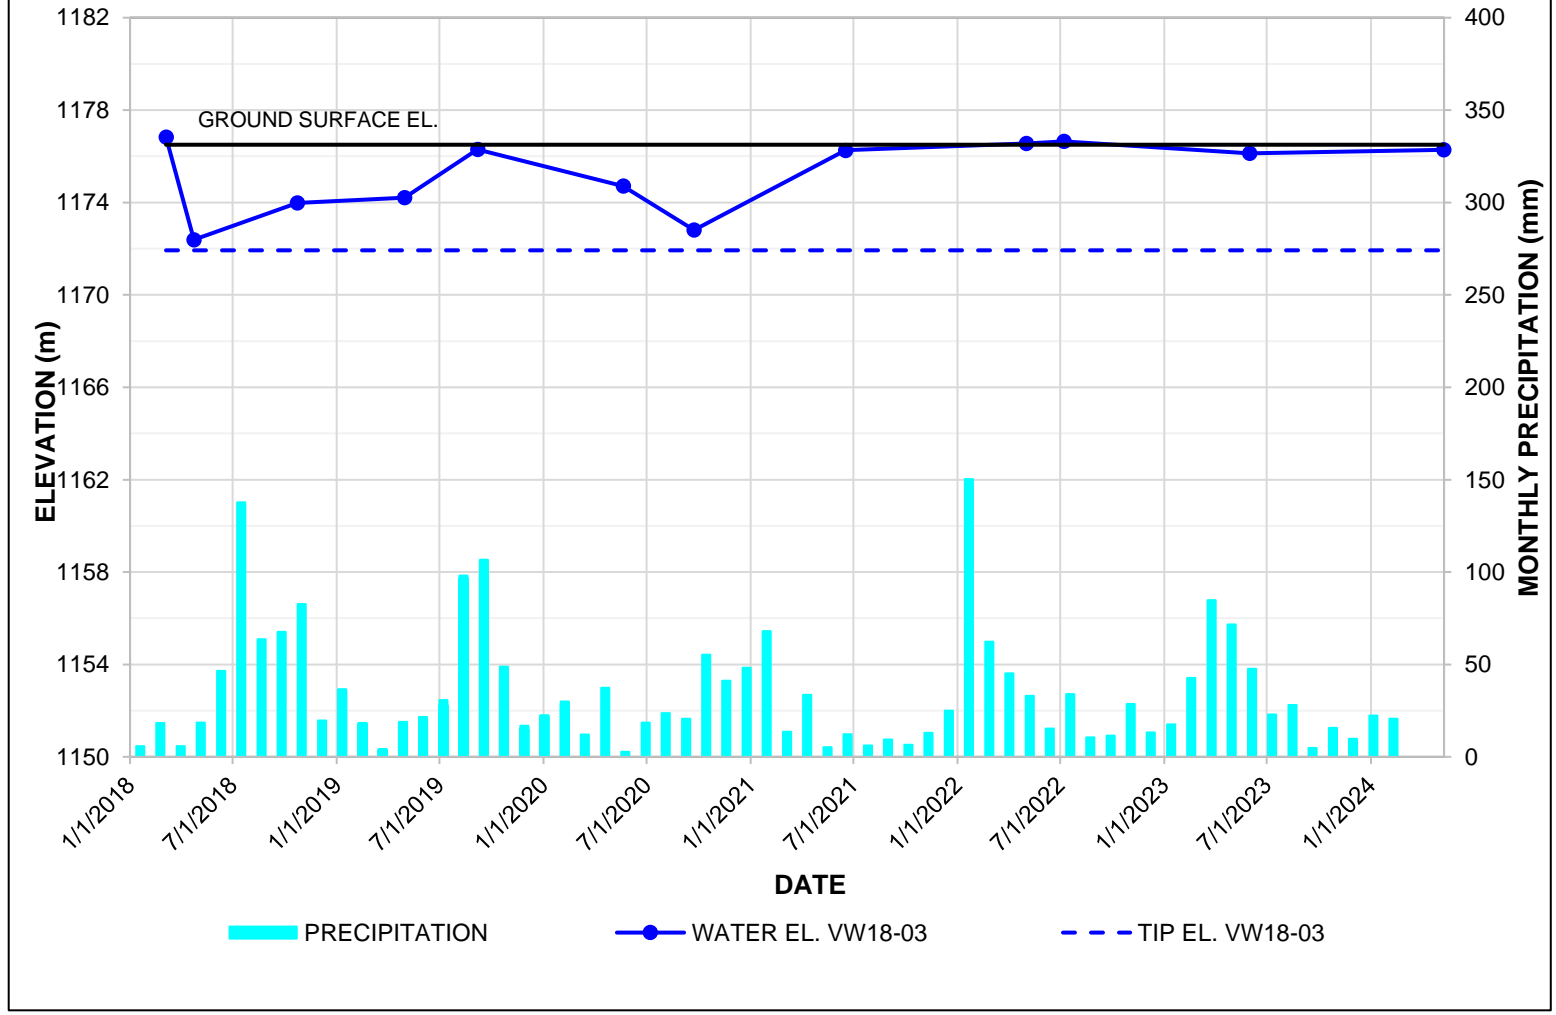
VW18-03 (SERIAL NO. 1800201)

Water levels recorded in VW18-03 (located in the west highway ditch) have been within 0.4 m of ground surface since 2021. The spring 2024 was recorded at 0.2 m below ground surface. Periods of increased water levels recorded in spring can most likely be attributed to periods of increased precipitation. Rainfall data past March 31, 2024 was not available at the time of writing this report, further discussion on how the piezometers respond to increased rainfall will be discussed in subsequent reports once the data is available.
