LANDSLIDE RISK ASSESSMENT
SOUTHERN REGION

SITE S5: CHIN COULEE LANDSLIDE

Alberta Transportation
Southern Region Landslide Monitoring Program
Spring 2001 Assessment Report

Site S5 – Chin Coulee

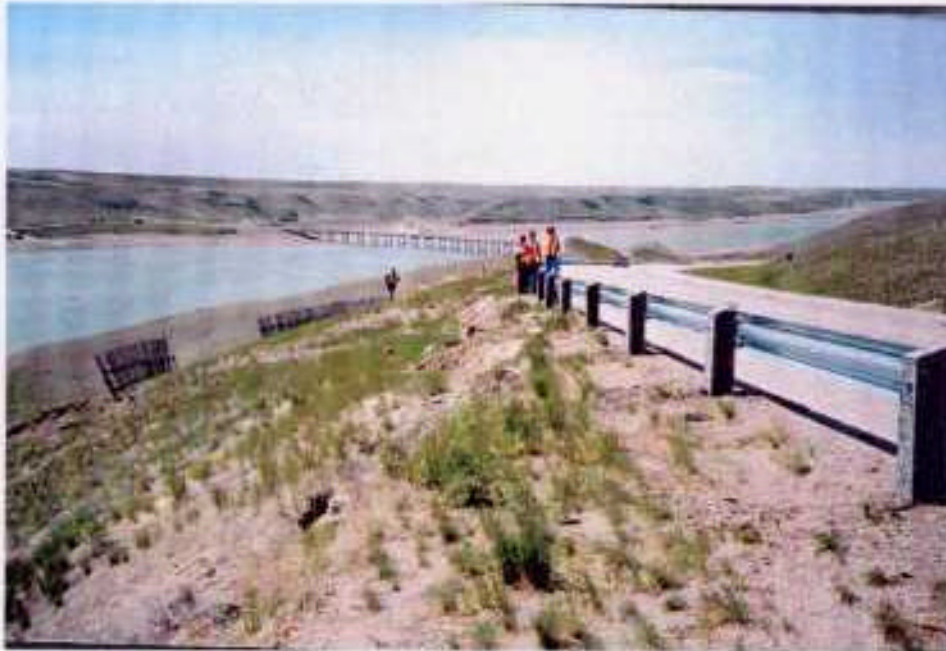
- The scarp area of the slide was directly adjacent to the north shoulder of the road. Photo 1 shows this feature.
- It was reported by maintenance personnel that the guardrail had been previously repaired, and fill had been placed on the downslope side of the guardrail. It was evident that at least portions of this fill had been lost downslope. There was some distortion to the guardrail, but it was not possible to determine if this was due to slope movement or was how the rail had been installed during realignment. See Photos 1 and 2, comparing the 2000 and 2001 assessments.

Photo 1 – View of downslope edge of the road above slide area (2001). Note newly-installed guardrail and slide scarp visible downslope of road.

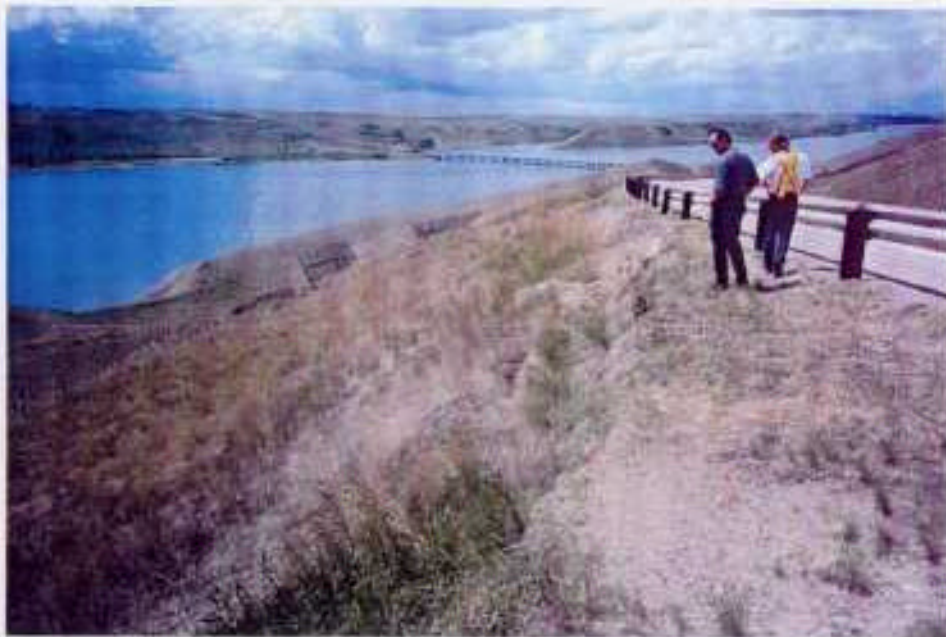
Photo 2 – Downslope edge of road as seen during the June 2000 assessment.

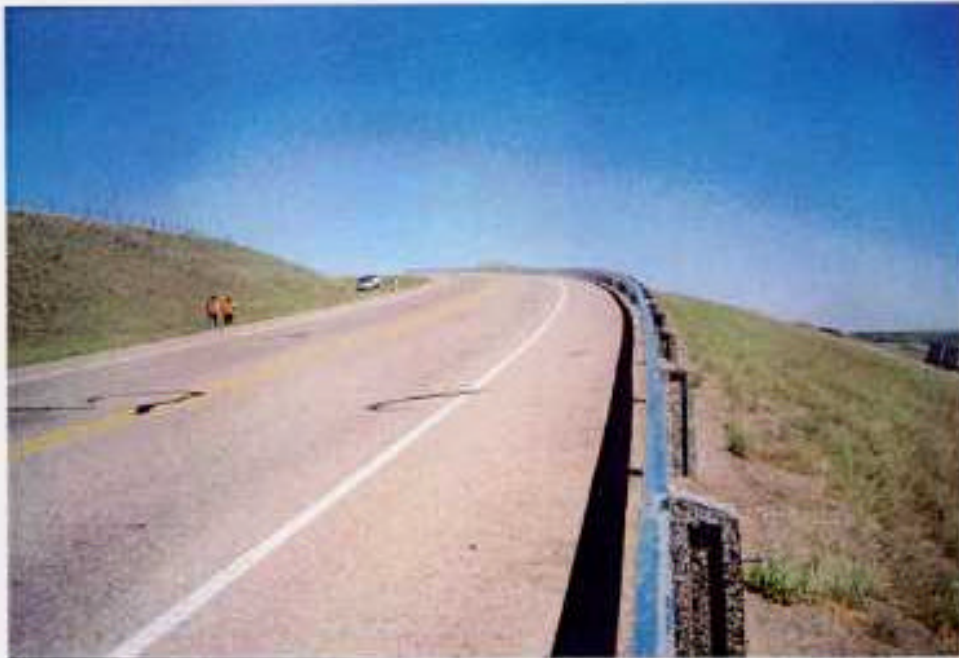
- One major longitudinal crack had been sealed in the eastbound lane adjacent to the slide. Horizontal displacements and distortion of the road surface were minimal. Refer to Photos 3 and 4.

Photo 3 – Facing northeast along road through slide area. Note newly-installed guardrail.

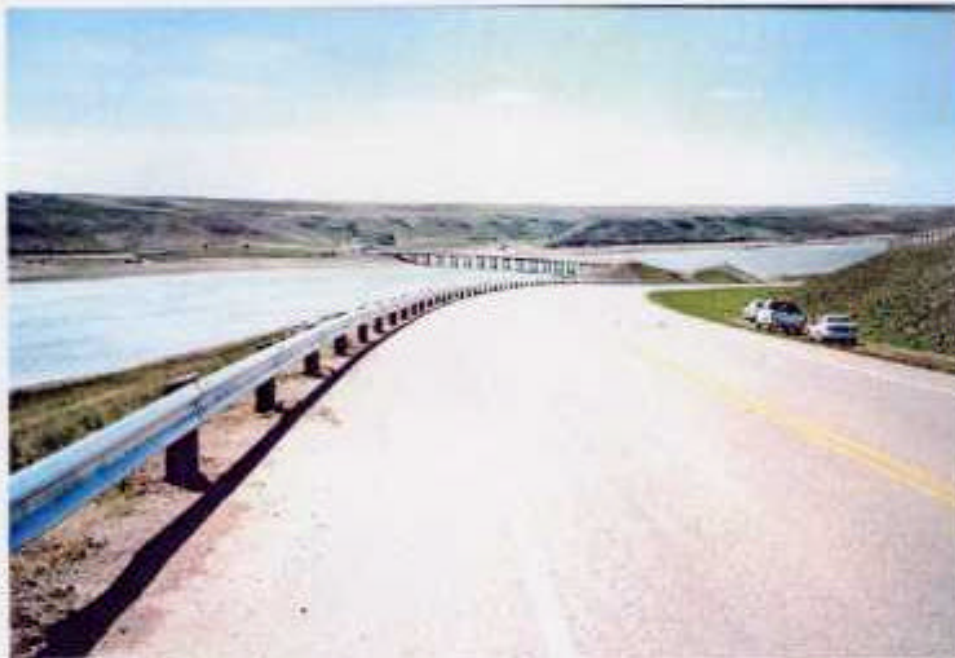
Photo 4 – Facing southwest along road through slide area. Note newly-installed guardrail.

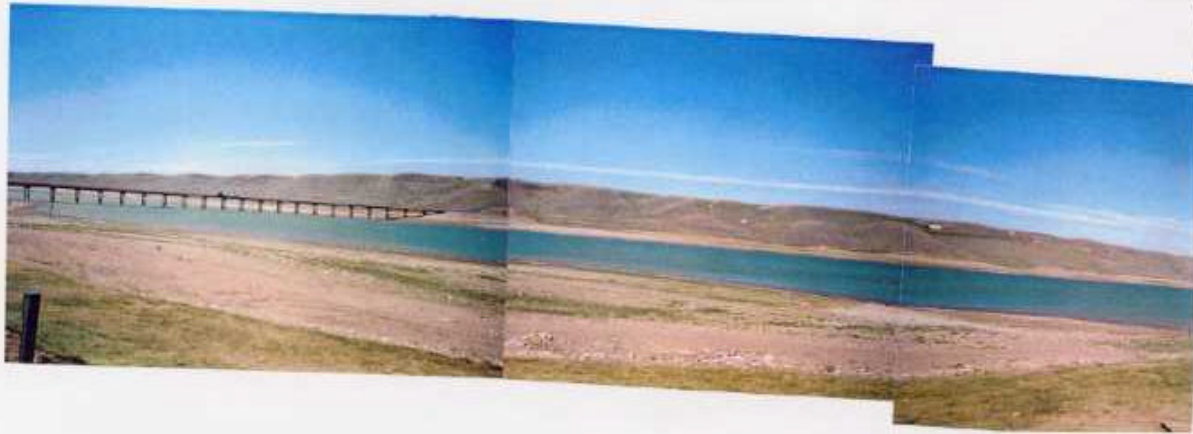
Photo 5 – View of Highway 36 on the north side of the Chin Coulee reservoir. The monitoring/assessment site is near the crest of the hill.
Note landslide throughout the north valley wall.
