| SITE NUMBER AND NAME:<br><b>S005 Chin Coulee</b> | | HIGHWAY & KM:<br>36:02, 37.101 | PREVIOUS INSPECTION DATE:<br>June 16, 2016 | INSPECTION DATE:<br><b>May 31, 2017</b> |

| PROJECT | SOUTHERN REGION GEOHAZARD RISK MANAGEMENT PROGRAM | |
| TITLE | Site Plan<br>S005 - Chin Coulee<br>Hwy 36:02, km 37.101 | |

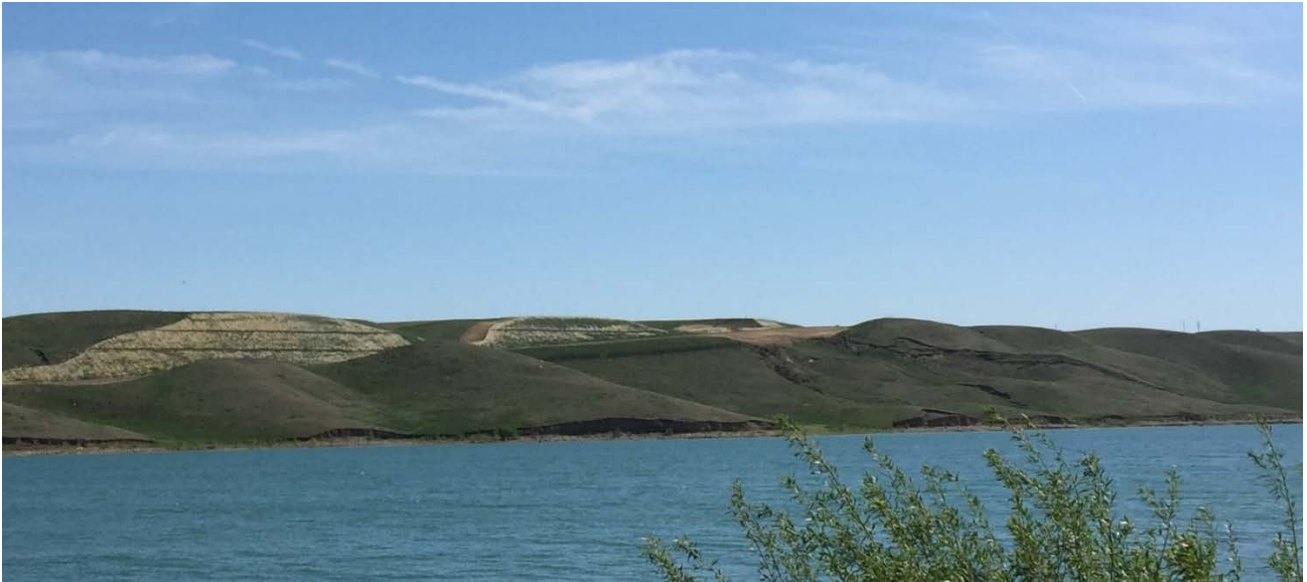
**Photo 1** Highway realigned north of slide area into embankment. Head scarp graded. Photo taken facing northeast from south side of Chin Coulee Reservoir on May 31, 2017.

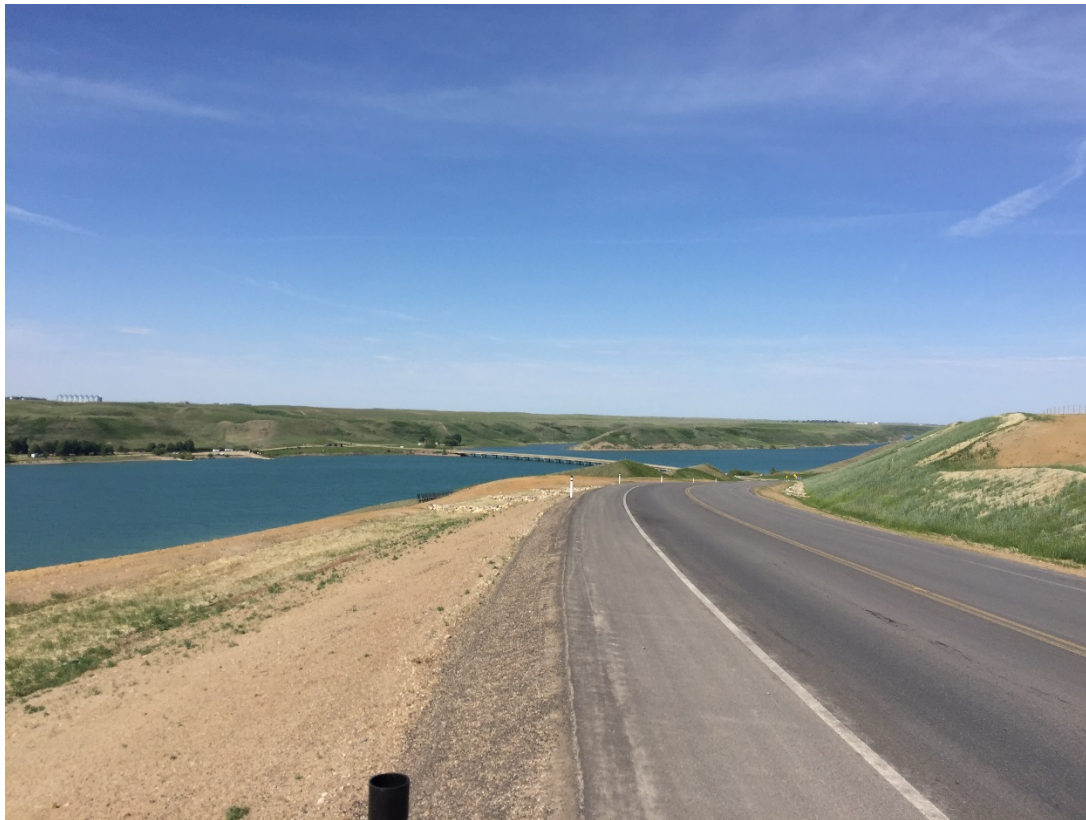
**Photo 2** New highway alignment north of slide area. Photo taken facing west on May 31, 2017.

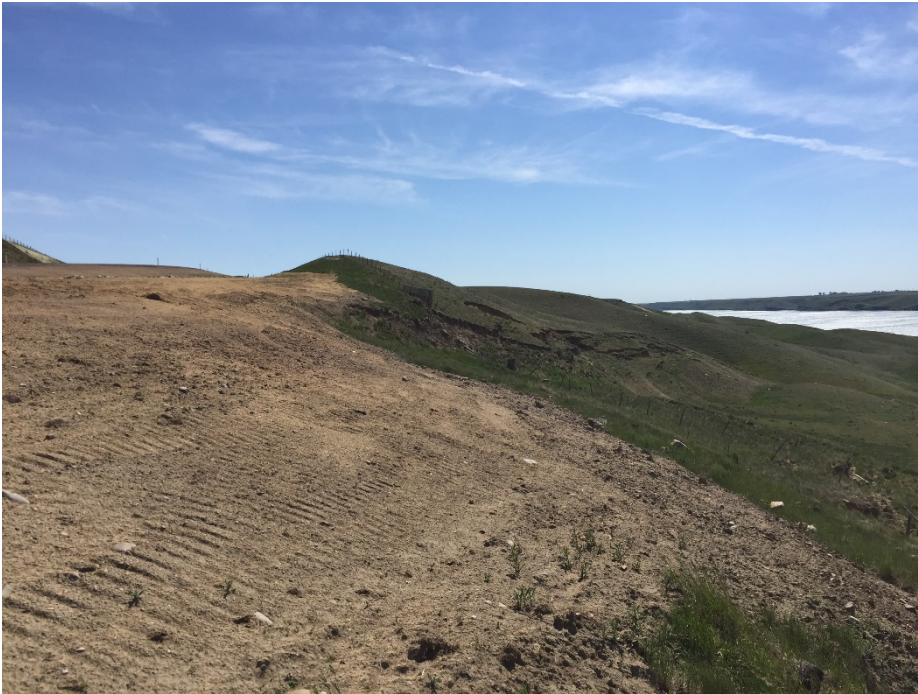
| ITEM | CONDITION EXISTS | | DESCRIPTION AND LOCATION | NOTICABLE CHANGE FROM LAST INSPECTION | |
|---|---|---|---|---|---|
| Slope Movement | x | | Previous head scarp at road surface graded. Movement ongoing downslope. | X | |

**Photo 3** Head scarp of slide graded, south of highway. Photo taken facing northeast on May 31, 2017

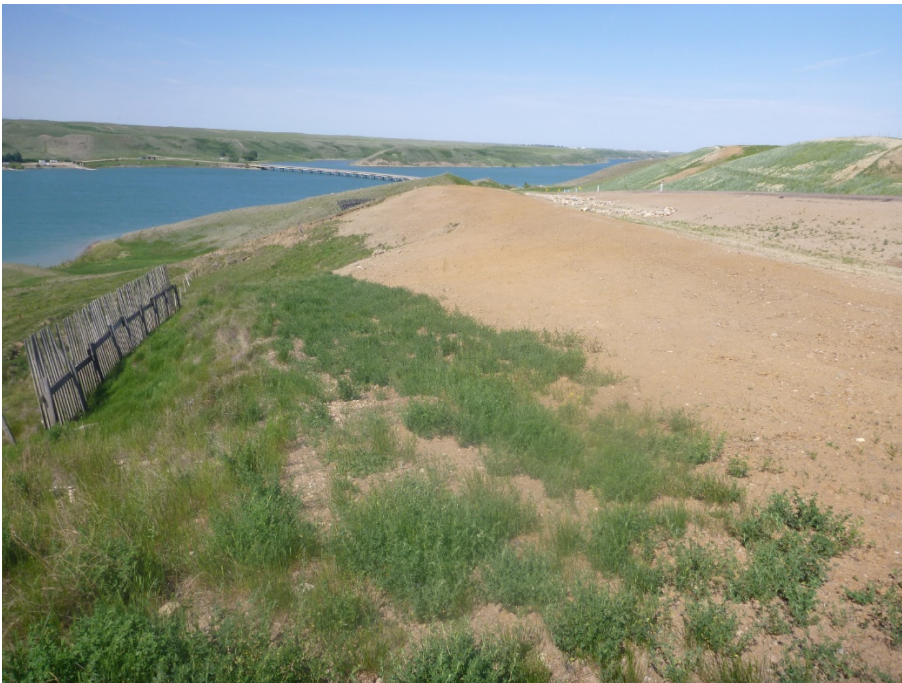
**Photo 4** Location of slope below former highway and realigned section of highway. Photo taken facing west on May 31, 2017.
