September 21, 2022

Alberta Transportation
2nd Floor, 803 Manning Road N.E.
Calgary, Alberta
T2E 7M8

**CON0022161 Southern Region GRMP Instrumentation Monitoring
Site S005; H36:02, km 37.1 Chin Coulee Slide
Section C – 2022 Spring Readings**

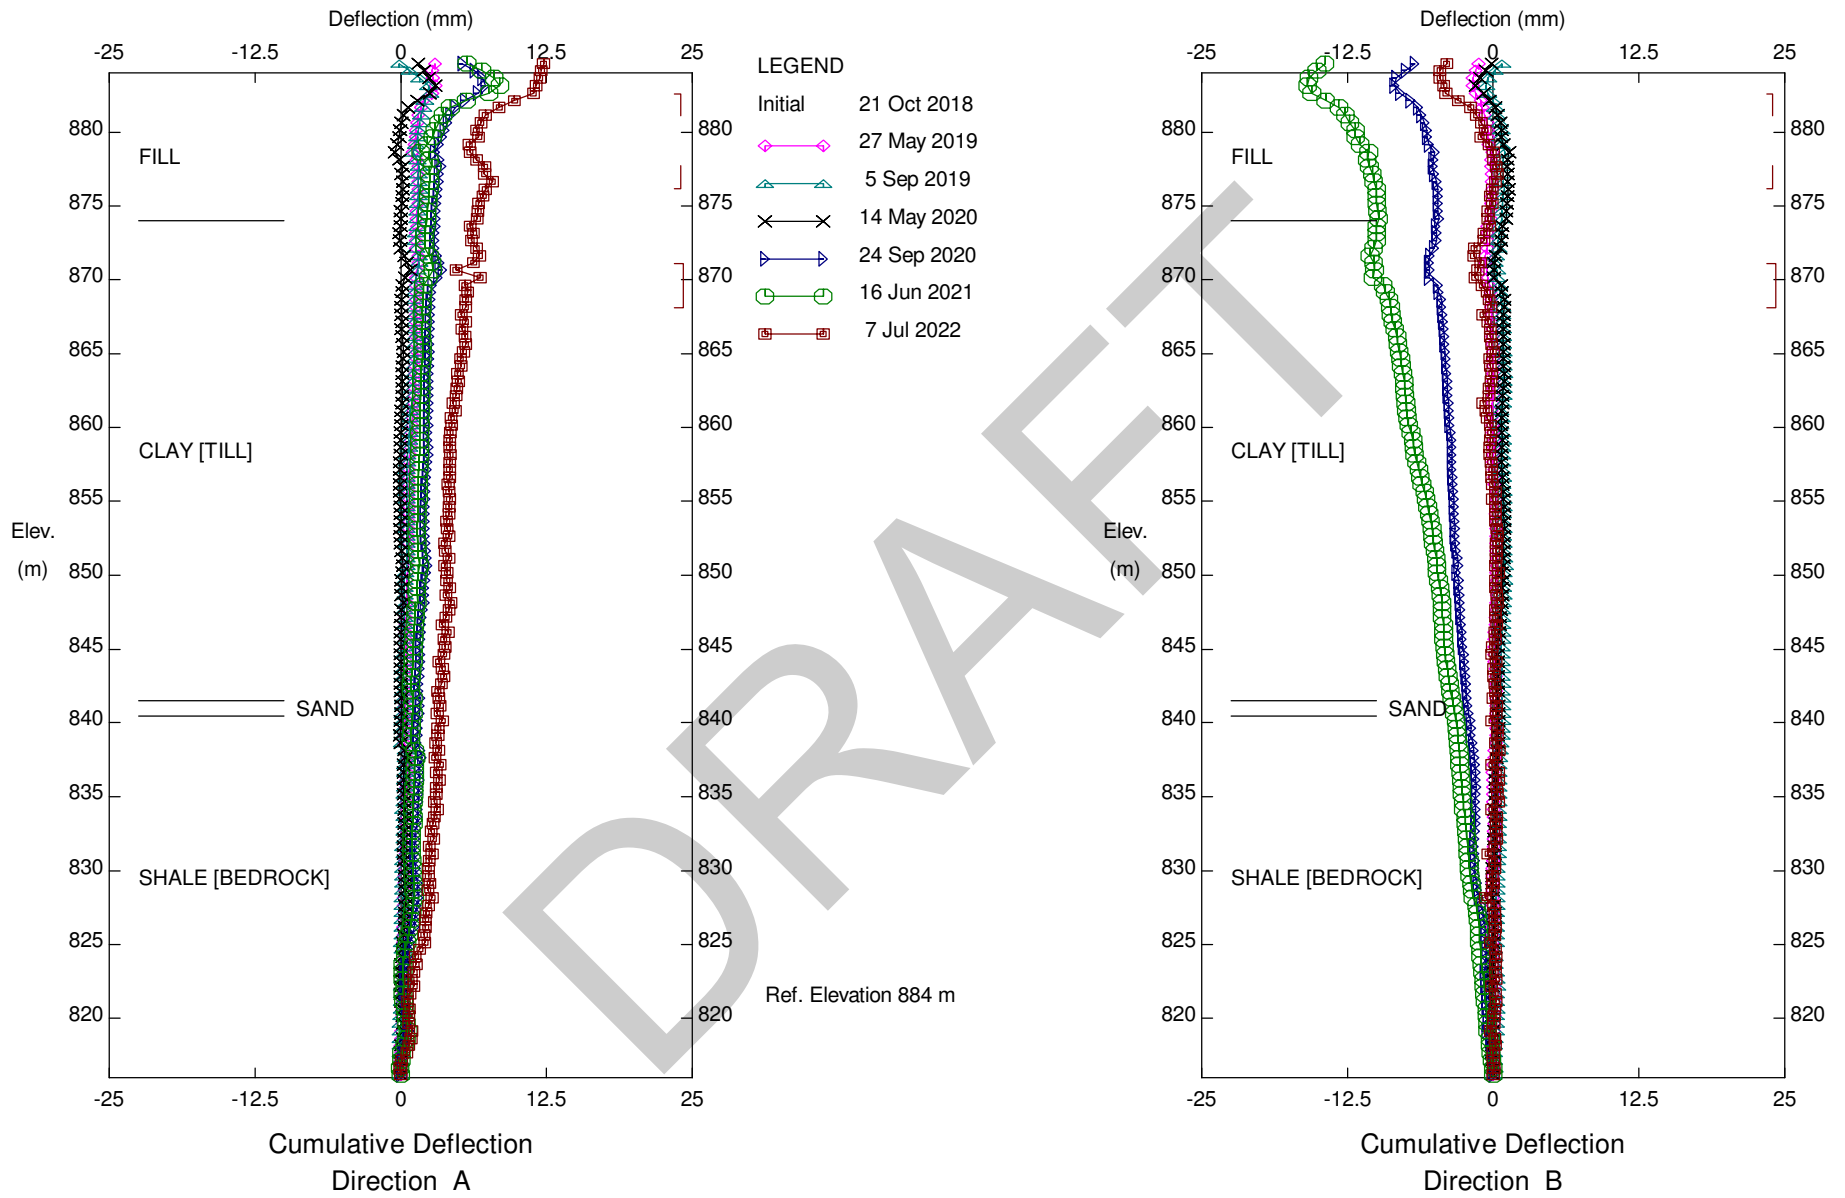
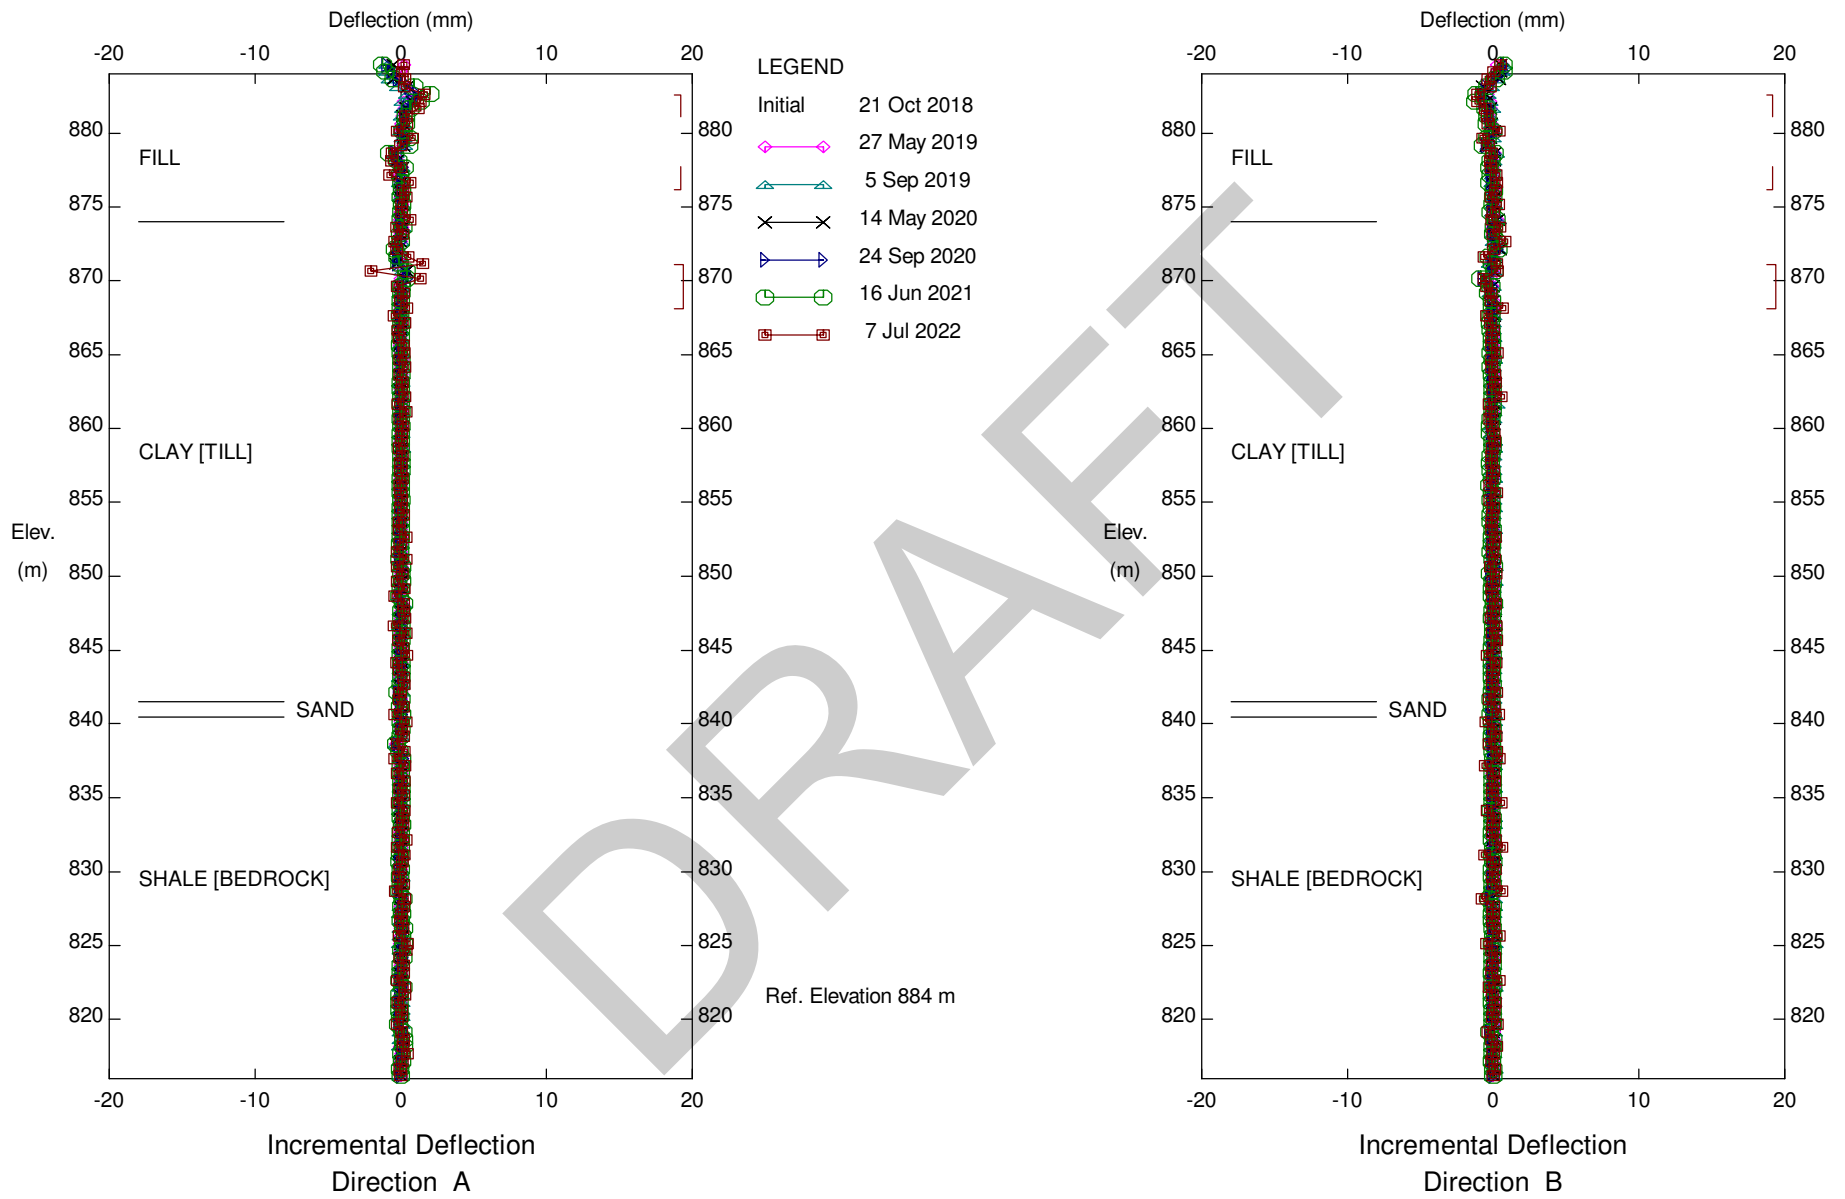
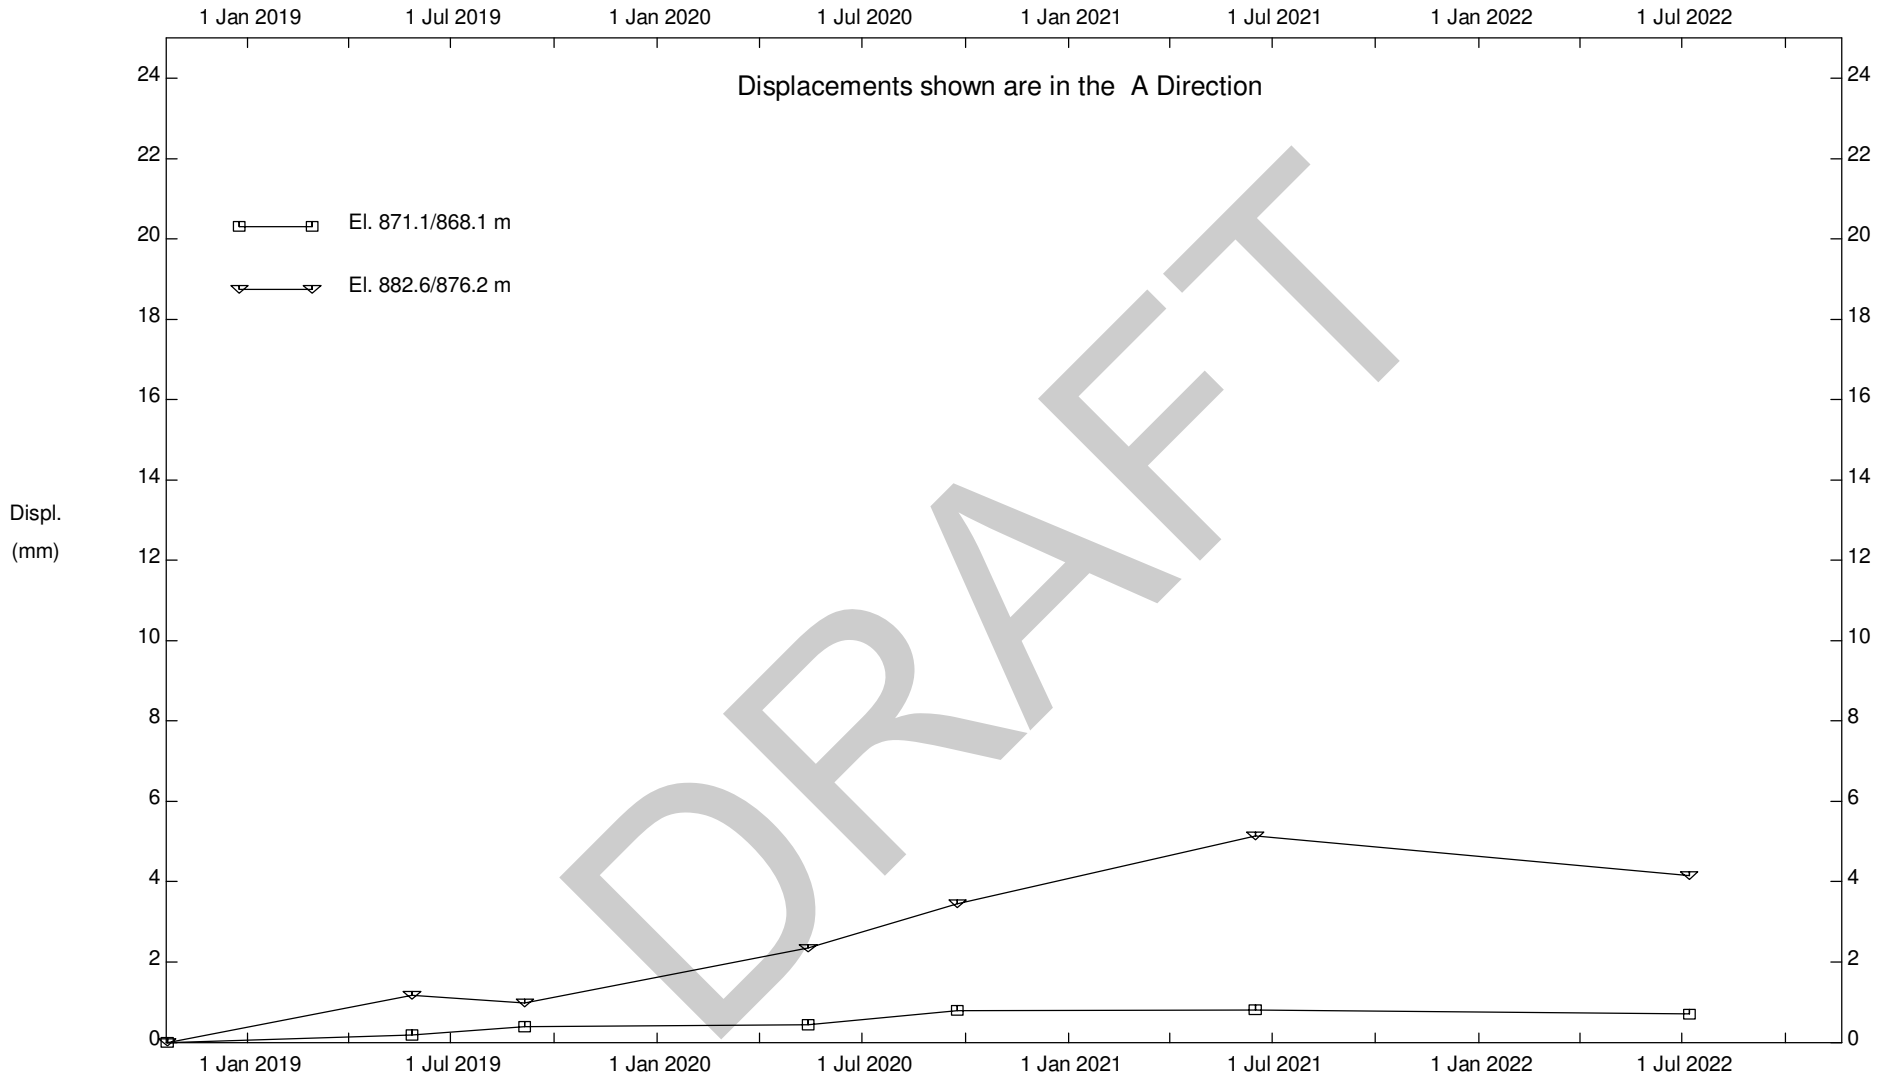
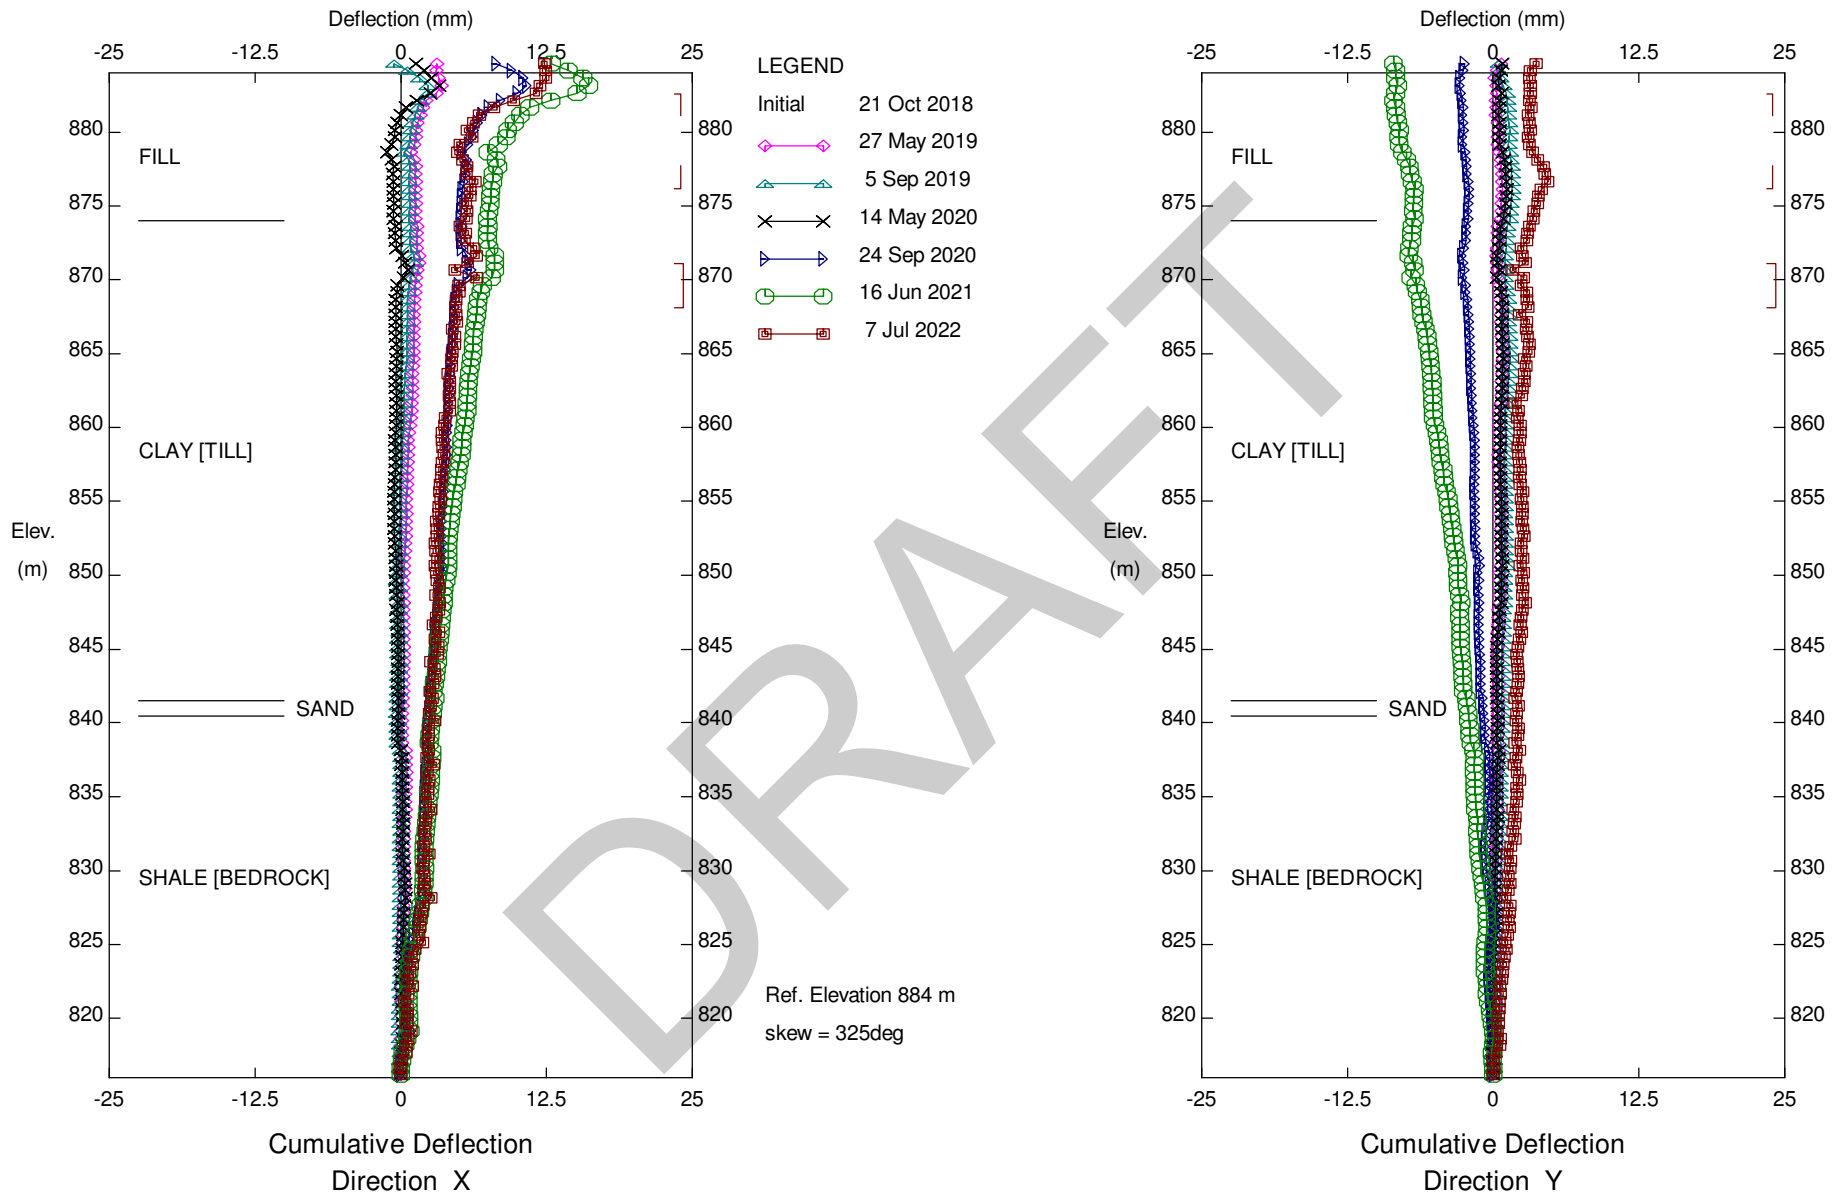
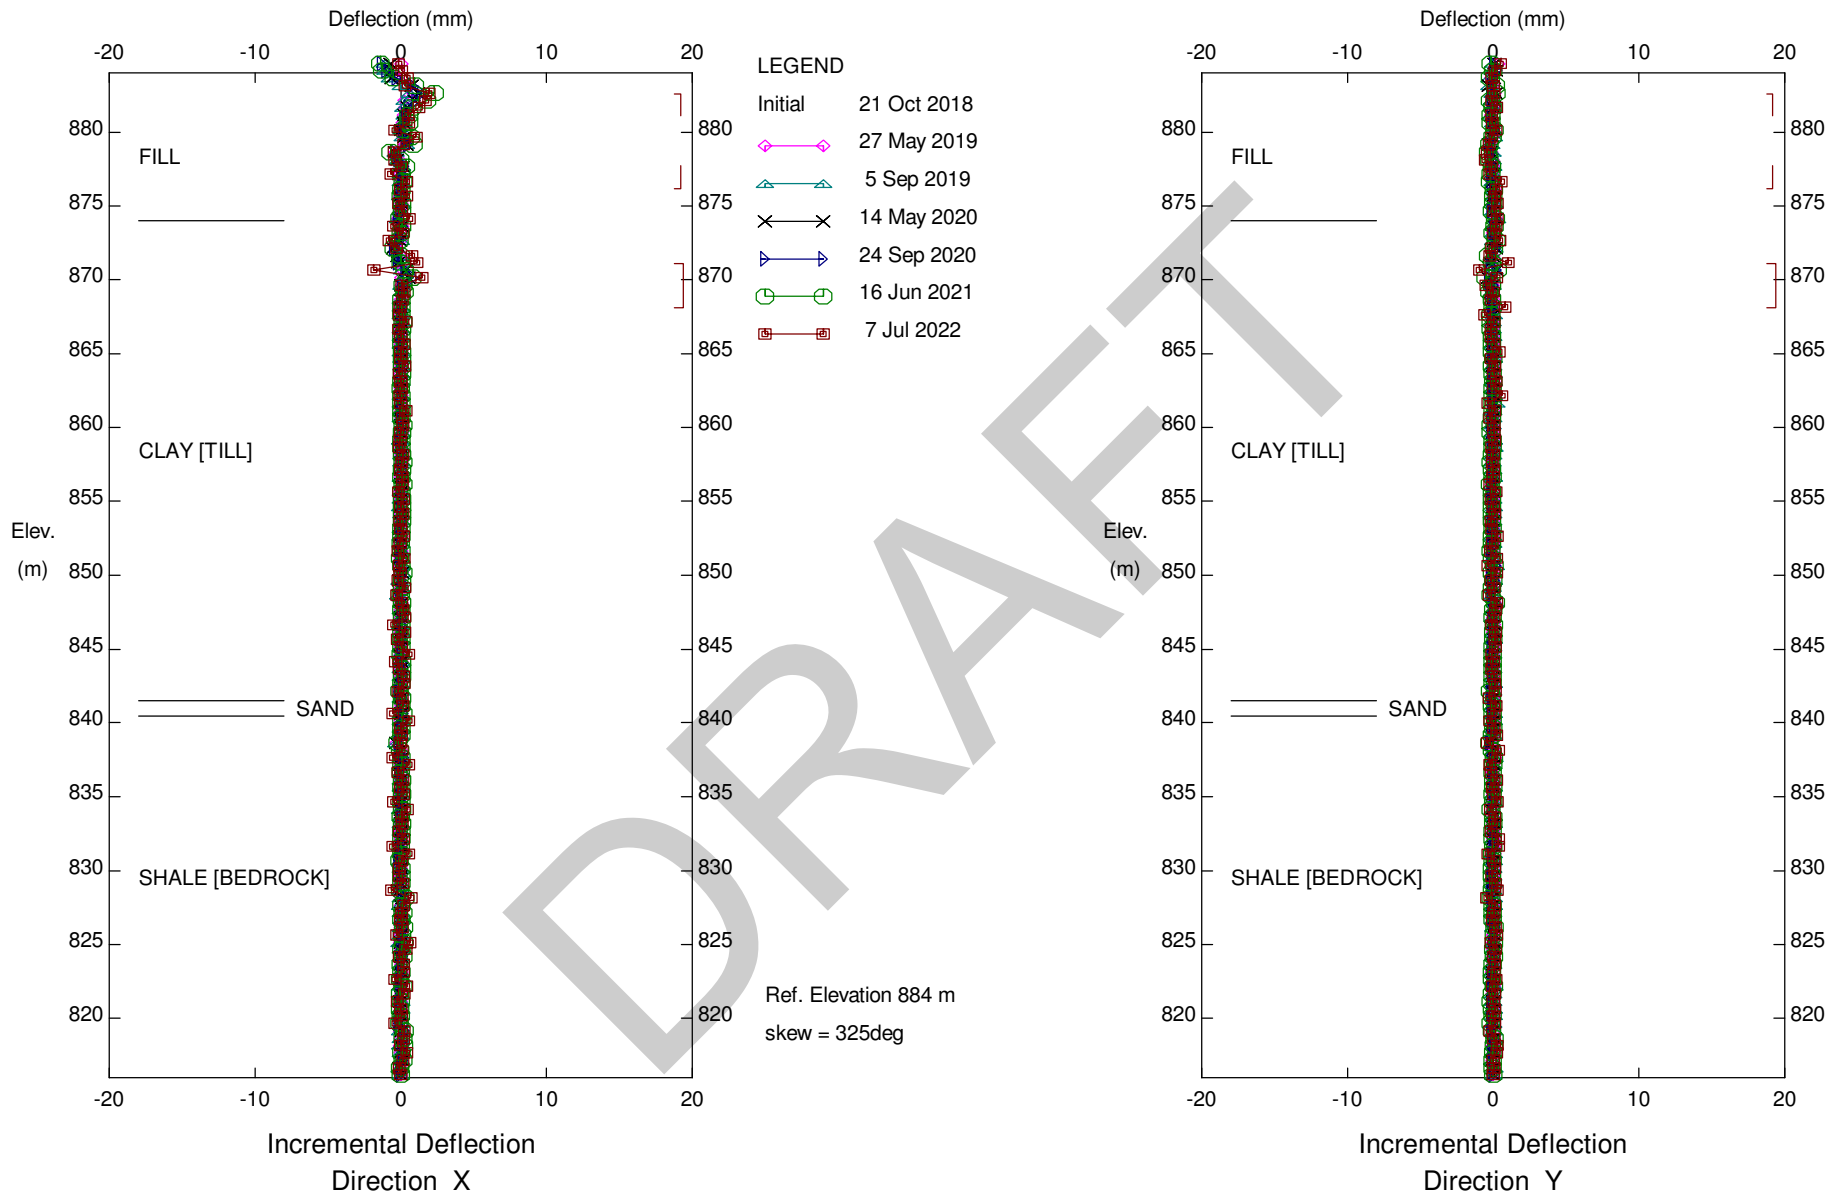
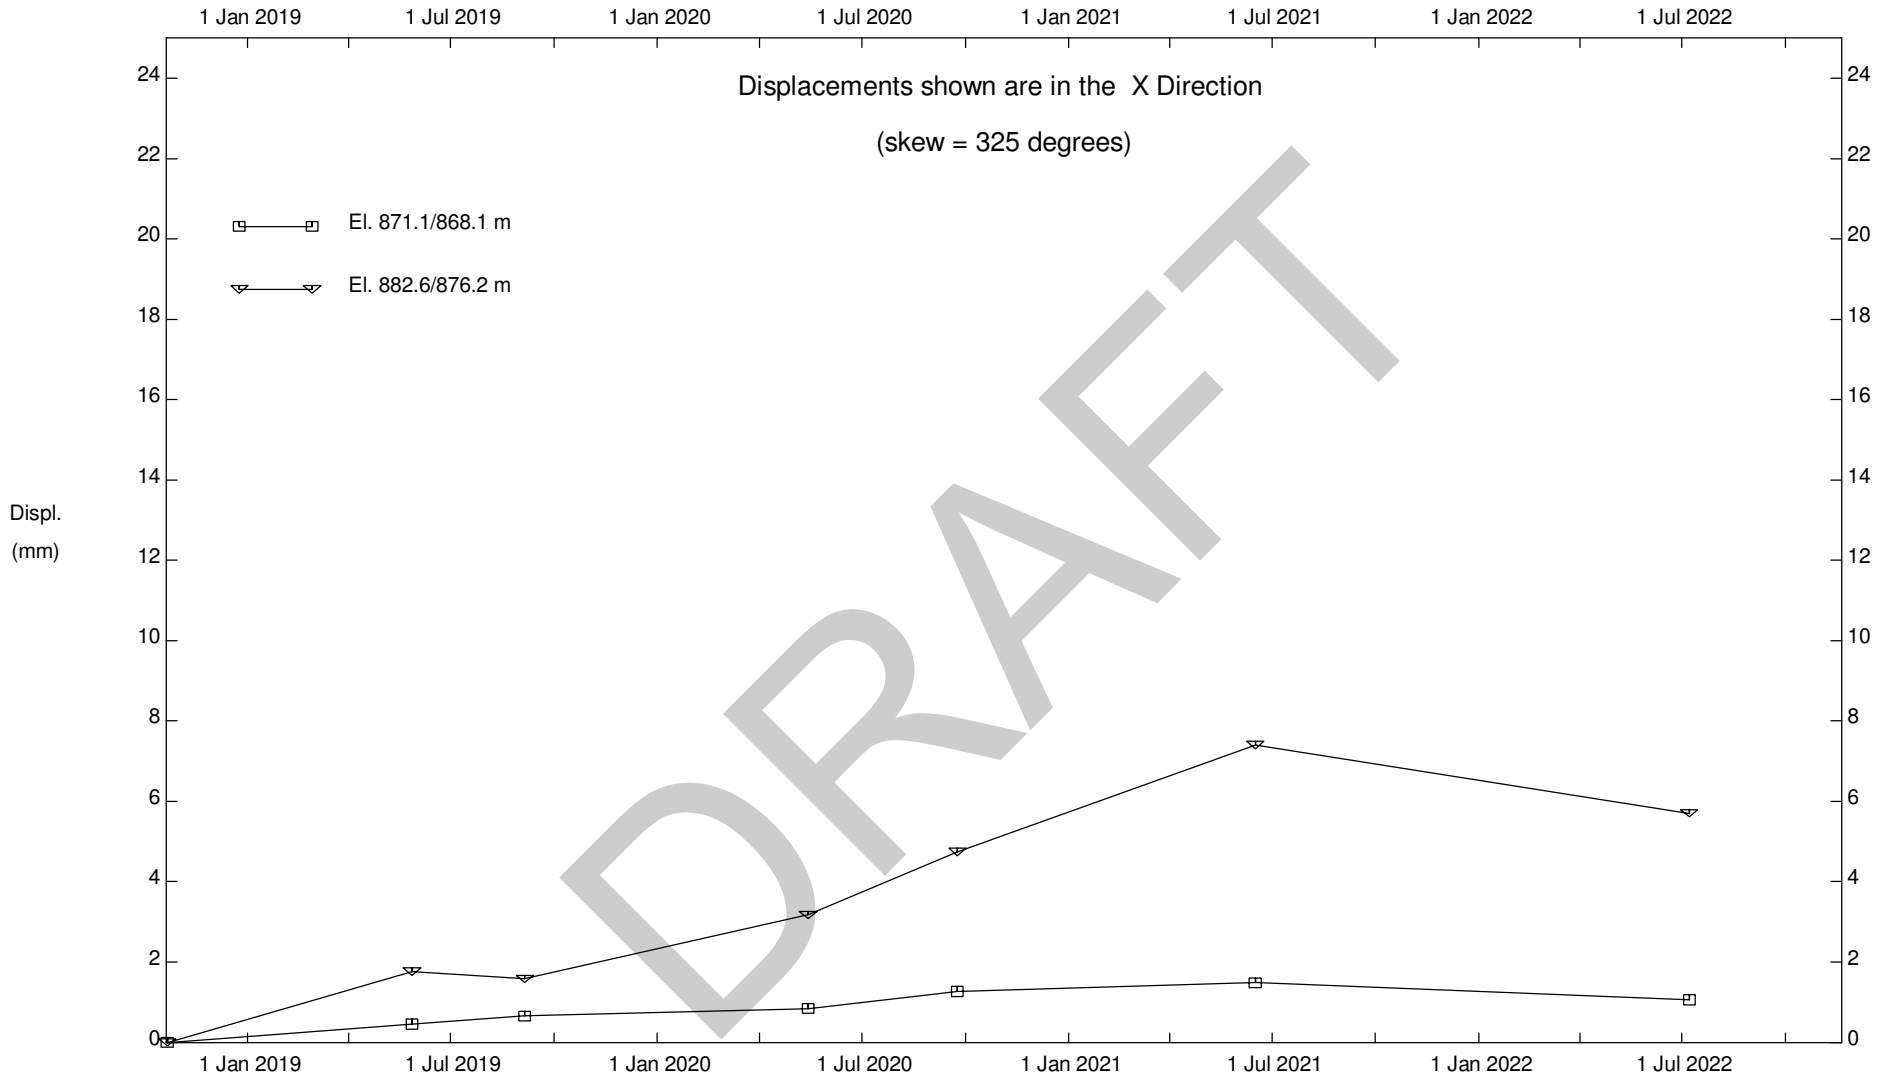
S005; H36:03, Chin Coulee, Inclinator SI18-01
 Alberta Transportation

Distributed movement has been recorded in SI18-01 from an approximate depth of 5 m to 60 m below ground surface (approximately El. 879 m to El. 824 m). The casing also appears to be settling or buckling between an approximate depth of 13.5 m and 16 m below ground surface (approximately El. 868.1 m and El. 871.1 m) as discussed below.

The settlement or buckling observed in SI18-01 (from approximately 13.5 m and 16 m below ground surface) could be an indication that the instrument is poorly grouted with a possible grout void. The movements of the slide mass and interpretation of the SI data is complicated by the potential for settlement or buckling of the SI casing in the poorly grouted casing segment. The instrument was previously re-initialized to the October 2018 reading to remove possible noise associated with this zone. Overall data quality has improved since the instrument was re-initialized, but settlement or buckling of the casing is still occurring at this depth. The rate of settlement or buckling has slowed since the first few months following installation and has been generally negligible since the instrument was re-initialized. If the settlement or buckling begins to impact interpretation of the SI data again the instrument may need to be re-initialized.

Since installation, the overall rate of movement recorded in SI18-01 and SI18-02 has been slow (less than 5 mm/year).

A small data shift was observed in the SI data between the June 2021 and July 2022 readings, which could be related to KCB changing the SI equipment when the old equipment became inoperable. The small rate of movement being recorded in the SIs makes the data sensitivity to changes in equipment.

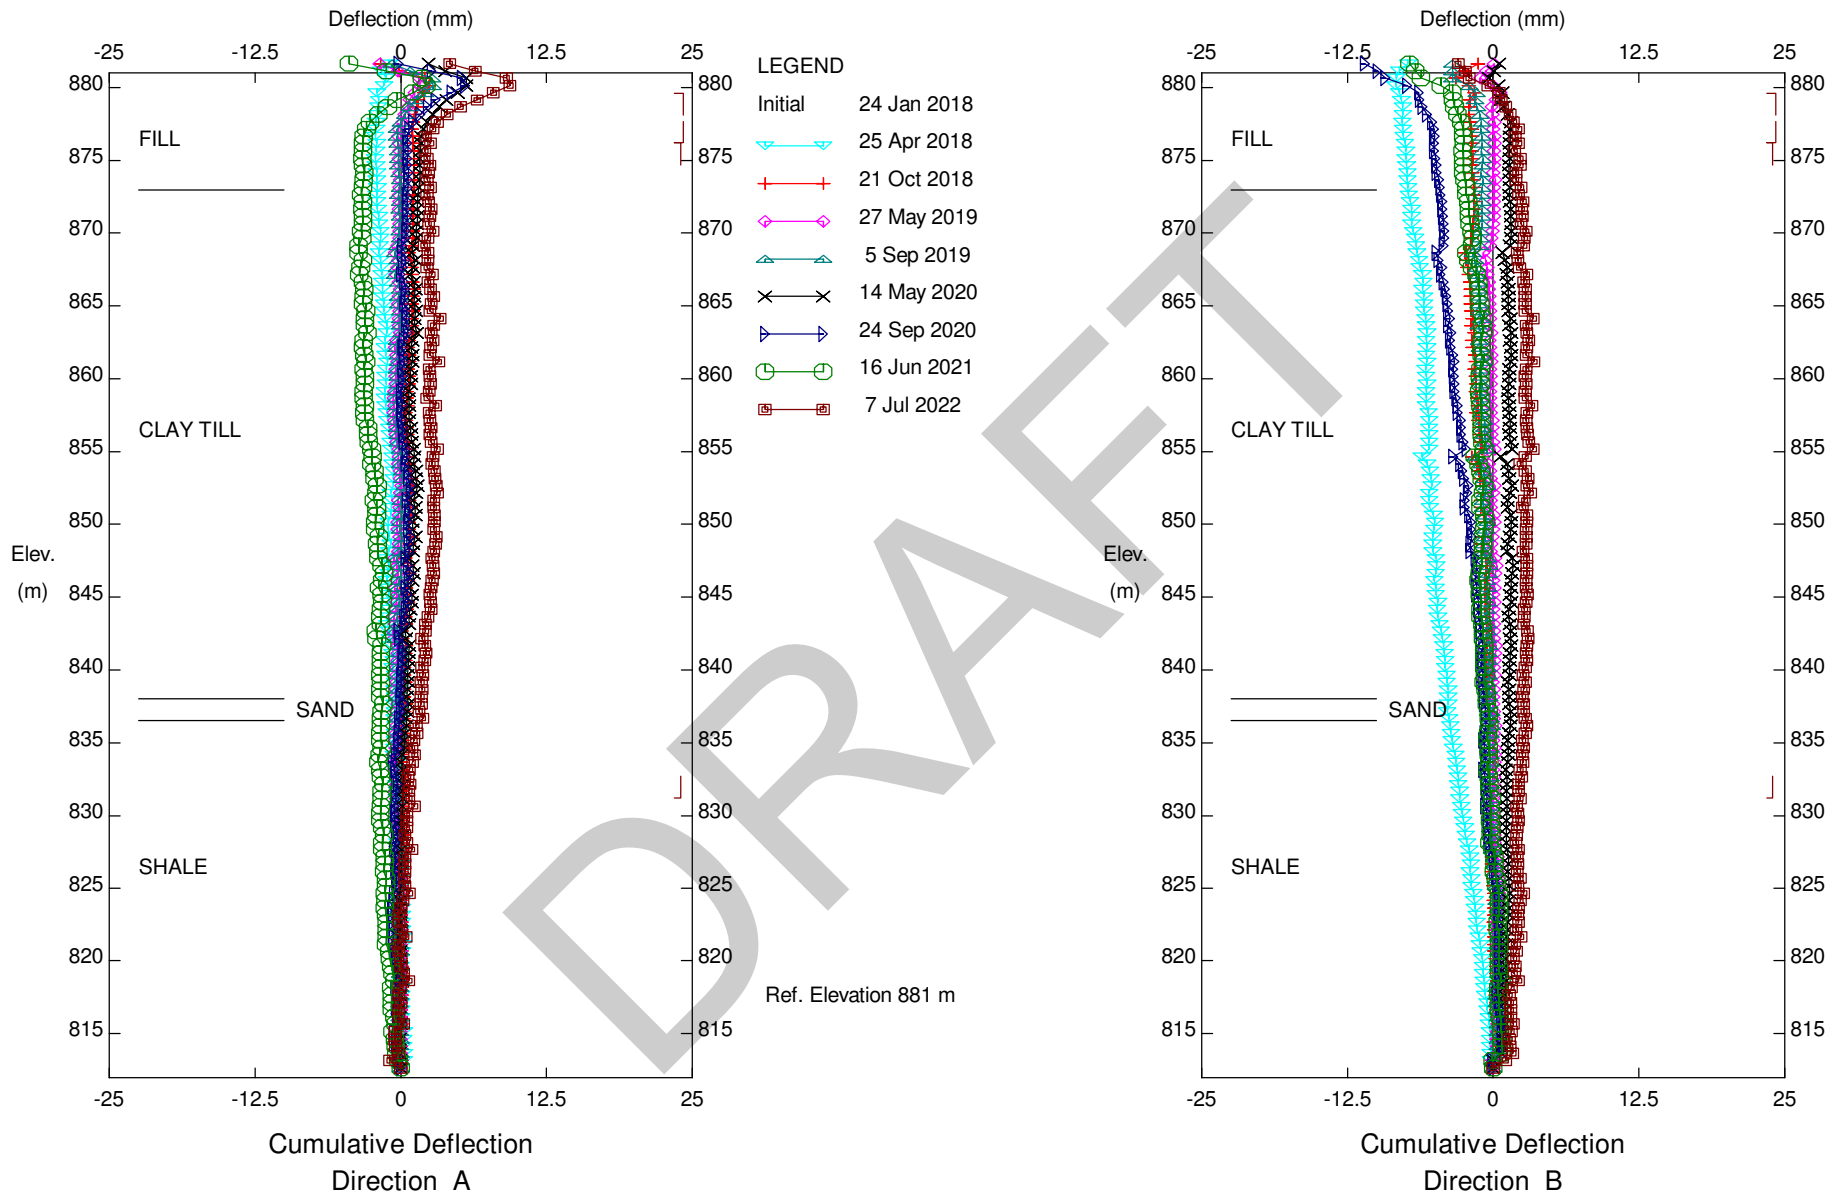
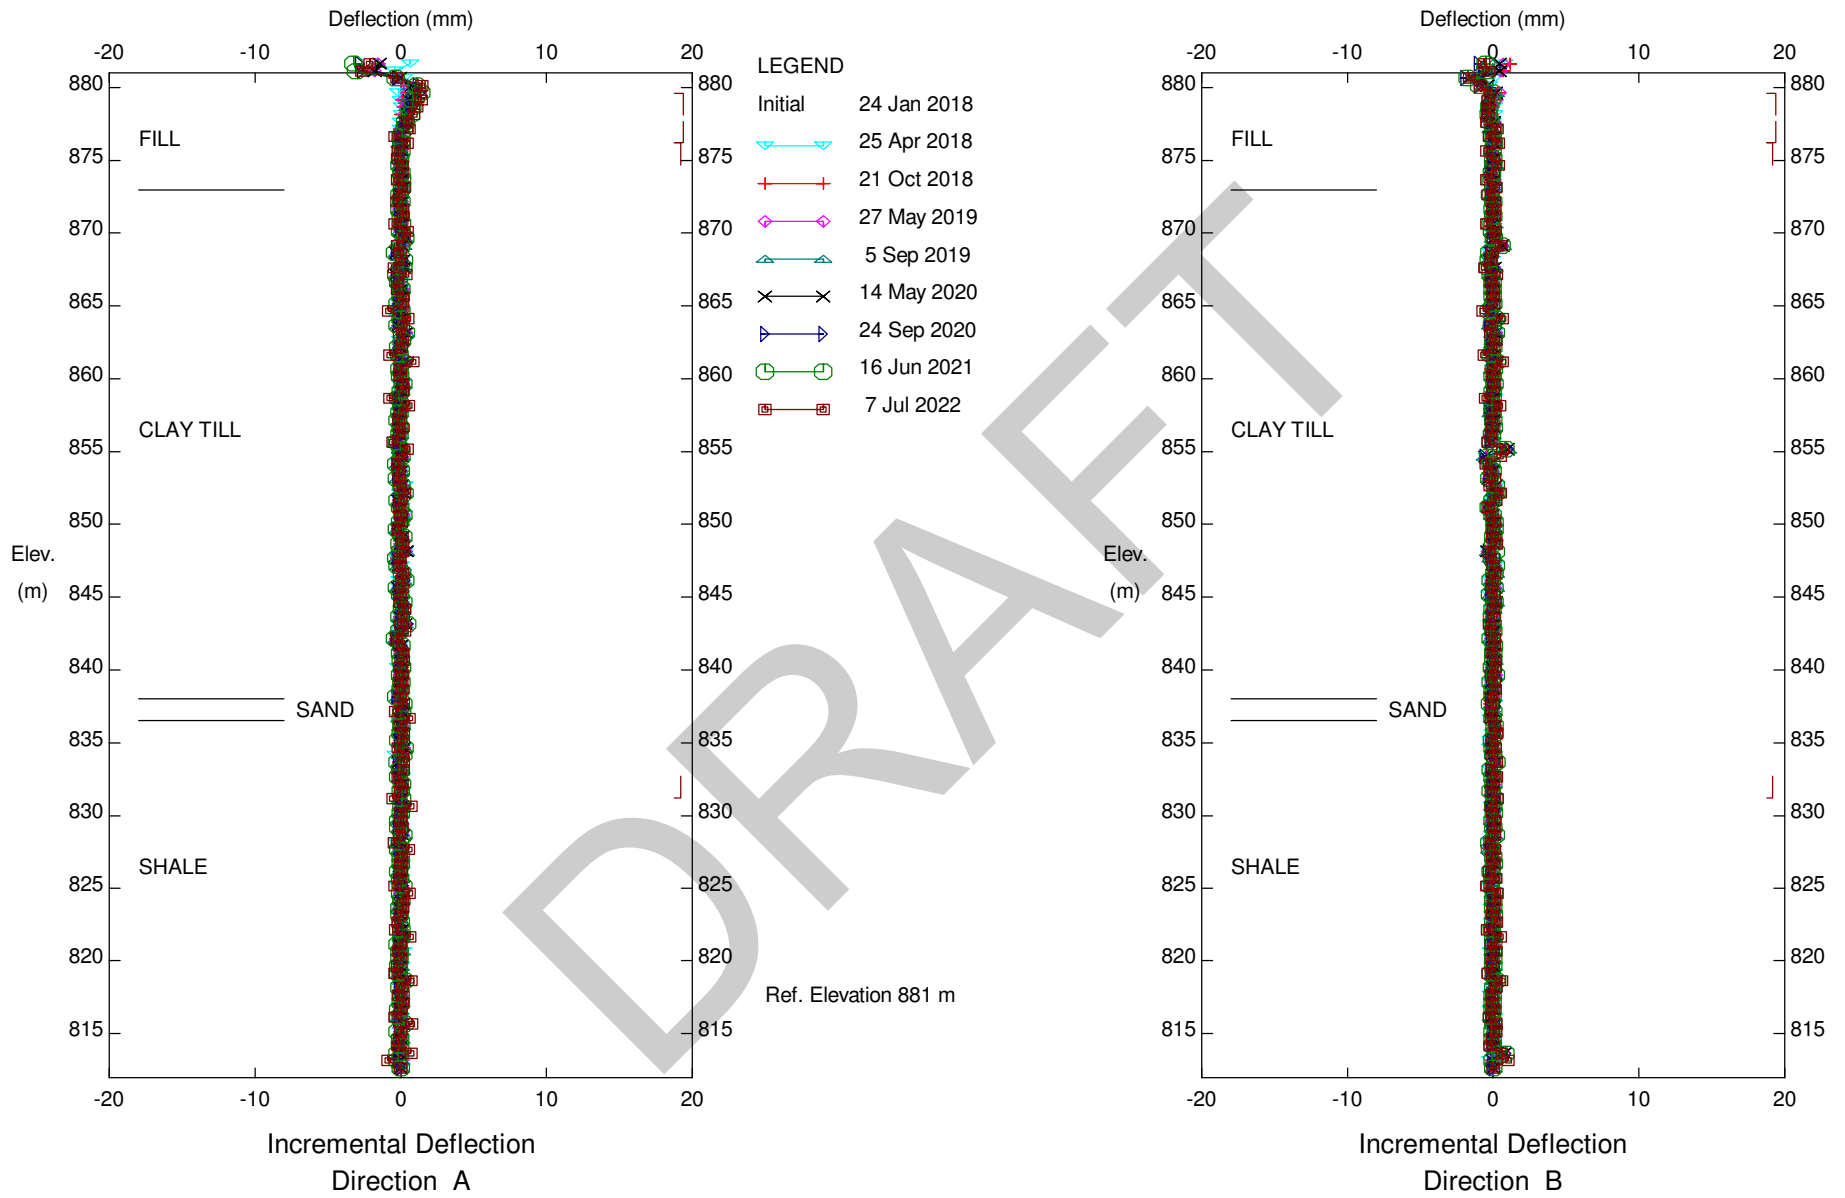
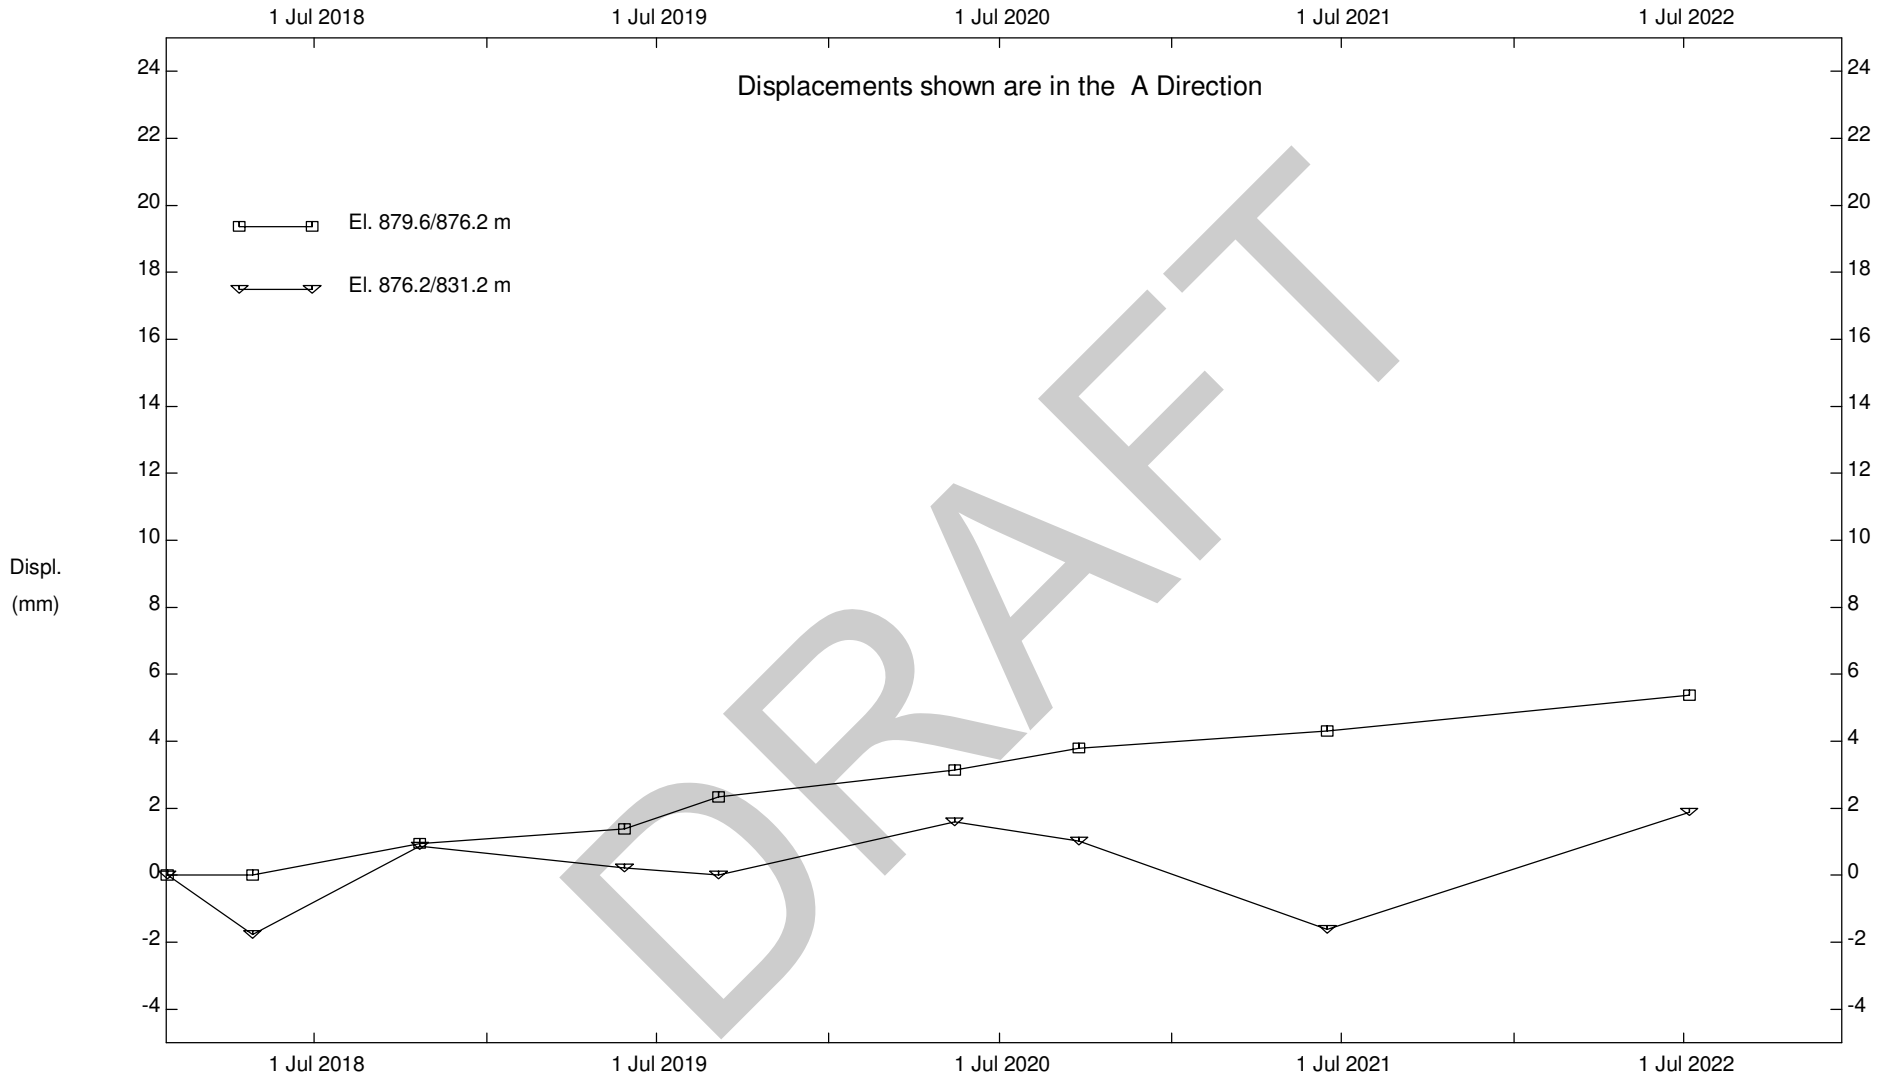
S005; H36:02, Chin Coulee, Inclinator SI18-02
 Alberta Transportation

Distributed movement has been recorded in SI18-02 from an approximate depth of 1 m to 50 m below ground surface (approximately El. 880 m to El. 831 m).

The near-surface movement recorded in the upper 5 m of SI18-01 and SI18-02 may be related to settlement of the highway-realignment fill or early signs of slope retrogression. The near-surface movements appear to be in the southeastern direction. Small tension cracks have been identified parallel to the crest where the SIs and geocube infrastructure are located, which may correspond with the near-surface movement recorded in the SIs. KCB recommends that future instrument readings include measurements and photographs of the small tension cracks near the SIs and geocube infrastructure, to verify a correlation with the SI readings.

KCB recommends that future instrument readings include measurements and photographs of the small tension cracks near the SIs and geocube infrastructure, to verify a correlation with the SI readings.

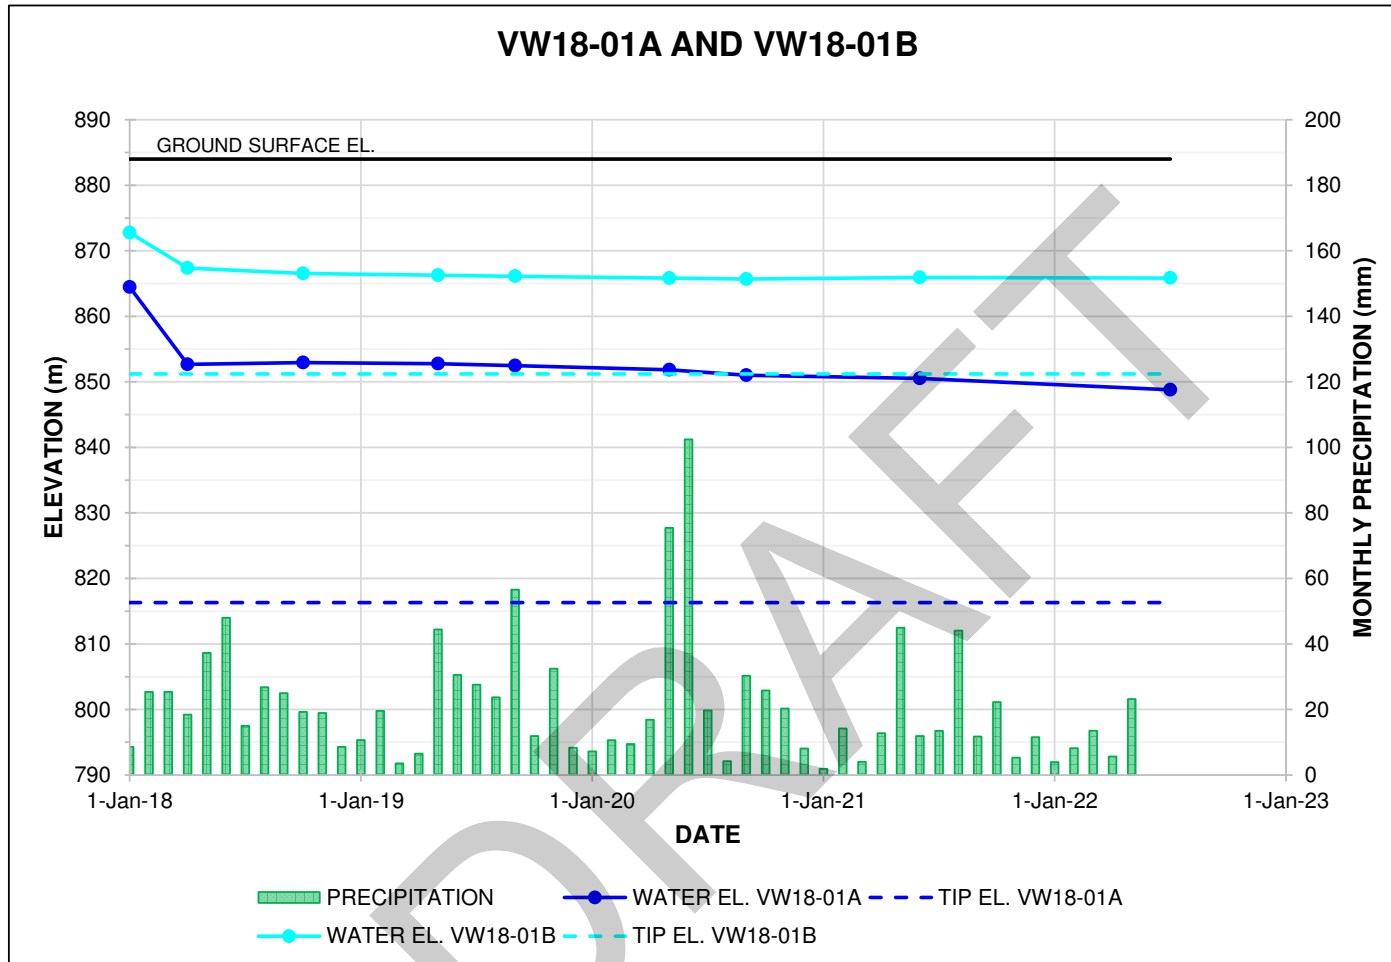
VW18-01A AND VW18-01B

The initial readings for the VWPs (VW18-01A/B and VW18-02A/B) were taken immediately following grouting operations, and KCB believes that the initial water levels recorded in the VWPs were artificially high due to grouting. Water levels recorded in these instruments decreased up to 13 m within a month of installation.

Overall, water levels recorded in VW18-01A, VW18-02A, and VW18-02B have steadily decreased approximately 2.4 m, 2.4, and 6.9 m, respectively, since the spring of 2018. Whereas water levels recorded in VW18-01A have remained relatively steady (± 0.1 m). The relatively steady decrease in water level recorded in VW18-01A, VW18-02A, and VW18-02B can most likely be attributed to excess porewater pressure dissipation following realignment of the highway (and the resulting fill placement) completed in 2016. It does not appear the water levels recorded in the VWPs at the S005 site fluctuate seasonally or in response to prolonged or heavy rainfall or freshet infiltration. However, the current annual reading frequency of the instruments may not capture short-term fluctuations (i.e., increases and decreases) in water level that occur between readings.
