September 21, 2022

Alberta Transportation
2nd Floor, 803 Manning Road N.E.
Calgary, Alberta
T2E 7M8

**CON0022161 Southern Region GRMP Instrumentation Monitoring
Site S005; H36:02, km 37.1 Chin Coulee Slide
Section C – 2022 Spring Readings**

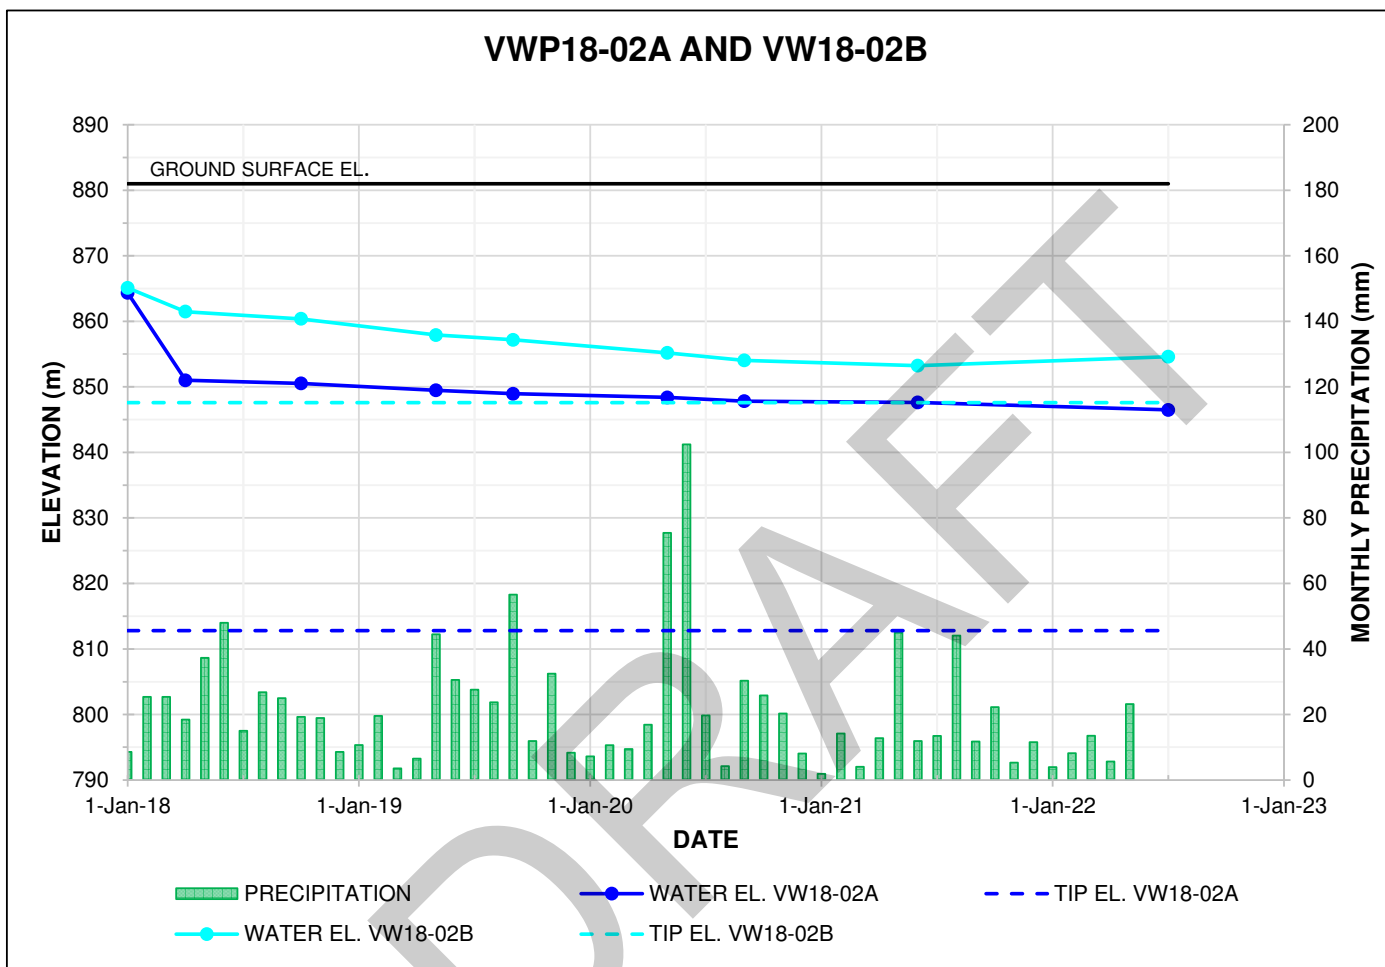
VWP18-02A AND VW18-02B

The initial readings for the VWPs (VW18-01A/B and VW18-02A/B) were taken immediately following grouting operations, and KCB believes that the initial water levels recorded in the VWPs were artificially high due to grouting. Water levels recorded in these instruments decreased up to 13 m within a month of installation.

Overall, water levels recorded in VW18-01A, VW18-02A, and VW18-02B have steadily decreased approximately 2.4 m, 2.4, and 6.9 m, respectively, since the spring of 2018. Whereas water levels recorded in VW18-01A have remained relatively steady (± 0.1 m). The relatively steady decrease in water level recorded in VW18-01A, VW18-02A, and VW18-02B can most likely be attributed to excess porewater pressure dissipation following realignment of the highway (and the resulting fill placement) completed in 2016. It does not appear the water levels recorded in the VWPs at the S005 site fluctuate seasonally or in response to prolonged or heavy rainfall or freshet infiltration. However, the current annual reading frequency of the instruments may not capture short-term fluctuations (i.e., increases and decreases) in water level that occur between readings.
