July 14, 2023

Alberta Transportation and Economic Corridors  
2<sup>nd</sup> Floor, 803 Manning Road N.E.  
Calgary, Alberta  
T2E 7M8

**CON0022161 Southern Region GRMP Instrumentation Monitoring  
Site S005; H36:02, km 37.1 Chin Coulee Slide  
Section C – 2023 Spring Readings**

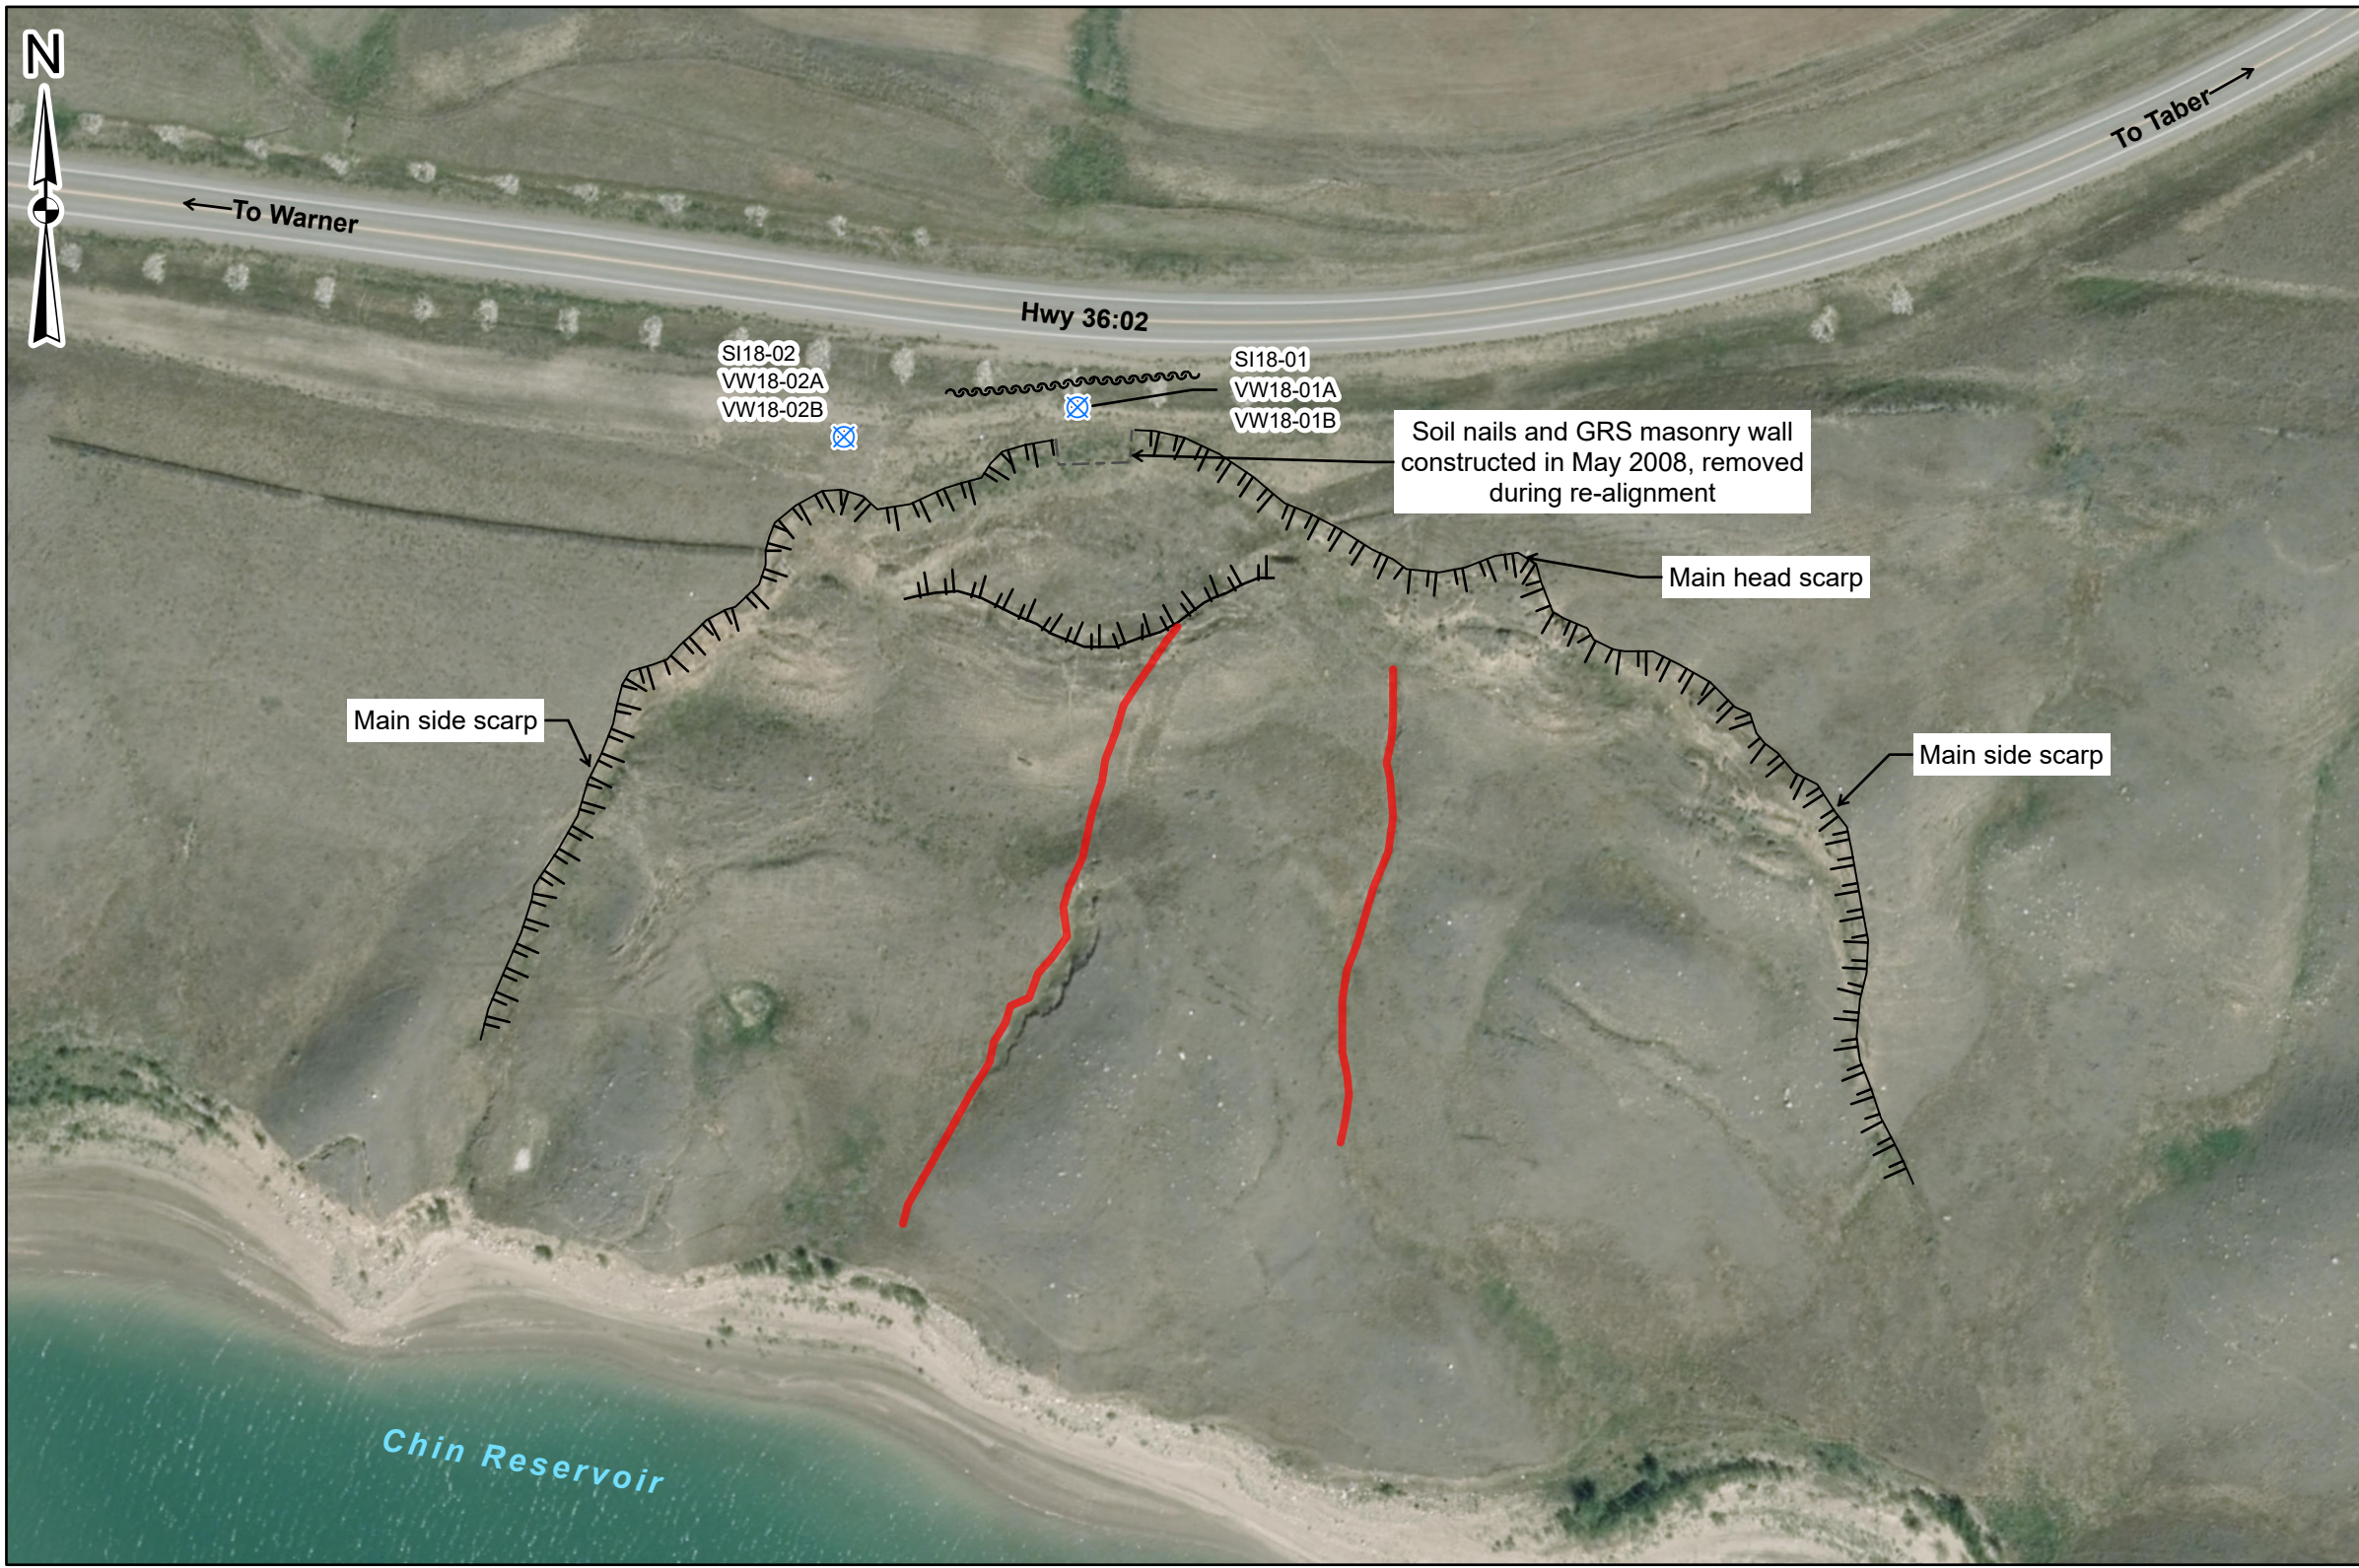
PROJECT SOUTHERN REGION GEOHAZARD RISK MANAGEMENT PROGRAM		
TITLE Site Plan S005 - Chin Coulee (South of Taber) Hwy 36:02, km 37.1		
SCALE 1:1,500	PROJECT No. A05116A03	FIG No. 1

The geohazard at the S005 site consists of a large, deep-seated translational landslide located on the north slope of the Chin Coulee Reservoir that is retrogressing north towards Hwy 36:02. Previous remedial actions at the site include:

The near-surface movement recorded in the upper 5 m of SI18-01 and SI18-02 may be related to settlement of the highway-realignment fill or early signs of slope retrogression. The near-surface movements appear to be in the southeastern direction. Small tension cracks have been identified parallel to the crest where the SIs and geocube infrastructure are located, which may correspond with the near-surface movement recorded in the SIs. KCB recommends that future instrument readings include measurements and photographs of the small tension cracks near the SIs and geocube infrastructure to verify a correlation with the SI readings.

KCB recommends that future instrument readings include measurements and photographs of the small tension cracks near the SIs and geocube infrastructure to verify a correlation with the SI readings.

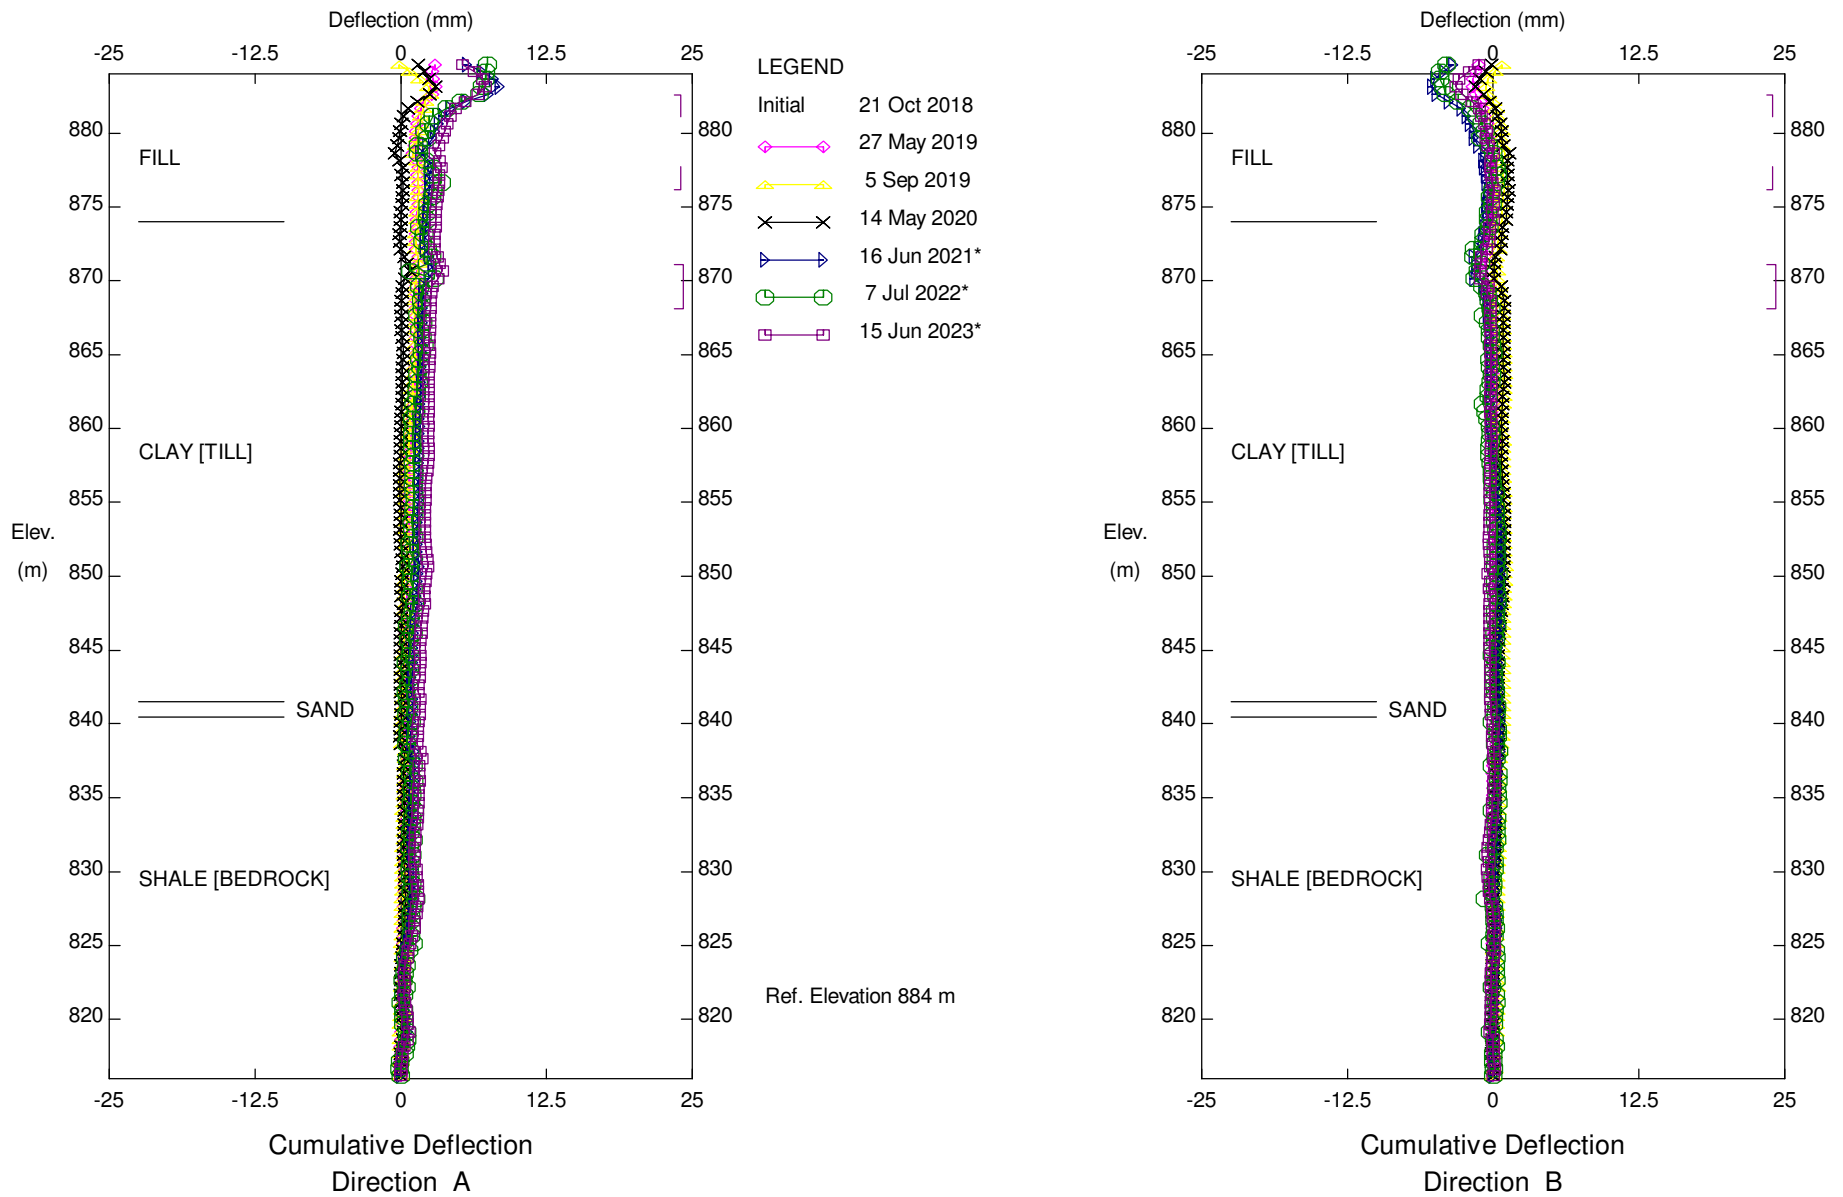
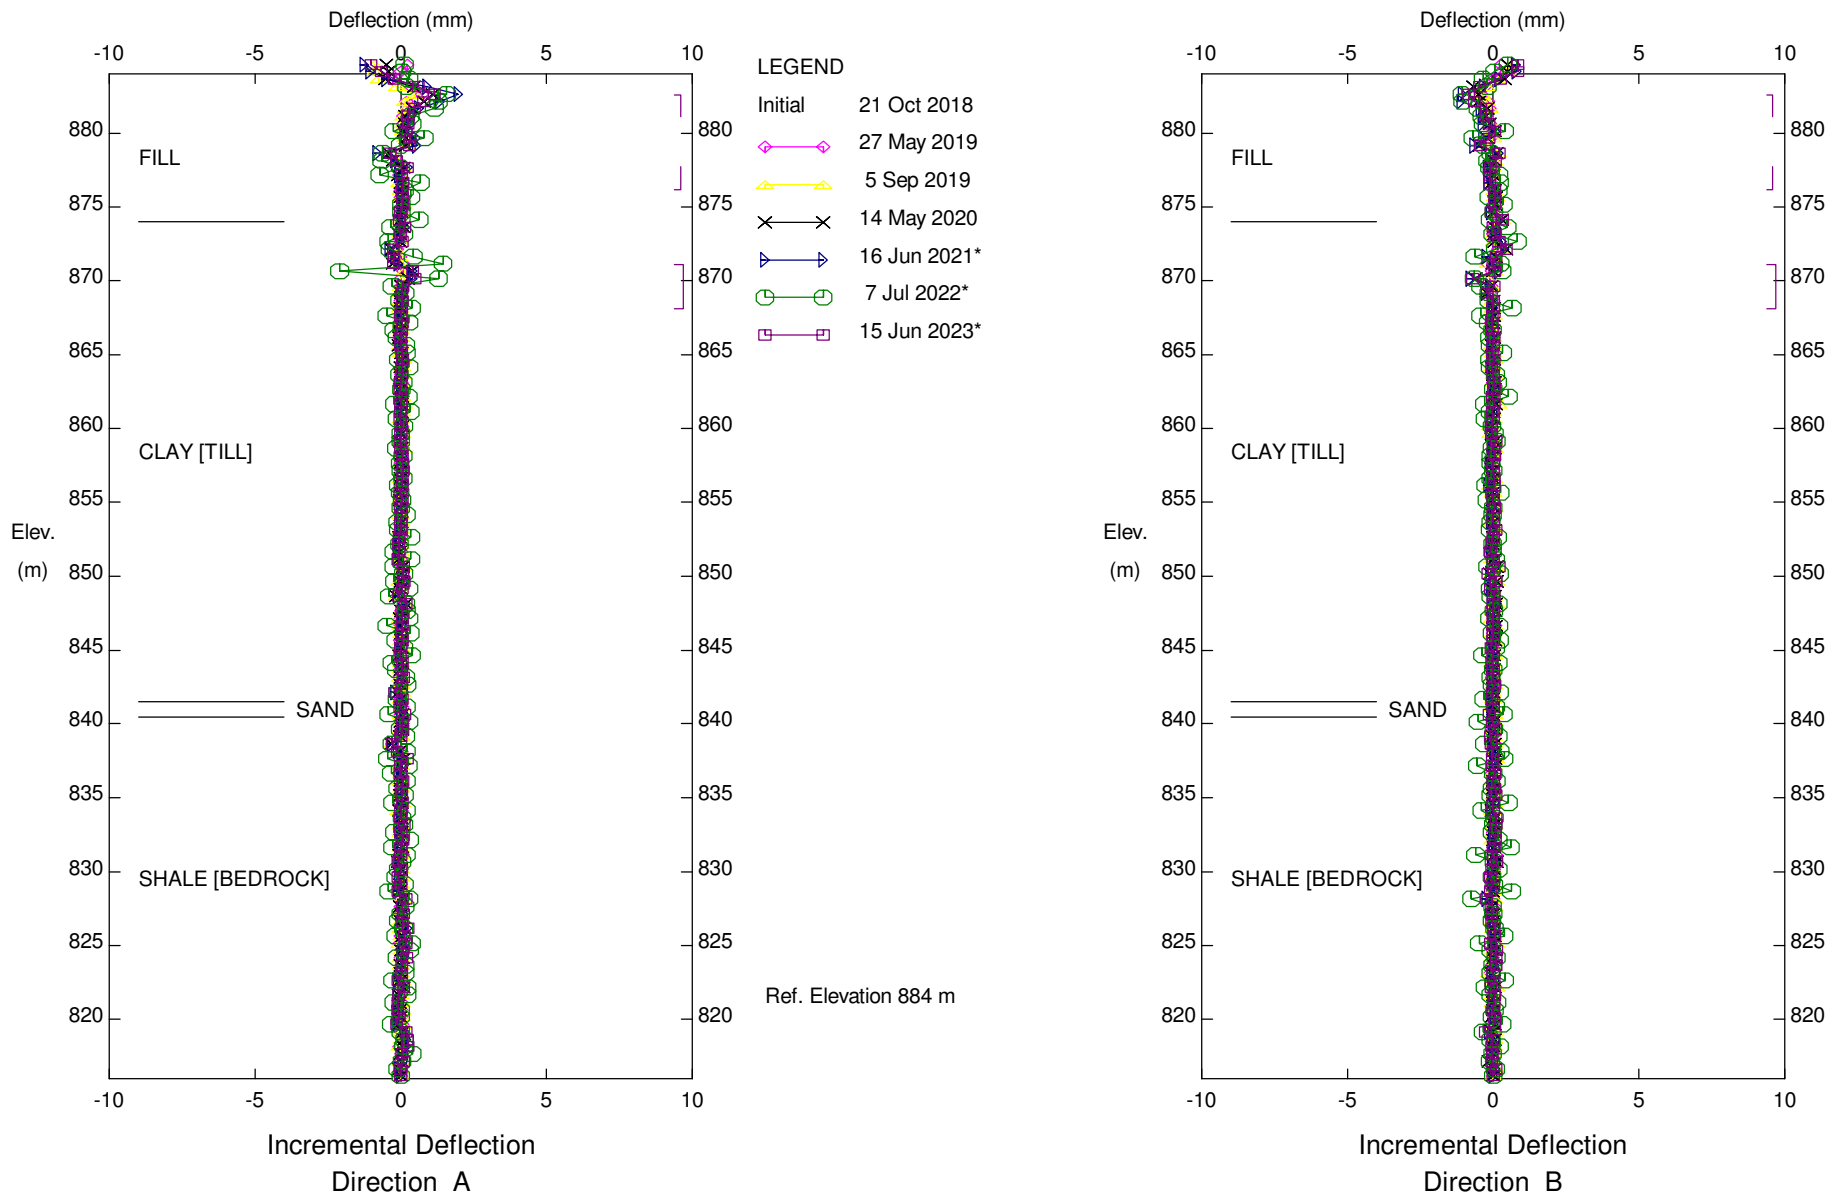
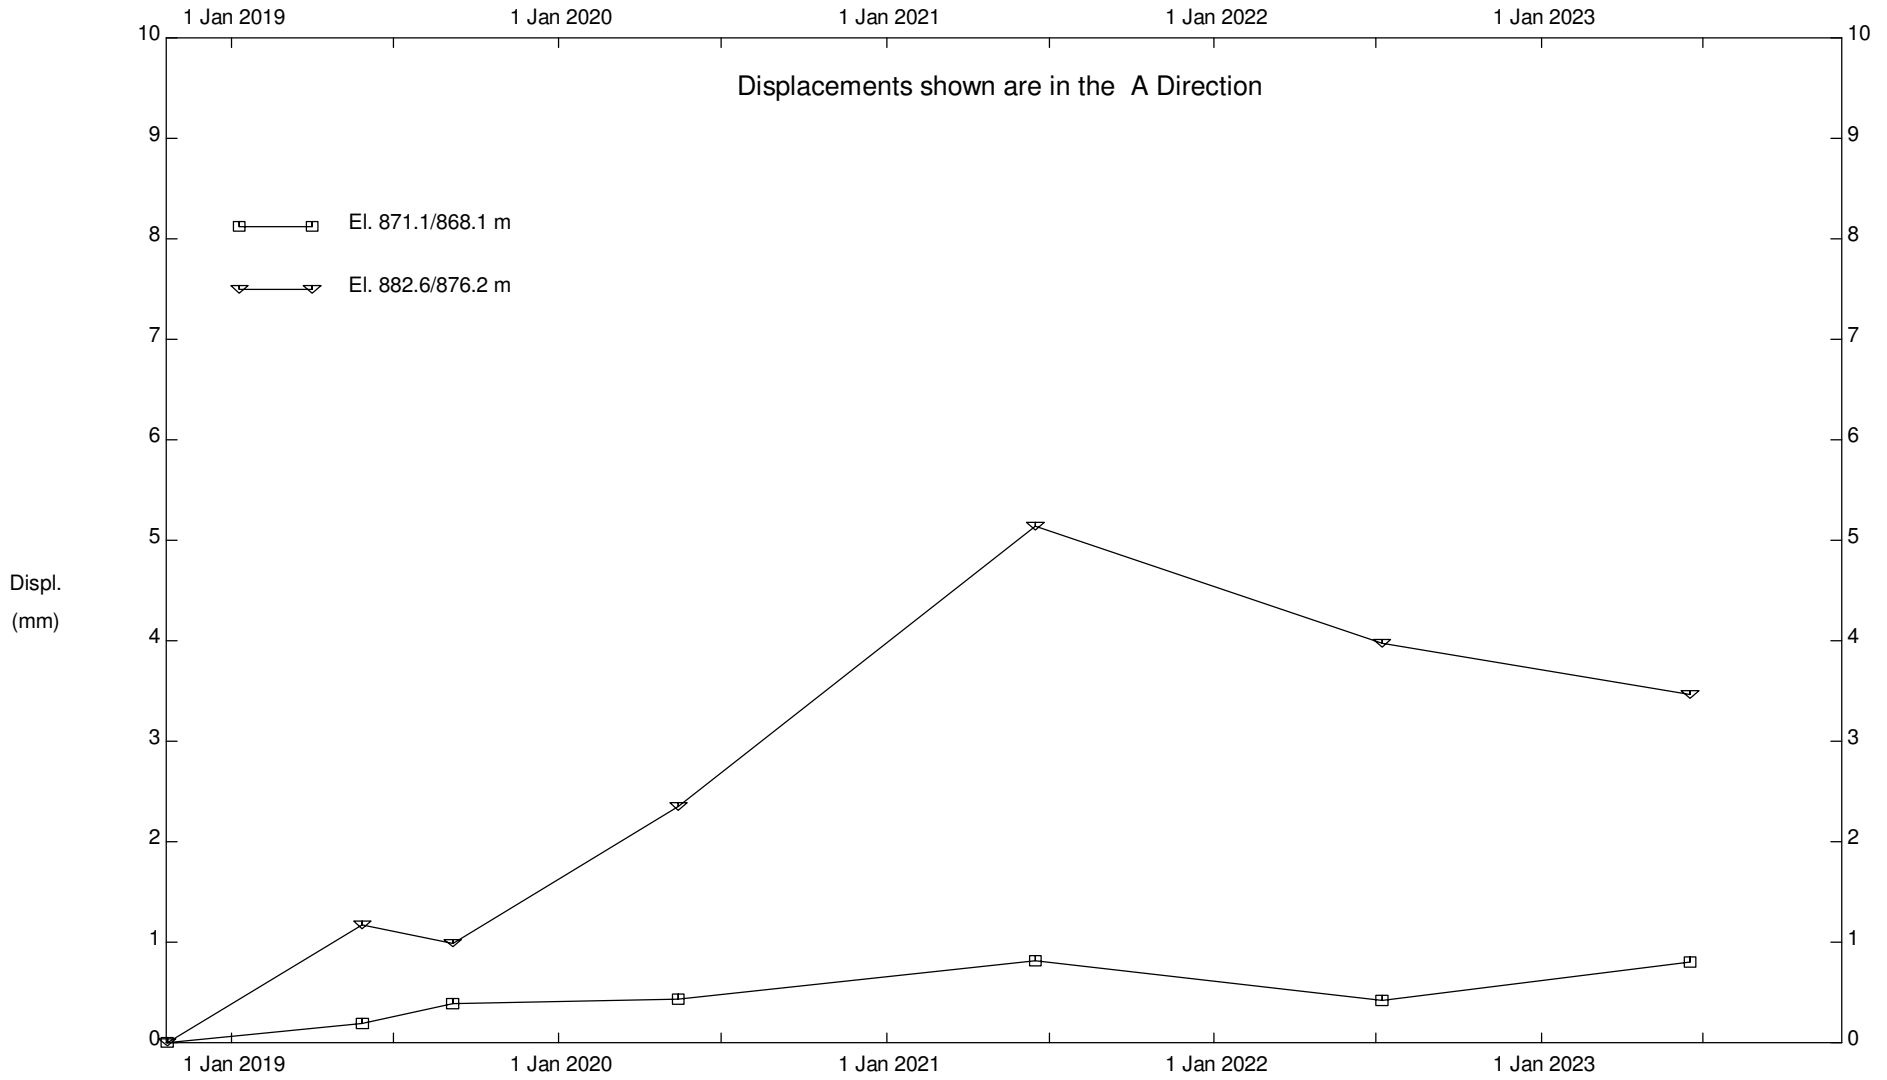
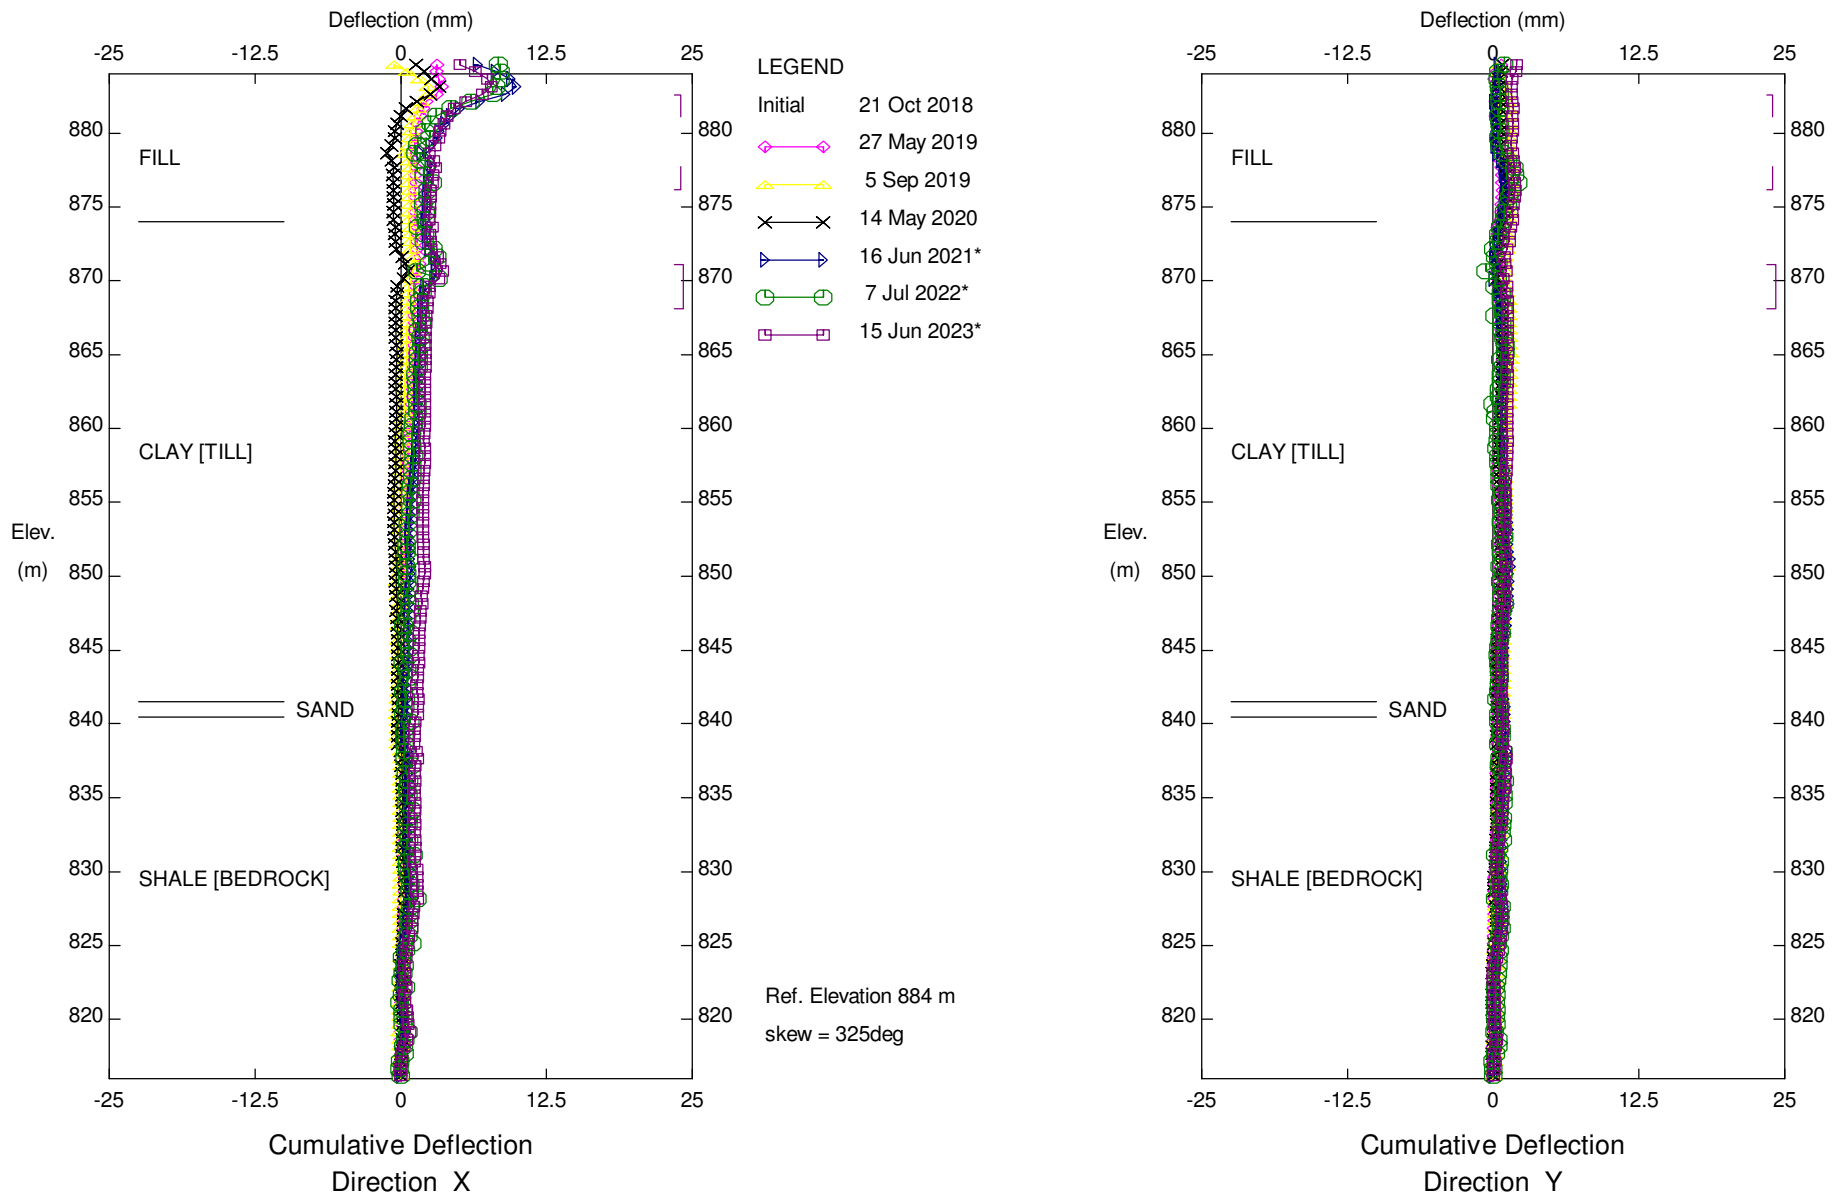
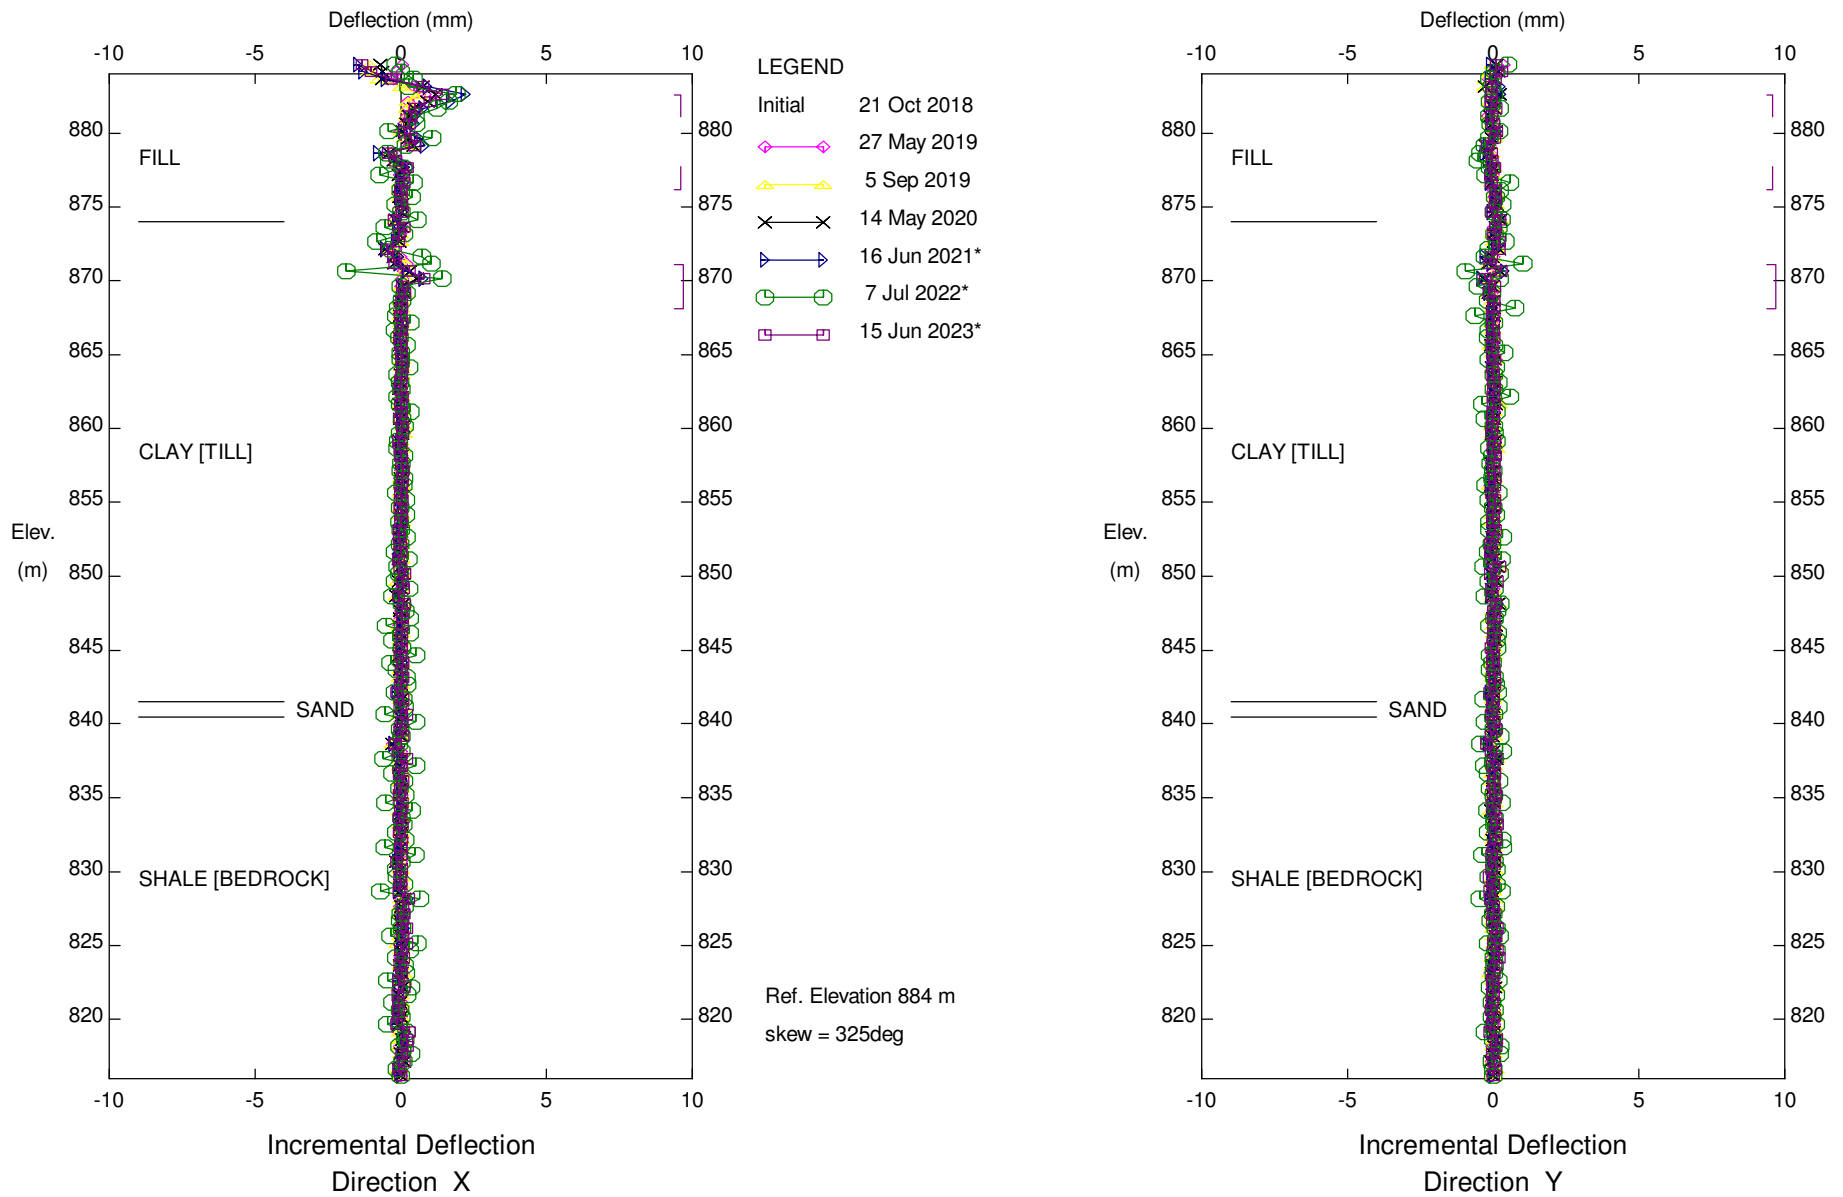
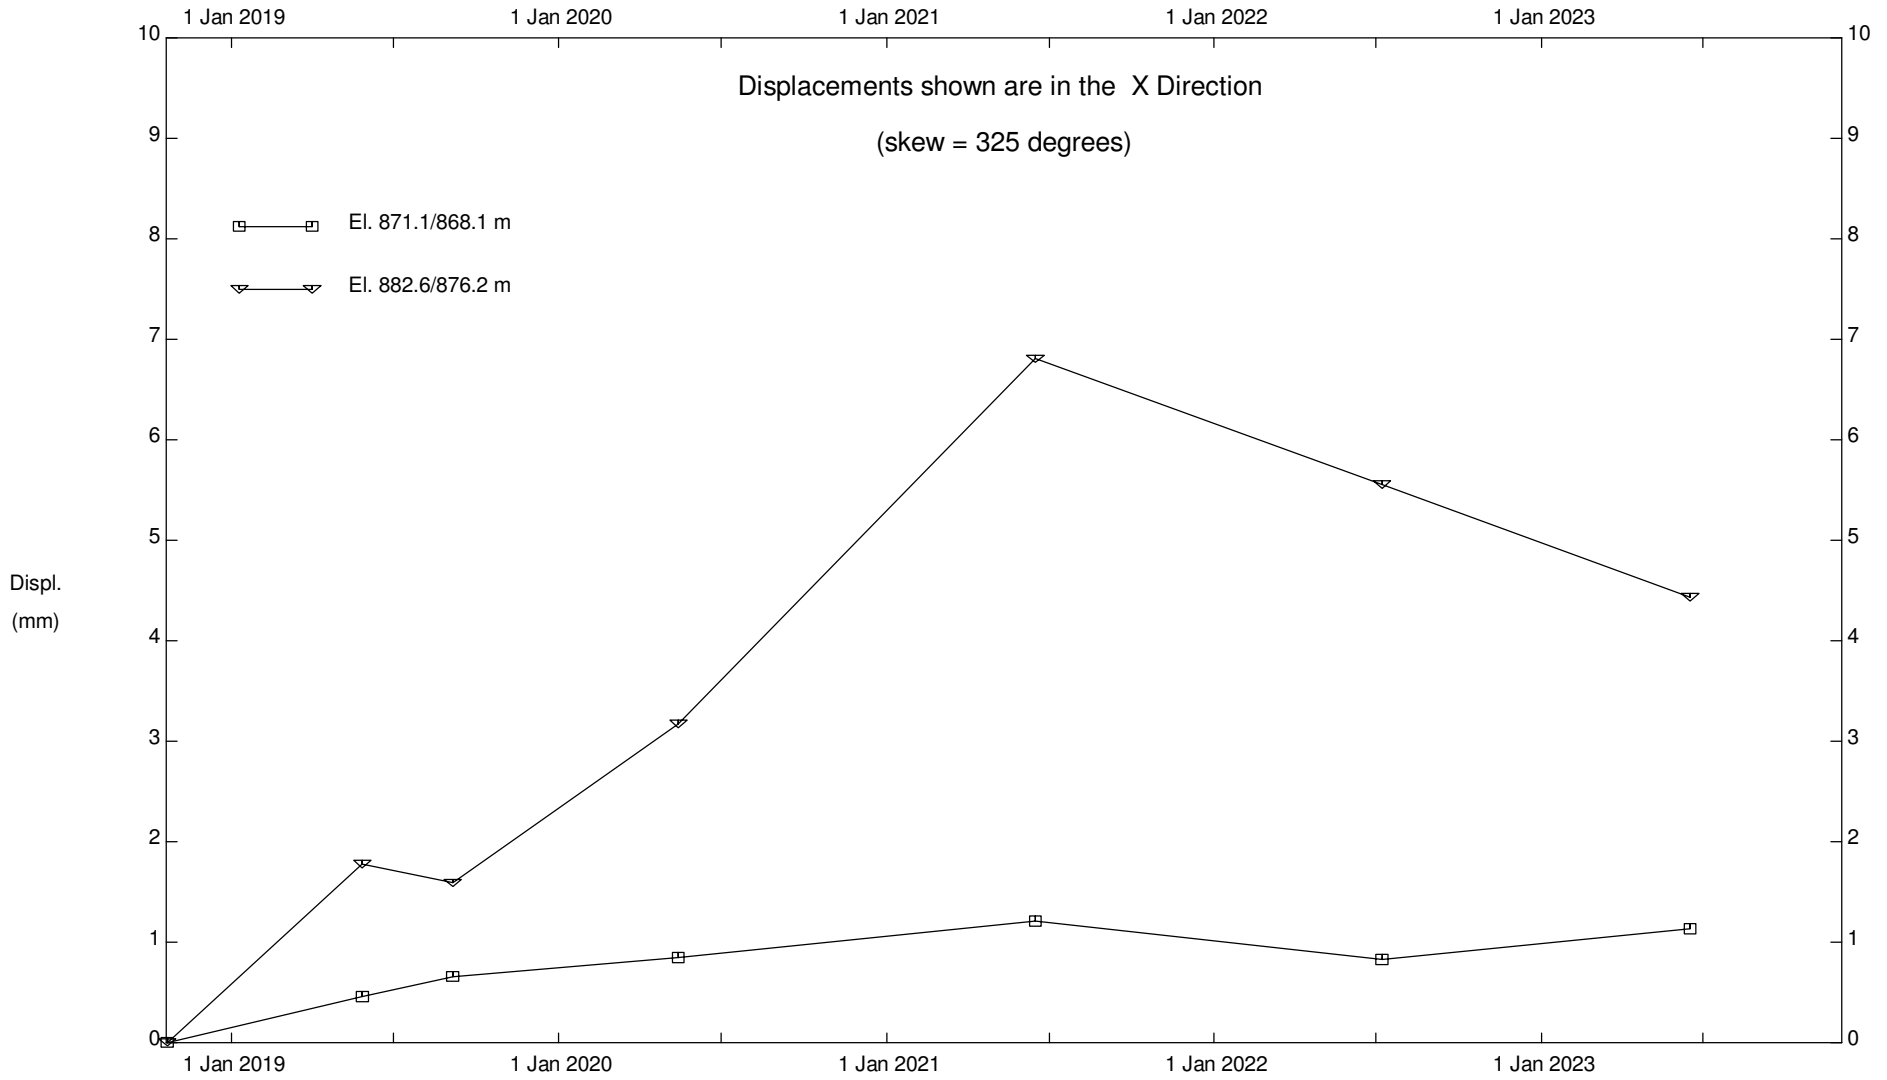
S005; H36:03, Chin Coulee, Inclinator SI18-01  
 Alberta Transportation

Distributed movement has been recorded in SI18-01 from an approximate depth of 5 m to 60 m below ground surface (approximately El. 879 m to El. 824 m). The casing also appears to be settling or buckling between an approximate depth of 13.5 m and 16 m below ground surface (approximately El. 868.1 m and El. 871.1 m), as discussed below.

The settlement or buckling observed in SI18-01 (from approximately 13.5 m and 16 m below ground surface) could be an indication that the instrument is poorly grouted with a possible grout void. The movements of the slide mass and interpretation of the SI data is complicated by the potential for settlement or buckling of the SI casing in the poorly grouted casing segment. The instrument was previously re-initialized to the October 2018 reading to remove possible noise associated with this zone. Overall, data quality has improved since the instrument was re-initialized, but settlement or buckling of the casing is still occurring at this depth. The rate of settlement or buckling has slowed since the first few months following installation and has been generally negligible since the instrument was re-initialized. If the settlement or buckling begins to impact the interpretation of the SI data again, the instrument may need to be re-initialized.

Since installation, the overall rate of movement recorded in SI18-01 and SI18-02 has been slow (less than 5 mm/year).
