July 14, 2023

Alberta Transportation and Economic Corridors  
2<sup>nd</sup> Floor, 803 Manning Road N.E.  
Calgary, Alberta  
T2E 7M8

**CON0022161 Southern Region GRMP Instrumentation Monitoring  
Site S005; H36:02, km 37.1 Chin Coulee Slide  
Section C – 2023 Spring Readings**

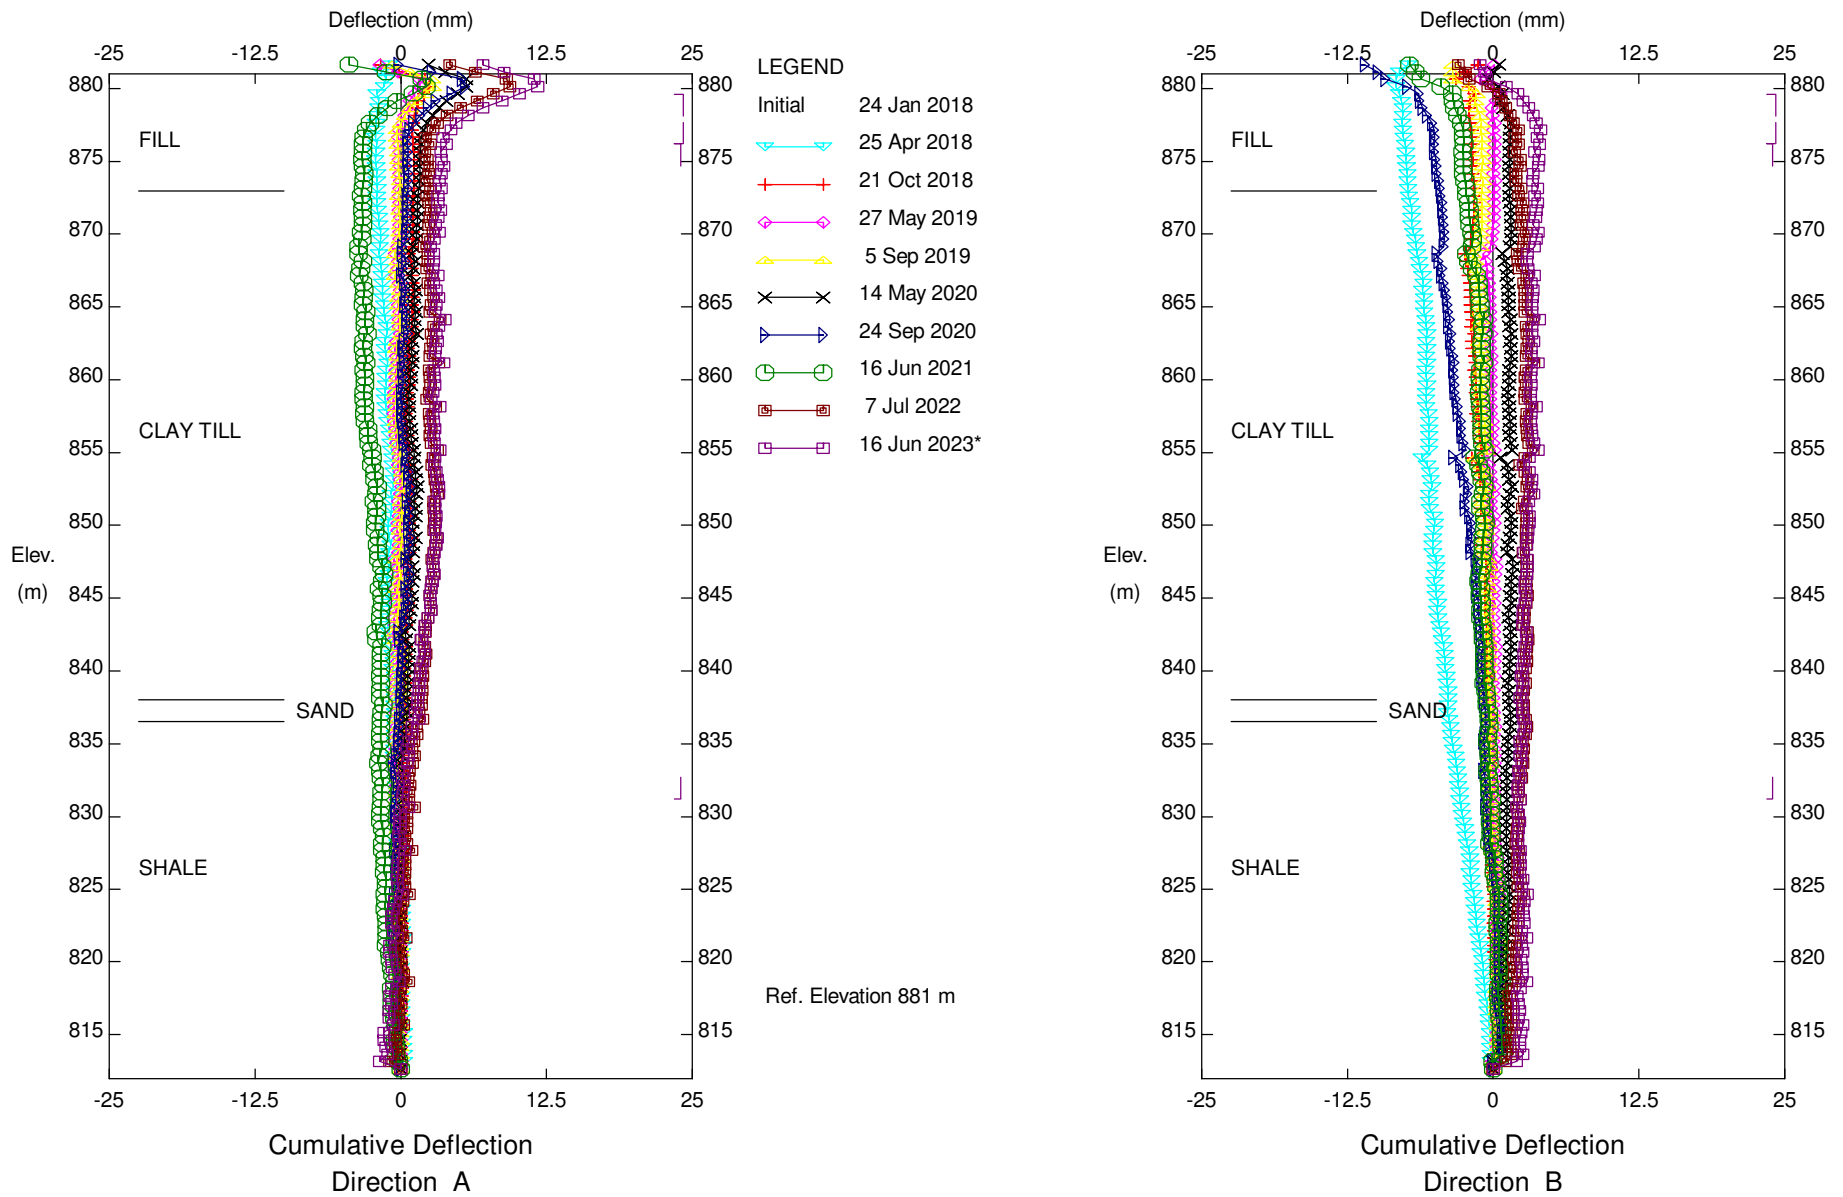
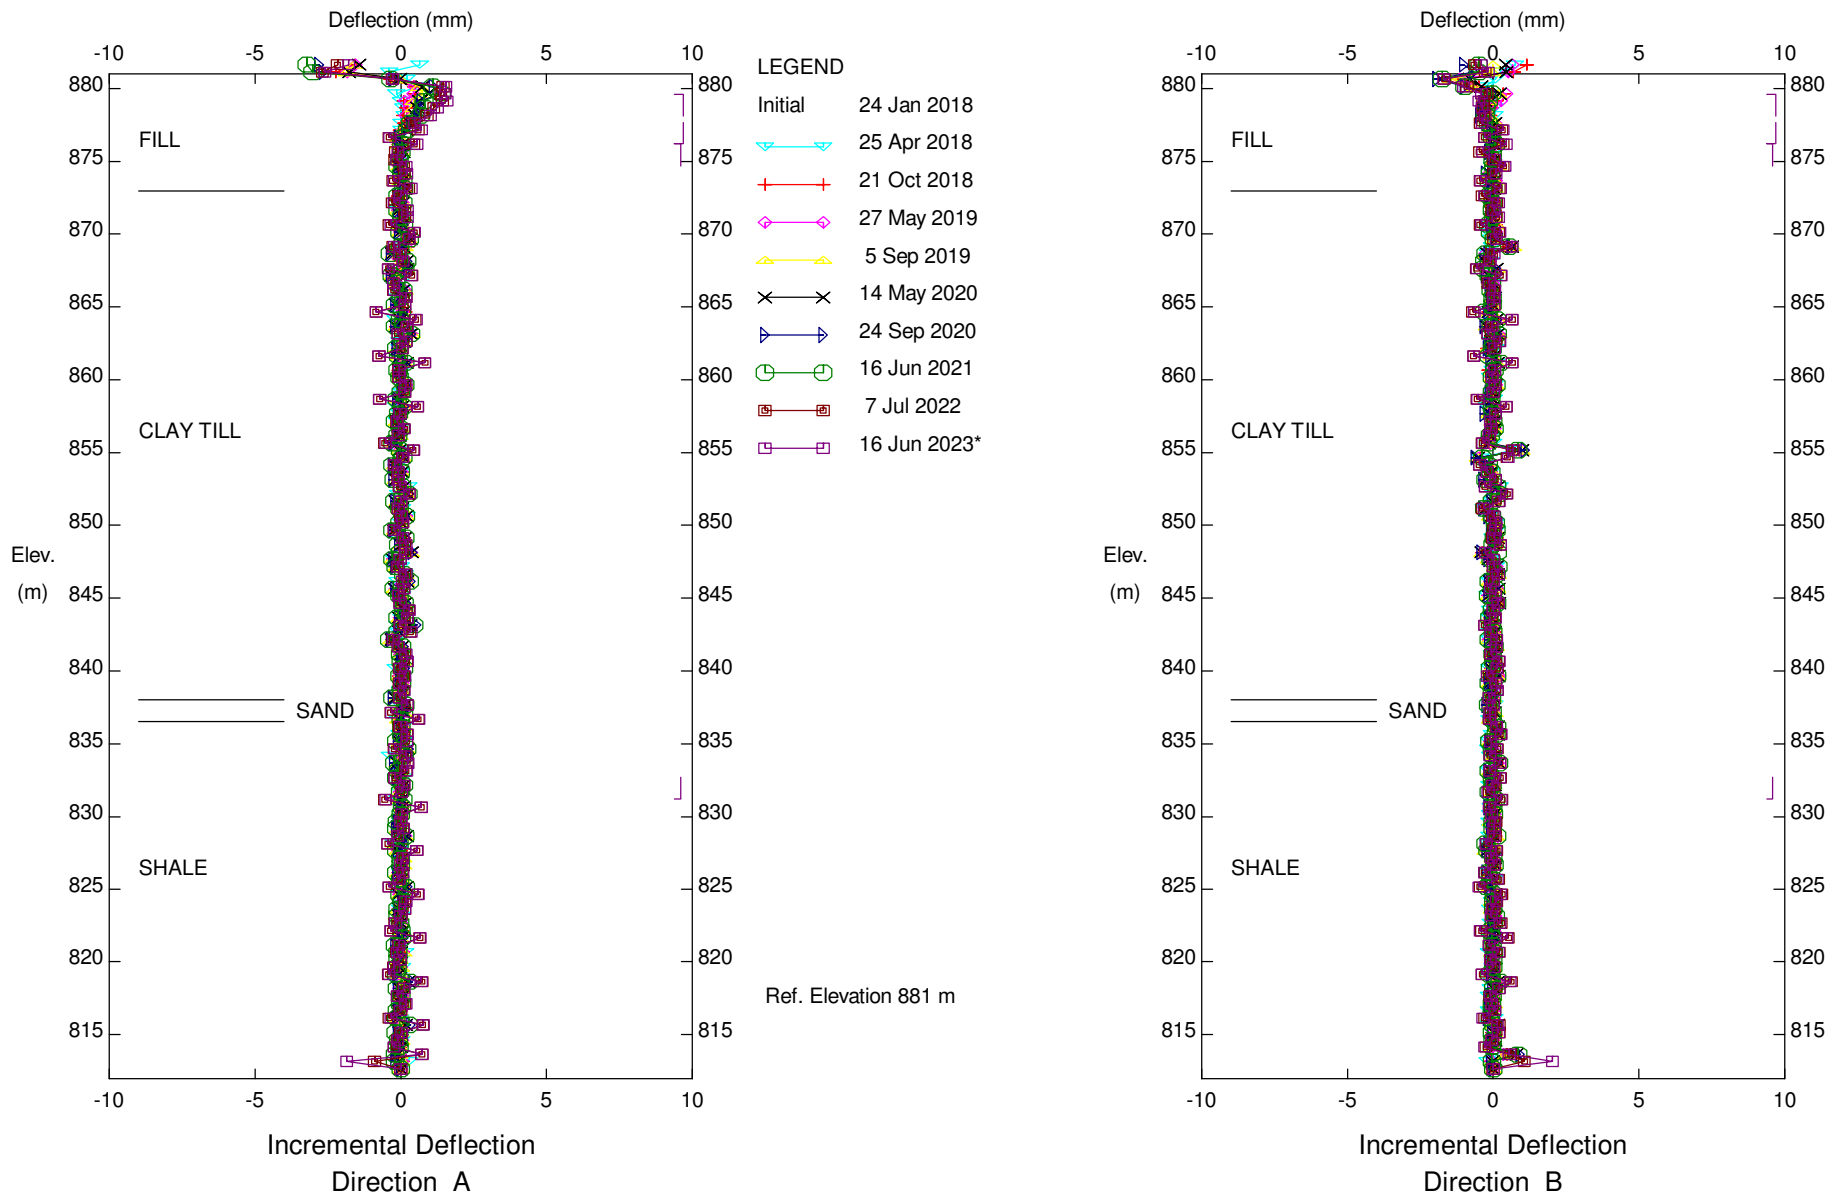
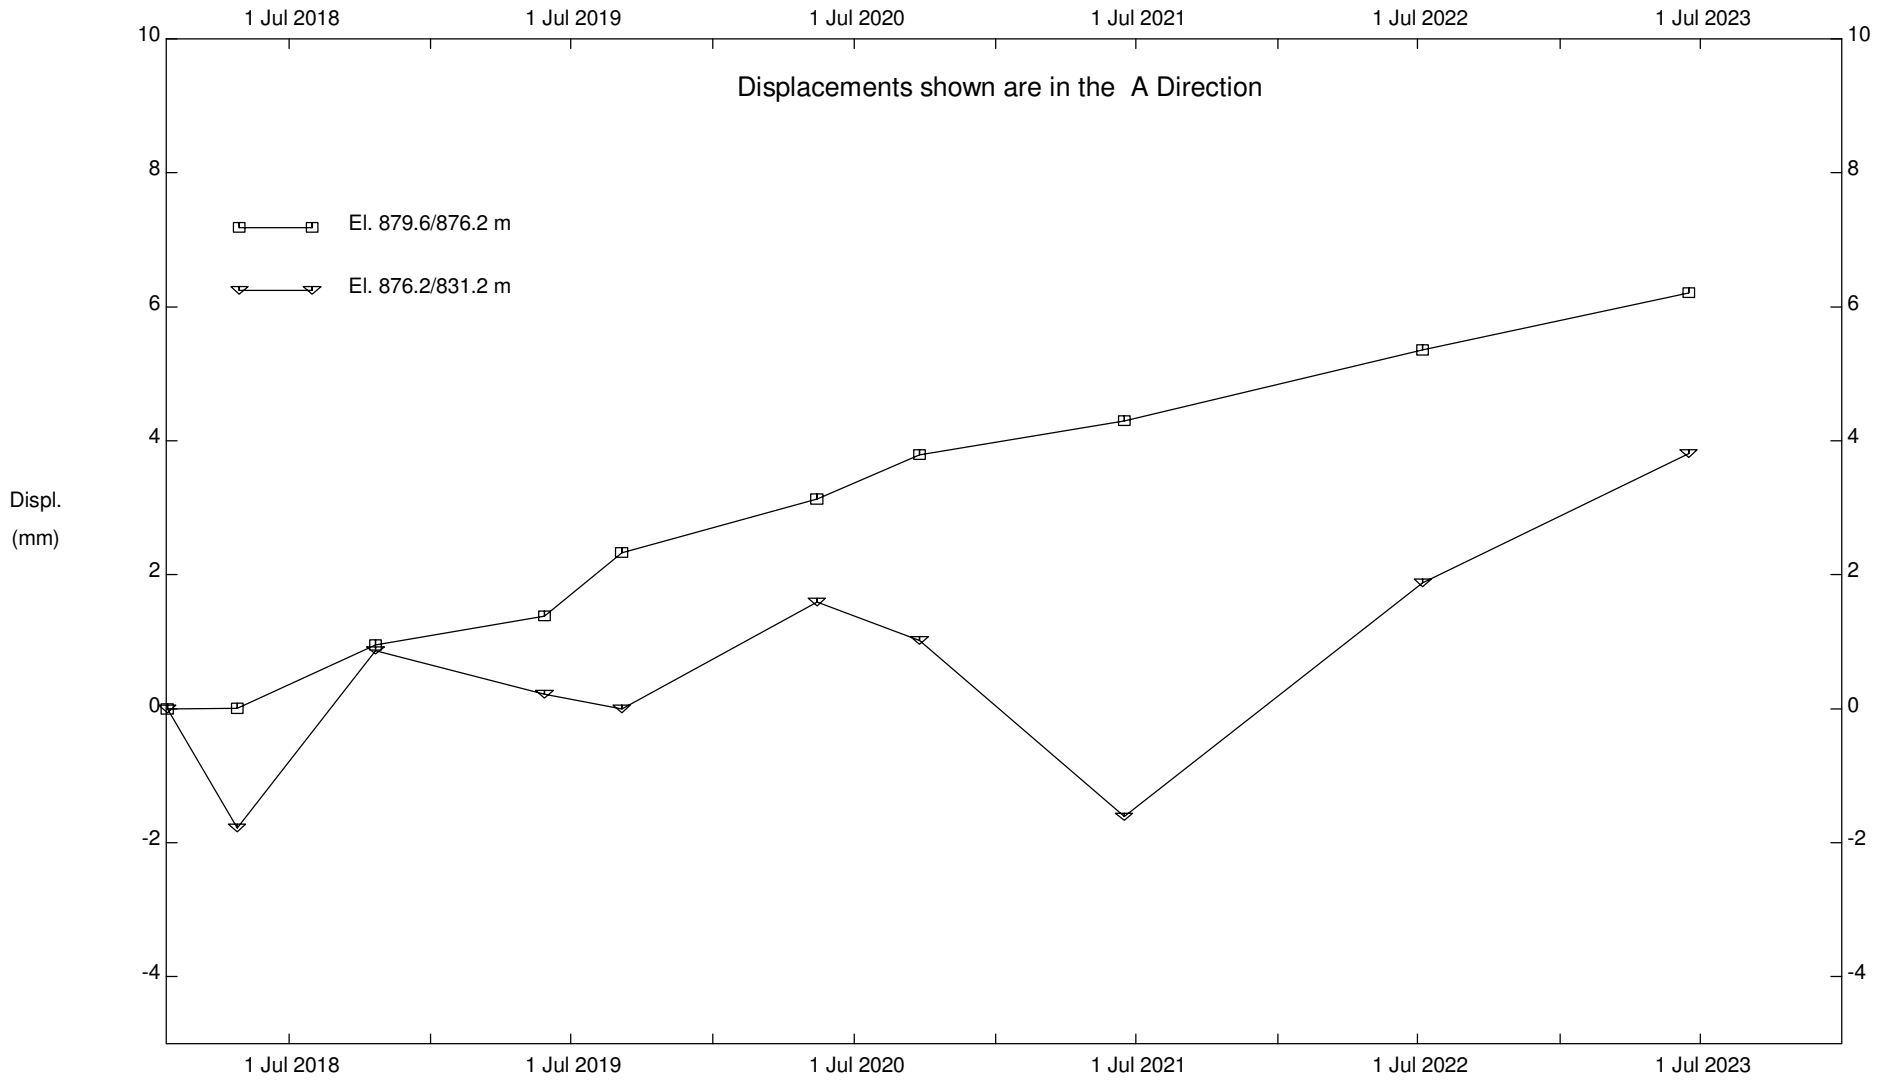
S005; H36:02, Chin Coulee, Inclinator SI18-02  
 Alberta Transportation

Distributed movement has been recorded in SI18-02 from an approximate depth of 1 m to 50 m below ground surface (approximately El. 880 m to El. 831 m).

The near-surface movement recorded in the upper 5 m of SI18-01 and SI18-02 may be related to settlement of the highway-realignment fill or early signs of slope retrogression. The near-surface movements appear to be in the southeastern direction. Small tension cracks have been identified parallel to the crest where the SIs and geocube infrastructure are located, which may correspond with the near-surface movement recorded in the SIs. KCB recommends that future instrument readings include measurements and photographs of the small tension cracks near the SIs and geocube infrastructure to verify a correlation with the SI readings.

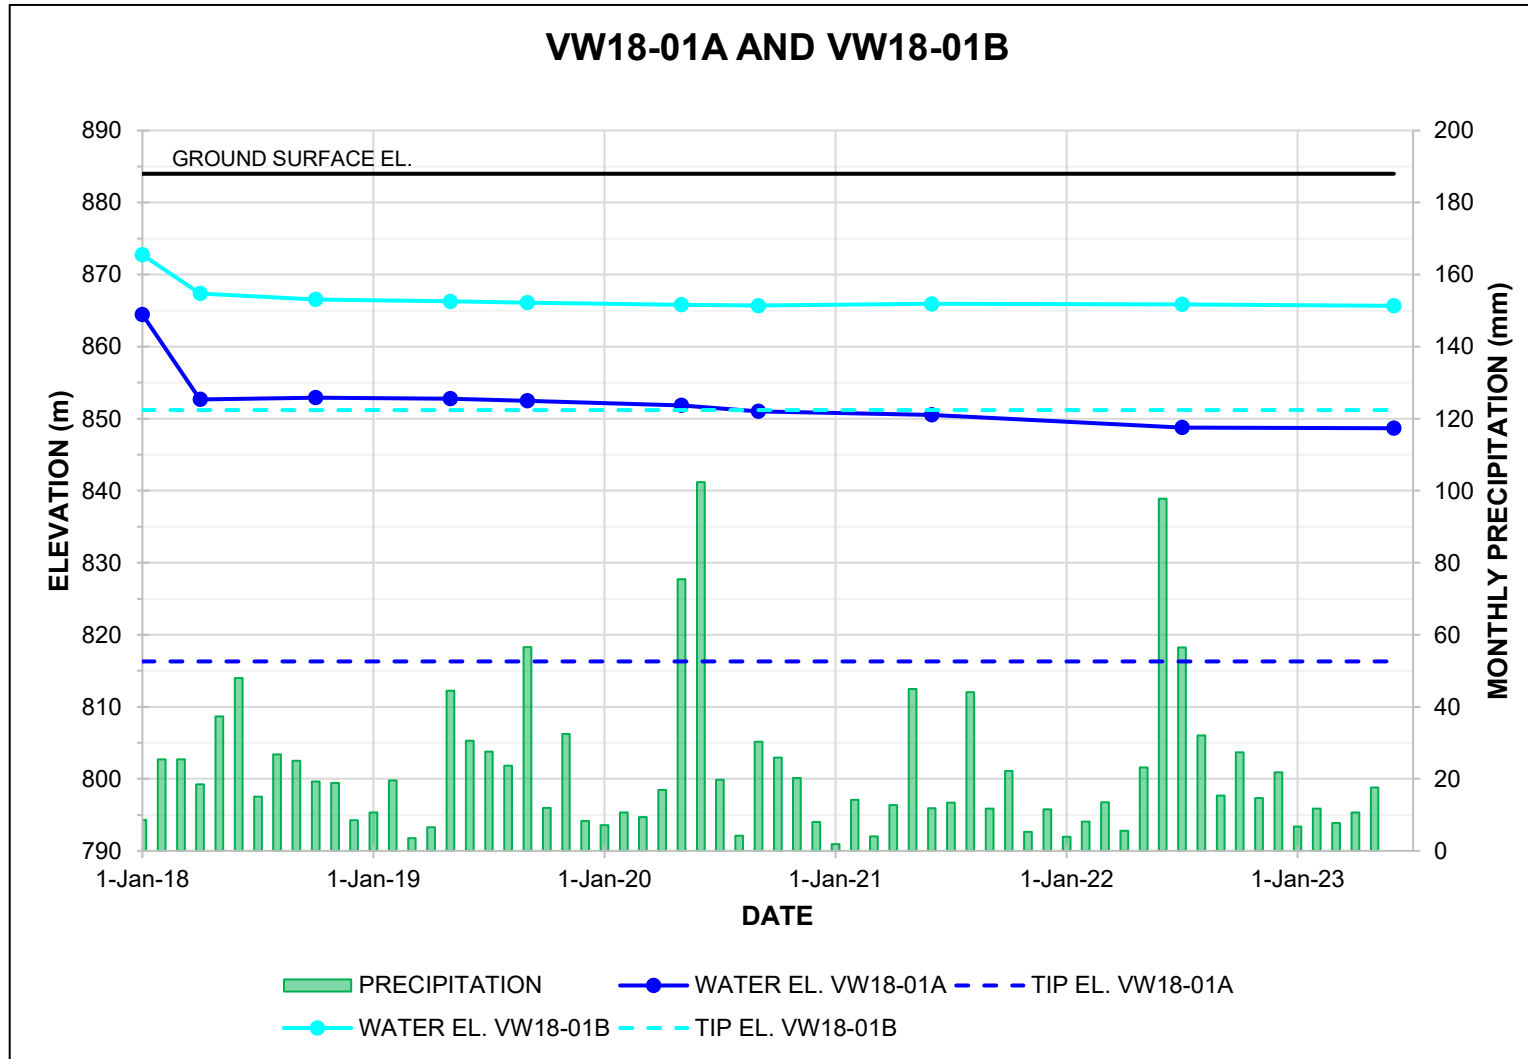
### VW18-01A AND VW18-01B

The initial readings for the VWPs (VW18-01A/B and VW18-02A/B) were taken immediately following grouting operations, and KCB believes that the initial water levels recorded in the VWPs were artificially high due to grouting. Water levels recorded in these instruments decreased up to 13 m within a month of installation.

Overall, water levels recorded in VW18-01A, VW18-02A, and VW18-02B have steadily decreased approximately 4.0 m, 4.6 m, and 7.0 m, respectively, since the spring of 2018. Whereas water levels recorded in VW18-01A have remained relatively steady ( $\pm 0.1$  m). The relatively steady decrease in water level recorded in VW18-01A, VW18-02A, and VW18-02B can most likely be attributed to excess porewater pressure dissipation following realignment of the highway (and the resulting fill placement) completed in 2016. It does not appear the water levels recorded in the VWPs at the S005 site fluctuate seasonally or in response to prolonged or heavy rainfall or freshet infiltration. However, the current annual reading frequency of the instruments may not capture short-term fluctuations (i.e., increases and decreases) in water levels that occur between readings.
