July 10, 2024

**CON0022161 Southern Region GRMP Instrumentation Monitoring
Site S005; H36:02, km 37.1 Chin Coulee Slide
Section C – 2024 Spring Readings**

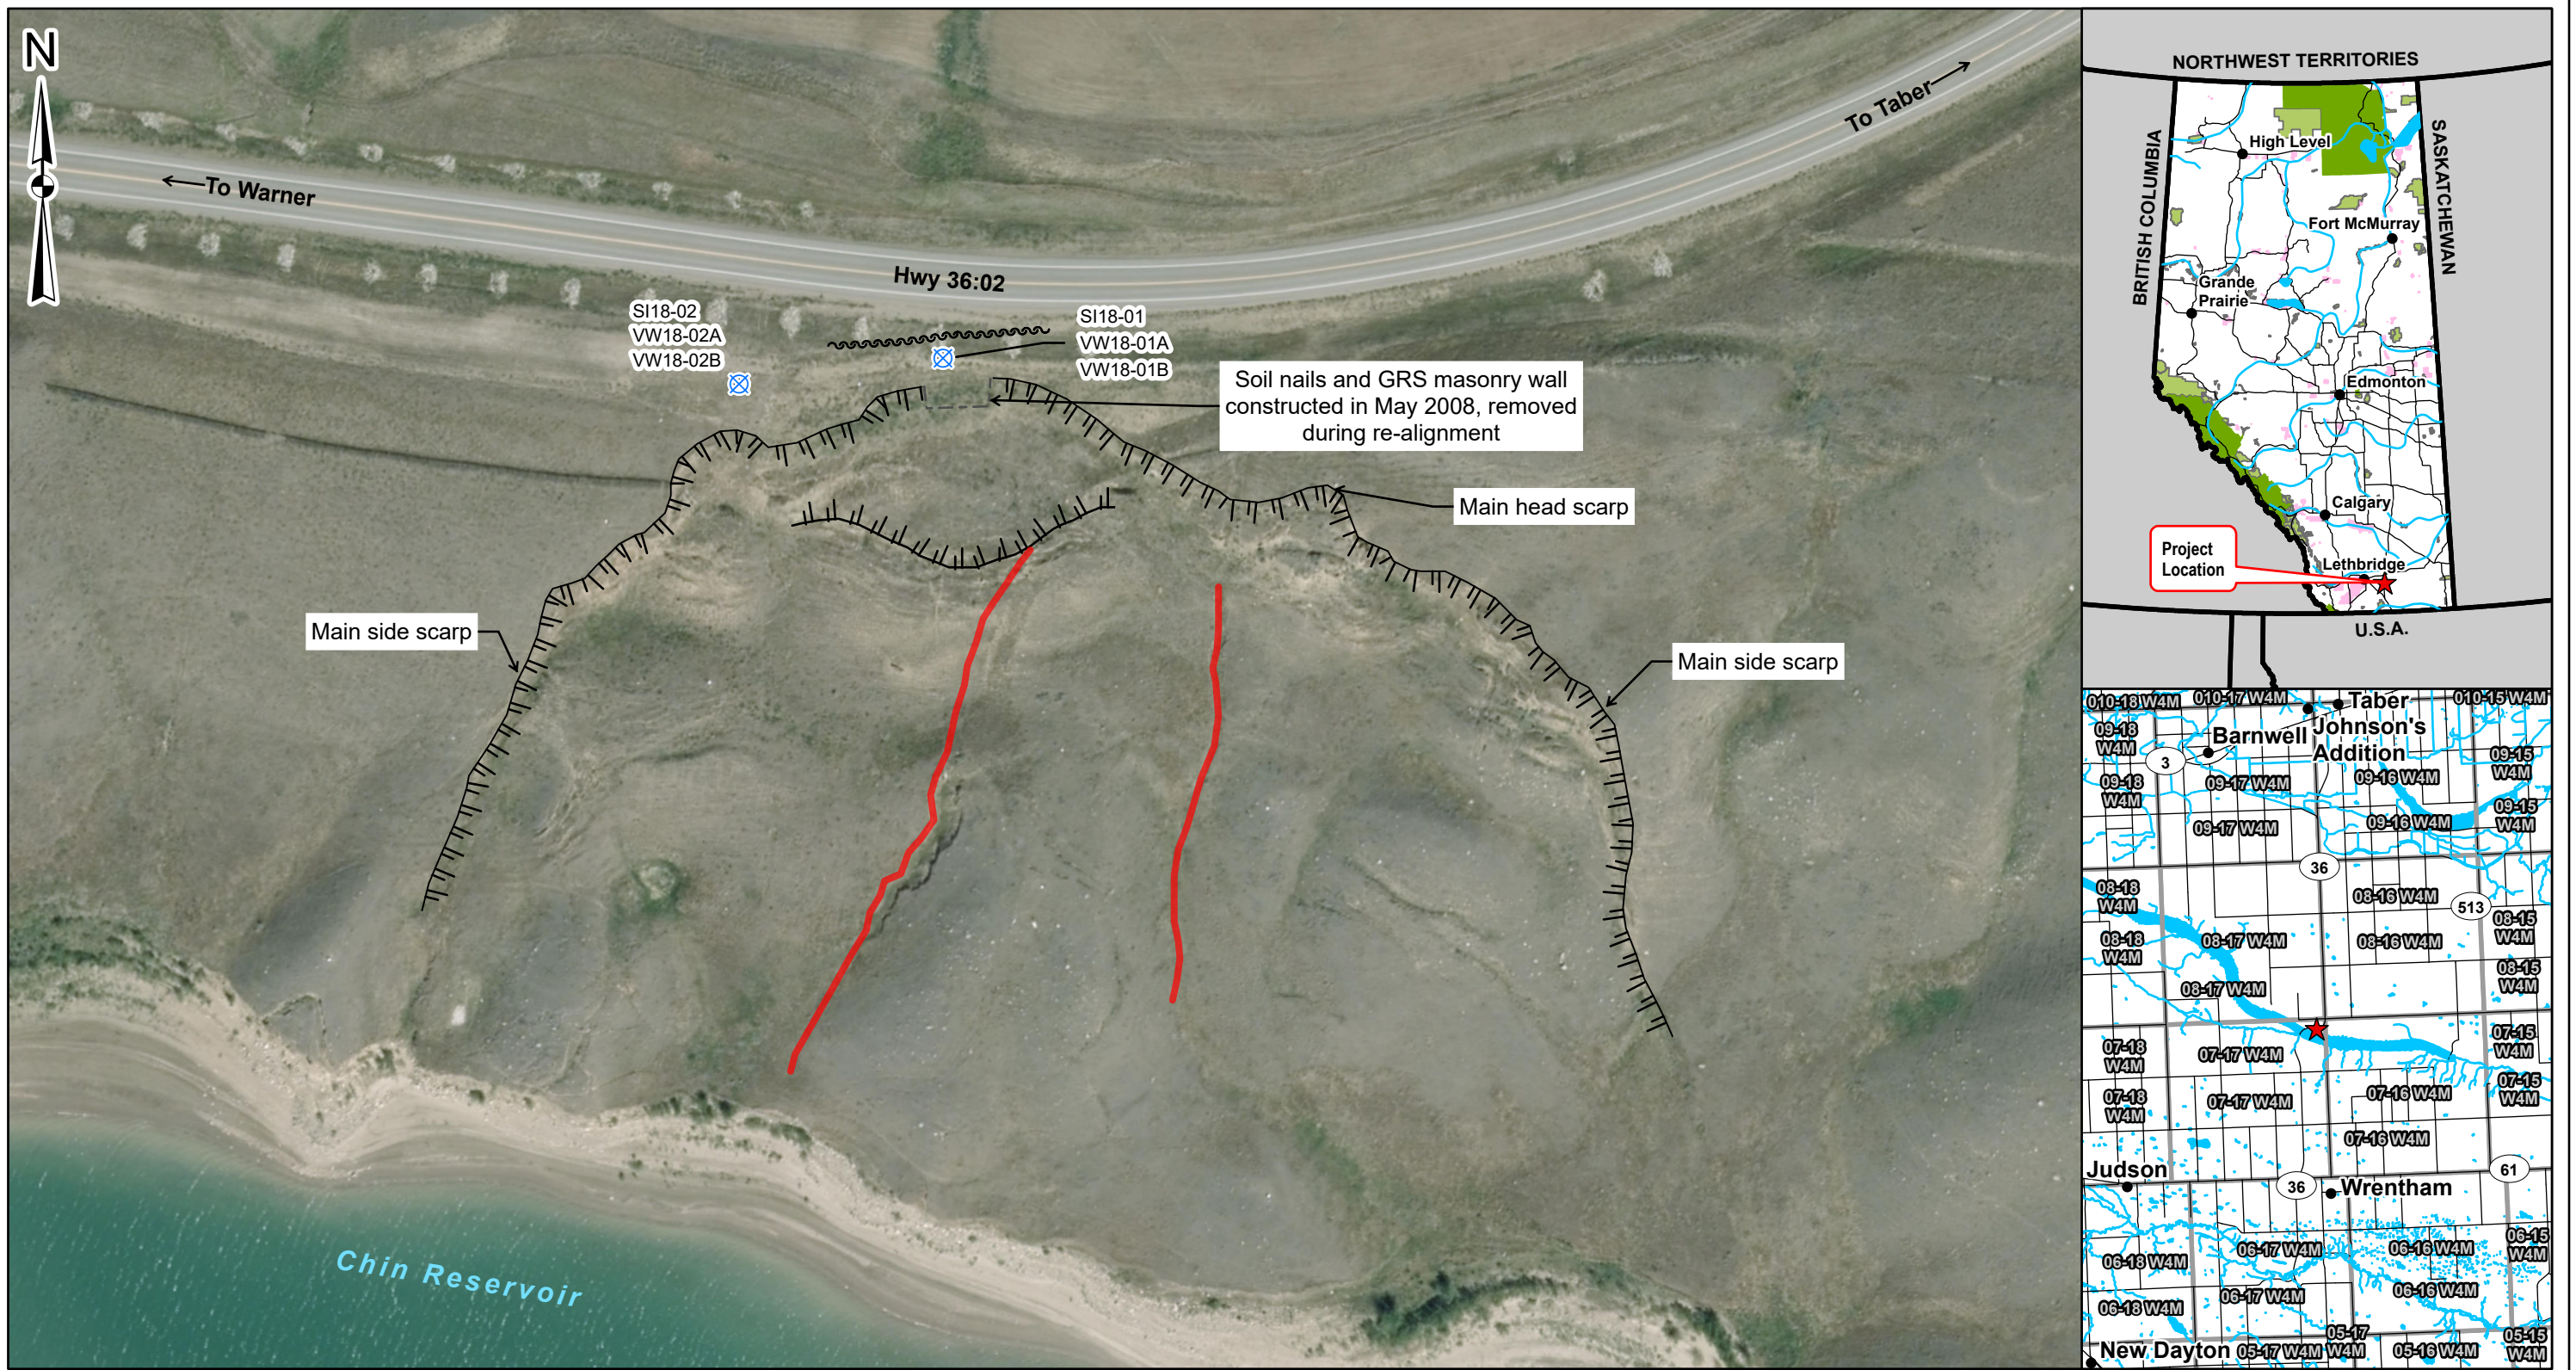
PROJECT SOUTHERN REGION GEOHAZARD RISK MANAGEMENT PROGRAM		
TITLE Site Plan S005 - Chin Coulee (South of Taber) Hwy 36:02, km 37.1		
SCALE 1:1,500	PROJECT No. A05116A03	FIG No. 1

The geohazard at the S005 site consists of a large, deep-seated translational landslide located on the north slope of the Chin Coulee Reservoir that is retrogressing north towards Hwy 36:02. Previous remedial actions at the site include:

The near-surface movement recorded in the upper 5 m of SI18-01 and SI18-02 may be related to settlement of the highway-realignment fill or early signs of slope retrogression. The near-surface movements appear to be in the southeastern direction. Small tension cracks have been identified parallel to the crest where the SIs are located, which may correspond with the near-surface movement recorded in the SIs.

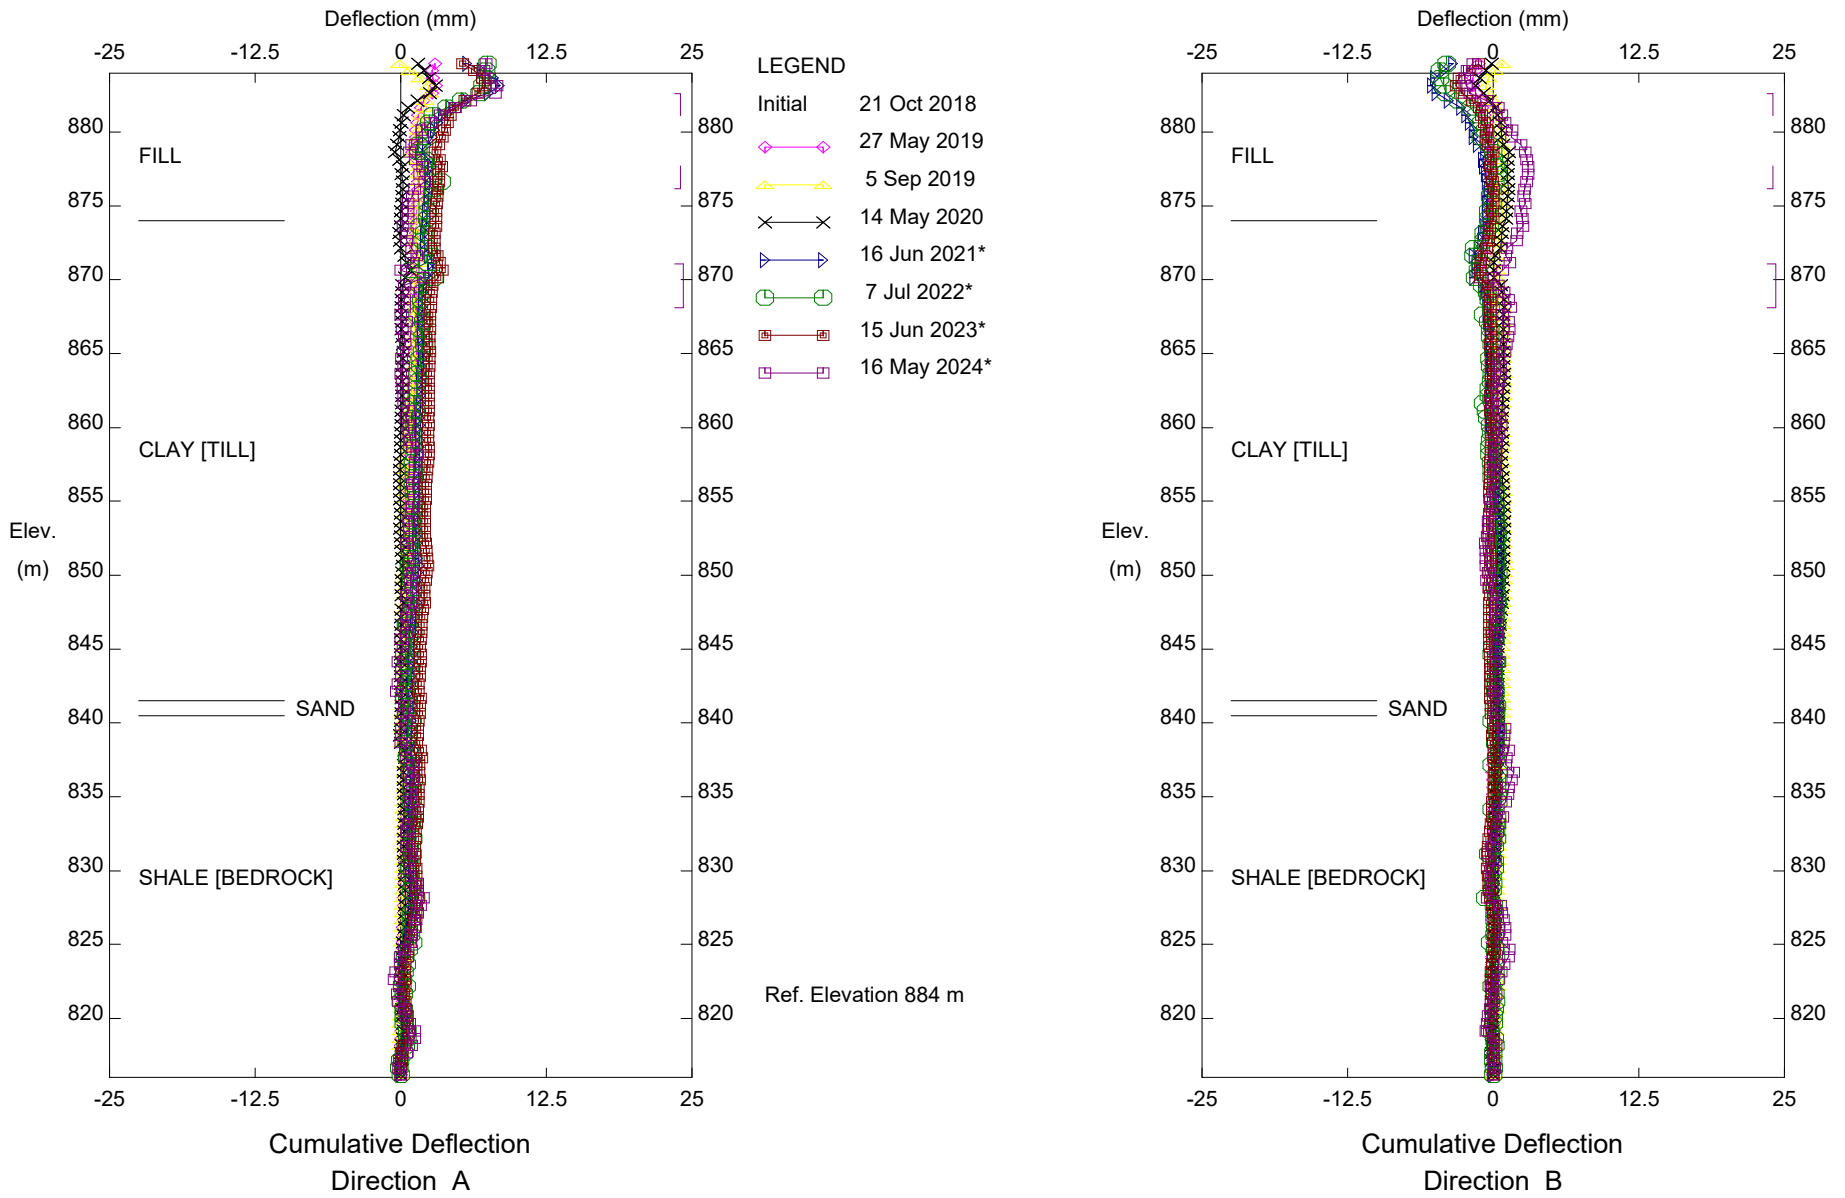
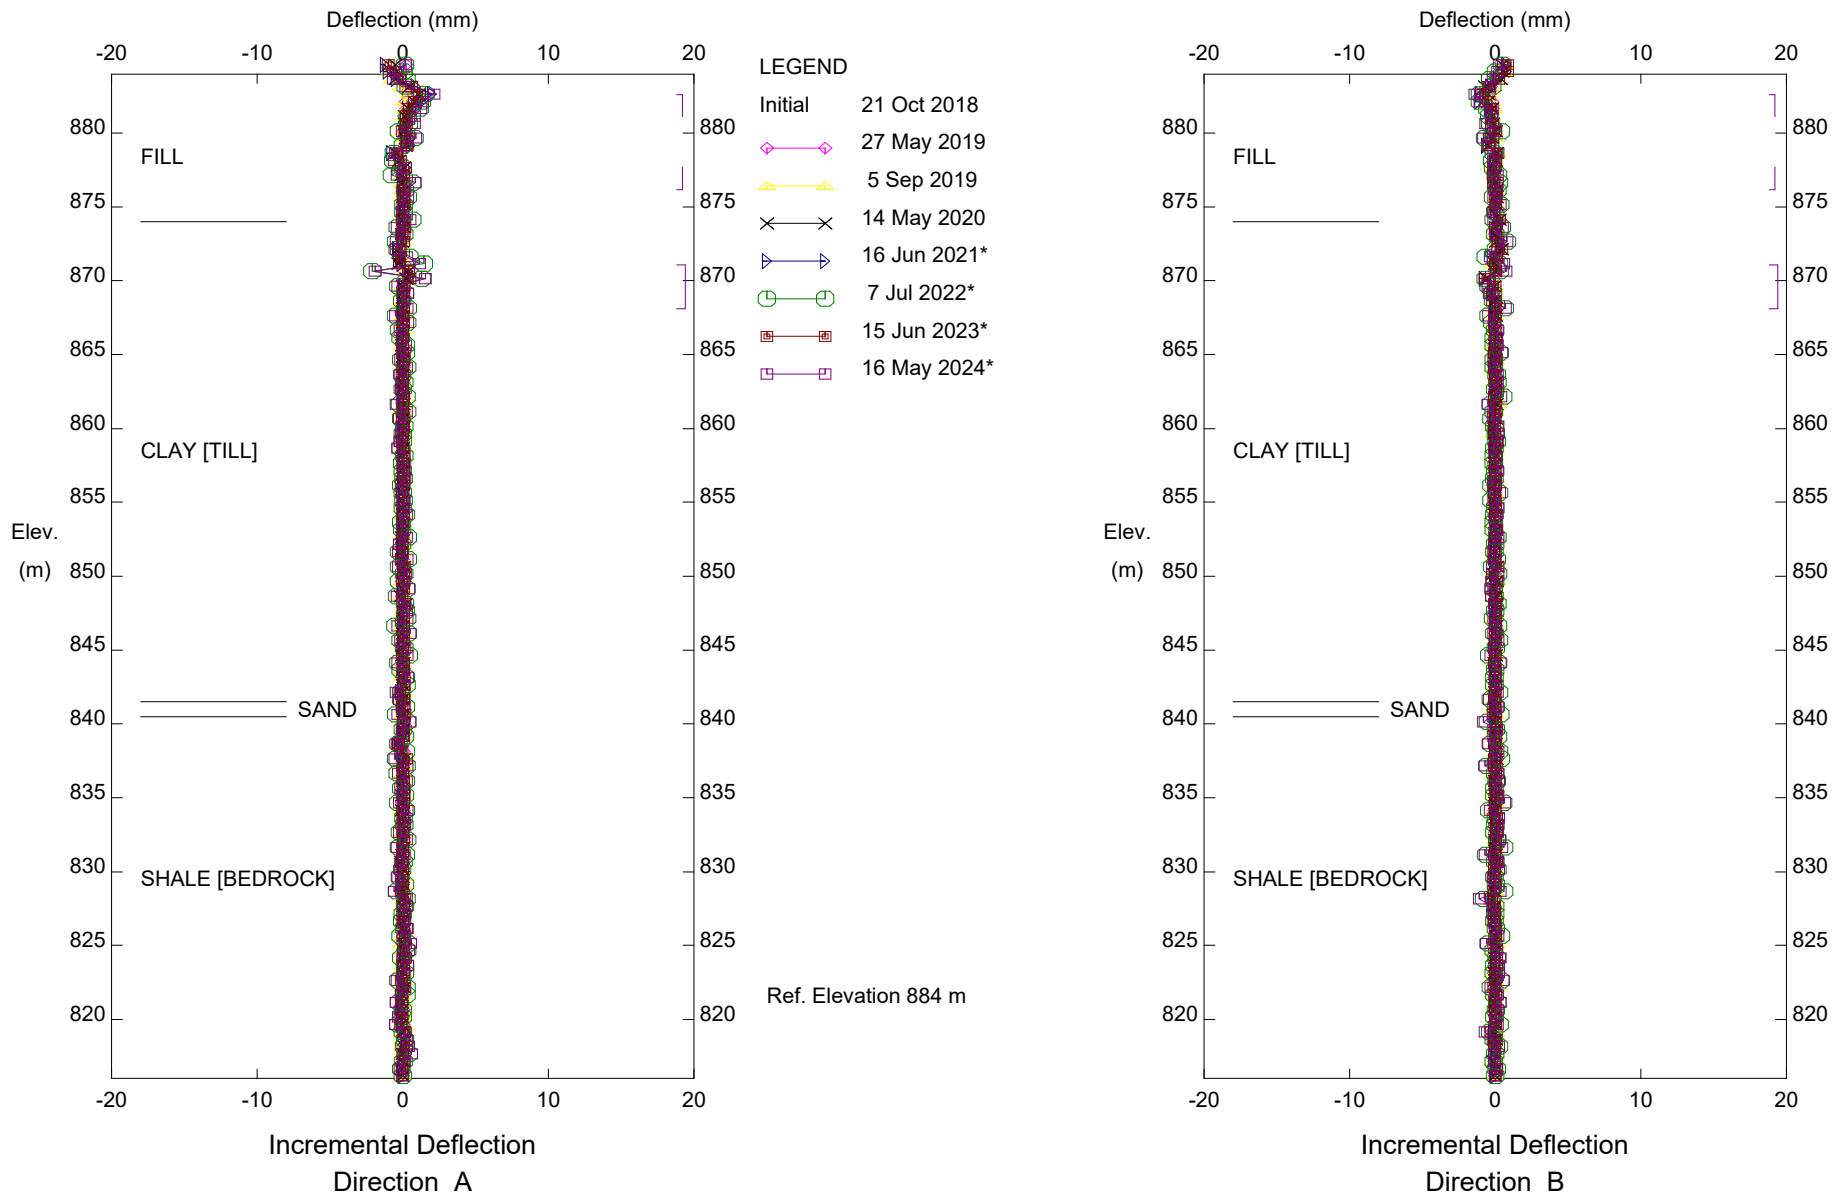
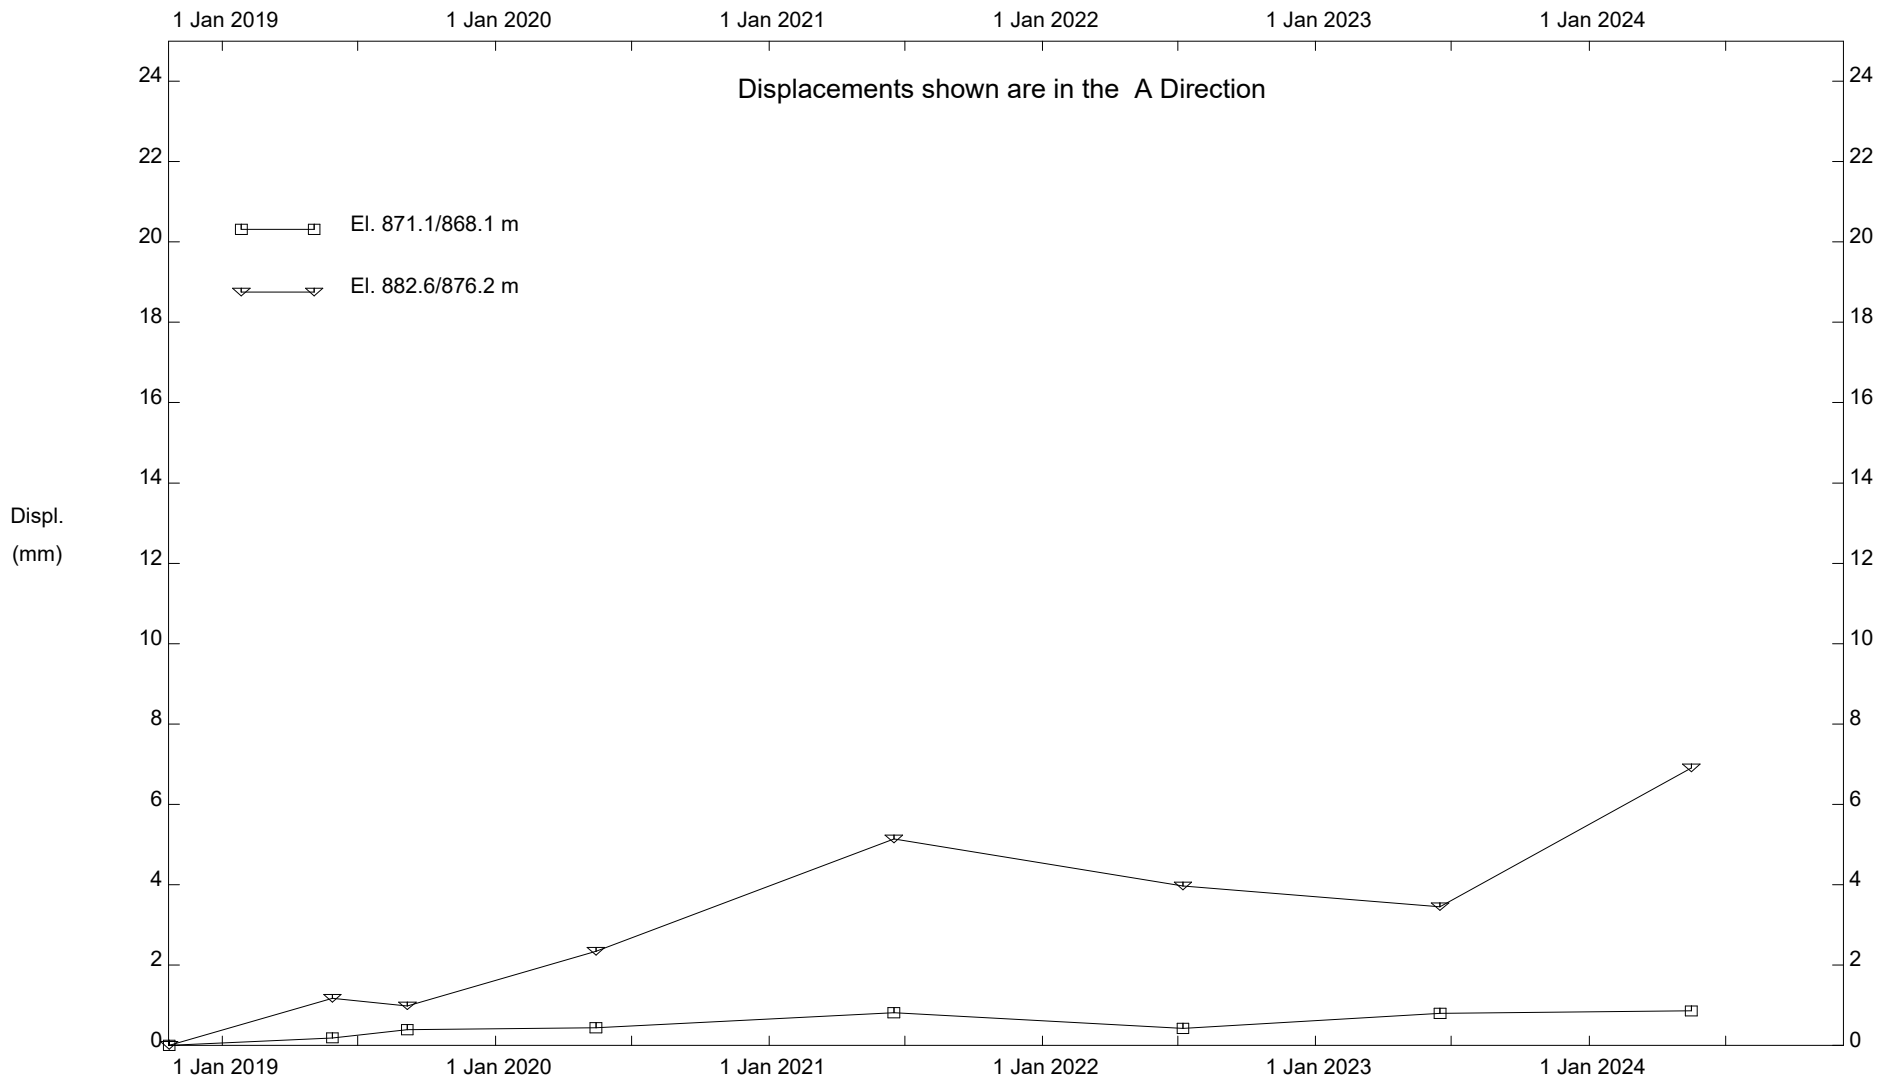
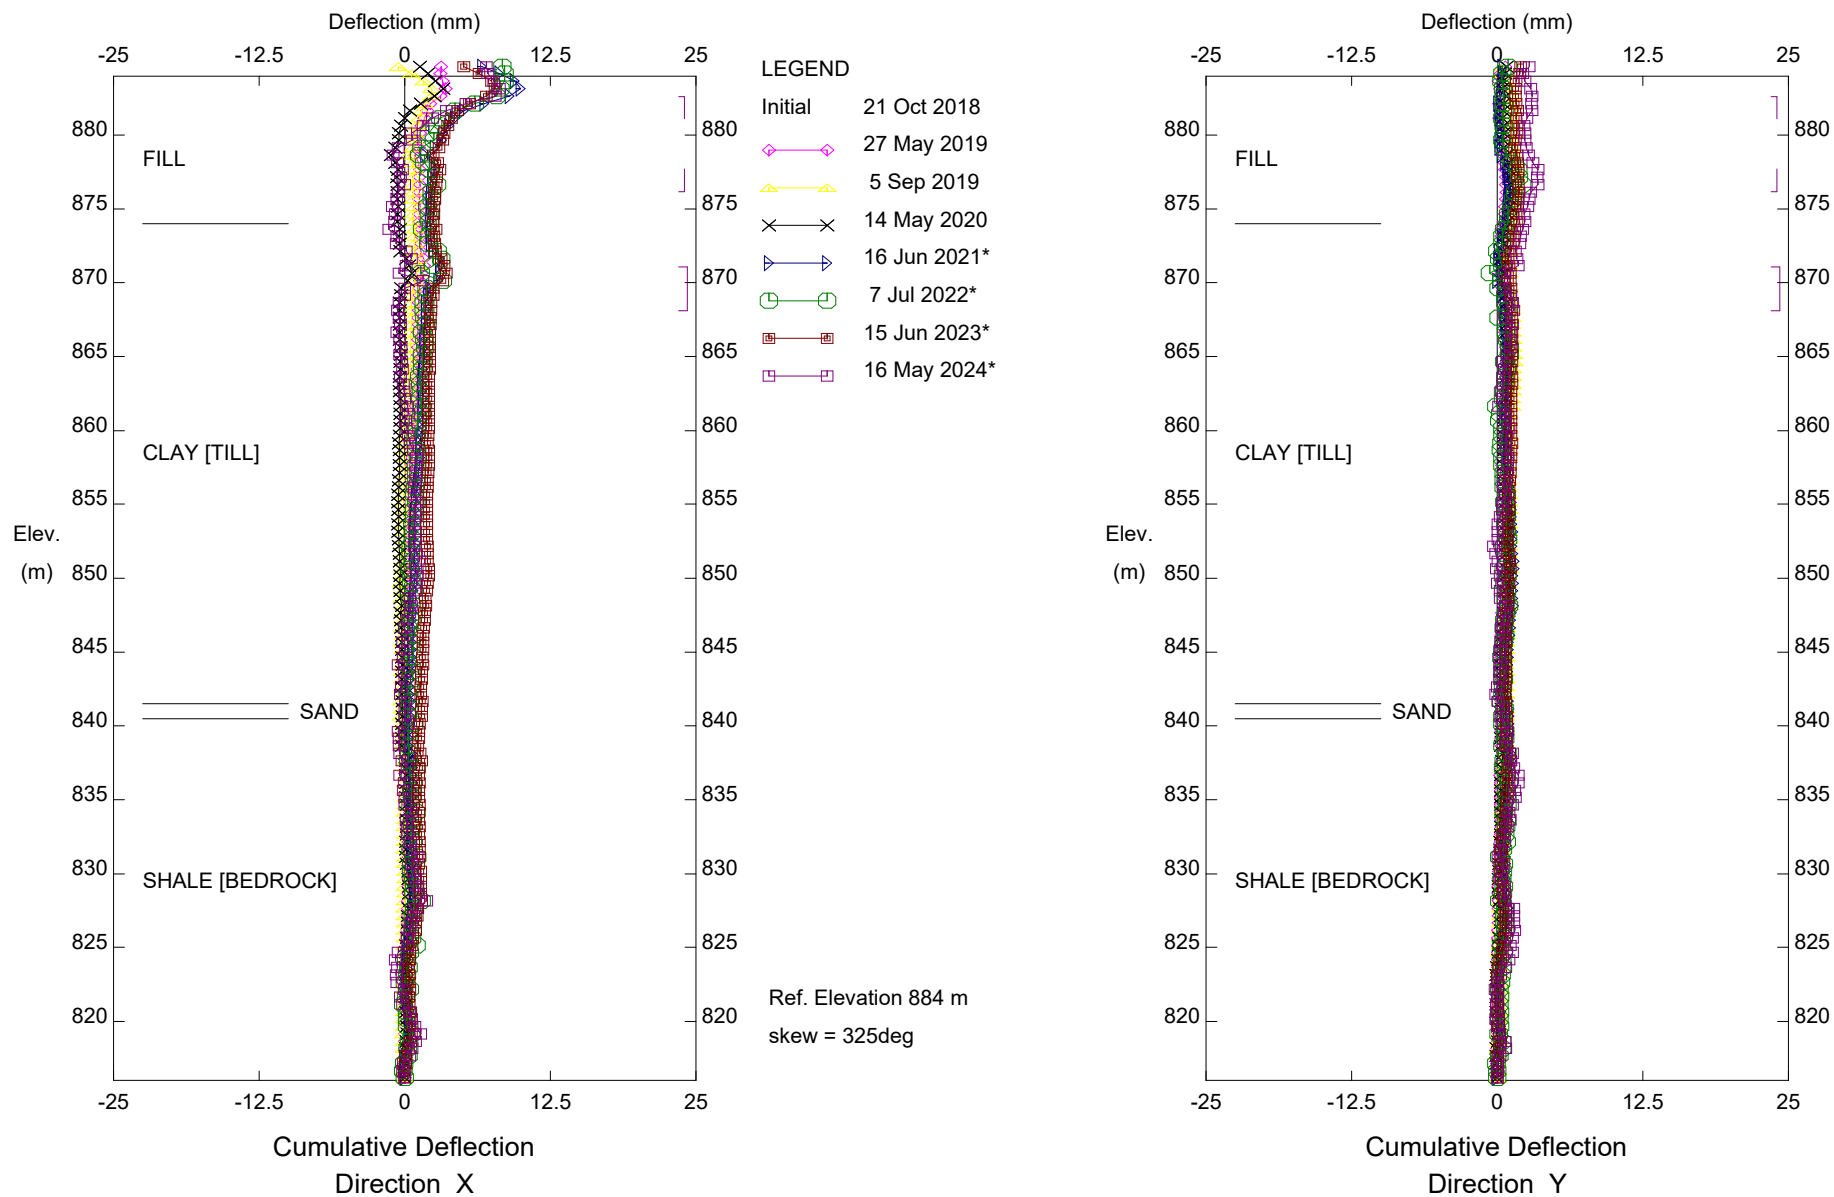
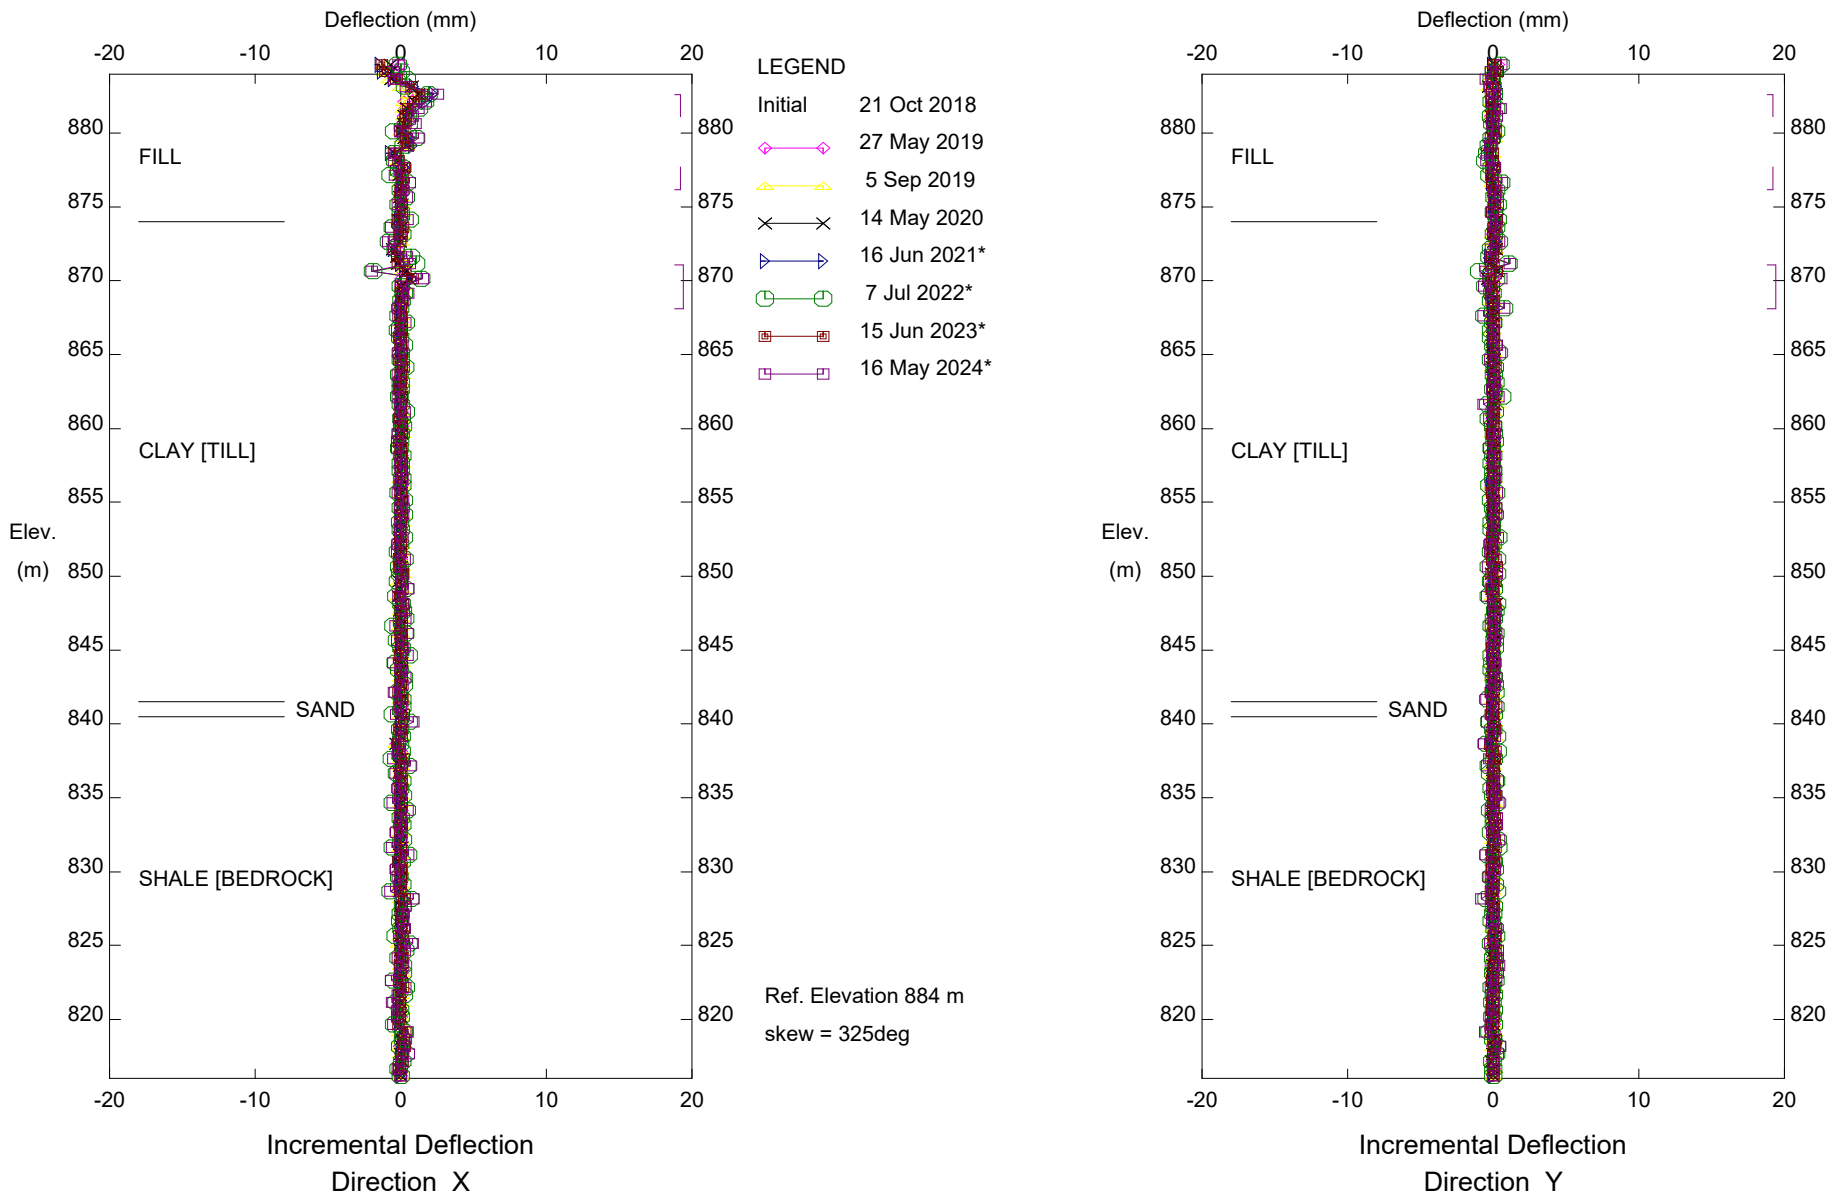
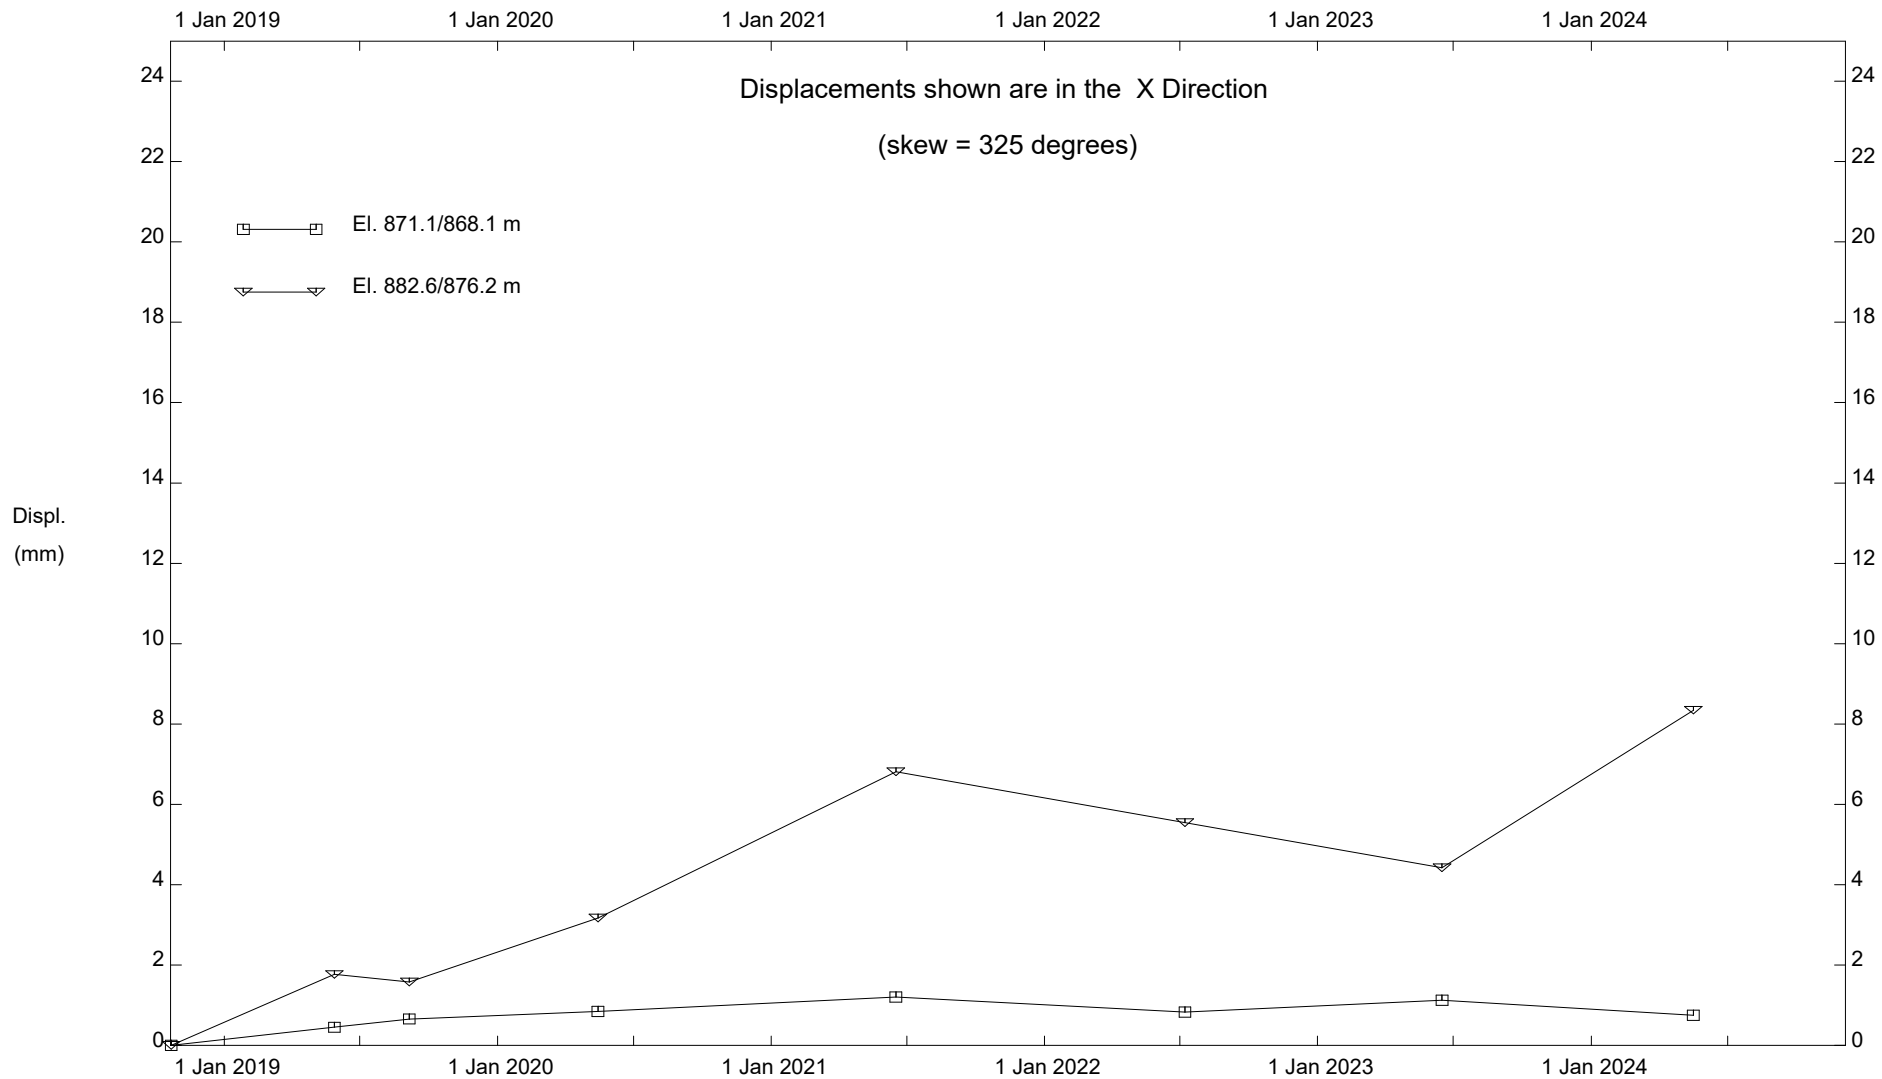
S005; H36:03, Chin Coulee, Inclinometer SI18-01

Distributed movement has been recorded in SI18-01 from an approximate depth of 5 m to 60 m below ground surface (approximately El. 879 m to El. 824 m). The casing also appears to be settling or buckling between an approximate depth of 13.5 m and 16 m below ground surface (approximately El. 868.1 m and El. 871.1 m), as discussed below.

The settlement or buckling observed in SI18-01 (from approximately 13.5 m and 16 m below ground surface) could be an indication that the instrument is poorly grouted with a possible grout void. The movements of the slide mass and interpretation of the SI data is complicated by the potential for settlement or buckling of the SI casing in the poorly grouted casing segment. The instrument was previously re-initialized to the October 2018 reading to remove possible noise associated with this zone. Overall, data quality has improved since the instrument was re-initialized, but settlement or buckling of the casing is still occurring at this depth. The rate of settlement or buckling has slowed since the first few months following installation and has been generally negligible since the instrument was re-initialized. If the settlement or buckling begins to impact the interpretation of the SI data again, the instrument may need to be re-initialized.

Since installation, the overall rate of movement recorded in SI18-01 and SI18-02 has been slow (less than 5 mm/year), with total movement of 8 mm and 6 mm, respectively, since installation.
