July 10, 2024

**CON0022161 Southern Region GRMP Instrumentation Monitoring
Site S005; H36:02, km 37.1 Chin Coulee Slide
Section C – 2024 Spring Readings**

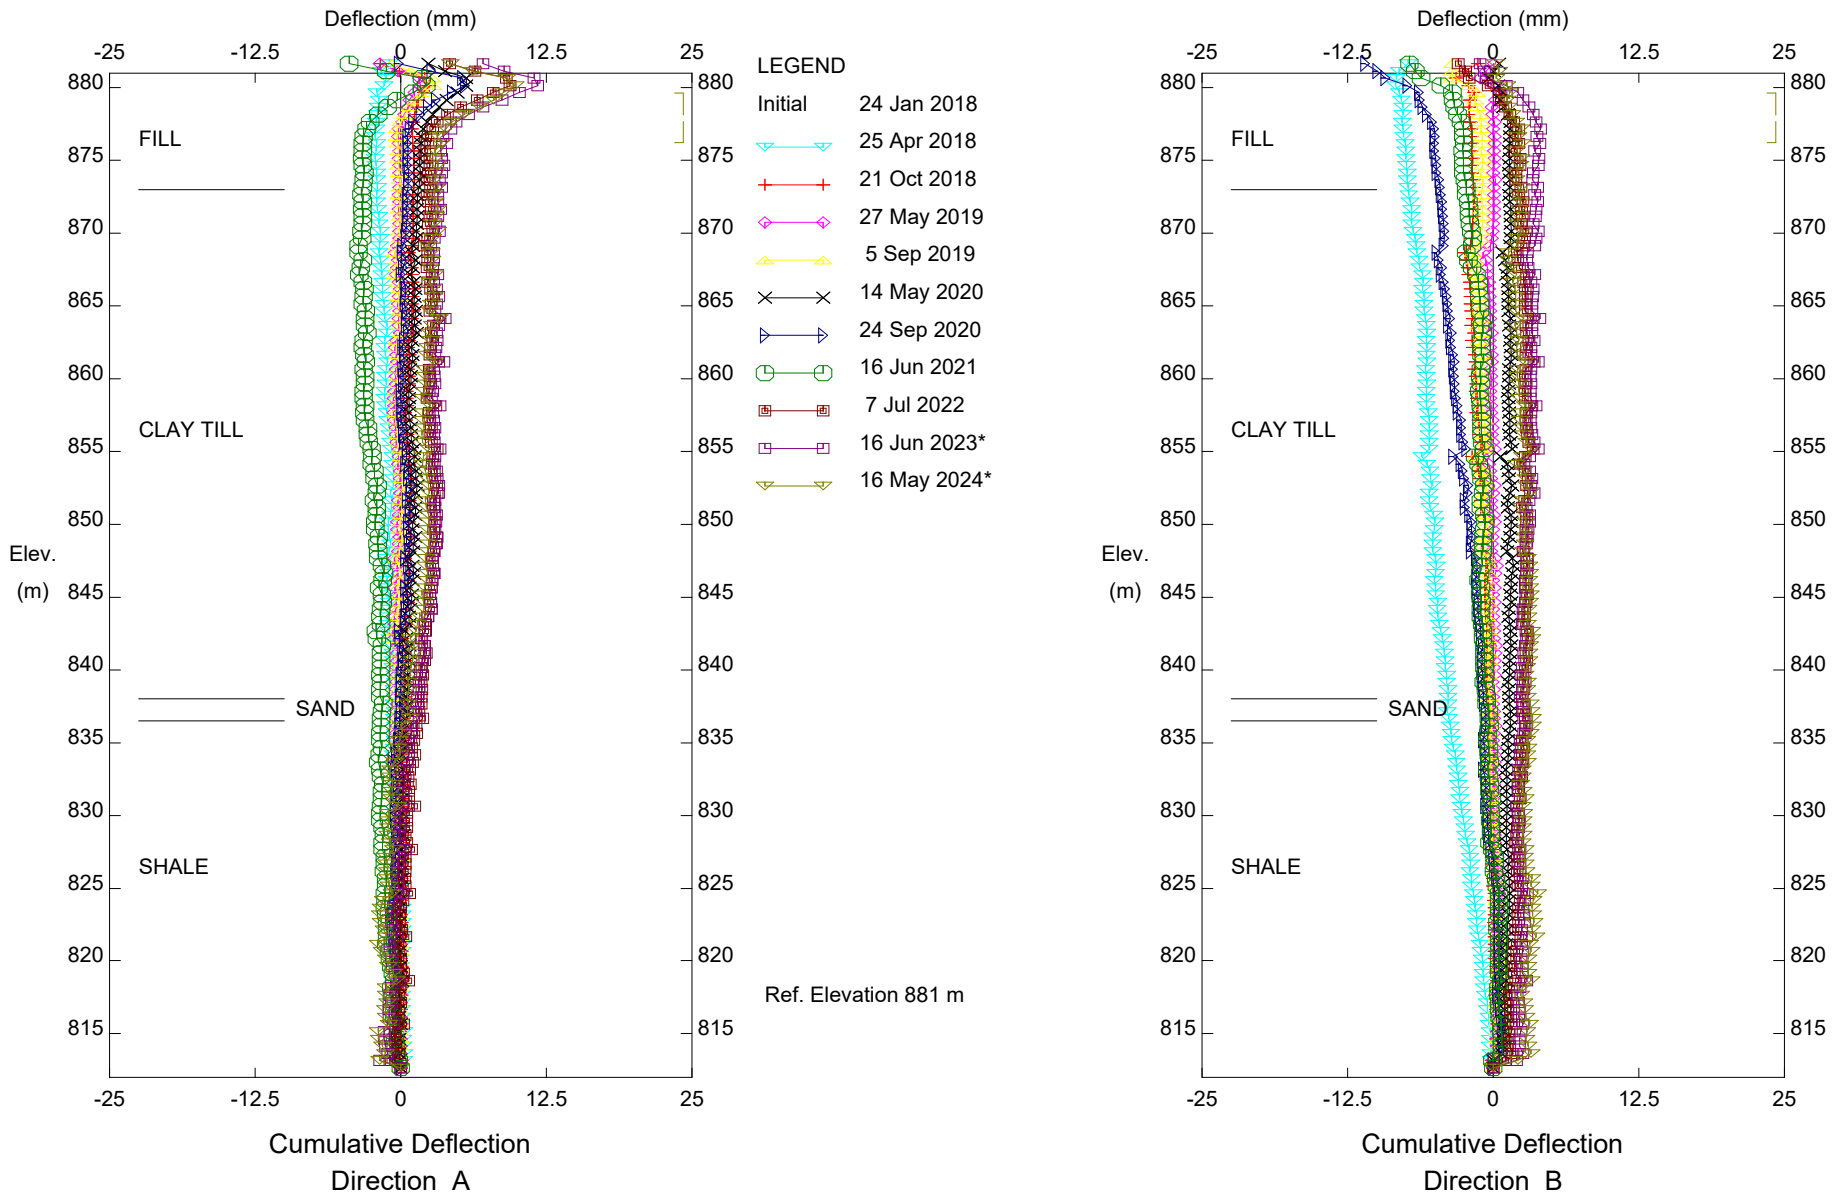
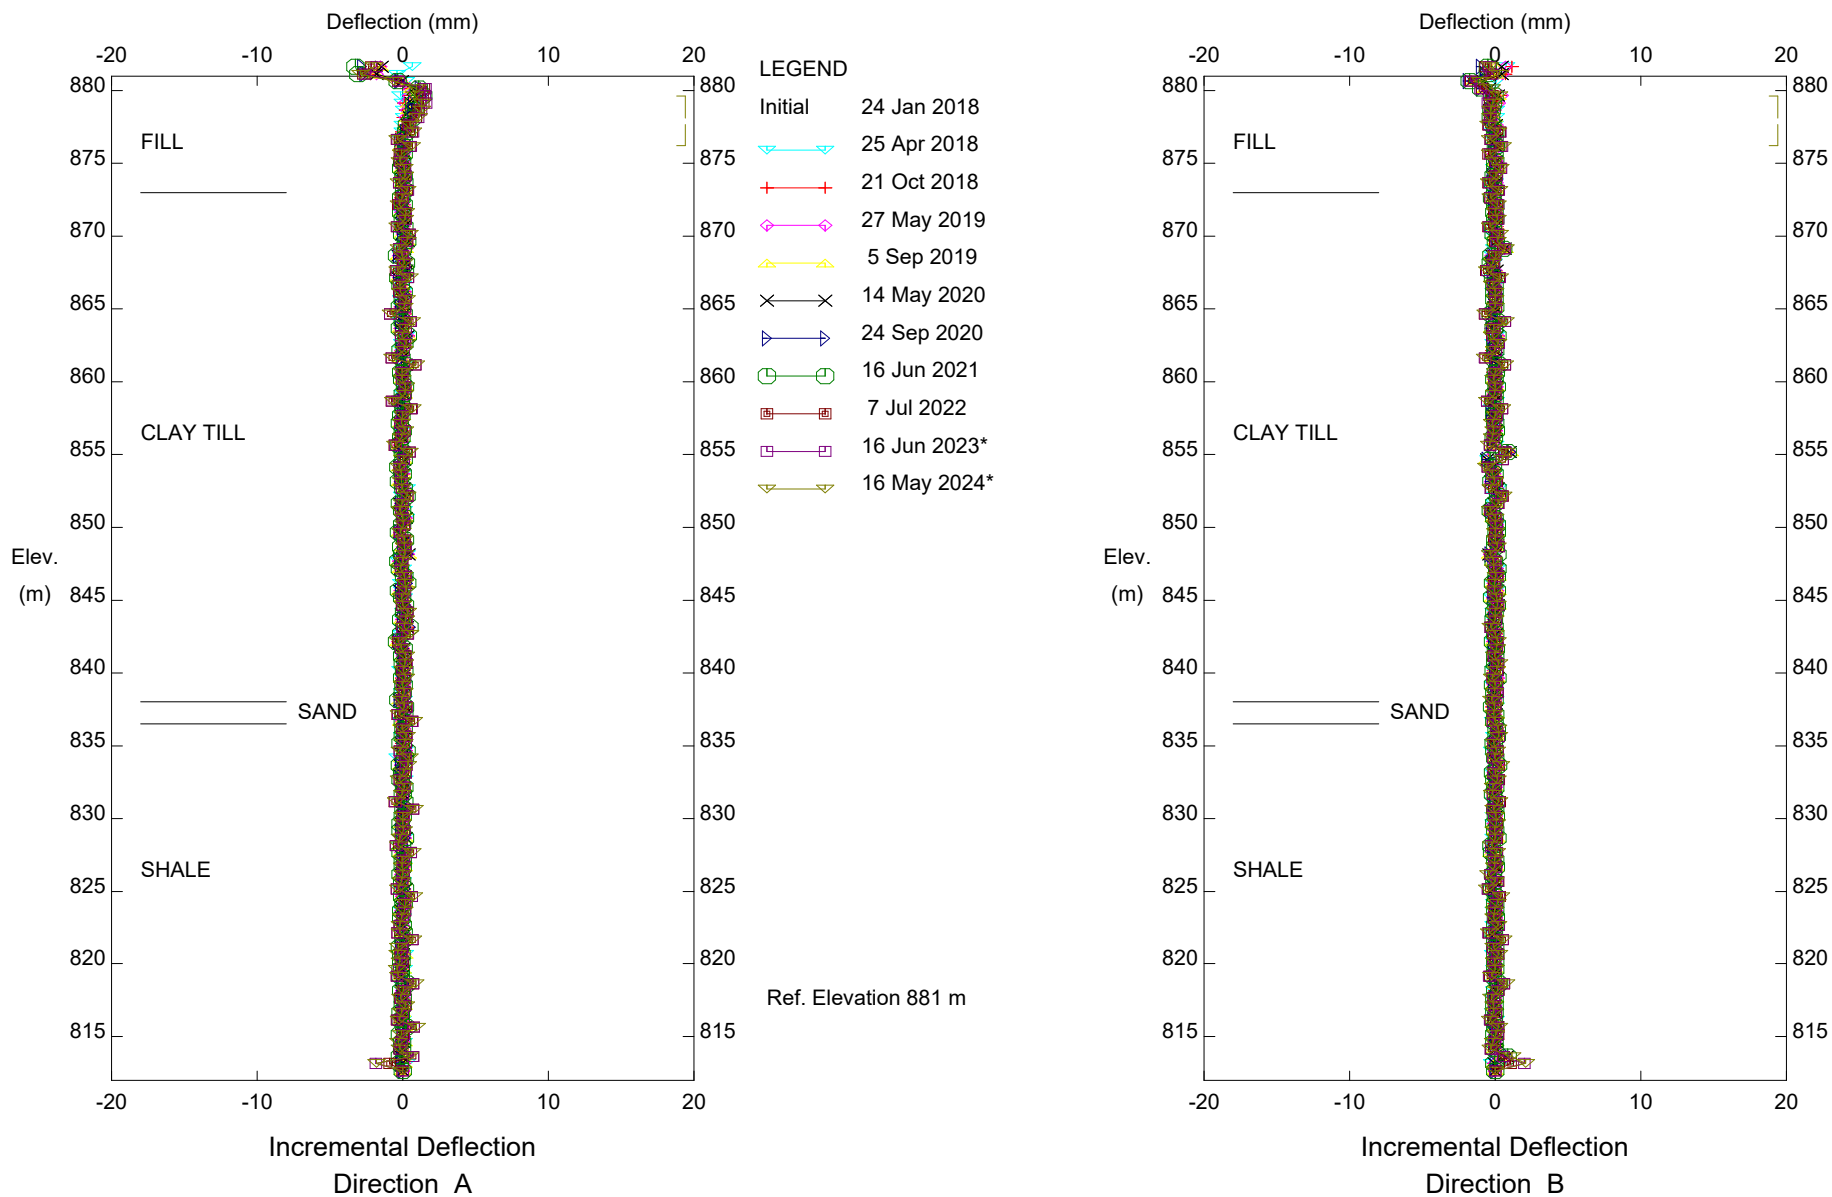
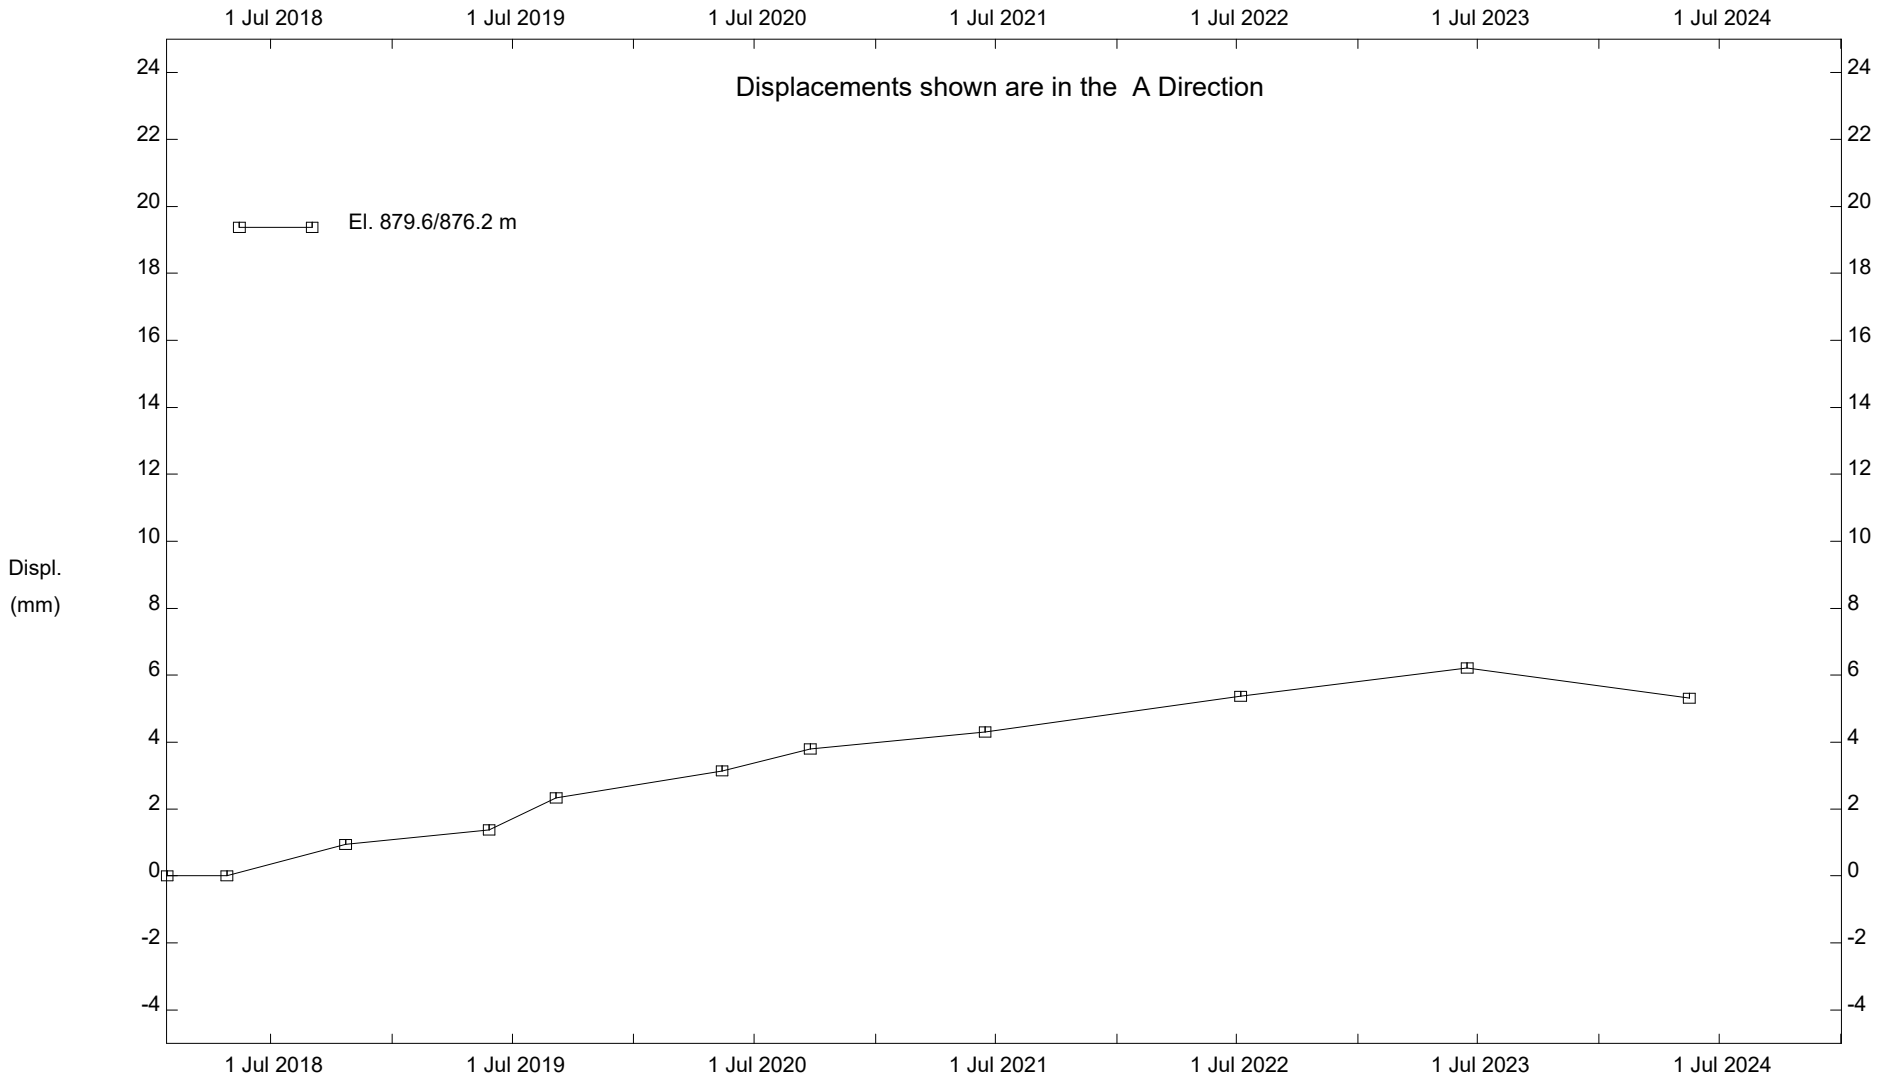
S005; H36:02, Chin Coulee, Inclinator SI18-02

Distributed movement has been recorded in SI18-02 from an approximate depth of 1 m to 50 m below ground surface (approximately El. 880 m to El. 831 m).

Since installation, the overall rate of movement recorded in SI18-01 and SI18-02 has been slow (less than 5 mm/year), with total movement of 8 mm and 6 mm, respectively, since installation.

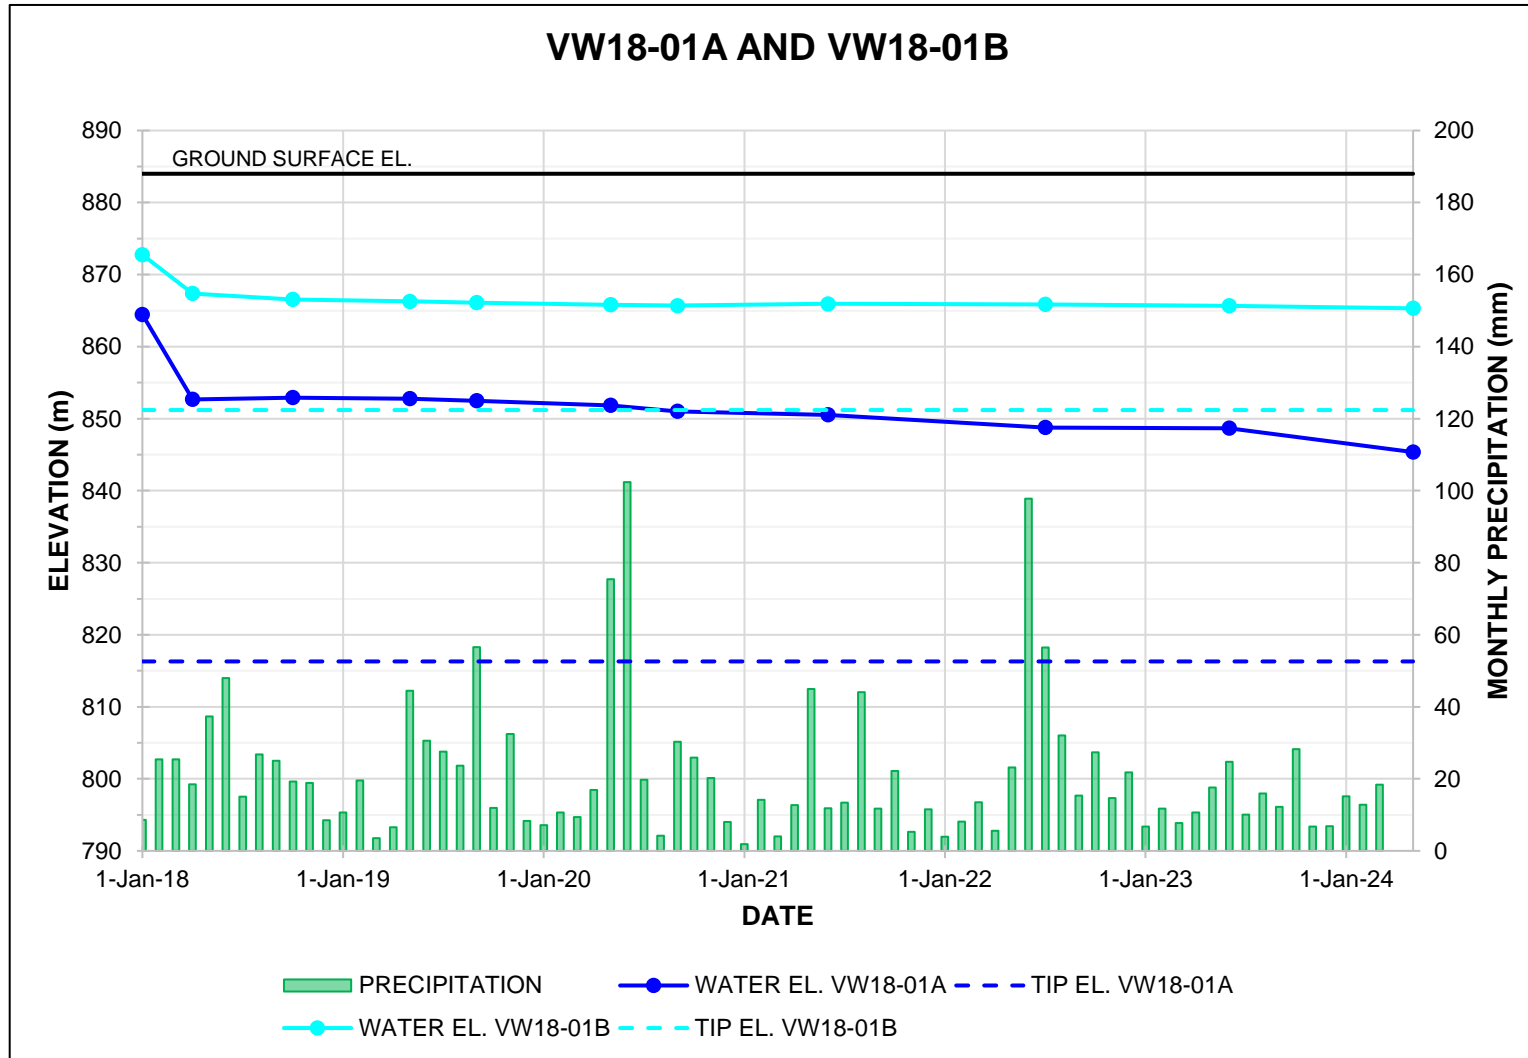
VW18-01A AND VW18-01B

The initial readings for the VWPs (VW18-01A/B and VW18-02A/B) were taken immediately following grouting operations, and KCB believes that the initial water levels recorded in the VWPs were artificially high due to grouting. Water levels recorded in these instruments decreased up to 13 m within a month of installation.

Overall, water levels recorded in VW18-01A, VW18-02A, and VW18-02B have decreased approximately 7.3 m, 5.7 m, and 5.2 m, respectively, since the spring of 2018. Whereas water levels recorded in VW18-01B have remained relatively steady (± 0.1 m). The relatively steady decrease in water level recorded in VW18-01A, VW18-02A, and VW18-02B can most likely be attributed to excess porewater pressure dissipation following realignment of the highway (and the resulting fill placement) completed in 2016. A water level increase of 1.8 m was recorded in VW18-02B between spring 2023 and spring 2024. Further readings will be needed to confirm if this increase is the start of a new trend. It does not appear the water levels recorded in the VWPs at the S005 site fluctuate seasonally or in response to prolonged or heavy rainfall or freshet infiltration. However, the current annual reading frequency of the instruments may not capture short-term fluctuations (i.e., increases and decreases) in water levels that occur between readings.
