SITE NUMBER AND NAME <b>S017 Mount Baldy Rock Cut</b>		HIGHWAY & KM 40:12, 37.302	PREVIOUS INSPECTION DATE June 14, 2016	INSPECTION DATE <b>May 1, 2018</b>
LEGAL DESCRIPTION NE 32-23-8-W5	NAD 83 COORDINATES Northing    Easting 51°0.481'    115°4.361'		RISK ASSESMENT PF: 12      CF: 2      TOTAL: 24	
Average Annual Daily Traffic (AADT): 2600 (north), 2580 (south), (Ref. No. 53190)			Contractor Maintenance Area (CMA): 28

PROJECT  
 SOUTHERN REGION GEOHAZARD RISK MANAGEMENT PROGRAM

TITLE  
 Site Plan  
 S017 - Mount Baldy Rock Cut  
 Hwy 40:12 km, 37.302

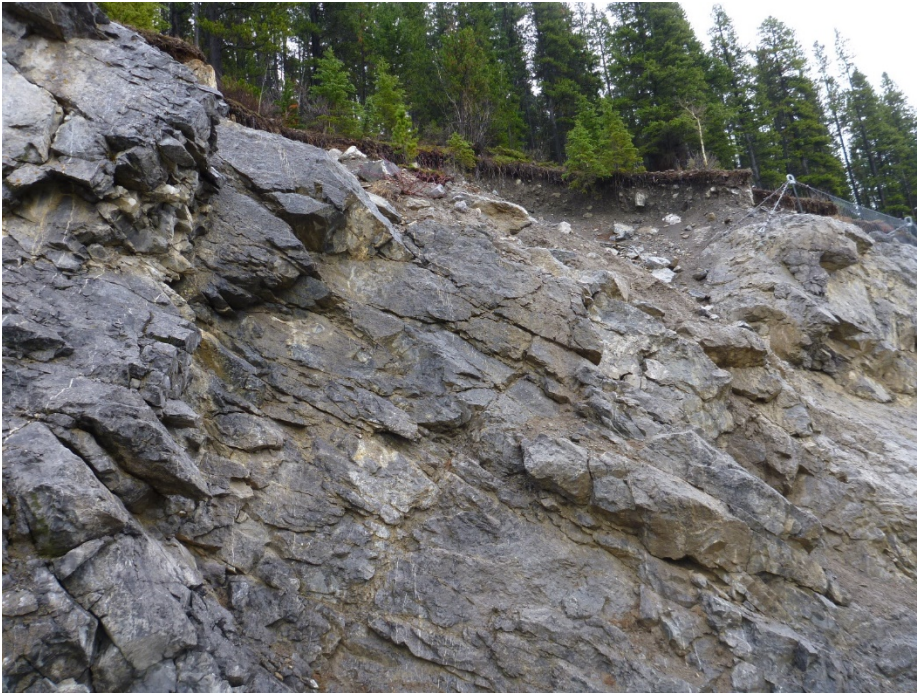
**Photo 1** Rock slope height is approximately 15 m. Loose material at the brow of the slope erodes and contributes to the rockfall. Photo was taken facing east on May 1, 2018.

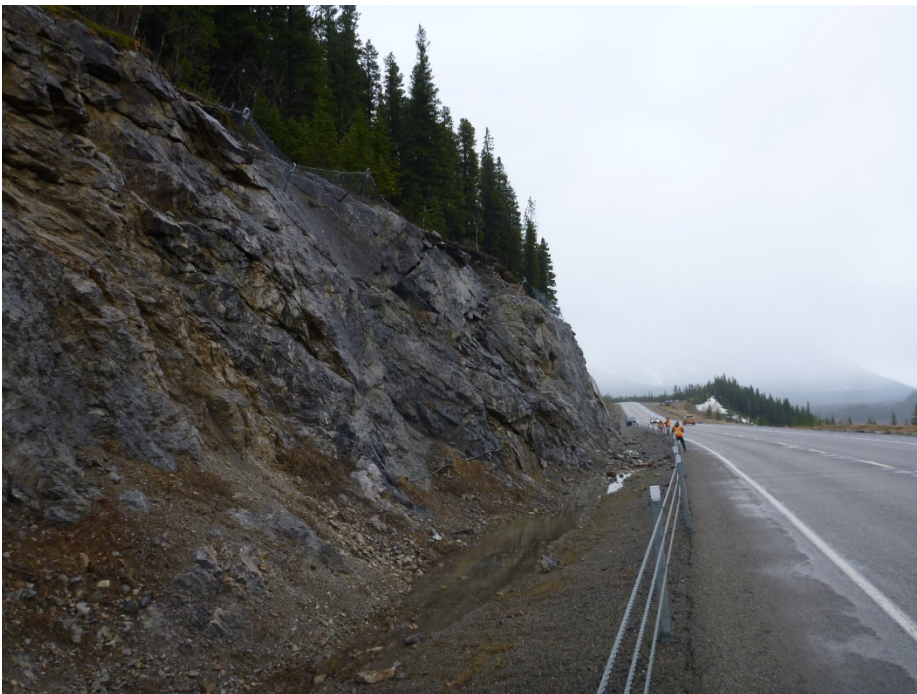
**Photo 2** Wire mesh and HTC B installed on slope in 2016. Photo was taken facing south on May 1, 2018.

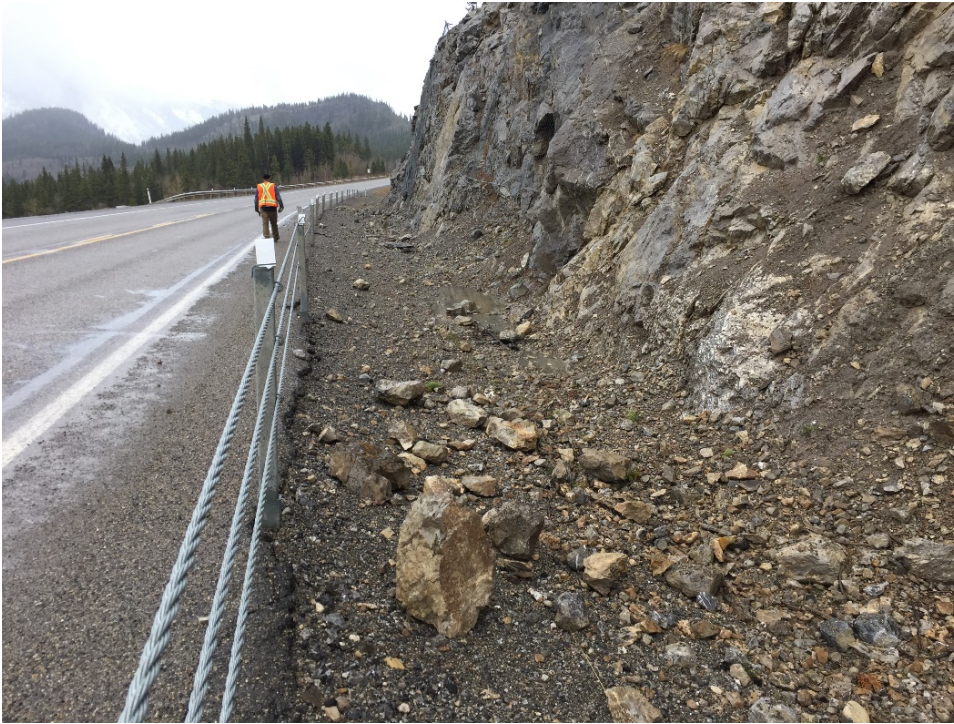
**Photo 3** Rock debris in ditch up to 0.5 m x 0.5 m x 0.5 m in size. Photo was taken facing north on May 1, 2018.

<b>COMMENTS</b>
Large debris piles in mesh gaps. The slope is less steep at the gaps in the mesh due to weathered rock and therefore were left open for animal access up the slope.
Rocks up to 0.5 m x 0.5 m x 0.5 m have fallen into the ditch.
Some tears in mesh due rock falls.
Ditch should be cleaned of debris regularly.
Narrow ditch. Rocks falling in the mesh gaps have the potential to roll onto the highway. The mesh should be repaired.
Increased exposed soil at the brow of the slope since the previous inspection in 2016
Fallen material could be used to create a small berm behind the HTCB at the mesh gaps to help reduce fallen material from rolling under the HTCB, onto the highway.
Inspect site every two years.

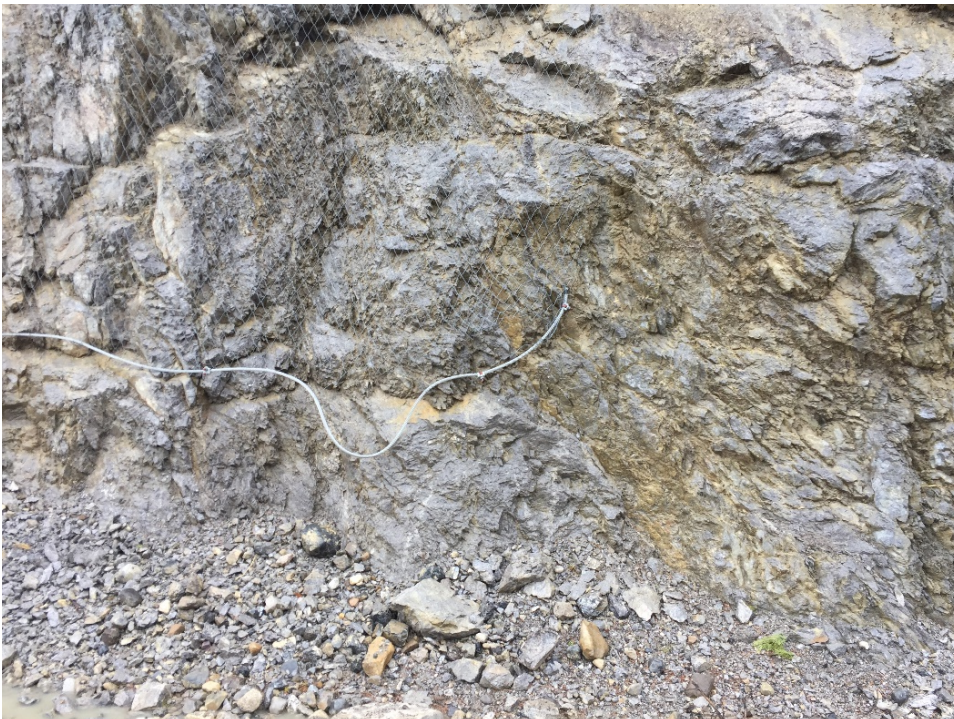
**Photo 4** Some tears noted in the wire mesh where attached to the cable at the base. Photo was taken facing east on May 1, 2018.
