SITE NUMBER AND NAME S017 Mount Baldy Rock Cut		HIGHWAY & KM 40:12, 37.302	PREVIOUS INSPECTION DATE May 1, 2018	INSPECTION DATE May 7, 2019
LEGAL DESCRIPTION NE 32-23-8-W5	NAD 83 COORDINATES UTM Northing Easting 11 5652484 634210		RISK ASSESMENT PF: 12 CF: 3 TOTAL: 36	
Average Annual Daily Traffic (AADT): 2600 (north), 2580 (south), (Ref. No. 53190)			Contractor Maintenance Area (CMA): 28

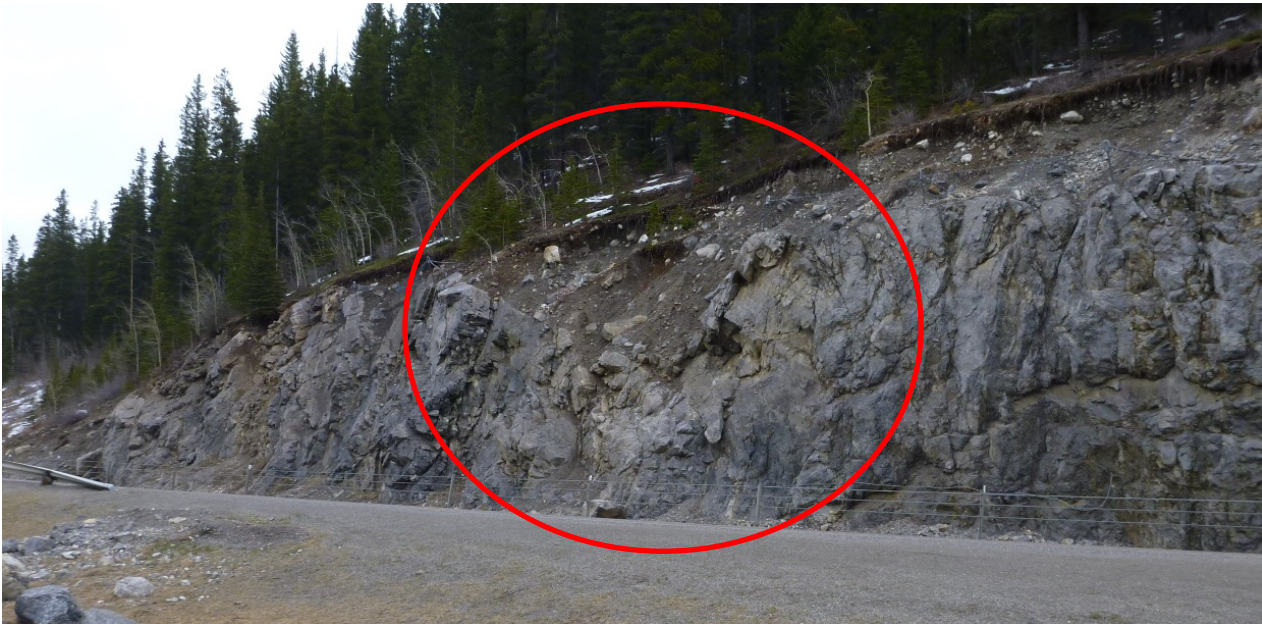
There is exposed soil at the brow of the slope. Crest anchors for the mesh are at risk of being undermined in places.

Photo 1 Rock slope height is approximately 15 m. Loose material at the brow of the slope erodes and contributes to the rockfall. Photo taken facing east on May 7, 2019.

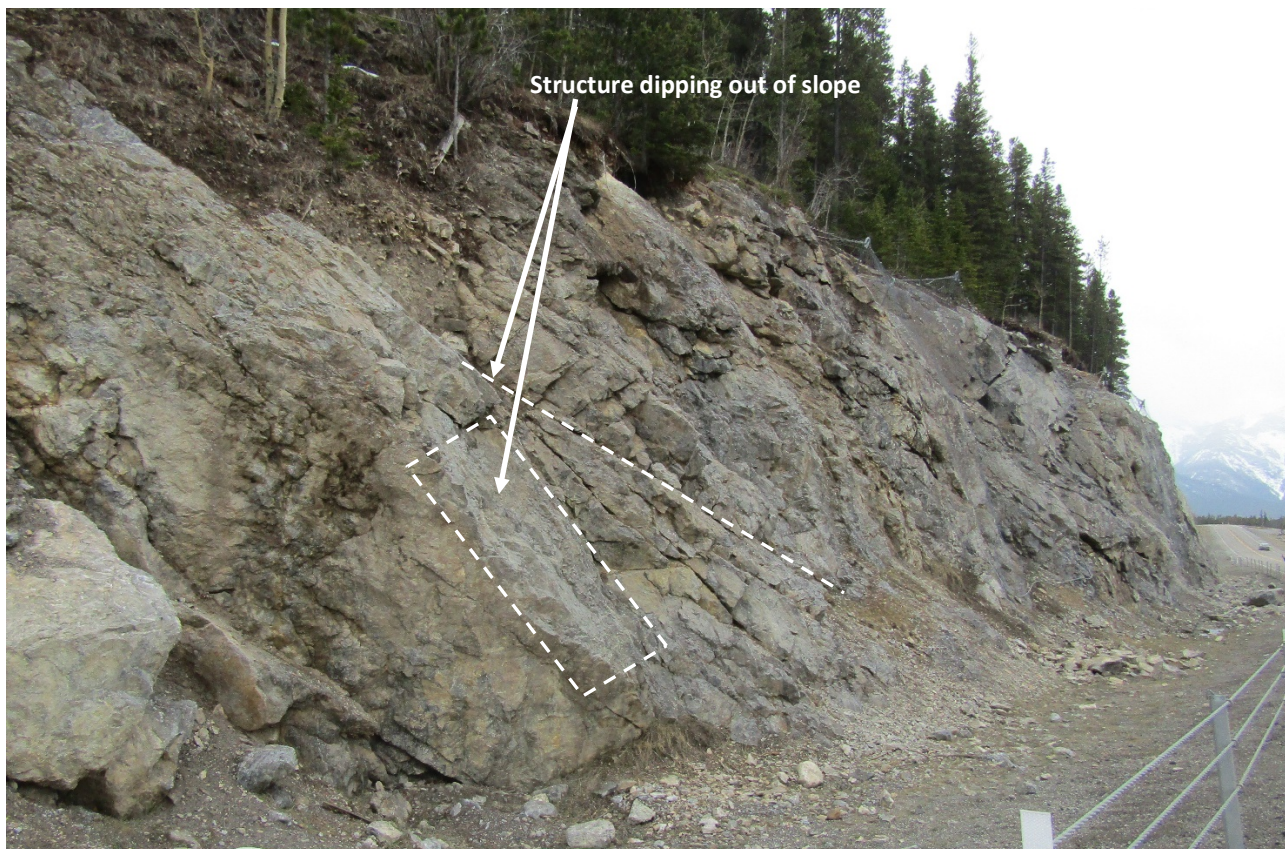
Sections of the rock face are sheared and unstable. Structural features dip out of slope, allowing blocks to detach and slide towards the highway (Photo 2). Potential for larger blocks to block a lane.

Photo 2 Wire mesh and HTCB installed in 2016. Photo was taken facing south on May 7, 2019.

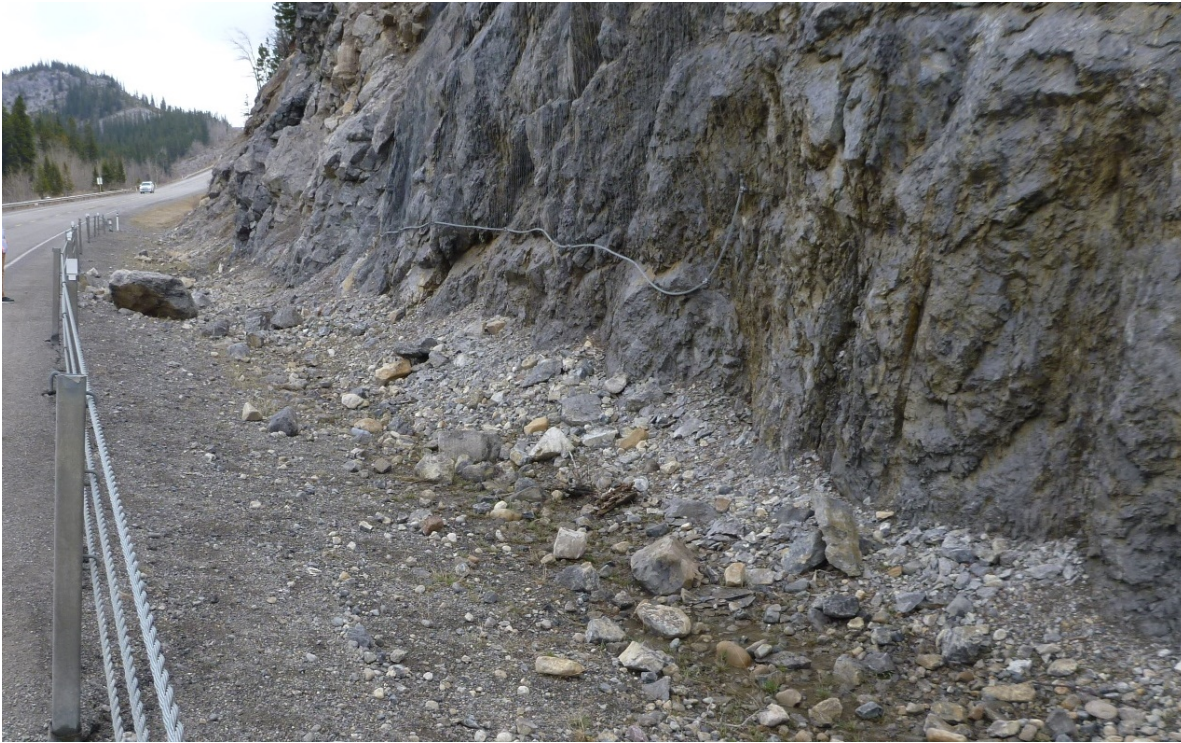
Existing ditch is narrow and flat, allowing some debris to roll onto the highway. Ditch should be cleaned of debris regularly. Maintenance contractor reports that ditches are typically cleaned every 3 to 5 years.

Photo 3 Rock debris in ditch up to 1.7 m x 1.2 m x 0.8 m in size. Photo was taken facing north on May 7, 2019.

- Rock debris should be cleaned from ditches this year; and
- Reattach the mesh to the base cable so that it functions effectively.

Fallen material could be used to create a small berm behind the HTCB at the mesh gaps, to reduce potential for rockfall material from rolling under the HTCB and onto the highway.

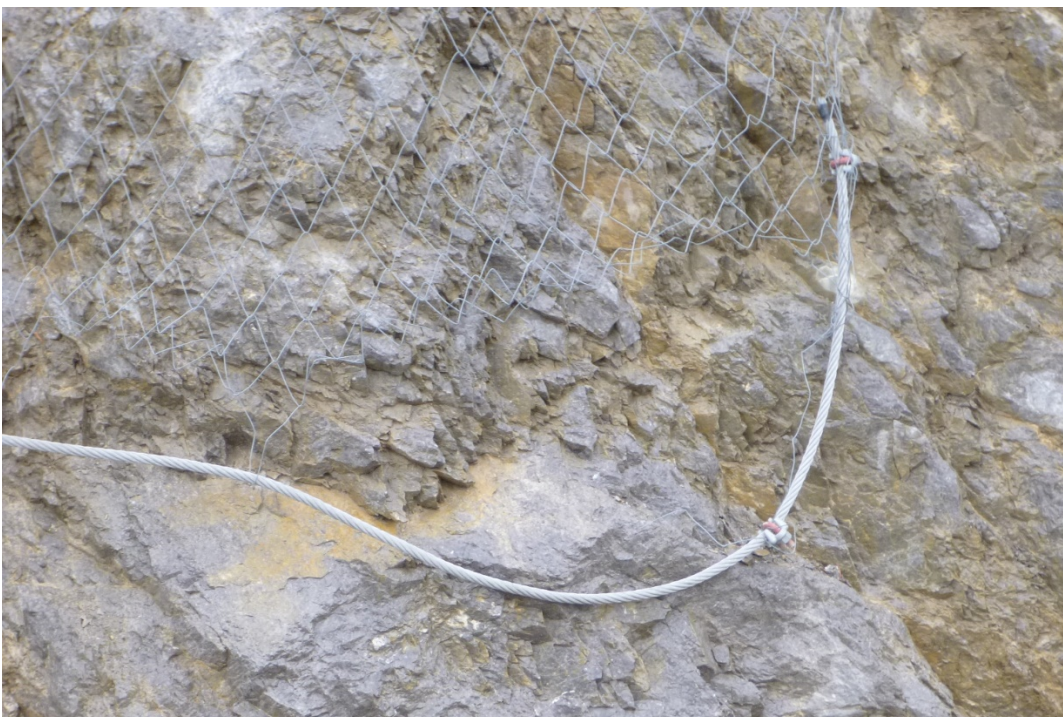
Photo 4 Some tears noted in the wire mesh where attached to the cable at the base. Photo was taken on May 7, 2019.
