Site 3 – Barrier Bluffs Through-Cut

This site is located approximately 3.8 km south of the junction between Highway 40 and Highway 68 and consists of rock cut slopes along both sides of the highway. The cut slopes extend for approximately 200 m along the highway. There are rockfall hazards along both cut slopes. There are warning signs (“Watch For Fallen Rock”) posted for traffic approaching the site from both directions.

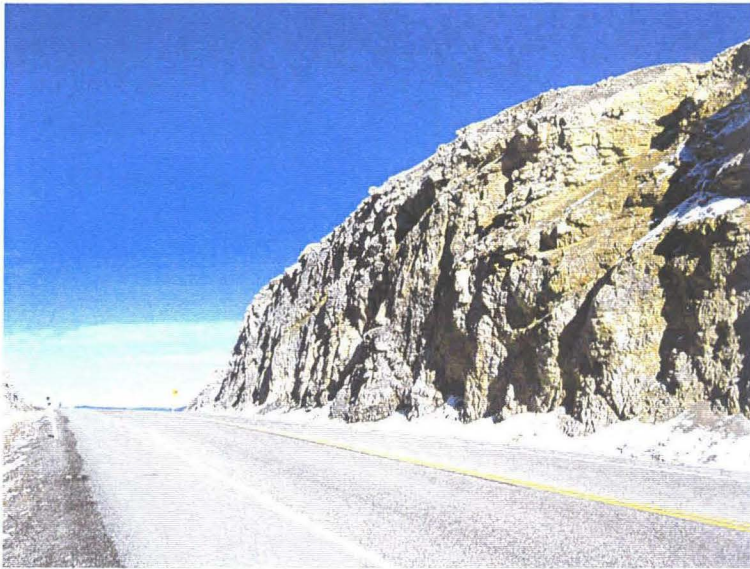
- The cut slope along the east side of the highway is near-vertical with a maximum height of approximately 14 m.
- The bedrock exposed in the cut slope is jointed, faulted and highly fractured. The south segment of the cut slope is particularly rough and fractured.

- The bedrock is steeply dipping with the dip direction roughly parallel to the highway, i.e. favorable from a stability perspective.
- Rockfalls along this slope are the result of erosion of the exposed rock. The erodibility of the exposed rock is exacerbated in places by the numerous discontinuities. The rockfall debris is typically gravel to cobble-sized although occasional boulder-sized rocks were noted.

Photo 1 (top) – Rock cut slope along the east side of the highway. The cut slope is near-vertical, with a maximum height of approximately 14 m. The bedrock is steeply dipping with the dip direction roughly parallel to the highway (which is favorable from a stability perspective). The bedrock is highly fractured, jointed and faulted, with the south end of the east cut slope particularly fractured and rough.

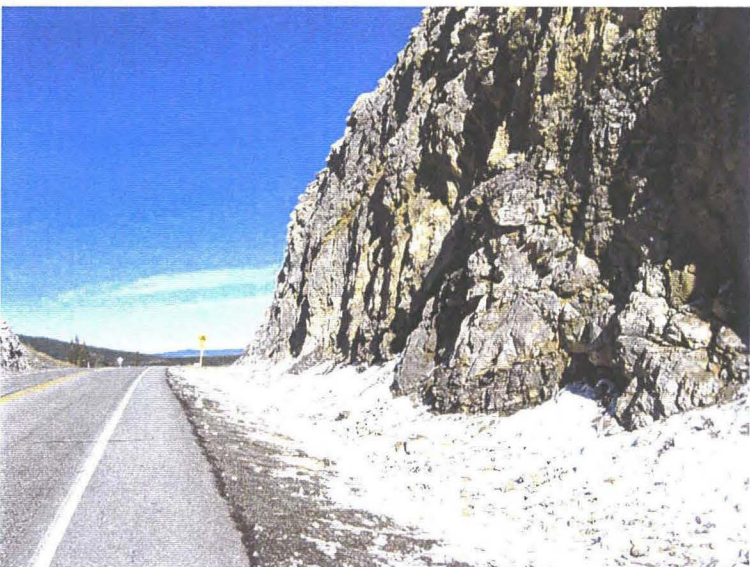
- The east ditch along the highway is typically 7 to 8 m wide and 1.25 m deep. The ditch sizing criteria shown on Figure B1 in Appendix B indicate that for a near-vertical slope at the maximum height of 14 m, the ditch width should be at least 5.3 m and the ditch depth should be at least 1.4 m. The existing ditch exceeds the minimum width criteria but does not meet the minimum depth criteria.

- As shown in Photo 2, there is an accumulation of rockfall debris along the toe of the cut slope that extends into the central portion of the ditch. At the time of the inspection in October 2005, the rockfall debris was entirely contained within the ditch and there were no signs of damage to the pavement from previous rockfall.

Photo 2 (middle) – Typical view along the east ditch showing the accumulation of rockfall debris along the toe of the cut slope and extending into the central portion of the ditch. The ditch was typically 7 to 8 m wide and 1.25 m deep. There were no rocks on the road or signs of pavement damage due to previous rockfall. The rockfall debris in this area was typically gravel to cobble-sized, however occasional boulder sized rocks were noted. The rockfall debris should be cleaned out of the ditch.

It is recommended that the rockfall debris be cleaned from the ditches as a proactive measure in order to restore the maximum ditch capacity. The ditch also should be cleaned in the future as an ongoing maintenance task in order to reduce the hazard of rockfall debris rolling onto the road.

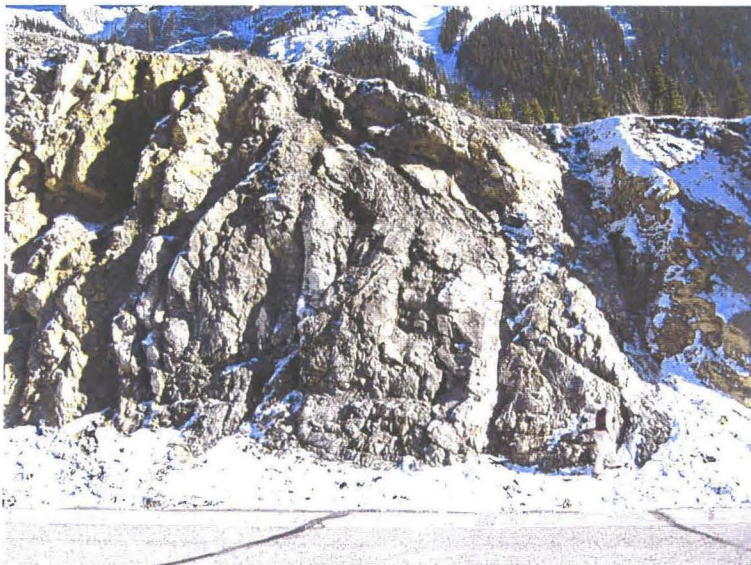
Photo 3 (bottom) – Typical view of the southern end of the east cut slope showing the fractured and rough cut face. Relatively large volumes of gravel sized rocks ravel off of these areas and accumulate at the toe of the cut slope.

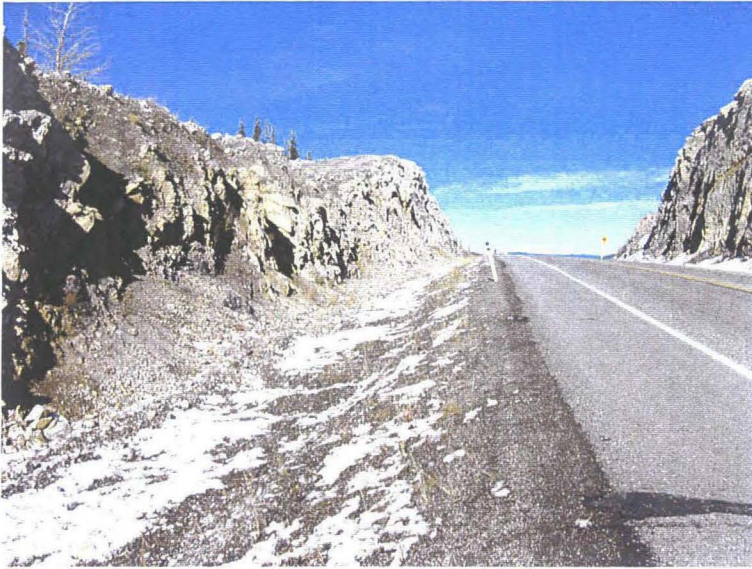
- The maximum height of the near-vertical cut slope along the west side of the highway varied between 4 and 6 m. The width and depth of the ditch are typically in the order of 5 m and 1.5 m, respectively. According to the ditch sizing criteria shown on Figure B1 in Appendix B, for a near-vertical cut slope of this maximum height the ditch width should be at least 3.7 m and the ditch depth should be at least 1.1 m. The existing ditch exceeds both of these criteria.
- Similar to the east cut slope, there are relatively large volumes of gravel to cobble sized rocks that ravel off the cut slope and accumulate within the ditch without rolling onto the road.

Photo 4 (top) – Facing north along the west cut slope. The maximum height of the near-vertical cut slope varies between 4 and 6 m. The width and depth of the ditch are typically in the order of 5 m and 1.5 m, respectively. Similar to the east cut slope, there are relatively large volumes of gravel to cobble sized rocks that ravel off the cut slope and accumulate within the ditch. The rockfall debris should be cleaned out of the ditch.
