SITE NUMBER AND NAME S017-II Mount Baldy Rockfall Hazards		HIGHWAY & KM 40:12, 38.28	PREVIOUS INSPECTION DATE May 7, 2019	INSPECTION DATE May 17, 2022
LEGAL DESCRIPTION NE 32-23-8-W5M	NAD 83 COORDINATES UTM Northing Easting 11 5653639 635354		RISK ASSESSMENT PF: 11 CF: 1 TOTAL: 11	
Average Annual Daily Traffic (AADT): 2600 (north) & 2580 (south) (Reference No. 53190)			Contractor Maintenance Area (CMA): 28

PROJECT SOUTHERN REGION GEOHAZARD RISK MANAGEMENT PROGRAM		
TITLE Site Plan S017-2 - Mount Baldy Rockfall Hazard Hwy 40:12, km 38.28		
SCALE 1:4,000	PROJECT No. A05116A03	FIG No. 1

Inspection Photographs S017-II (East)

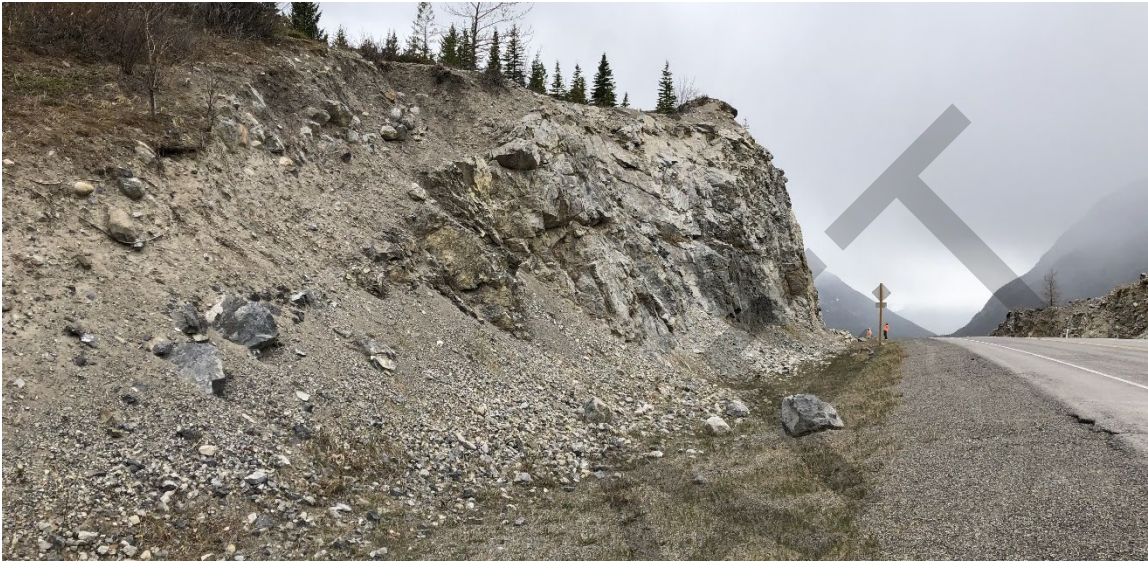
COMMENTS
<p>S017-II (East):</p> <ul style="list-style-type: none"> The rock slope on the east (northbound) side of the highway is 16 m to 18 m in height. Loose material at the top of the slope is eroding and contributing to the rockfall. The east (northbound) ditch is narrower than the west (southbound) resulting in less rockfall debris capacity (Photo 1 and 2). Debris has accumulated in the ditch at the toe of the slope. New rockfall debris up to 1 m in length was observed in the ditch (Photo 3) (WP 97). At the south end of the site the rock slope is more severely weathered than other parts of the rock slope. The weathering appears more severe along a shear plane, and appears to be undermining an overlying and relatively more competent rock mass causing more overhangs that could lead to future rockfall events (Photo 4).

Photo 1 Rock slope height is approximately 16 m to 18 m. Loose material at the brow of the slope erodes and contributes to the rockfall. Photo taken May 17, 2022, facing southwest.

- The ditch should be cleaned of debris more regularly. The MCI reports that ditches are typically cleaned every 3 to 5 years.
- The rock slopes should be scaled to remove loose materials and reduce potential for rockfall hazard.
- The site should be inspected every two-years as part the Southern Region Section B inspections.

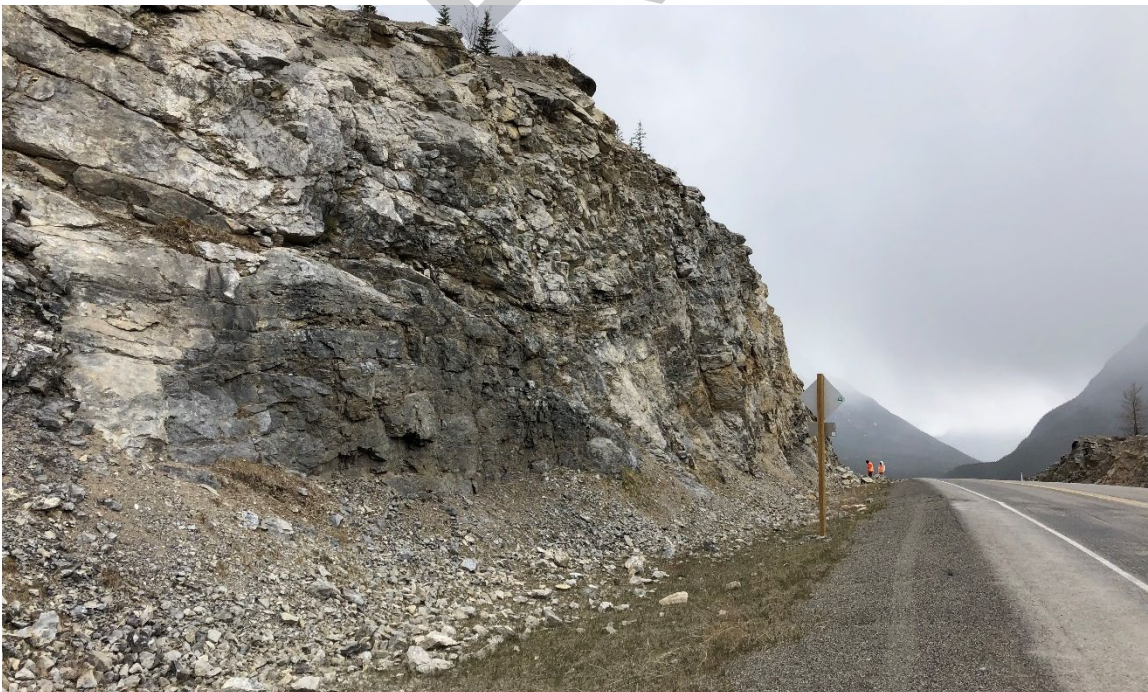
Photo 2 The ditch along the east (southbound) site of the highway is narrow and has less rockfall capacity than the west ditch. Photo was taken May 17, 2022, facing southwest.

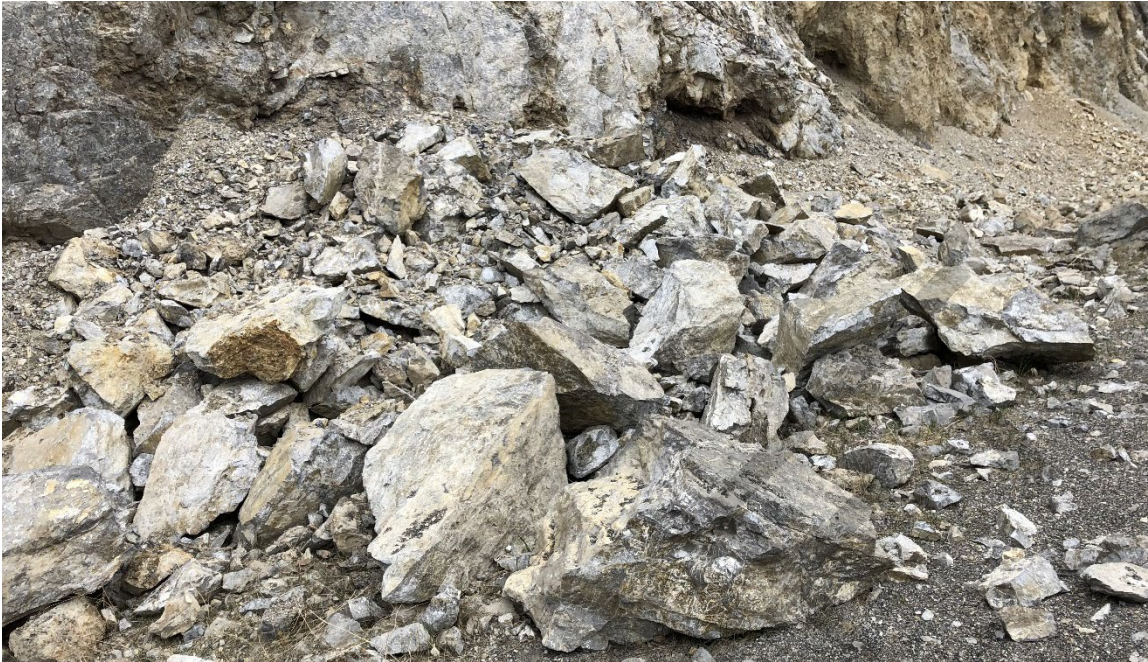
Photo 3 New rockfall debris in the east (southbound) ditch (WP 97). Photo taken May 17, 2022, facing northwest.

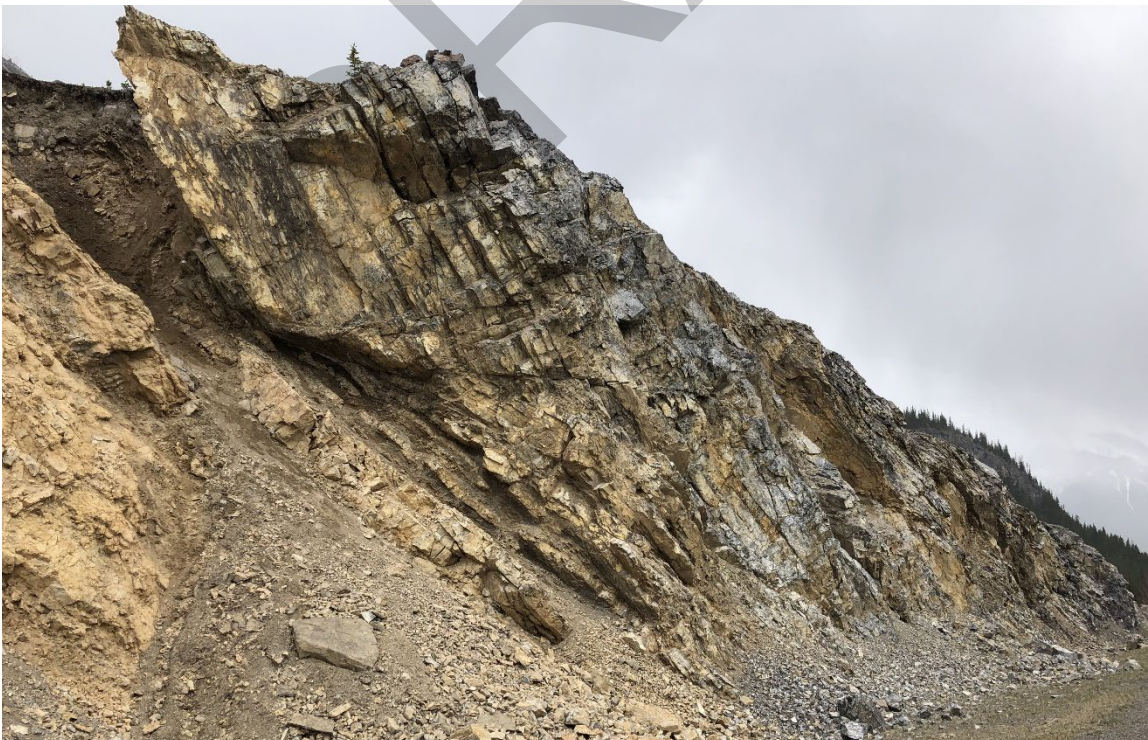
Photo 4 At the south end of the east rockfall site there is more severe weathering along the bedding planes leading to more overhangs that could lead to more rockfall debris. Photo taken May 17, 2022, facing southwest.

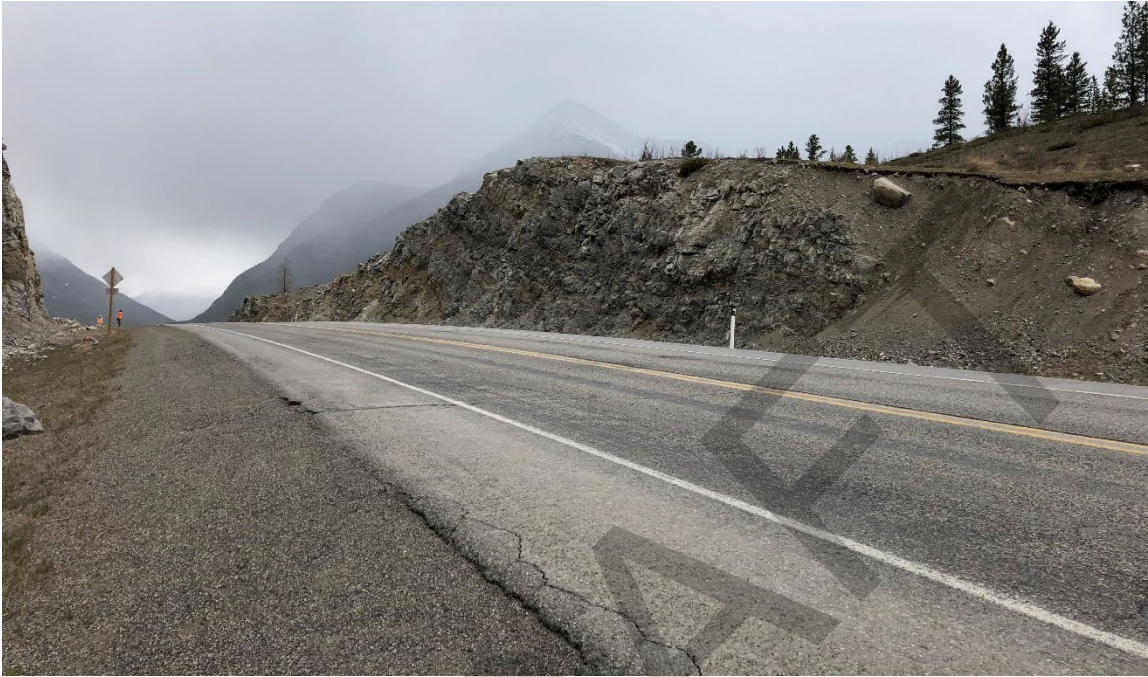
- The rock slope on the west (southbound) side of the highway is approximately 6 m to 8 m in height. Loose material at the top of the slope is eroding (more towards the north side of the site) and contributing to the rockfall (Photo 5).
- The west (southbound) ditch is up to 1.0 m deep and 3 m wide. Debris has accumulated along the west side of the ditch at the toe of the rock slope (Photo 6).
- The top of the rock slope is more weathered than the lower portions of the rock slope and is more susceptible to falling down the slope (Photo 7). There are numerous cracks and blocks up to 1.0 m may break away over the next freeze-thaw cycle (Photo 8).

Photo 5 The rock slope on the west (southbound) side of the highway is approximately 8 m to 10 m in height. Photo taken May 17, 2022, facing southwest.

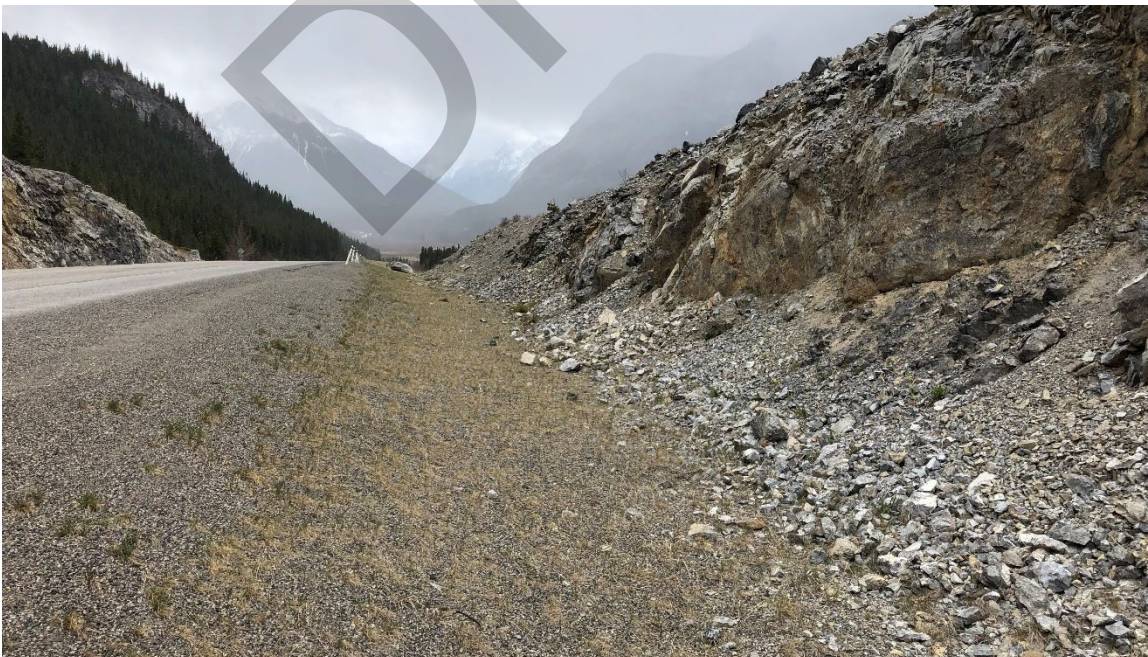
Photo 6 The west (southbound) ditch is approximately 0.8 m to 1.0 m deep and 3 m wide and has more rockfall capacity than the east (northbound) ditch. Photo taken May 17, 2022, facing southwest.

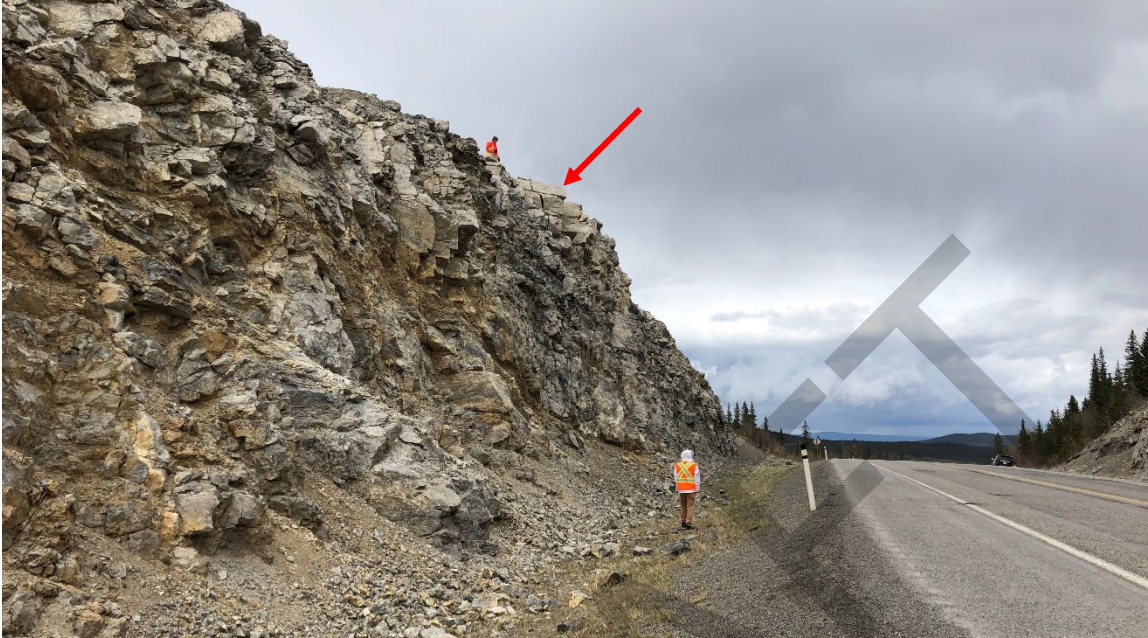
Photo 7 The rock face near the top of the slope (indicated by red arrow) is more weathered and are more likely to fail than lower portions of the slope. Photo taken May 17, 2022, facing northeast.

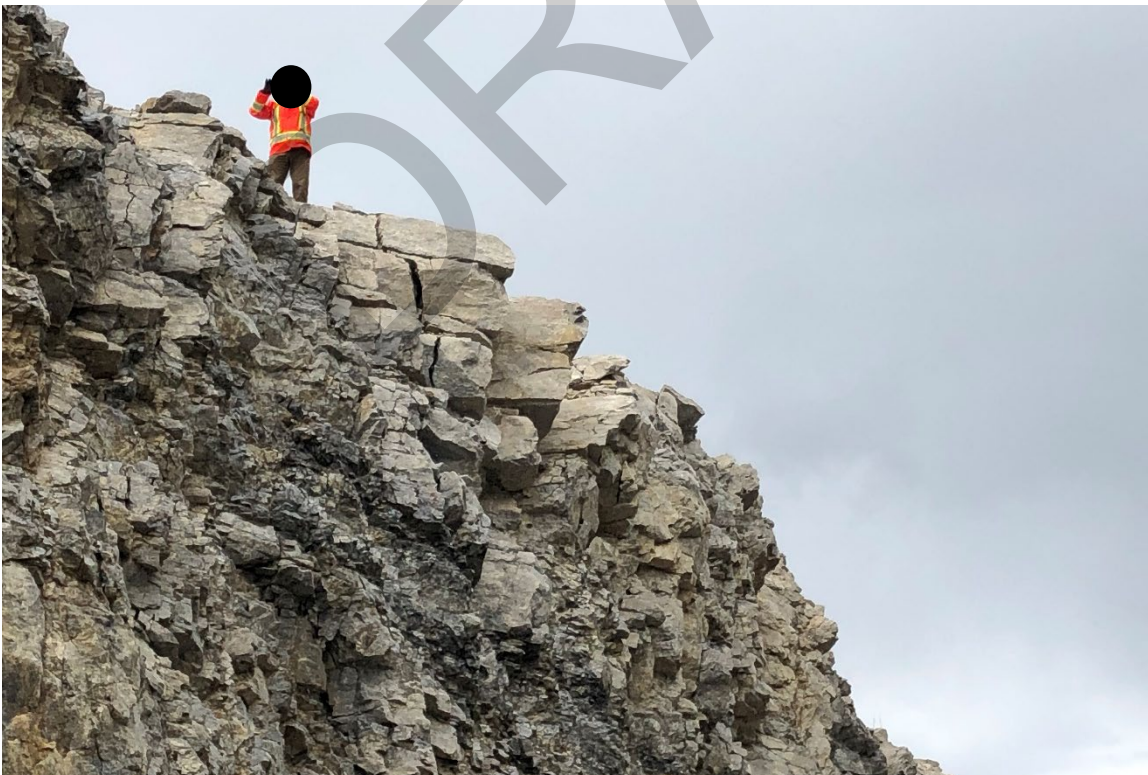
Photo 8 A zoomed in photo of the weathered rock slope shown in Photo 7. Photo taken May 17, 2022, facing northeast.
