Site 2 – Barrier Bluffs Rock Slope

PROJECT: HWY 40/HWY 541 GEOHAZARDS REVIEW			
	TITLE: SCHEMATIC CROSS-SECTION BARRIER BLUFFS ROCK SLOPE			
CLIENT:		DATE: DECEMBER 2005	JOB No.: CG25211	CAD FILE: 25211N01.dwg
			FIGURE No.: FIGURE E1	REV. A

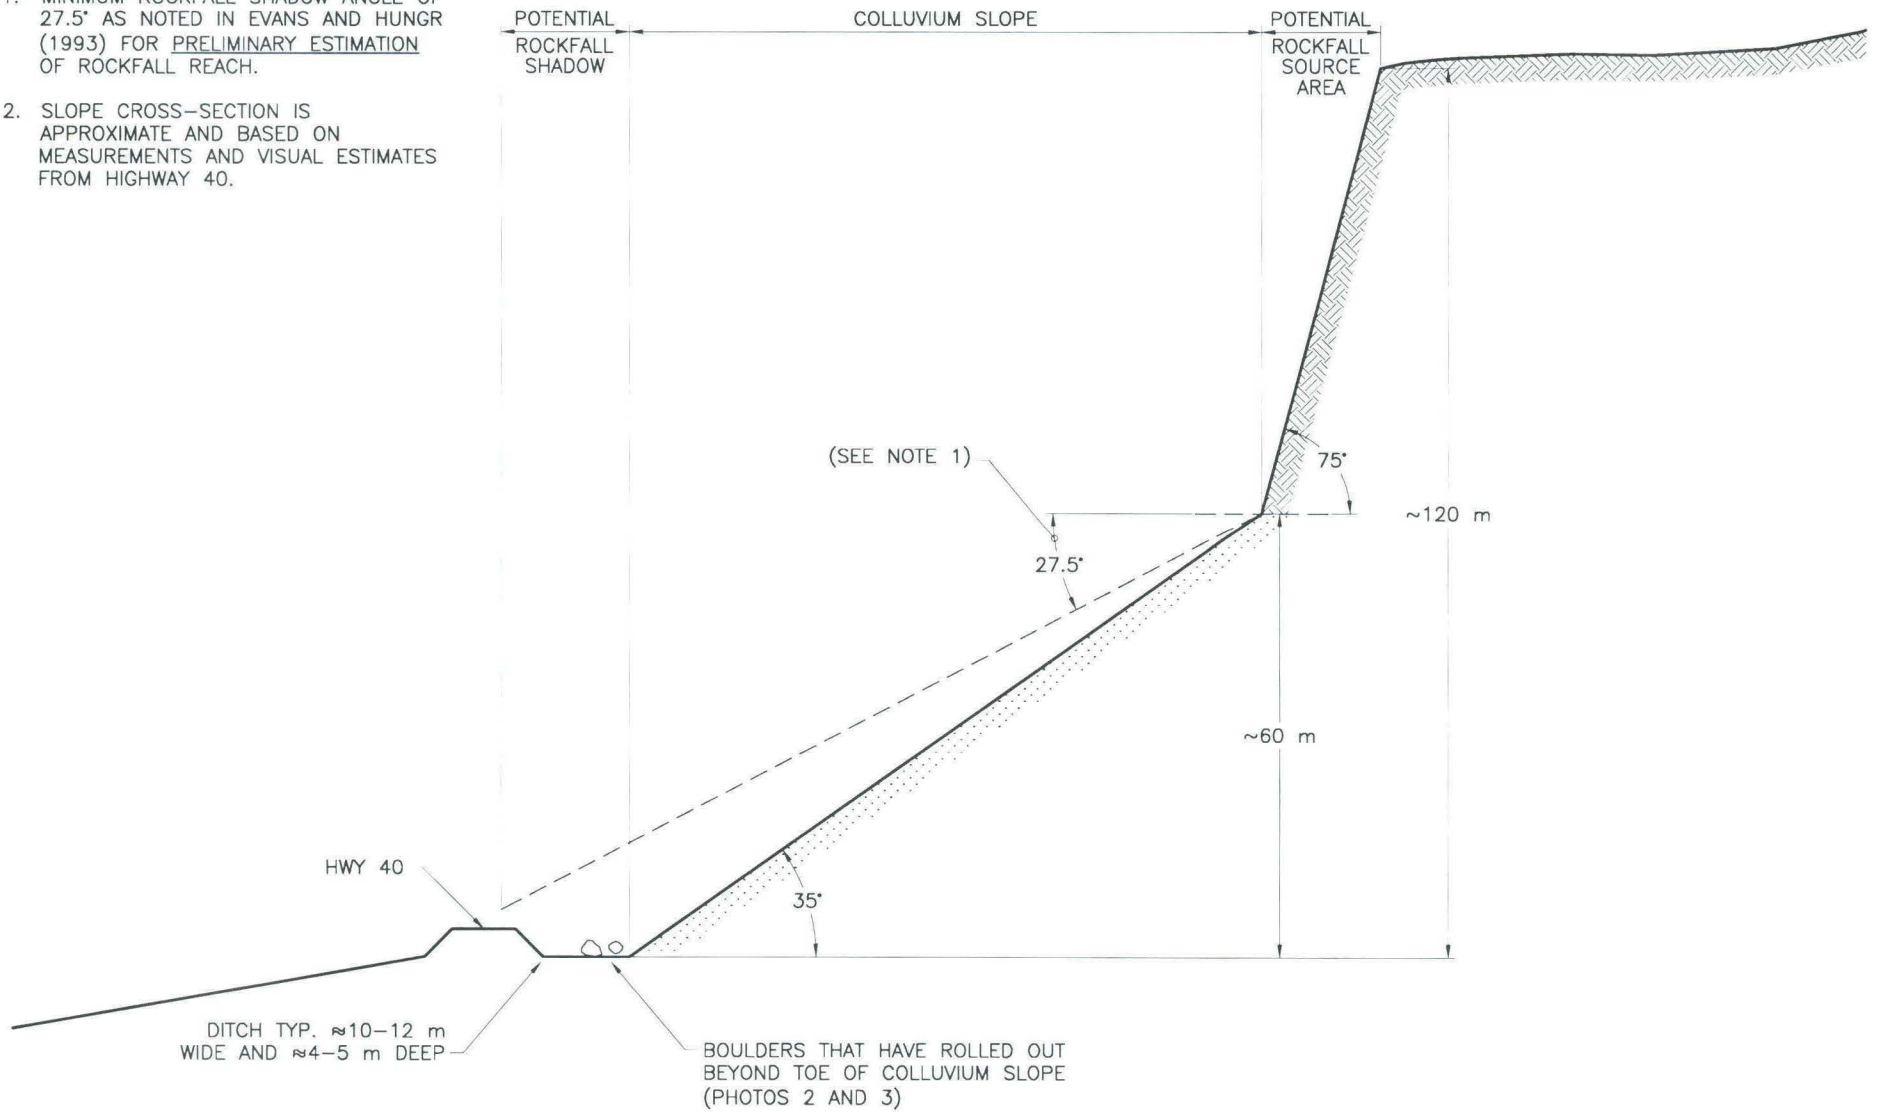
A schematic cross-section of the slope above the highway is shown on Figure E1. This cross-section is based on field measurements made from the highway and along the toe of the colluvium slope as well as data from topographic maps. A minimum “rockfall shadow” angle of 27.5° – defined in Evans and Hungr (1993) as useful for the preliminary estimation of maximum rockfall reach – has been plotted on Figure E1 and shows that the highway could potentially be impacted by rockfall originating from above the colluvium slope. The actual run-out distances of such rockfalls are a function of their source point, the amount of kinetic energy retained by the rocks as they roll down the colluvium slope (including the effects of the rocks breaking apart into smaller pieces), and the ability of the existing ditch to contain rocks that roll out beyond the toe of the colluvium slope. The ditch at the toe of the colluvium slope has a considerable capacity to contain rocks that roll downslope and beyond the toe of the colluvium slope. Based on the observations during the site inspection, it is judged that a minimum “rockfall shadow” angle of 27.5° is likely conservative for this site, and the majority of rockfalls will not roll out beyond the toe of the colluvium slope. However, such a hazard cannot be completely ruled out on the basis of the available information. The risk to the highway from such a rockfall hazard is also a function of how many such rockfalls occur, for which there is essentially no data beyond a judgemental correlation with the number of large rocks noted to have rolled out beyond the toe of the colluvium slope.

- The visual evidence of at least two large boulders rolling out beyond the toe of the colluvium slope and into the ditch.
- A preliminary estimation of the maximum rockfall reach from the application of the minimum “rockfall shadow” angle of 27.5° to the estimated slope profile.

1. Plotting the minimum rockfall shadow angle of 27.5° on a surveyed slope profile to check of whether or not the highway lies within the potential rockfall shadow of this slope. This will affect the recommended Consequence Factor for this site. A survey of the slope profile using AIT’s proposed Thales “Mobilemapper” handheld GPS unit would likely be suitable for this purpose.
2. Noting and documenting any boulders that roll out beyond the toe of the colluvium slope in future years. This data can be used to clarify the Probability Factor for this site. Visual checks by personnel working for the maintenance contractor would be suitable provided there is a procedure in place to contact AIT geotechnical personnel for follow-up inspection when appropriate.

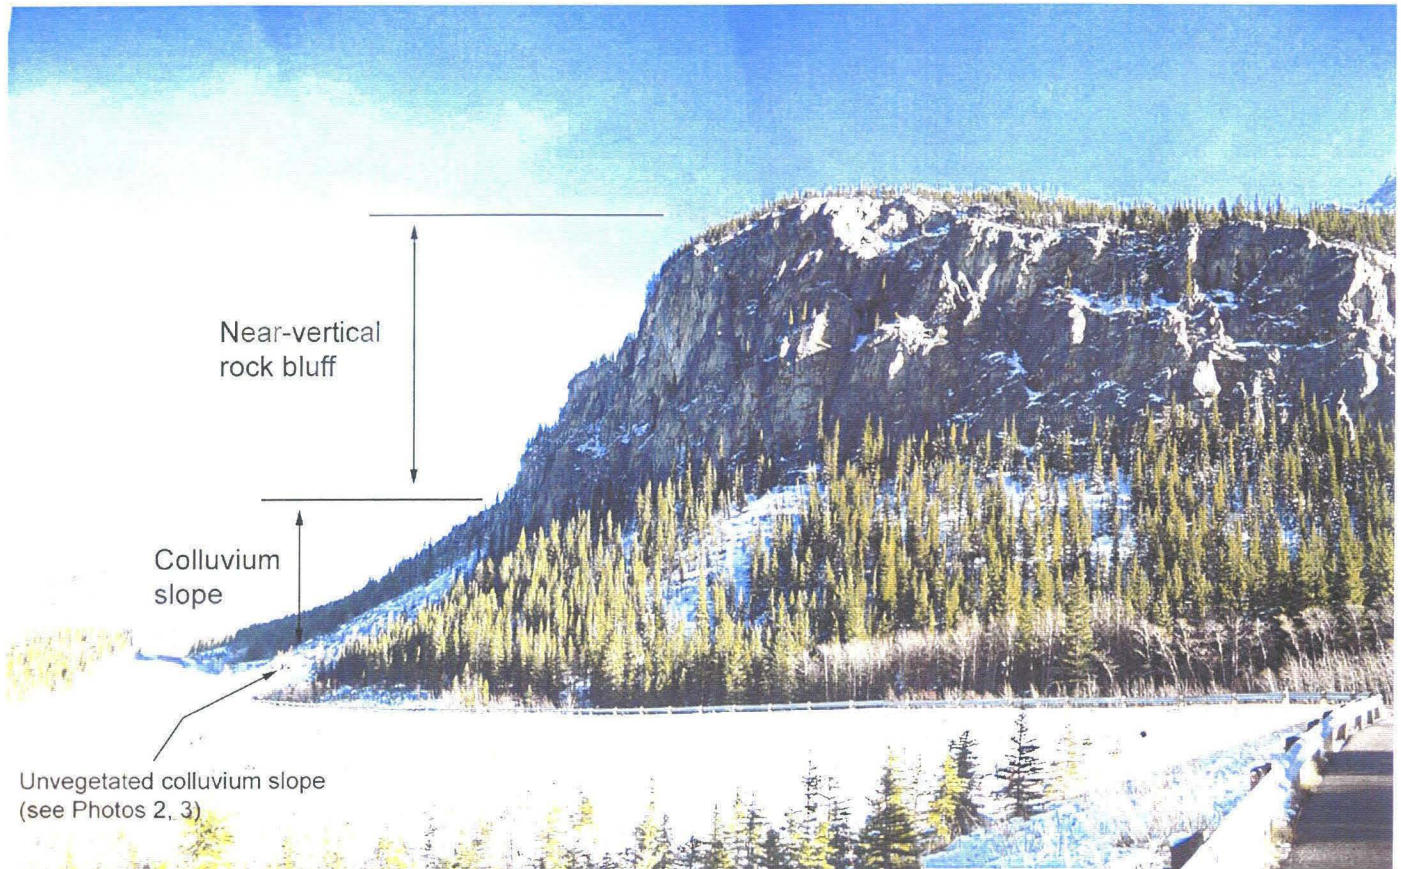
This site is located on the east shore of Barrier Lake where the Highway 40 alignment is along the lowermost slopes of Mount Baldy. As shown on Photo 1, the highway is located adjacent to the toe of a large colluvium slope below a near-vertical rock slope known as Barrier Bluffs. The estimated total vertical height of the slope above the highway is 120 m. The colluvium slope angle is around 35°. The inclination of the upper rock slope angle could not be measured directly and was estimated from the highway to be around 75°. The majority of the colluvium slope was treed, however there was one area where an unvegetated colluvium slope extended down to the highway ditch (Photo 1).

Photo 1 (top) – The Barrier Bluffs rock slope above Highway 40. The highway is located adjacent to the toe of a colluvium slope below a near-vertical rock slope. The colluvium slope is at an angle of around 35°. The ditch between the highway and the toe of the colluvium has a minimum width of approximately 10 m and a depth of approximately 3 to 4 m relative to the road surface.

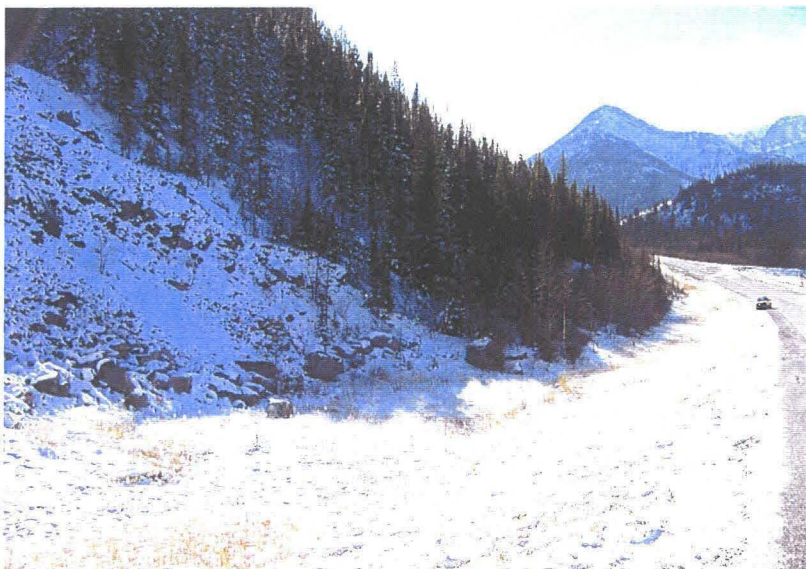
There is a hazard of rockfall debris from the upper rock slope rolling down the unvegetated colluvium slope and impacting upon the highway. As shown in Photos 2 and 3, there were a number of large boulders in the ditch in this area that had rolled out beyond the toe of the colluvium slope and come to rest in the ditch adjacent to the highway. The width of the ditch (as measured between the toe of the colluvium slope and the east edge of the pavement) varied with a minimum of approximately 10 m. The depth of the ditch (relative to the pavement surface) was typically 3 to 4 m.

Photo 2 (bottom) – Closer view of the ditch along the toe of the colluvium slope without trees showing the minimum 10 m offset from the edge of the highway. Note the large boulders that have rolled slightly beyond the toe of the colluvium slope.

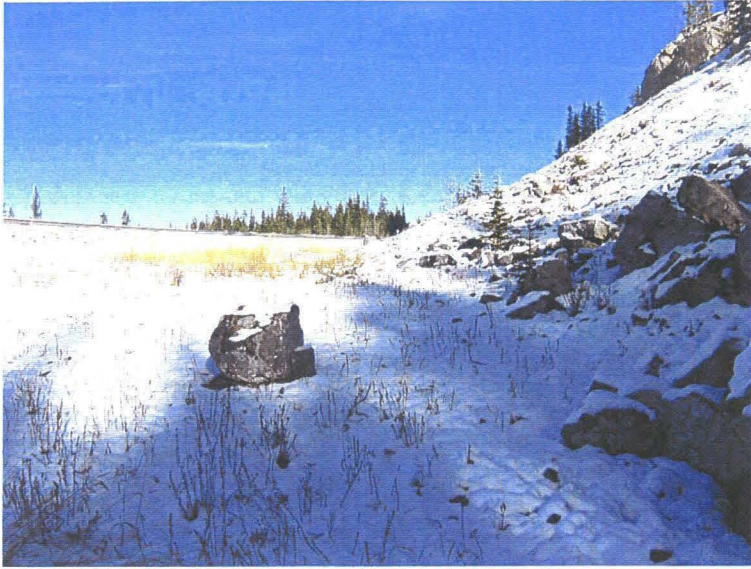
Photo 3 (top) – Large boulder that has rolled beyond the toe of the colluvium slope and come to rest in the central portion of the ditch along the highway.
