August 28, 2009

CG25309.B

**Re: Southern Region Geohazard Assessment Program
Highway 40, Barrier Bluffs Rock Slope
June 2009 Inspection Report**

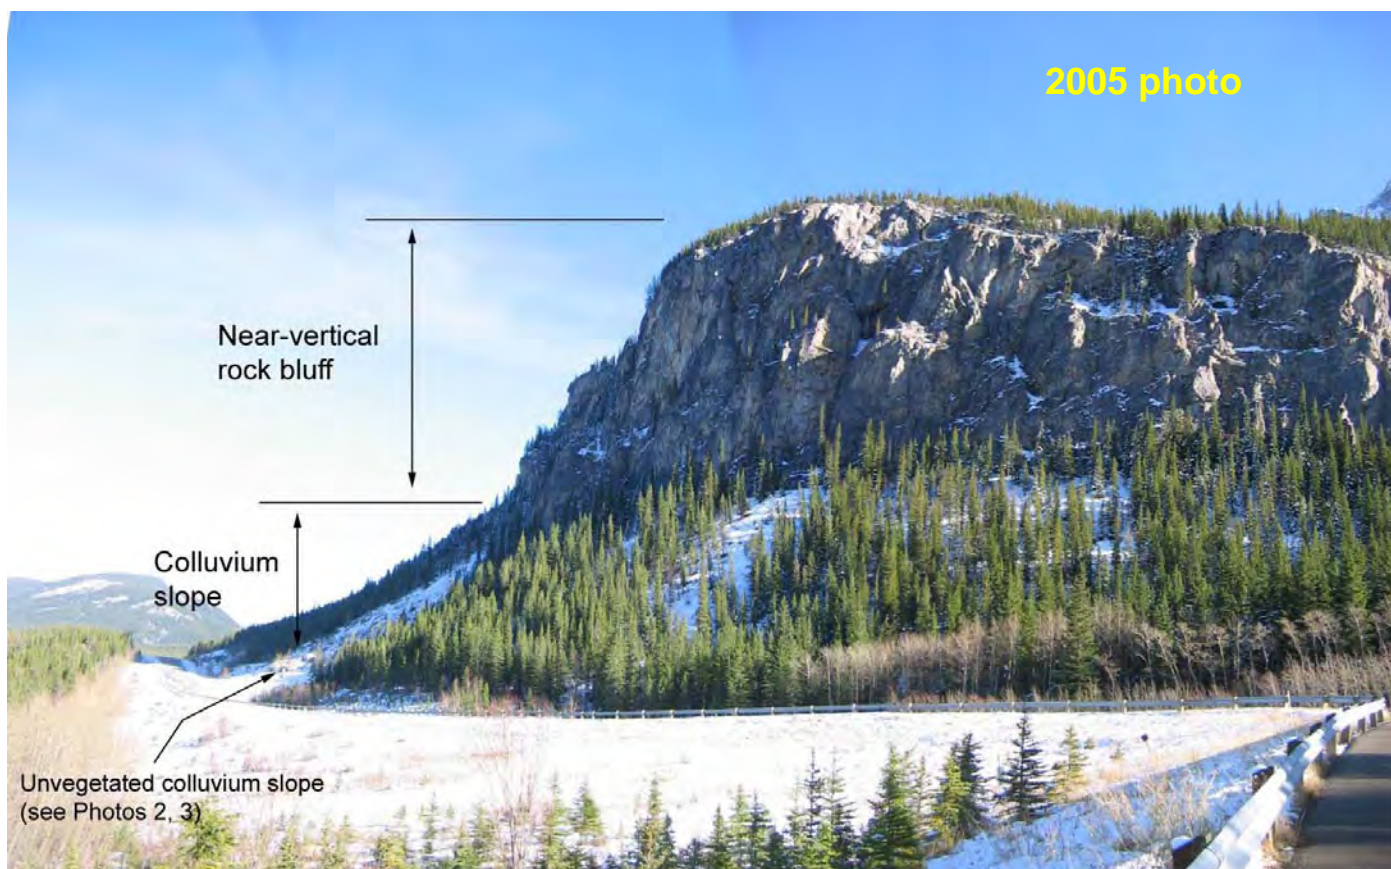
Photo 1 – 2005

- There is a hazard of rockfall debris from the upper rock slope rolling down the unvegetated colluvium slope and impacting upon the highway. Photo 1, attached, illustrates the relative position of the rock slope, colluvium slope and Highway 40.
- It is judged that the essentially all rockfalls from the slope above the highway will come to rest on the slope or be contained within the large ditch between the toe of the colluvium slope and the highway. However, the rockfall hazard to the highway cannot be entirely ruled out.

General view of the Barrier Bluffs site from the 2005 inspection, illustrating the relative position of the slope (potential rockfall source area) and Highway 40.

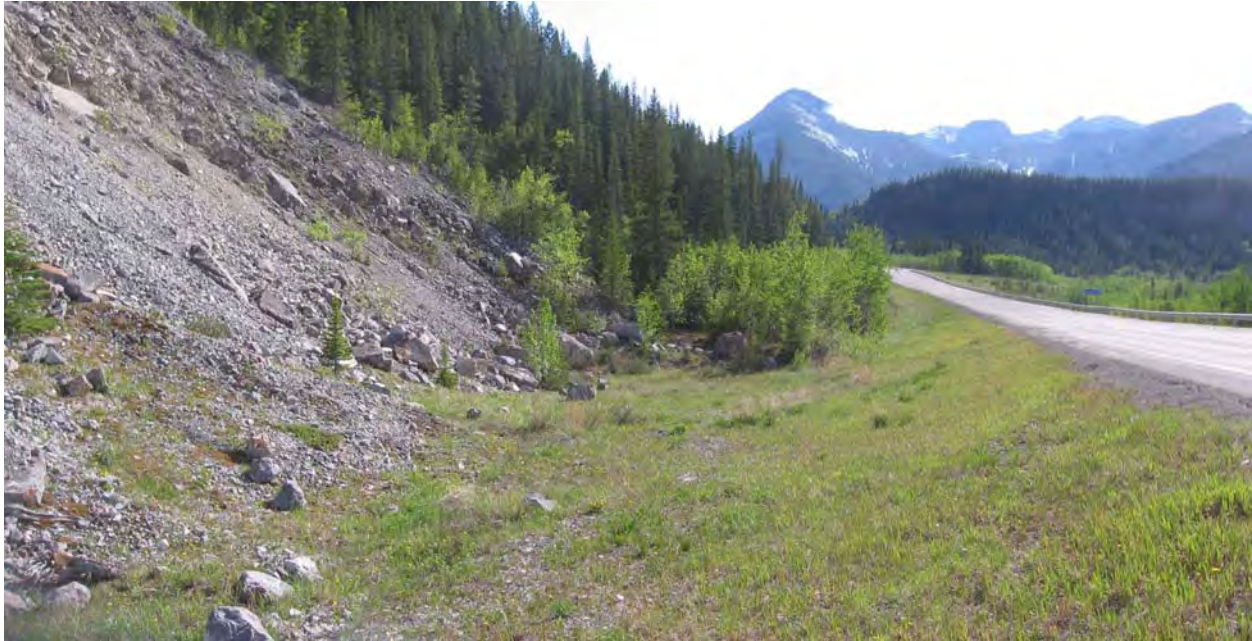
Photo 2 (top) – June 2009

The site conditions appeared unchanged since the 2005 inspection. The numerous large boulders along and slightly out from the toe of the colluvium slope were still present, but it did not appear that there were any new boulders that had rolled out beyond the toe of the slope since the 2005 inspection. Photos 2 and 3 show the debris along the toe of the slope at the time of the June 2009 inspection.

Ditch along the toe of the unvegetated colluvium slope. Note the large boulders that have rolled slightly beyond the toe of the cut slope. However, no new boulders were evident in comparison to the photos from the 2005 inspection.

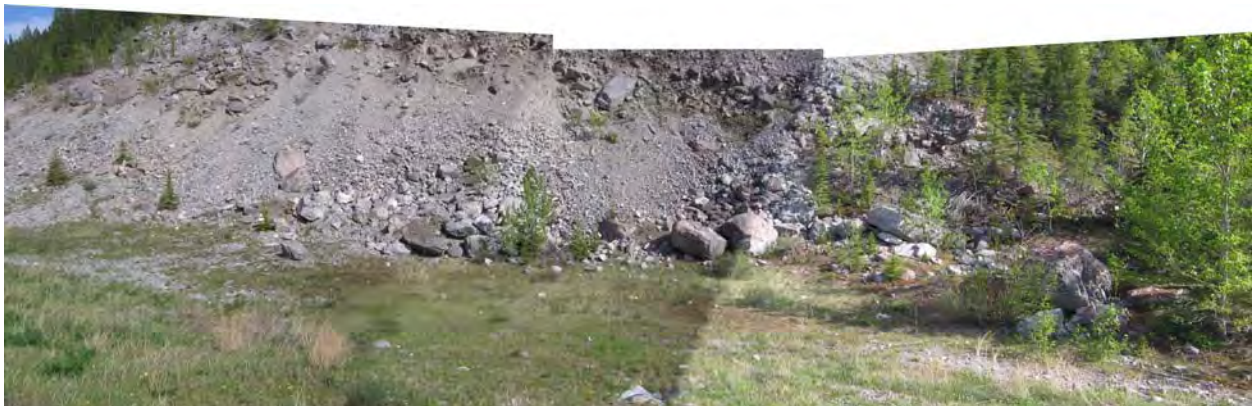
Photo 3 (bottom) – June 2009

Closer view of the toe of the colluvium slope, as seen from the edge of the highway.
