Site 1 – Lusk Creek

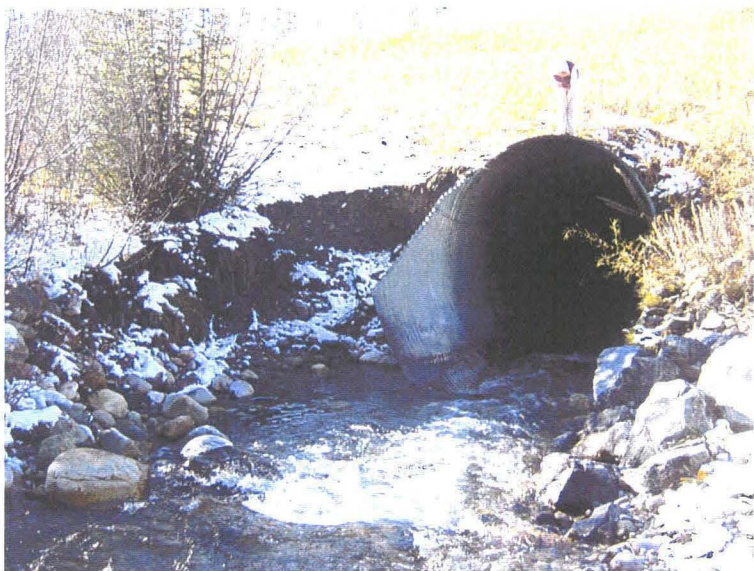
As shown in Photo 1, some erosion of the soil at the toe of the embankment sideslope immediately south of the culvert inlet was noted at the time of the field inspection in October 2005. It is judged that this erosion was caused by peak flows during and after the heavy rainfall in this area during June 2005. The culvert inlet does not appear to have been damaged by the erosion. If the eroded area is left in this condition, the exposed soil will continue to erode in the future and the erosion will likely retrogress slightly further into the toe of the highway embankment.

Photo 1 (top) – October 2005 – Culvert inlet at the toe of the east highway embankment sideslope at the Lusk Creek crossing. Peak flows earlier in 2005 have caused soil erosion at the toe of the sideslope immediately south of the culvert inlet (on the left side of this photo).

It is recommended that the erosion area on the south side of the culvert inlet be armored with rip-rap in order to prevent future erosion of the exposed soil.

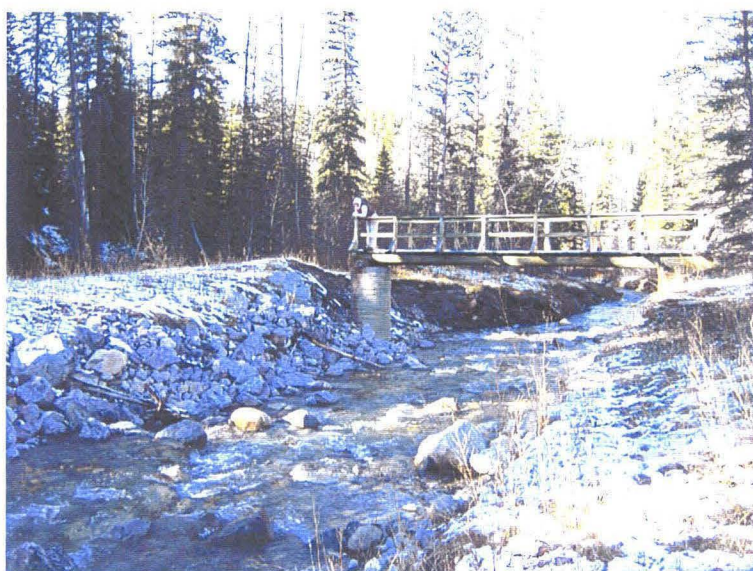
As shown in Photo 2, a footbridge along a hiking trail that crosses Lusk Creek approximately 50 m downstream of Highway 40 was also damaged during peak creek flows earlier in 2005.

Photo 2 (bottom) – Footbridge across Lusk Creek, approximately 50 m downstream of the culvert at Highway 40. The south end of this bridge was washed out during peak flows in June 2005.
