SITE NUMBER AND NAME S018 Galatea Creek		HIGHWAY & KM 40:12, 18.469	PREVIOUS INSPECTION DATE June 14, 2016	INSPECTION DATE May 1, 2018
LEGAL DESCRIPTION SW 15-22-9-W5	NAD 83 COORDINATES Northing Easting 50°51.834' 115°10.594'		RISK ASSESMENT PF: 12 CF: 3 TOTAL: 36	
Average Annual Daily Traffic (AADT): 2600 (north), 2580 (south), (Ref. No. 53190)			Contractor Maintenance Area (CMA): 28

SUMMARY OF SITE INSTRUMENTATION: None LAST READING DATE: N/A	INSPECTED BY: Chris Gräpel (KCB) Peter Roy (KCB) Renato Macciotta (KCB) Roger Skirrow (AT) Alex Frotten (AT)
PRIMARY SITE ISSUE: Rockfall from rock cut on both sides of highway.	
APPROXIMATE DIMENSIONS: Slope height is approximately 16 m (maximum)	
DATE OF ANY REMEDIAL ACTION: Wire mesh installed on rock slope on the east side of the highway in 2016.

PROJECT SOUTHERN REGION GEOHAZARD RISK MANAGEMENT PROGRAM		
TITLE Site Plan S018 - Galatea Through Cut Hwy 40:12, km 18.469		
SCALE 1:2,200	PROJECT No. A05115A03	FIG No. 1

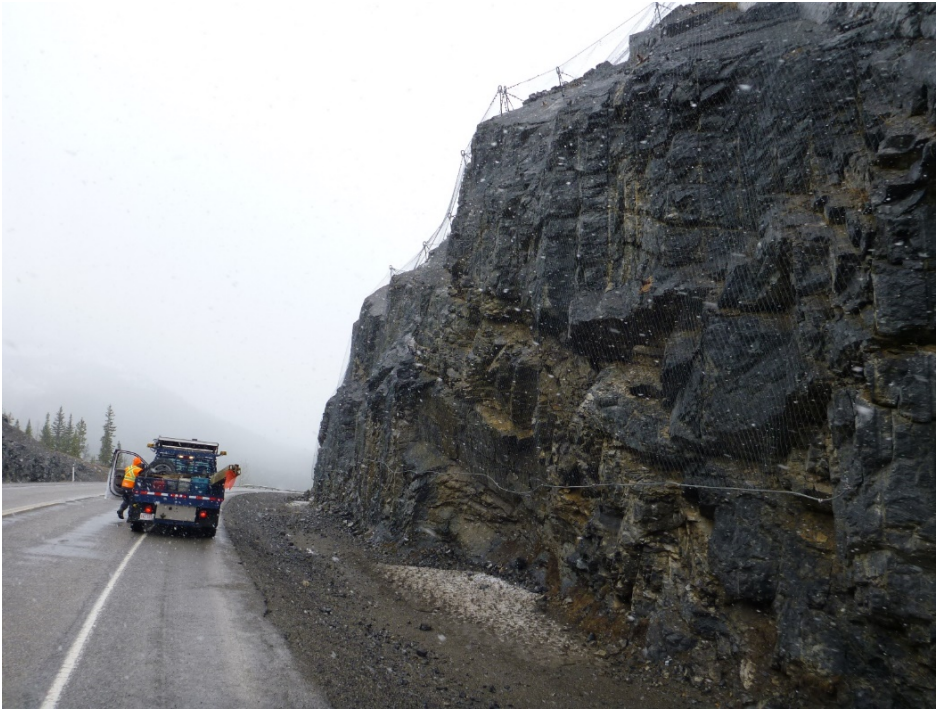
Photo 1 Wire mesh installed on rock slope in 2016. Maintenance contractor on site, removing fallen rocks from highway. Photo was taken facing northeast on May 1, 2018.

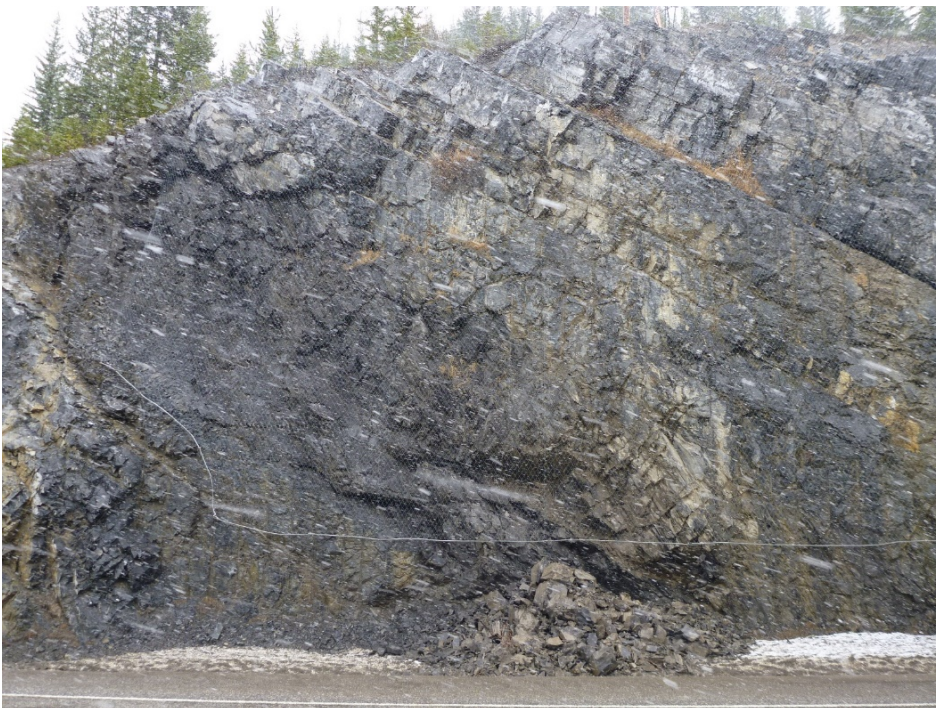
COMMENTS
Wire mesh is functioning as designed. Rock falls, for the most part, are being contained by the mesh. Some rocks making it to the highway surface.
Some damaged mesh noted near the cable at the base, due to large falling rocks.
Recent rockfall of about 1 m ³ from approximately 2 m above ground surface. Rockfall was contained by wire mesh.
West slope not as much of an issue due to favorable hydrology and slope height. Ditch is larger on west side of highway.
The rock mass on the east slope has pervasive planar joints, in an adverse orientation. Some of the rock mass joints are dilated, with some rock blocks on the verge of falling.
More concentrated debris located in the gaps in the wire mesh. Gaps provide animal access up the slope.
Rock debris should continue to be cleaned from ditch and highway surface.
Visit site once every two years.

Photo 2 Recent rock fall of about 1 m³ from approximately 2 m above ground, behind wire mesh. Photo was taken facing east on May 1, 2018.

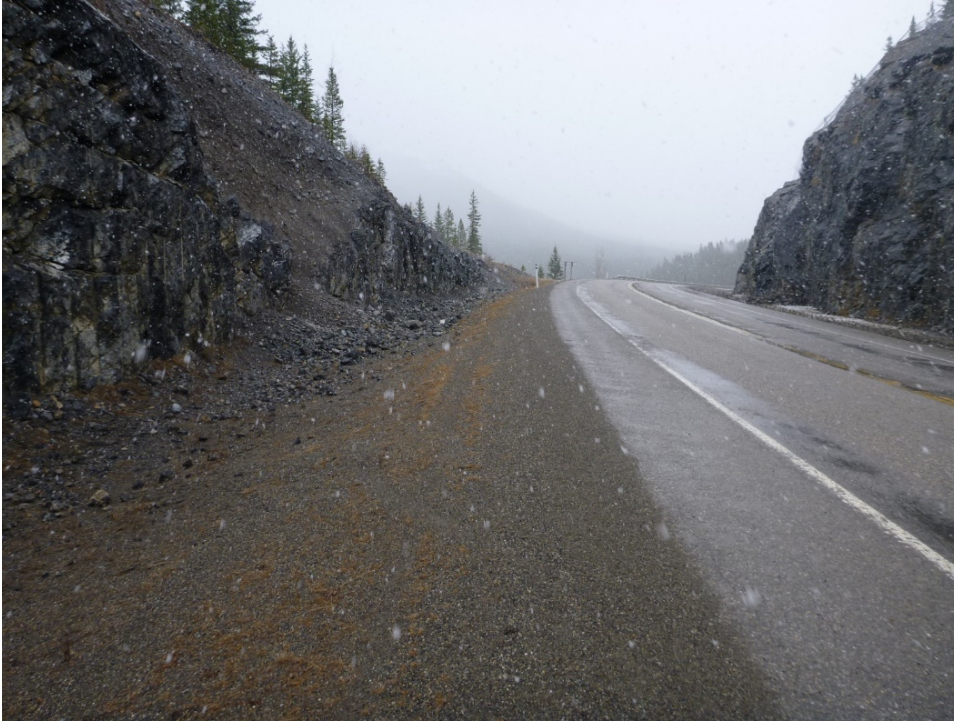
Photo 3 Rock debris in west ditch. Photo was taken facing northeast on May 1, 2018.
