SITE NUMBER AND NAME S018 Galatea Creek Through-Cut		HIGHWAY & KM 40:12, 18.469	PREVIOUS INSPECTION DATE May 1, 2018	INSPECTION DATE May 7, 2019
LEGAL DESCRIPTION SW 15-22-9-W5	NAD 83 COORDINATES UTM Northing Easting 11 5636274 628319		RISK ASSESMENT PF: 13 CF: 3 TOTAL: 39	
Average Annual Daily Traffic (AADT): 940 (north), 440 (south), (Ref. No. 52170)			Contractor Maintenance Area (CMA): 28

SUMMARY OF SITE INSTRUMENTATION: None LAST READING DATE: N/A	INSPECTED BY: Chris Gräpel (KCB) Chris Morgan (KCB) Renato Macciotta (KCB) Alex Frotten (AT) Roger Skirrow (AT) Nicolas Ropchan (AT)
PRIMARY SITE ISSUE: Rockfall from rock cut faces on east and west sides of the highway.	
APPROXIMATE DIMENSIONS: Slope height is approximately 16 m (maximum)	
DATE OF ANY REMEDIAL ACTION: Wire mesh installed on rock slope on the east side of the highway in 2016.

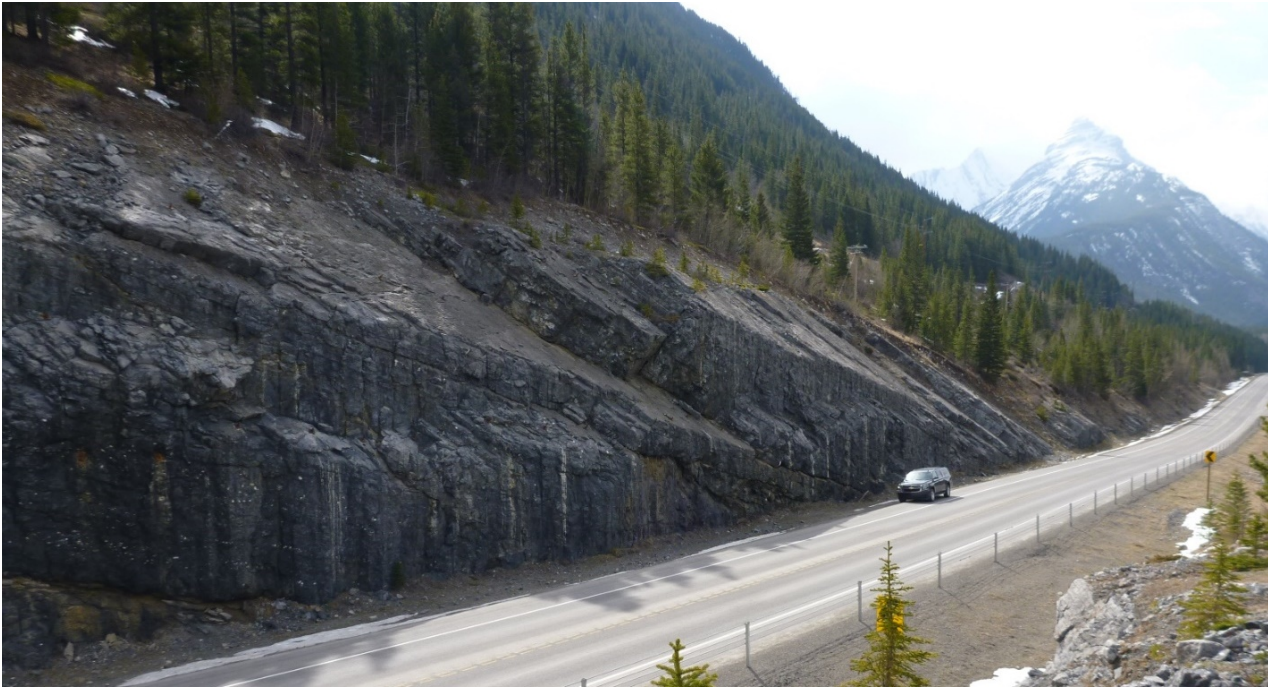
Photo 1 South portion of east rock slope. Photo taken facing southeast on May 7, 2019.

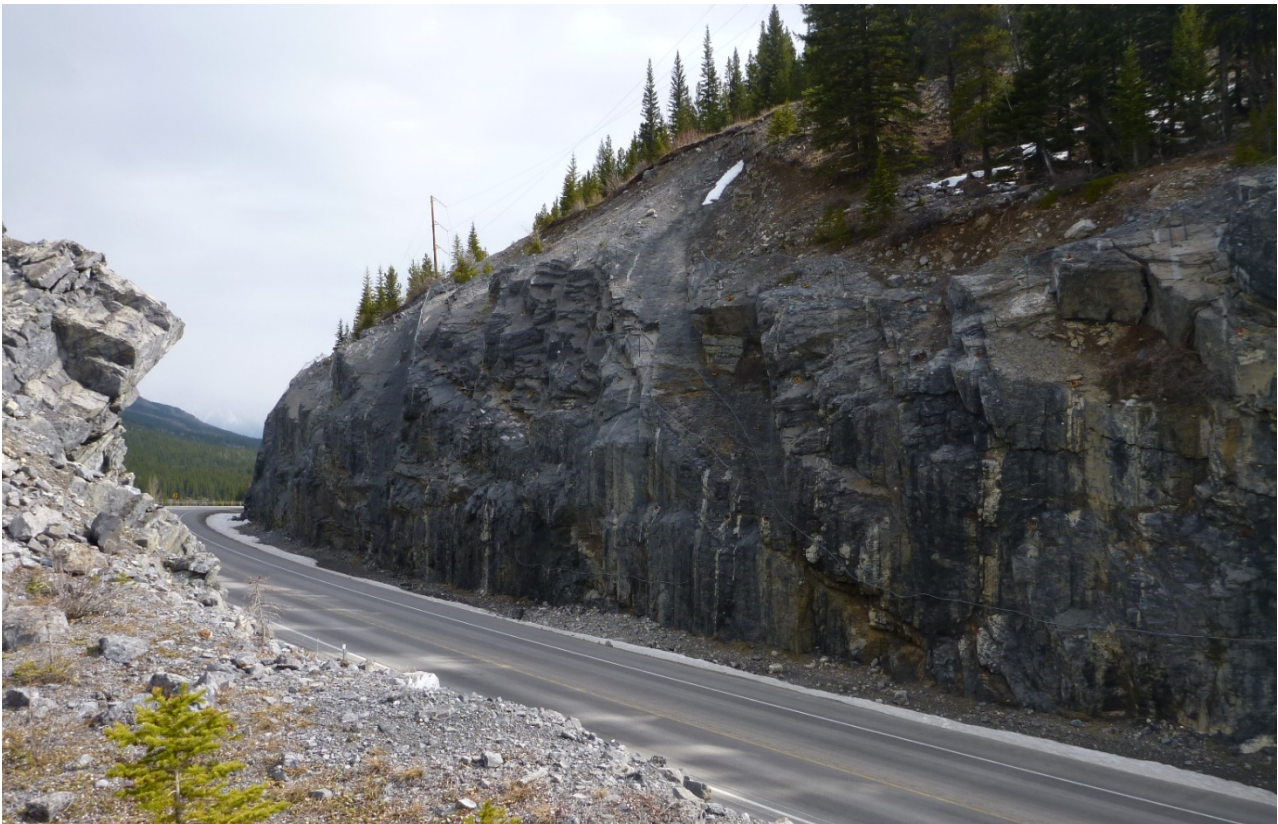
Photo 2 Central portion of east rock slope. Photo taken facing east on May 7, 2019.

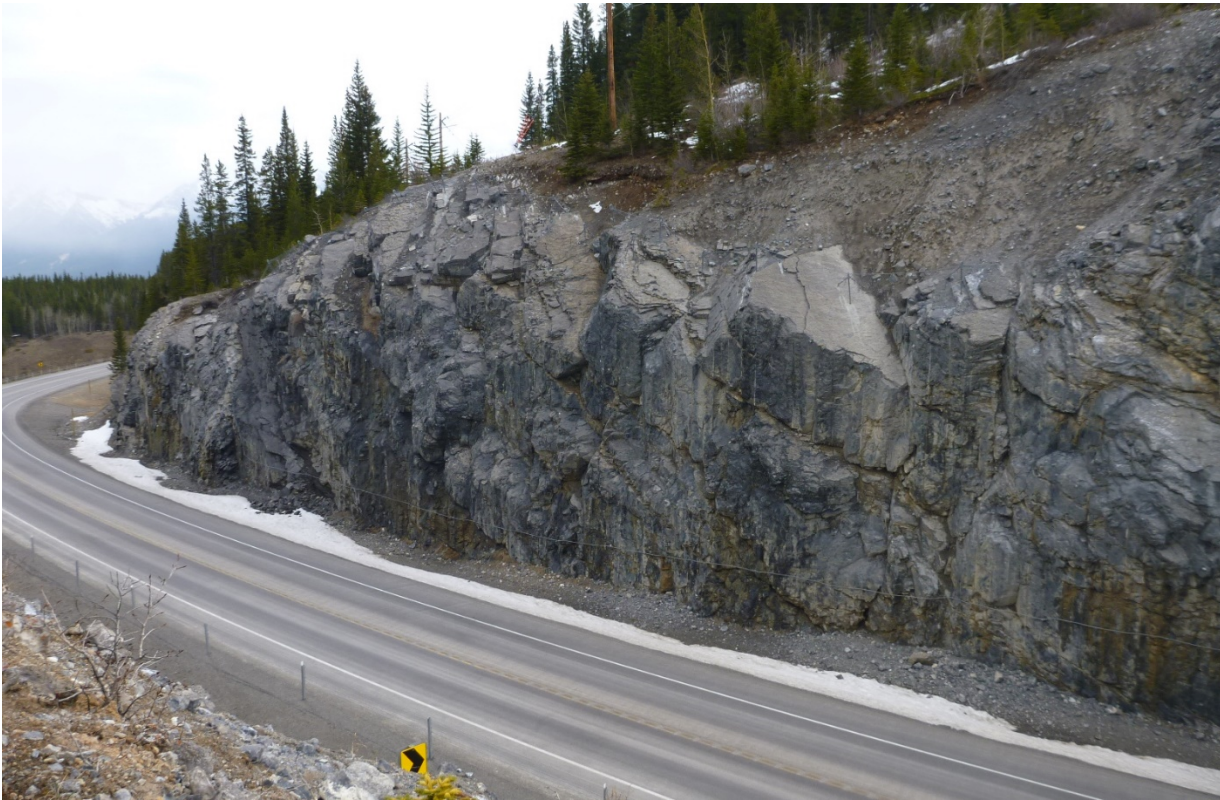
Photo 3 North portion of east rock slope. Photo taken facing northeast on May 7, 2019.

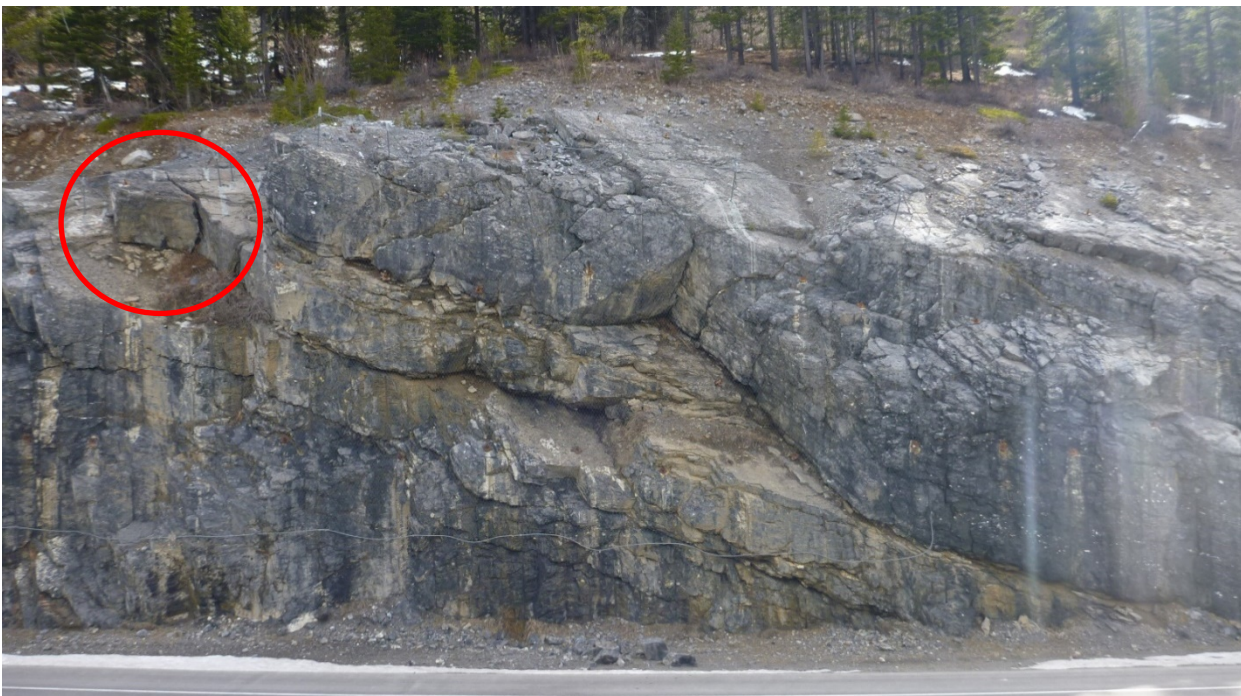
COMMENTS
Active site with small rockfalls at the time of inspection, and potential larger instabilities (Photo 4). Visit site every two years.
Multiple old rock bolts are present on the east side, possibly from original construction in the mid 1980s. The condition of the bolts is unknown. Several of the bolts appear loose or not flush with the rock face due to weathering of the rock slope over time. The slope contains large blocks which are held by rock bolts that are potentially exerting minimal stabilizing force. There are potential wedge failure locations.
Wire mesh on the east side is functioning as designed. Rockfalls, for the most part, are being contained by the mesh. Some areas of damaged mesh were noted at the base of the mesh due to large falling rocks. Large rockfalls are damaging the mesh joint with the lower cable, creating loose sections. Loose sections of mesh may be more prone to tearing and the mesh should be repaired.

<p>The rock mass on the east slope has pervasive planar joints, in an adverse orientation (dipping out of slope). Some of the rock mass joints are dilated, with some rock blocks on the verge of falling. Continuous weathering is leading to block falls.</p>
<p>Recent rockfall block of 0.9 m by 0.55 m by 0.6 m (0.3 m³) observed in the ditch and was not contained by the wire mesh. Older blocks of up to 1 m³ have been observed at this site.</p>
<p>Some rocks are making it to the highway surface.</p>
<p>A fallen tree was observed at the south end of the east side, possibly due to surface weathering at the crest of the slope.</p>
<p>West slope not as much of an issue due to favorable hydrology and lower slope height. Ditch is larger on west side of highway, however, a section of the west slope appears to be feeding small rocks onto the road. The west slope has an overhanging section estimated as 2 to 5 m³ in size.</p>

Photo 4 Central portion of east rock slope, including large block held by an off-centre rock bolt. Photo taken facing southeast on May 7, 2019.

<p>Recommendations are:</p> <p><u>Short-Term</u></p> <ul style="list-style-type: none"> • Rock debris should be cleaned from ditches and highway surface. Ditches reported as not cleaned out this year; • Reattach the mesh to the base cable so that it functions effectively; • Carry out spot bolting on blocks which are considered to be at risk of movement; and • Carry out rock mechanics photogrammetry assessment of the east and west slopes.

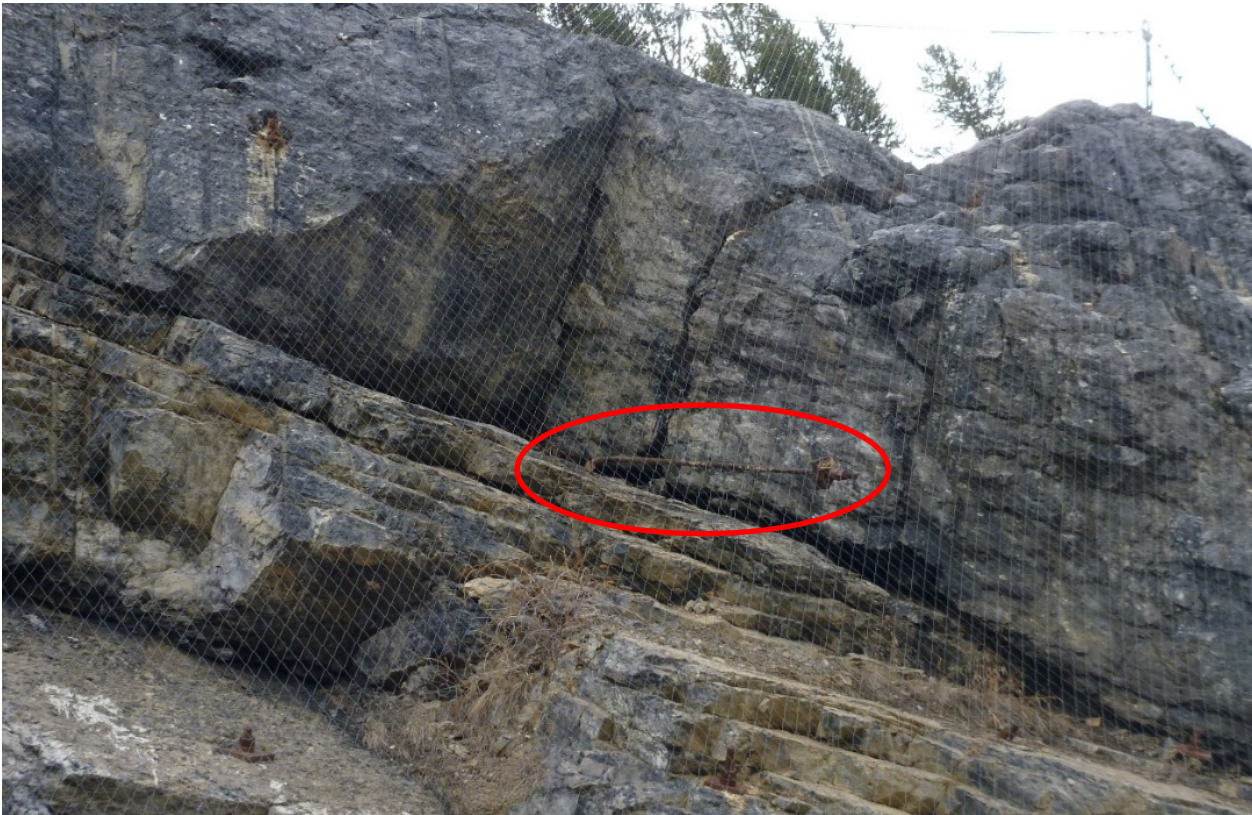
Photo 5 Mid slope rock bolt in poor condition on east slope. Photo taken on May 7, 2019.

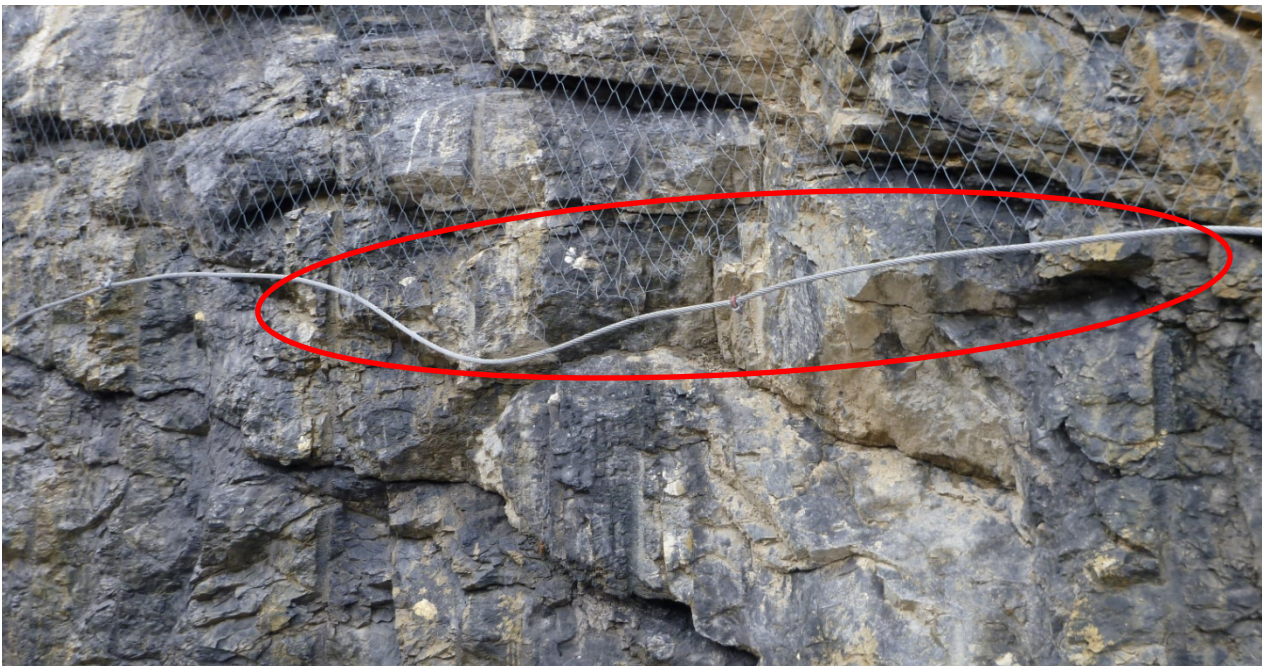
Photo 6 Damaged connections between the wire mesh and base cable due to rockfall impacts. Photo taken on May 7, 2019.

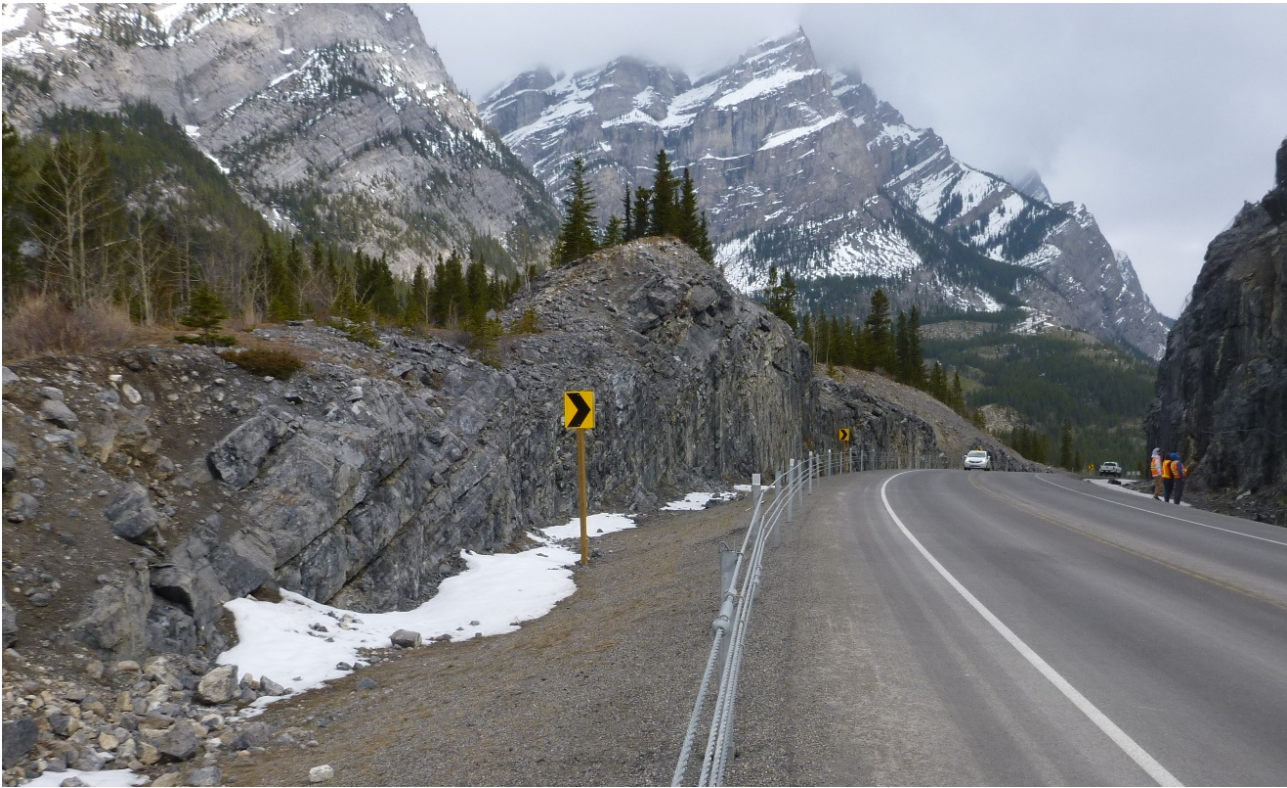
Photo 7 West side of the cutting. Photo was taken facing north on May 7, 2019.

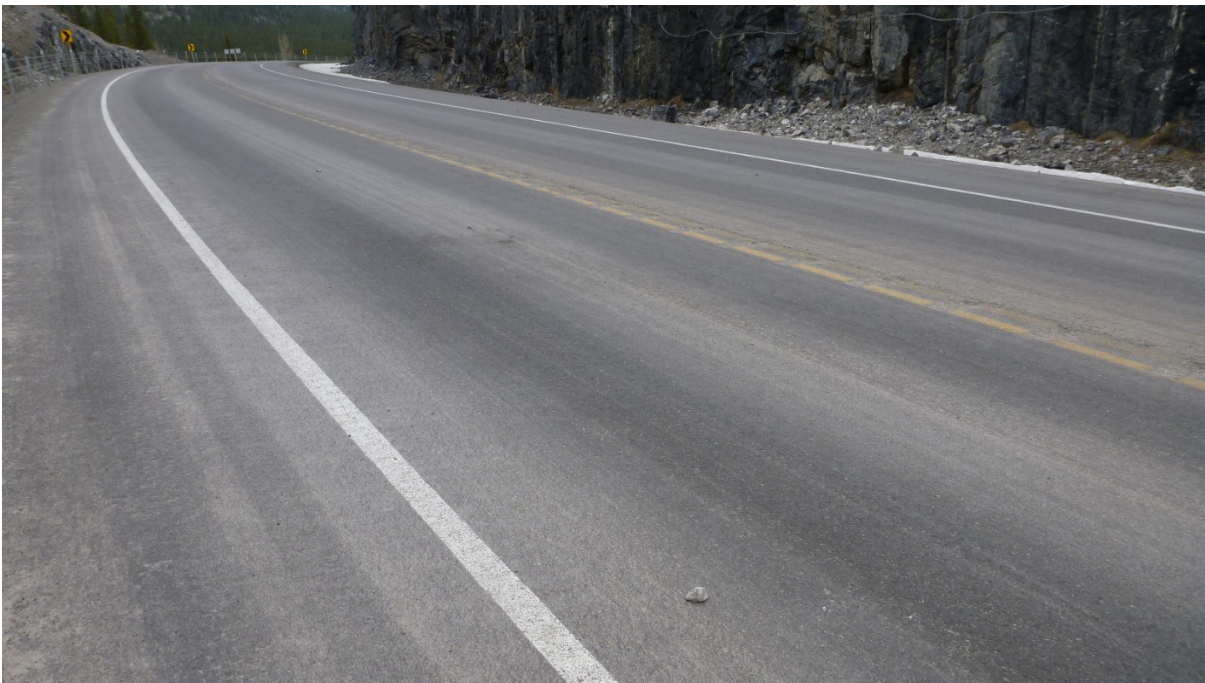
Photo 8 Minor rockfall on the road. Photo was taken facing north on May 7, 2019.
