August 28, 2009

CG25309.B

**Re: Southern Region Geohazard Assessment Program
Highway 40, Rocky Creek, Hood Creek and Fortress Junction Cracking Sites
June 2009 Inspection Report**

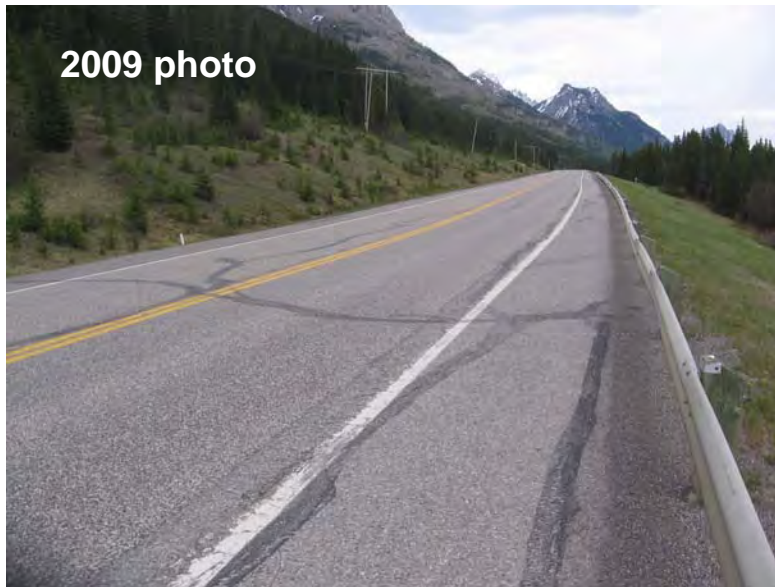
- There was little to no change in the cracking and slight downdrop of the segment of the southbound lane that was noted during the 2005 inspection. Photos 3 and 4 show comparative views of the site from the 2005 and 2009 inspections.
- No additional cracking or other damage to the road surface was noted, nor any toe bulge or visible deformation of the embankment slope below the highway.

The pattern and distribution of the cracking and downdrop of the road surface is still suggestive of slumping of a segment of the southbound lane. However, the damage to the road surface has not noticeably worsened since the 2005 inspection. Therefore, any slumping that may have caused the cracking and downdrop of the road surface does not appear to have been active between the 2005 and 2009 inspections.

Therefore, the recommended Risk Level for this site is 12, which is a reduction from the value of 20 recommended after the 2005 inspection.

Photo 3 (top) – June 2009
Fortress Junction Road Cracking Site
Facing southbound across the settlement and cracking area in the southbound lane. The pattern of the cracking and downdrop is suggestive of slumping of a segment of the downslope lane, however when compared to Photo 4 from the 2005 inspection it does not appear that the damage to the road surface has worsened in recent years.

No further inspections of this site are recommended, unless in the future AT or maintenance contractor personnel note additional damage to the road surface.

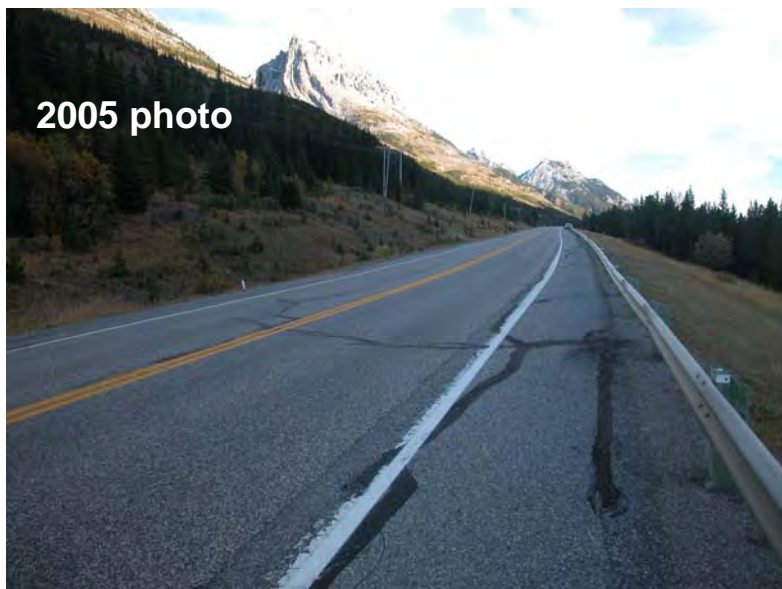
Photo 4 (bottom) – 2005
Fortress Junction Road Cracking Site
The same area as shown in Photo 3, as it appeared during the 2005 inspection.
