SITE NUMBER AND NAME S018-IV Rocky Creek		HIGHWAY & KM 40:12, 15.88	PREVIOUS INSPECTION DATE April 2006	INSPECTION DATE May 17, 2022
LEGAL DESCRIPTION NW 3-22-9-WM5	NAD 83 COORDINATES UTM Northing Easting 11 5634403 629029		RISK ASSESSMENT S018-IV: PF: 7 CF: 6 TOTAL: 42	
Average Annual Daily Traffic (AADT): 940 (north) & 440 (south), (Reference No. 52170)			Contractor Maintenance Area (CMA): 28

PROJECT SOUTHERN REGION GEOHAZARD RISK MANAGEMENT PROGRAM		
TITLE Site Plan S018-4 - Galatea, Rocky Creek, Limestone Mt, Wedge Pond Rock Hazards Hwy 40:12, km 15.552		
SCALE 1:2,500	PROJECT No. A05116A03	FIG No. 1

Inspection Photographs

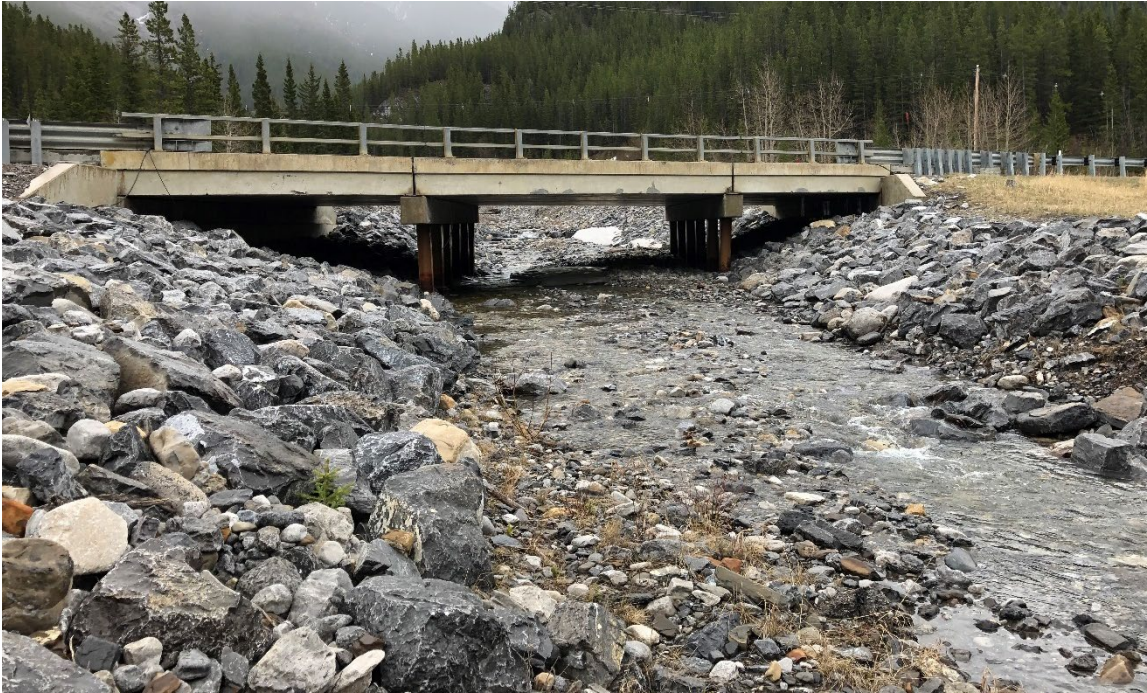
COMMENTS
The Rocky Creek Bridge was previous damaged during a flood event and was repaired in 2013.
The creek channel is well defined, and the creek banks have been armoured with riprap. The riprap appears to be in good condition (Photo 1 and 2).
The previous bridge and highway alignment is approximately 140 m west (downstream) of the current highway alignment (Photo 3).
There was low flow observed during the 2022 inspection (Photos 1 through 4).
The upstream H-pile bridge piers appear to have been partially displaced, most likely due to debris (e.g., ice, logs) moving at a high rate of speed during a high-water event (Photo 2).
The pavement and guardrails leading up to and over the bridge appear to be in good condition (Photo 4).

Photo 1 Downstream side of Rocky Creek Bridge. The creek channel is well defined and the creek banks are armoured with riprap. Photo taken May 17, 2022, facing west.

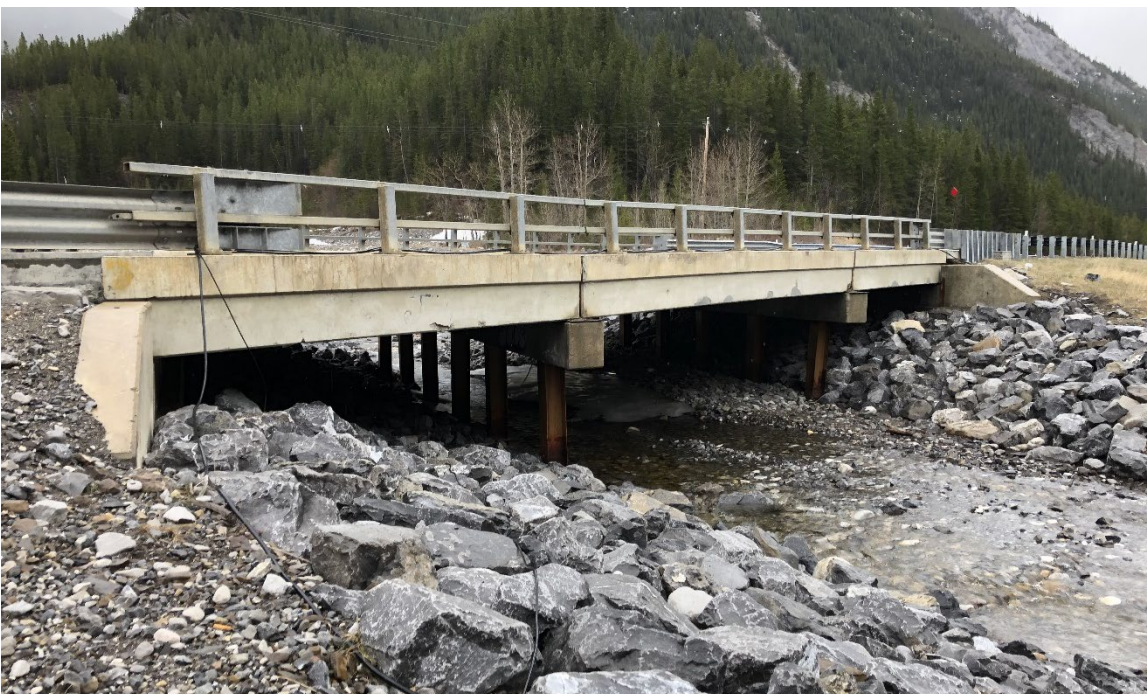
Photo 2 Upstream side of Rocky Creek Bridge. The upstream H-piles appear partially displaced from a suspected high-water event. Photo taken May 17, 2022, facing east.

- The site should be regularly inspected by the MCI and as part of the Southern Region GRMP Section B inspections.
- The bridge piers should be monitored to assess if they continue to deflect. If the displacement of the upstream H-pile piers continues they should be repaired/reinforced. Given the previous damage to the foundation and structure, AT's bridge branch should inspect this bridge and foundation.

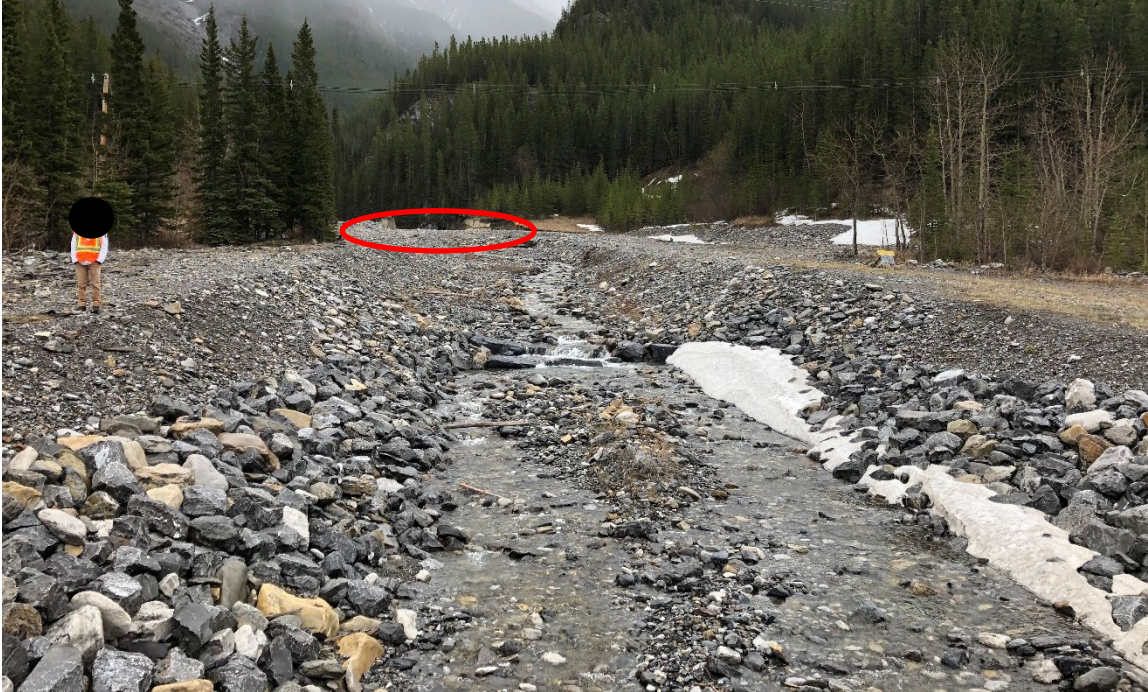
Photo 3 Rocky Creek upstream of the Rocky Creek Bridge. The old highway alignment/location is indicated by the red circle. The creek channel is well defined and is armoured with riprap. Photo taken May 17, 2022, facing west.

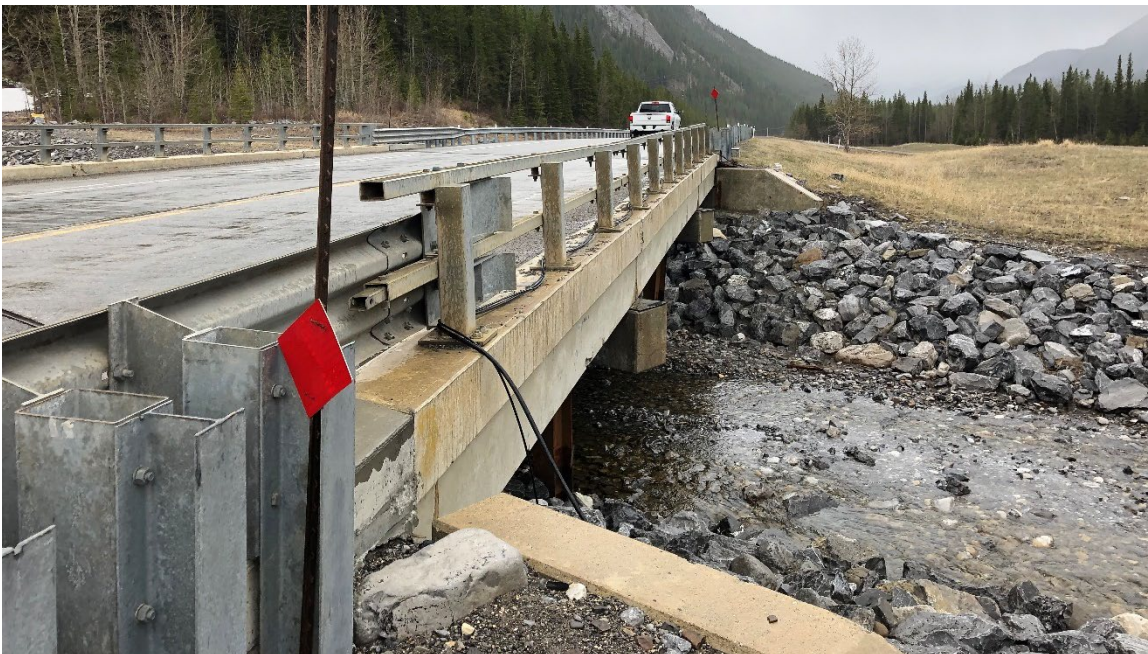
Photo 4 The pavement north/south and above the Rocky Creek Bridge appears to be in good condition. Guardrails have been installed along the east and west sides of the highway leading up to and along the bridge. Photo taken May 17, 2022, facing south.
