SITE NUMBER AND NAME: S060 Lost Knife Creek		HIGHWAY & KM: 40:14, 34.480	PREVIOUS INSPECTION DATE: July 6, 2020	INSPECTION DATE: July 6, 2021
LEGAL DESCRIPTION: 15-29-019-05 W5M	NAD 83 COORDINATES: UTM Northing Easting 11 5612799 665797		RISK ASSESSMENT: PF: 12 CF: 6 TOTAL: 72	
MONTHLY AVERAGE DAILY TRAFFIC (MADT): May 2020 390 (west), 382 (east). (Ref. No. 55460220)			CONTRACTOR MAINTENANCE AREA (CMA): 28

PROJECT SOUTHERN REGION GEOHAZARD RISK MANAGEMENT PROGRAM		
TITLE Site Plan S060 - Lost Knife Creek Hwy 40, Forestry Trunk Road		
SCALE 1:1,500	PROJECT No. A05116A03	FIG No. 1

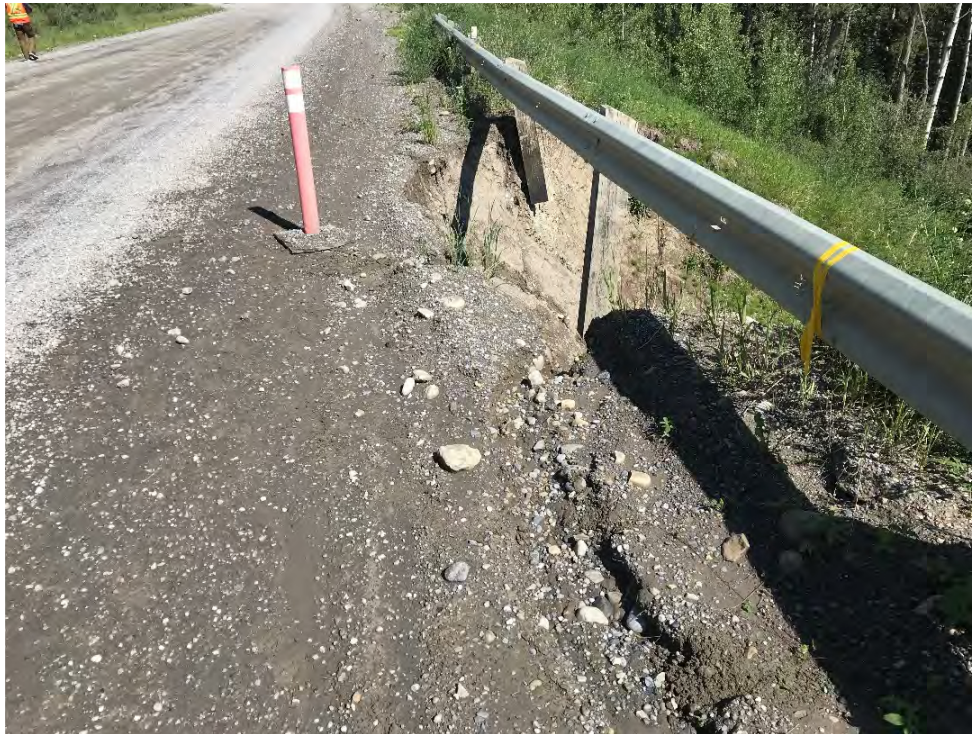
Photo 1 Head scarp on east side of Hwy 40. Erosion extends 1.2 m into the highway. Photo taken facing northwest on July 6, 2021.

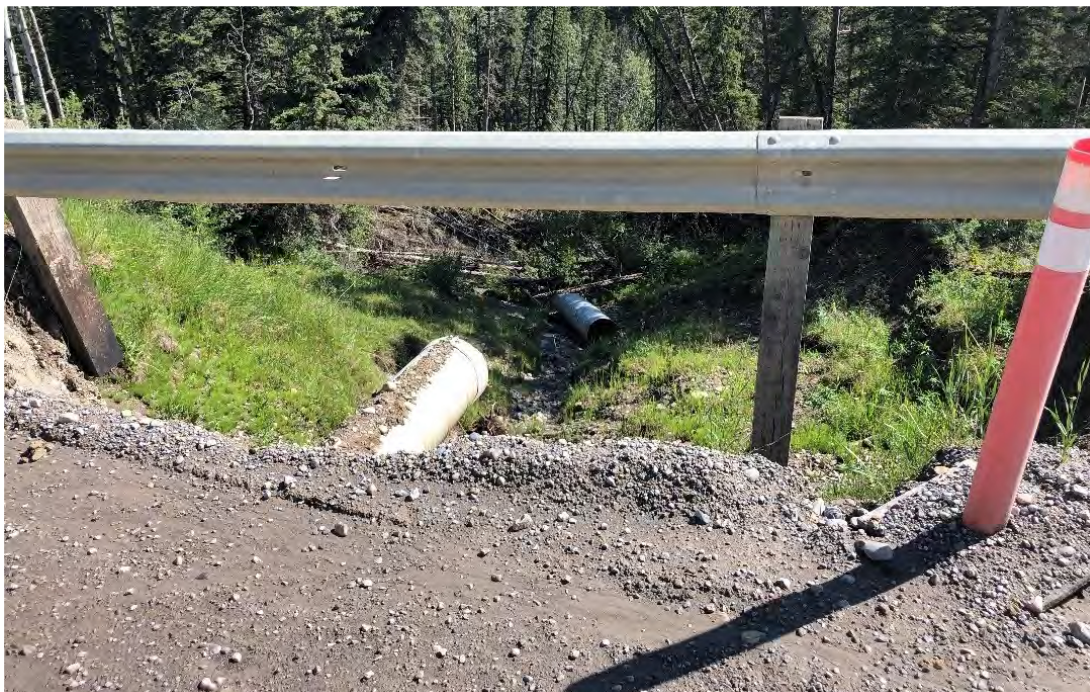
Photo 2 View from highway down the erosion gully and separated culvert. Photo taken facing northeast on July 6, 2021.

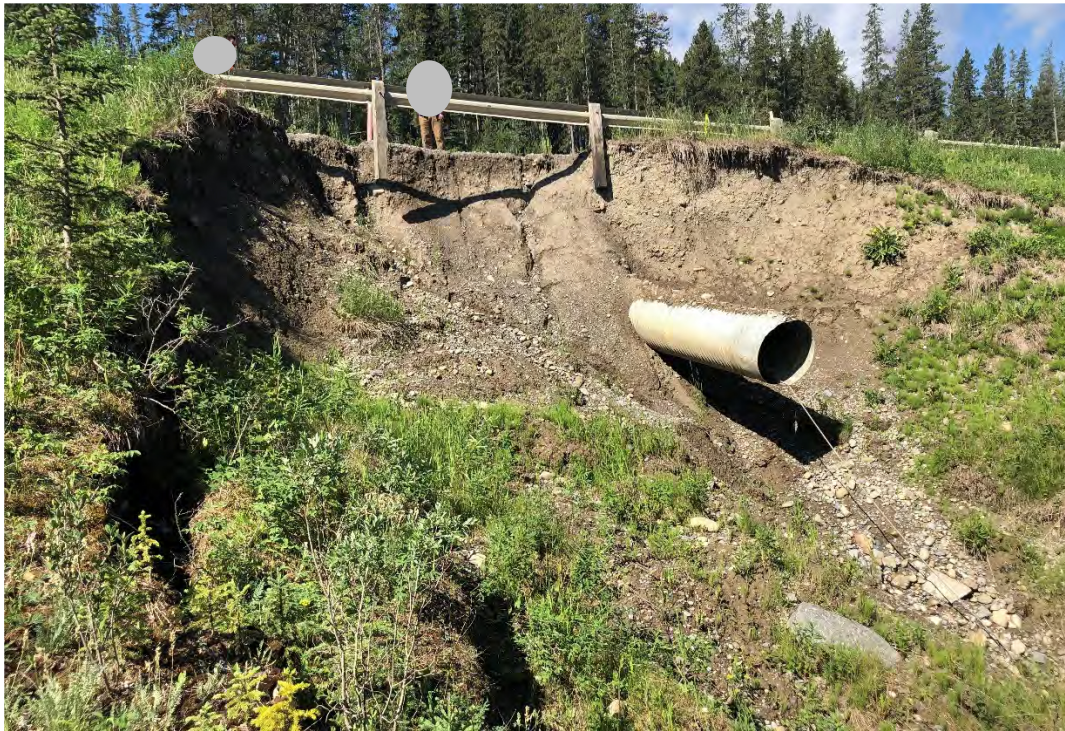
Photo 3 Two undermined safety barrier fence posts on the highway. Slumping visible on the right flank due to ongoing erosion. Photo taken facing northwest on July 6, 2021.

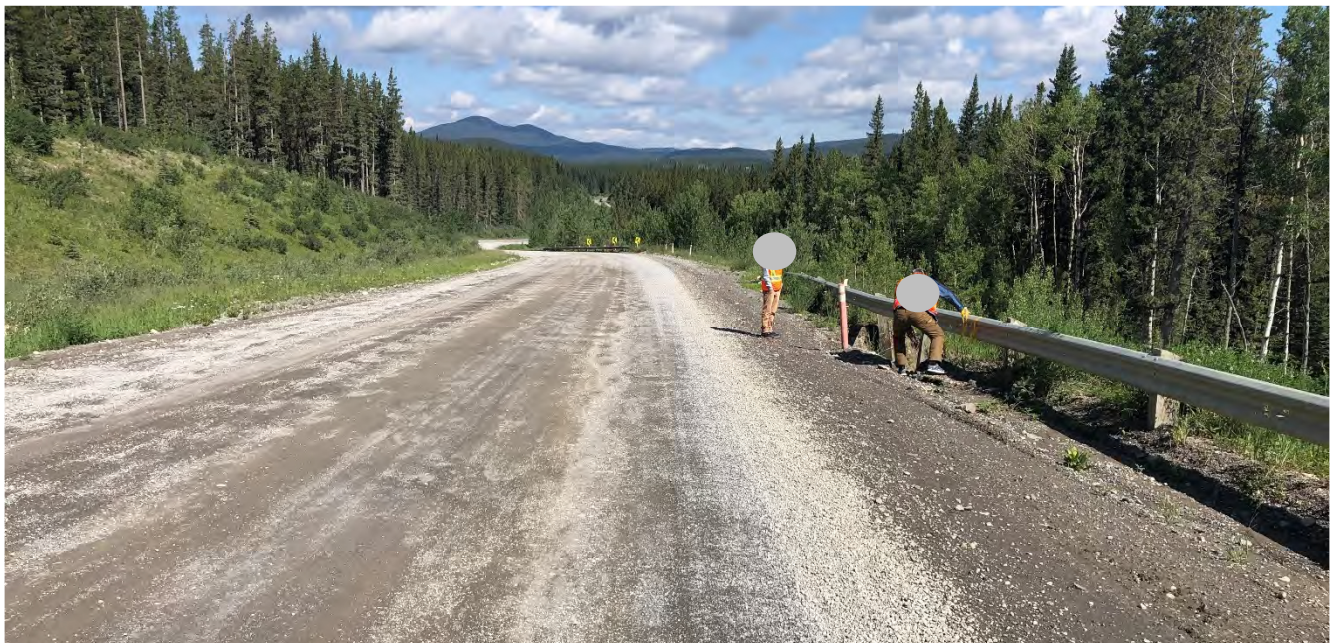
Photo 4 Delineator used to mark erosion retrogressing into the gravel road surface. Photo taken facing northwest on July 6, 2021.
