SITE NUMBER AND NAME: S060 Lost Knife Creek		HIGHWAY & KM: 40:14, 34.480	PREVIOUS INSPECTION DATE: July 6, 2021	INSPECTION DATE: May 18, 2022
LEGAL DESCRIPTION: 15-29-19-05 W5M	NAD 83 COORDINATES: UTM Northing Easting 11 5612799 665797		RISK ASSESSMENT: PF: 12 CF: 6 TOTAL: 72	
MONTHLY AVERAGE DAILY TRAFFIC (MADT): May 2020 390 (west) & 382 (east) (Reference No. 55460220)			CONTRACTOR MAINTENANCE AREA (CMA): 28

PRIMARY SITE ISSUE: Erosion channel / slope failure on the east side of the highway. The culvert under the highway at the centre of the slide mass has disconnected at a joint; however, it is unknown whether slope movement led to culvert separation, or whether culvert separation led to the erosion feature.
APPROXIMATE DIMENSIONS: Head scarp is approximately 5.8 m wide (5.3 m in 2020) at the crest of a 30 m to 40 m high slope above an unnamed creek (possibly Lost Knife Creek).
DATE OF ANY REMEDIAL ACTION: None

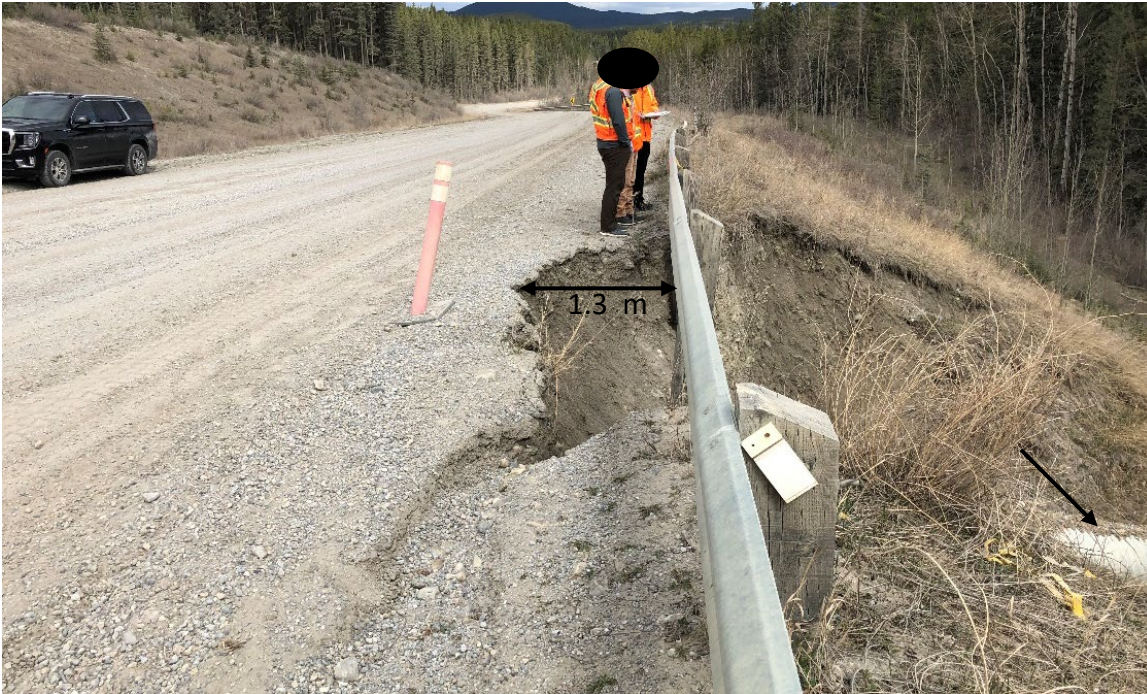
COMMENTS
The site is on a gravel surfaced road, oriented roughly southeast to northwest at the site.
Surface water runoff has undermined approximately 5.8 m of the east (northbound) guardrail (Photo 1). The erosion has retrogressed approximately 1.3 m (measured from the guardrail) (Photo 2) since the 2020 inspection and has undermined 2 guardrail posts (WP 102) (Photo 3). Slope erosion will likely continue to undermine the guardrail and further encroach past the guardrail on the highway surface.

Photo 1 Head scarp on east side of Hwy 40. The erosion extends approximately 1.3 m west from the guardrail (indicated by black line). The CSP culvert is being undermined (indicated by black arrow). Photo taken May 18, 2022, facing northwest.

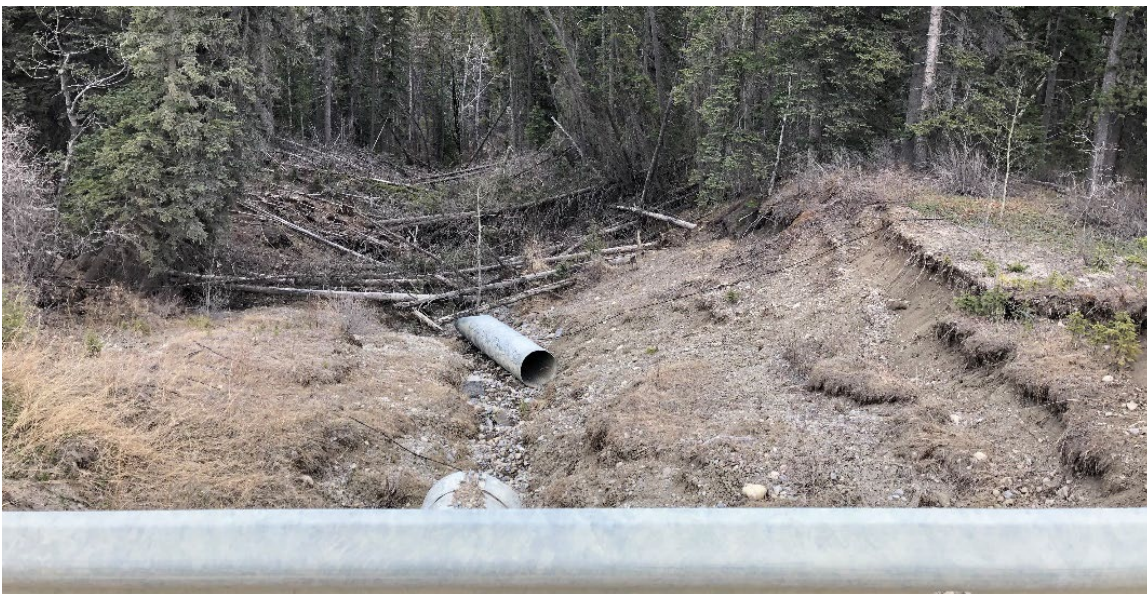
Surface water runoff, snow melt, culvert discharge, and groundwater seepage through the embankment are contributing to ongoing erosion and sloughing of embankment material, undermining of the culvert, and retrogression of the erosion feature laterally and longitudinally. Sloughing material is accumulating on top of the culvert. The erosion channel downstream of the culvert is approximately 5 m to 6 m deep and is discharging sediment into a fish bearing creek (potentially Lost Knife Creek) (Photo 2). The sloughing is worse at the left (north) flank.

Photo 2 View from highway down the erosion gully and toward the separated culvert. Photo taken May 18, 2022, facing northeast.

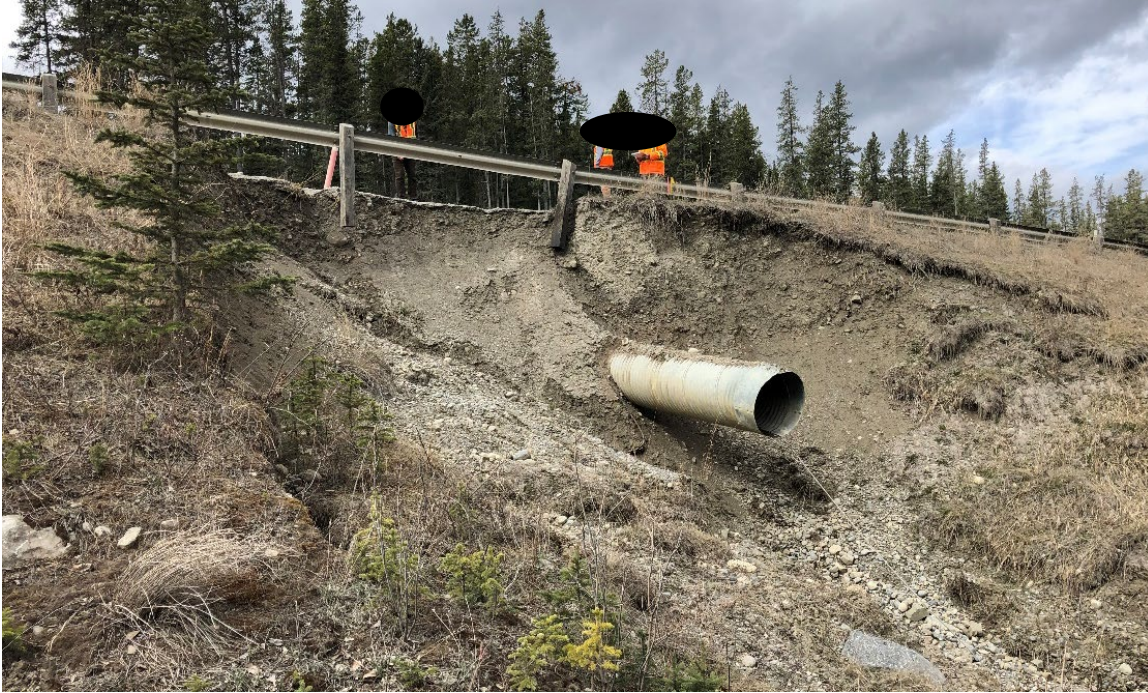
Photo 3 The erosion has undermined two guardrail posts and they are hanging. Slumping is visible on the right flank due to the ongoing erosion. The length of the undermined CSP culvert is approximately 3.5 m. Photo taken May 18, 2022, facing northwest.

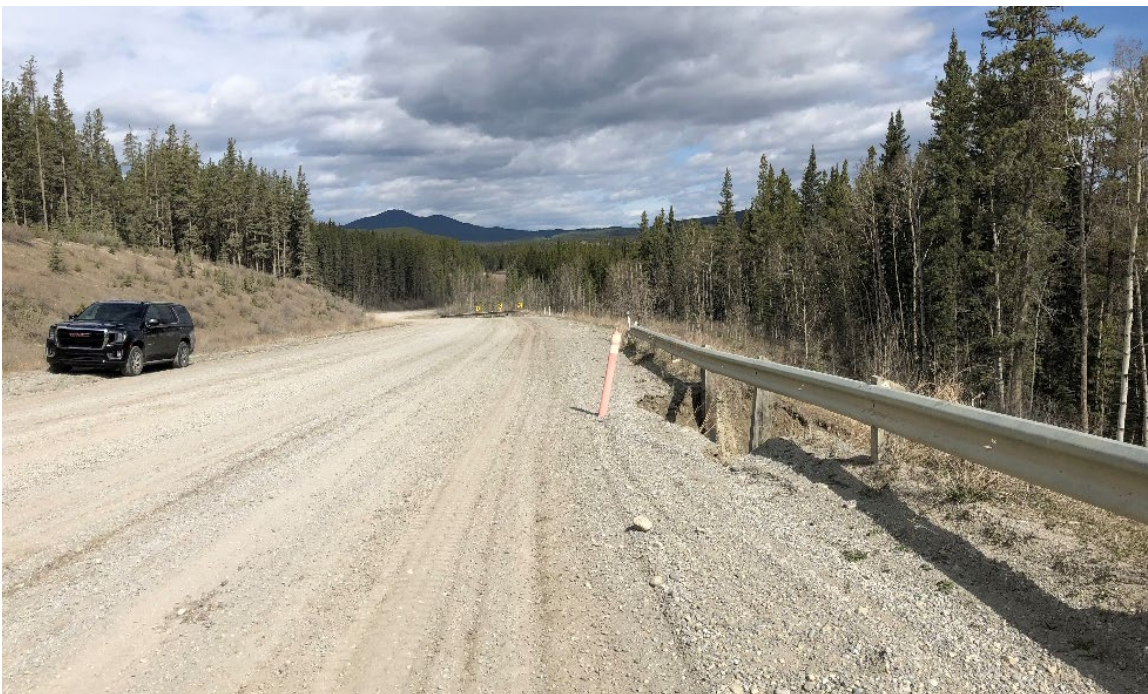
A delineator post was placed near the edge of the gravel road to indicate the erosion that is encroaching on the highway surface (Photo 4).

Photo 4 Delineator used to mark the location of where the erosion is retrogressing into the gravel road surface. Photo taken May 18, 2022 facing northwest.
