SITE NUMBER AND NAME: <b>S060 Lost Knife Creek</b>		HIGHWAY & KM: 40:14, 34.480	PREVIOUS INSPECTION DATE: May 18, 2022	INSPECTION DATE: <b>May 8, 2023</b>
LEGAL DESCRIPTION: 15-29-19-05 W5M	NAD 83 COORDINATES: UTM Northing Easting 11 5612799 665797		RISK ASSESSMENT: PF: 10 CF: 7 TOTAL: 70	
AVERAGE ANNUAL DAILY TRAFFIC (AADT): 279 (north) & 382 (south) (Reference No. 00401450)			CONTRACTOR MAINTENANCE AREA (CMA): 28

**PRIMARY SITE ISSUE:** Erosion channel / slope failure on the east side of the highway. The culvert under the highway at the centre of the slide mass has disconnected at a joint; however, it is unknown whether slope movement led to culvert separation, or whether culvert separation led to the erosion feature.

PROJECT SOUTHERN REGION GEOHAZARD RISK MANAGEMENT PROGRAM		
TITLE Site Plan S060 - Lost Knife Creek Hwy 40:14, km 34.480		
SCALE 1:1,250	PROJECT No. A05116A03	FIG No. 1

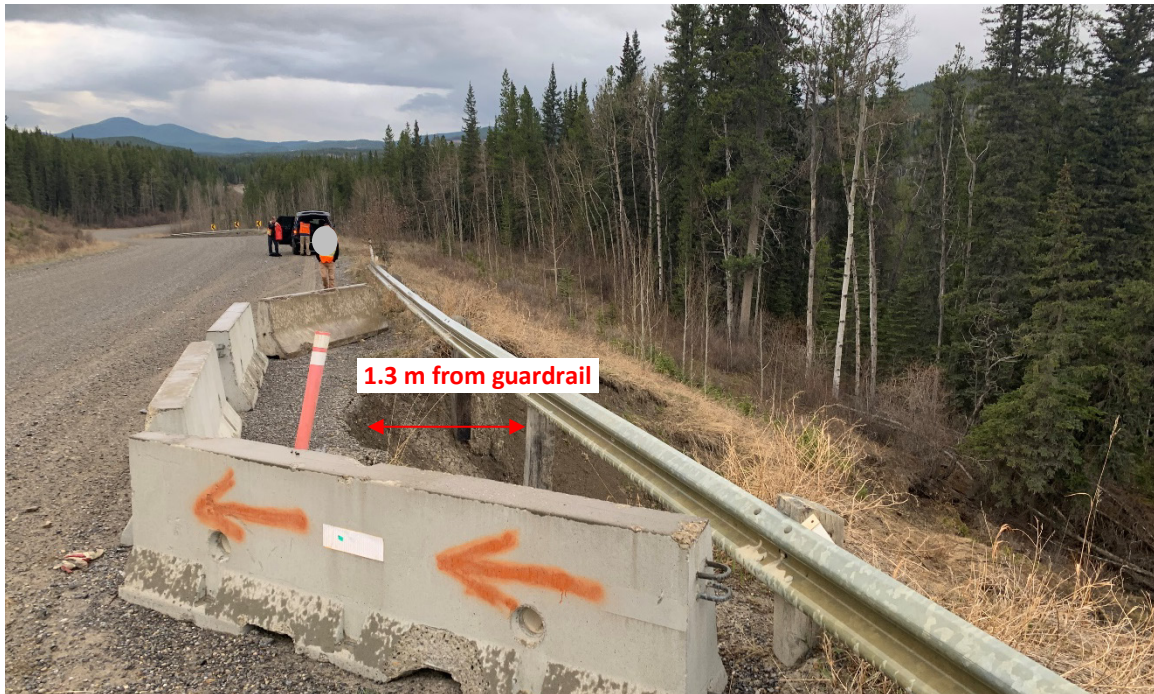
Surface water runoff has undermined approximately 8.0 m of the east (northbound) guardrail, an increase from the previously measured 5.8 m in 2022. The erosion has retrogressed approximately 1.3 m past the guardrail and has undermined 2 guardrail posts. This measurement was unchanged from 2022. Slope erosion will likely continue to undermine the guardrail and further encroach past the guardrail on the highway surface.

**Photo 1** Head scarp on east side of Hwy 40. Erosion extends approximately 1.3 m into the highway. Photo taken facing north on May 8, 2023.

- Embankment stabilization including; (i) reconstruction of the embankment slope with granular fill, construction of a slope drain, and armouring the toe of the embankment and creek channel downstream of the culvert inlet; (ii) installation of a gabion basket retaining wall and rebuilding the embankment with granular fill and repairing the CSP culvert; or
- Realigning the highway to the west.

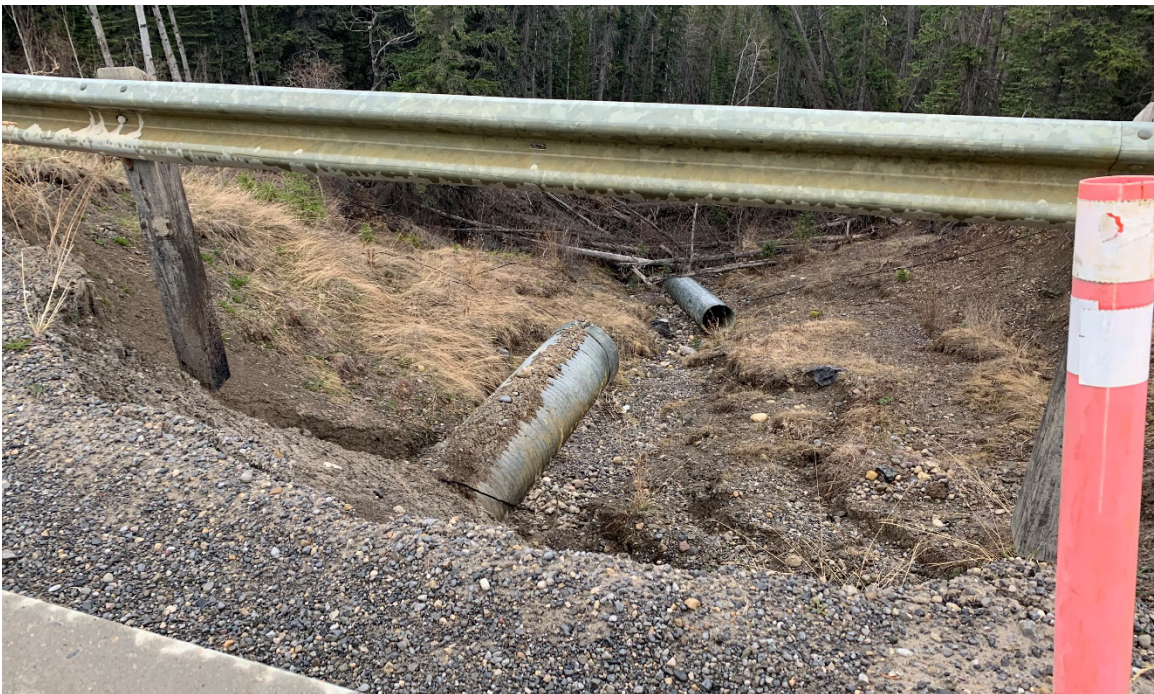
Surface water runoff, snow melt, culvert discharge, and groundwater seepage through the embankment are contributing to ongoing erosion and sloughing of embankment material, undermining of the culvert, and retrogression of the erosion feature laterally and longitudinally. Sloughing material is accumulating on top of the culvert. The erosion channel downstream of the culvert is approximately 5 m to 6 m deep and is discharging sediment into a fish bearing creek (potentially Lost Knife Creek). The sloughing is worse at the left (north) flank.

Water in the ditch on the west side of the highway is discharging into the culvert and draining onto the slide area. Active seepage and slope retrogression of the saturated embankment side slope is occurring.

**Photo 2** View from highway down the erosion gully and separated culvert. Photo taken facing east on May 8, 2023.

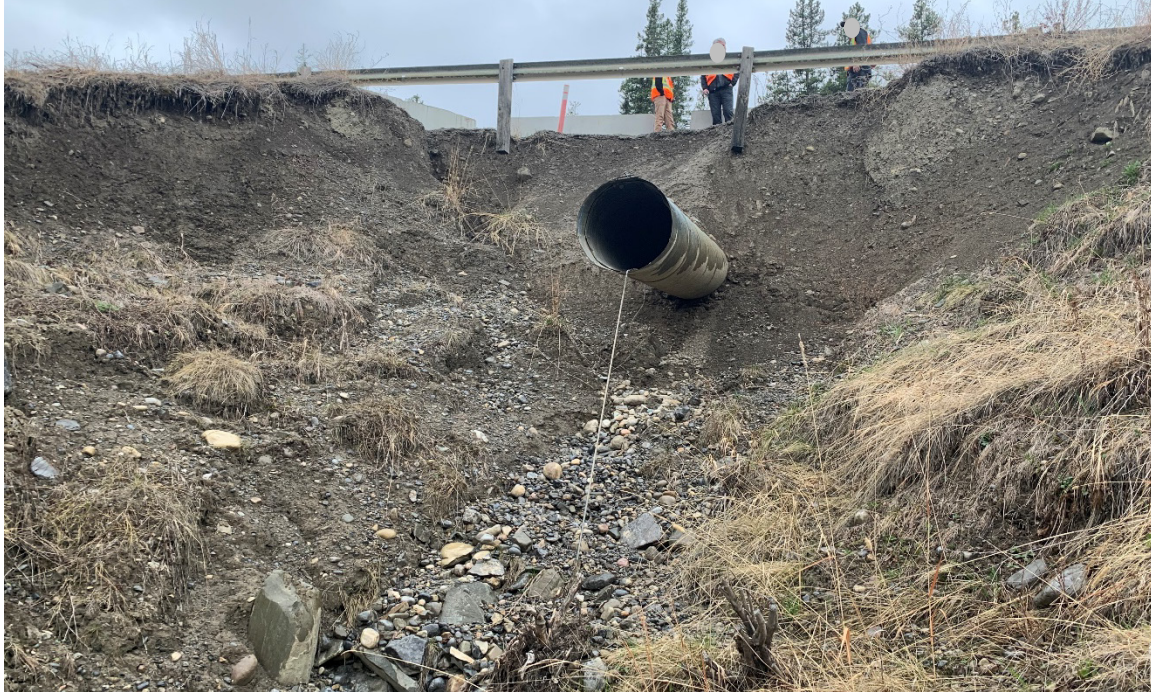
**Photo 3** Two undermined guardrail posts on the highway. Slumping visible on the right and left flanks due to ongoing erosion. Culvert extrudes over 3.5 m from slope. Photo taken facing west on May 8, 2023.

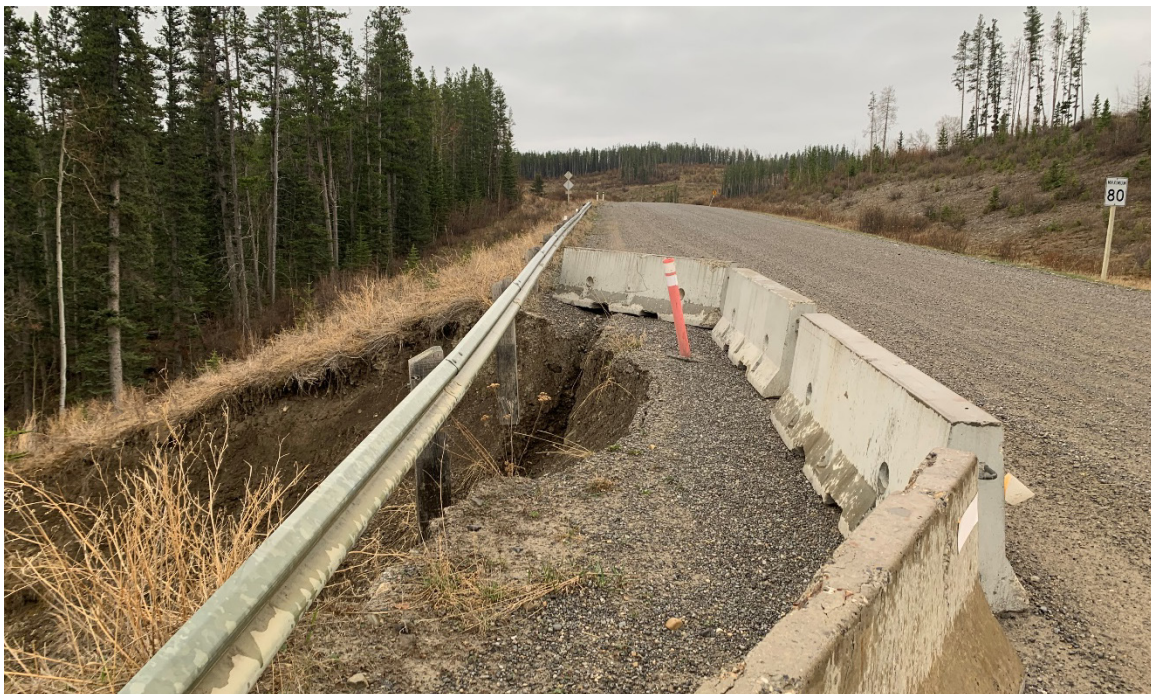
**DATE OF ANY REMEDIAL ACTION:** Jersey barriers installed around failure since 2022.

**Photo 4** Barriers placed around the erosion into the road. Photo taken facing south on May 8, 2023.
