SITE NUMBER AND NAME: S060 Lost Knife Creek		HIGHWAY & KM: 40:14, 34.480	PREVIOUS INSPECTION DATE: May 8, 2023	INSPECTION DATE: May 27, 2024
LEGAL DESCRIPTION: 15-29-19-05 W5M	NAD 83 COORDINATES: UTM Northing Easting 11 5612799 665797		RISK ASSESSMENT: PF: 10 CF: 7 TOTAL: 70	
AVERAGE ANNUAL DAILY TRAFFIC (AADT): 175 (north) & 265 (south) (Reference No. 00401450)			CONTRACTOR MAINTENANCE AREA (CMA): 28

PRIMARY SITE ISSUE: Erosion channel / slope failure on the east side of the highway. The culvert under the highway at the centre of the slide mass has disconnected at a joint; however, it is unknown whether slope movement led to culvert separation, or whether culvert separation led to the erosion feature.

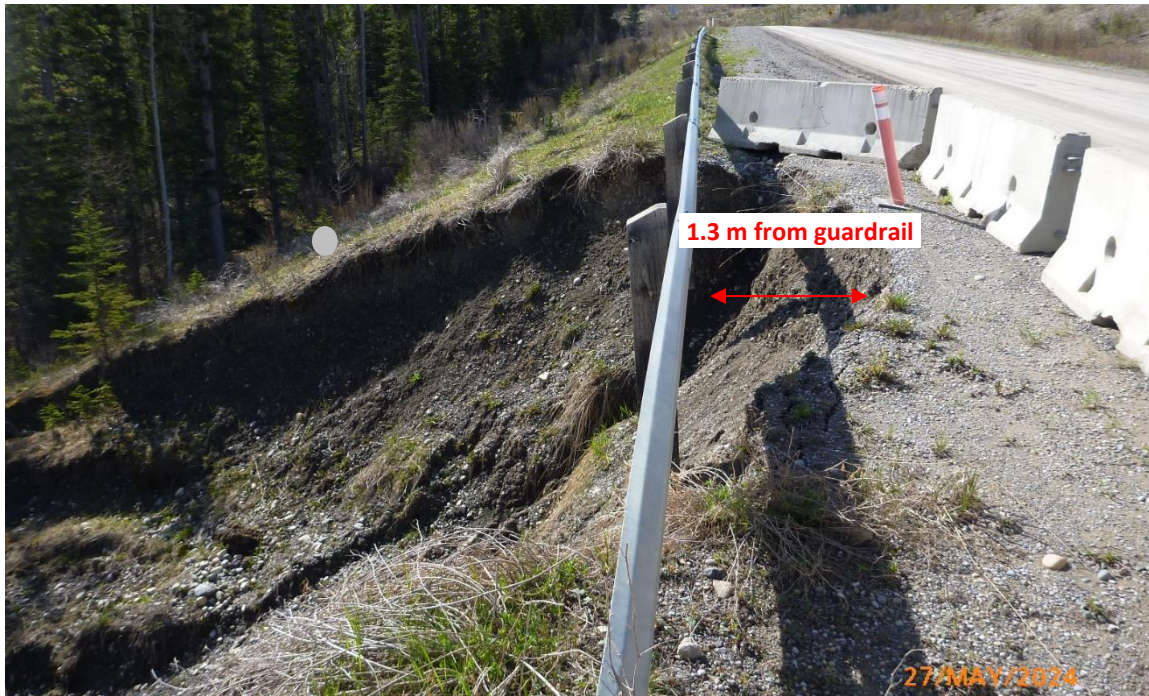
Surface water runoff has undermined approximately 8.0 m of the east (northbound) guardrail, no change noted since 2023. The erosion has retrogressed approximately 1.3 m past the guardrail and has undermined 2 guardrail posts. This measurement was unchanged from 2023. Slope erosion will likely continue to undermine the guardrail and further encroach past the guardrail on the highway surface.

Photo 1 Head scarp on east side of Hwy 40. Erosion extends approximately 1.3 m into the highway. Photo taken facing south on May 27, 2024.

- Embankment stabilization including; reconstruction of the embankment slope with granular fill, construction of a slope drain, and armouring the toe of the embankment and creek channel downstream of the culvert inlet and repairing the CSP culvert.

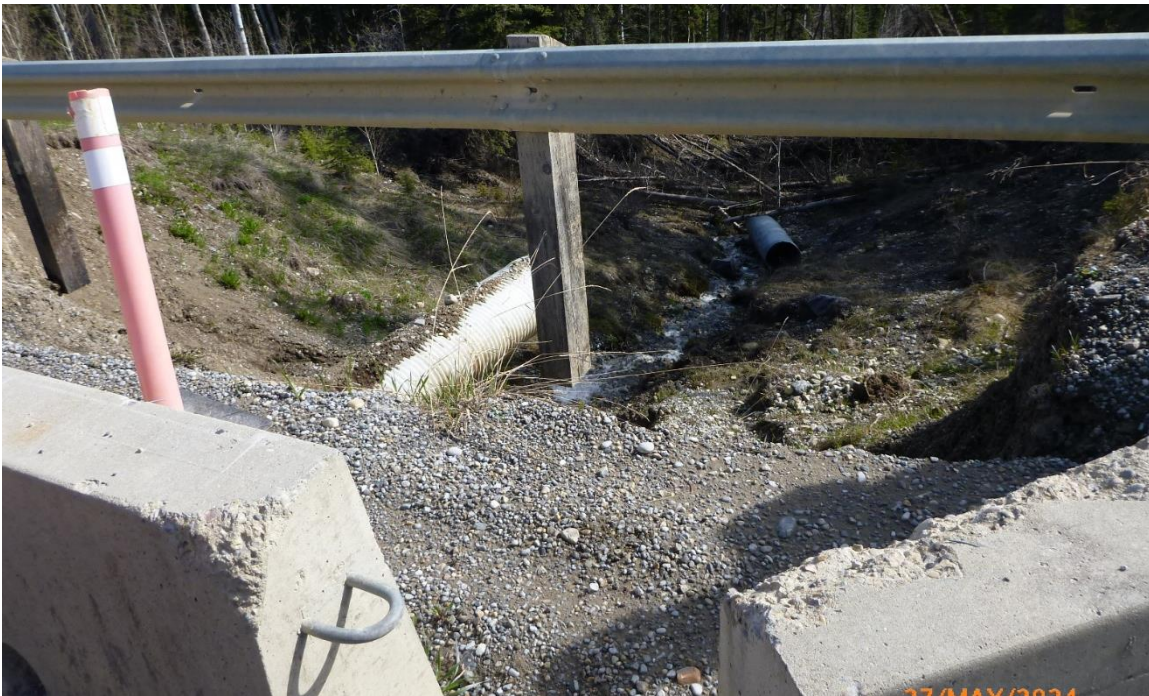
Photo 2 View from highway down the erosion gully and separated culvert. Photo taken facing east on May 27, 2024.

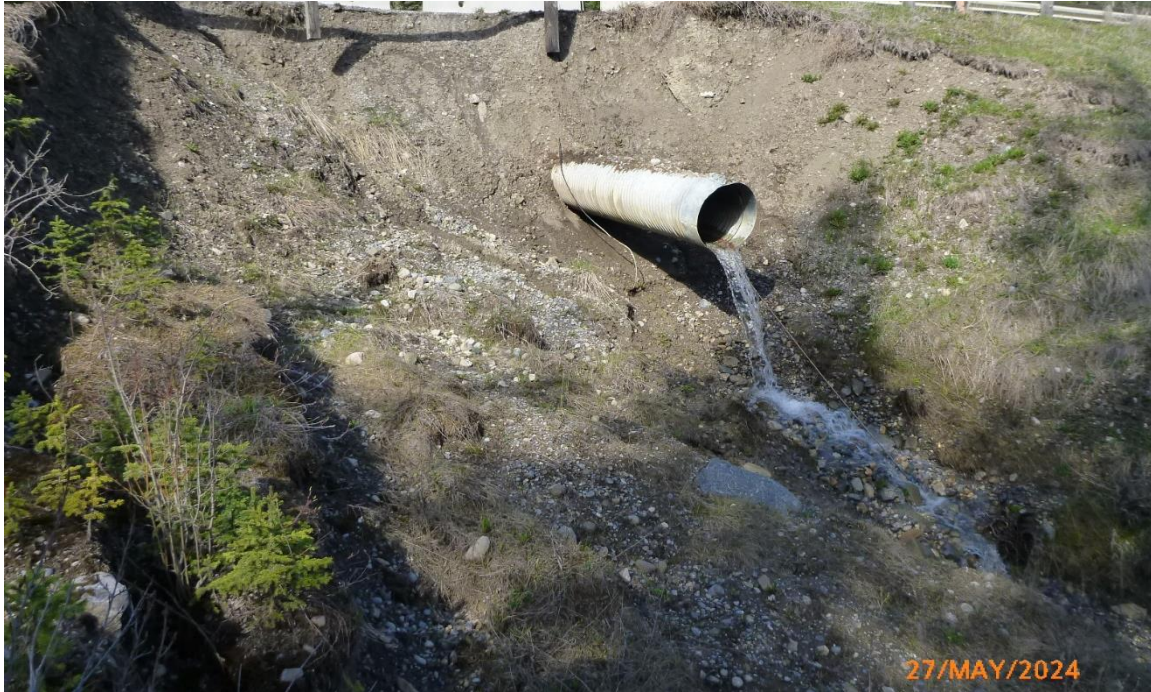
Surface water runoff, snow melt, culvert discharge, and groundwater seepage through the embankment are contributing to ongoing erosion and sloughing of embankment material, undermining of the culvert, and retrogression of the erosion feature laterally and longitudinally. Sloughing material is accumulating on top of the culvert. The erosion channel downstream of the culvert is approximately 5 m to 6 m deep and is discharging sediment into a fish bearing creek. The sloughing is worse at the left (north) flank.

Photo 3 Two undermined guardrail posts on the highway. Slumping visible on the right and left flanks due to ongoing erosion. Culvert extrudes over 3.5 m from slope. Photo taken facing northwest on May 27, 2024.

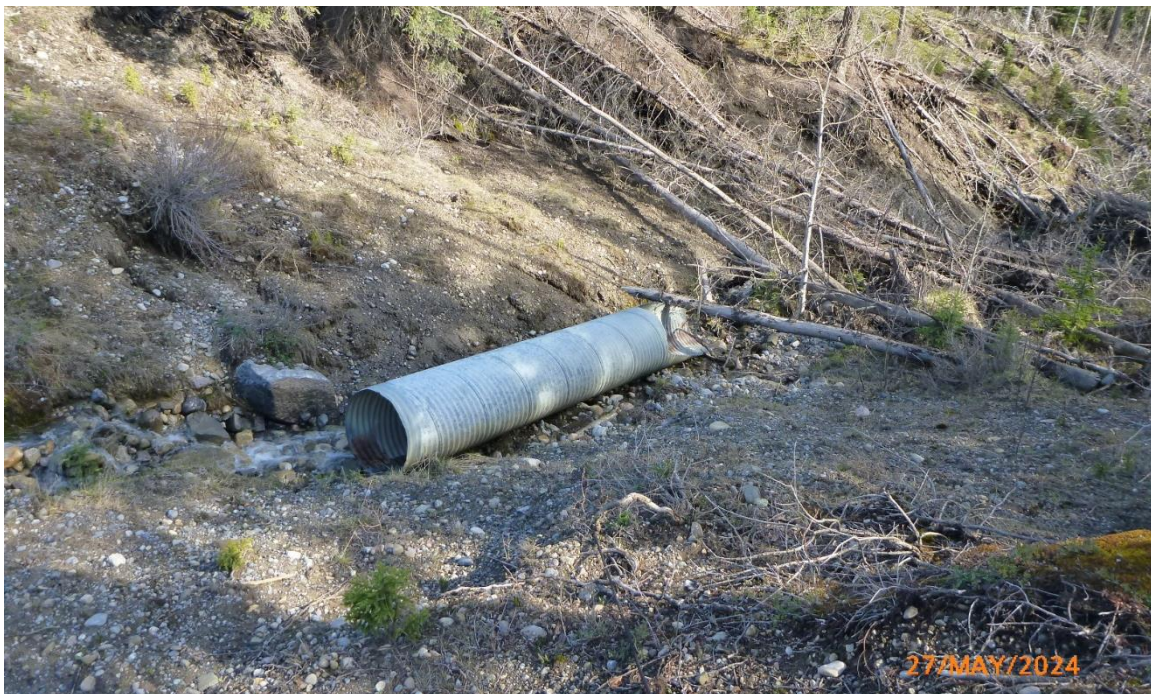
Photo 4 Separated culvert and trees felled in the erosion site. Photo taken facing northeast on May 27, 2024.
