SITE NUMBER AND NAME: <b>Unnumbered Site South Ghost Erosion</b>		HIGHWAY & KM: 40:14, 29.00	PREVIOUS INSPECTION DATE: N/A	INSPECTION DATE: <b>May 18, 2022</b>
LEGAL DESCRIPTION: SW 20-27-07-W5M	NAD 83 COORDINATES: UTM Northing Easting 11 5686872 642530		RISK ASSESMENT: PF: 9 CF: 3 TOTAL: 27	
Average Annual Daily Traffic (AADT): 690 (north) & 210 (south) (Ref. No. 70000143 & 53240)			CONTRACTOR MAINTENANCE AREA (CMA): 28

PROJECT SOUTHERN REGION GEOHAZARD RISK MANAGEMENT PROGRAM		
TITLE Site Plan Unnumbered Site - South Ghost Erosion Hwy 40:14, km 29.00		
SCALE 1:1,250	PROJECT No. A05116A03	FIG No. 1

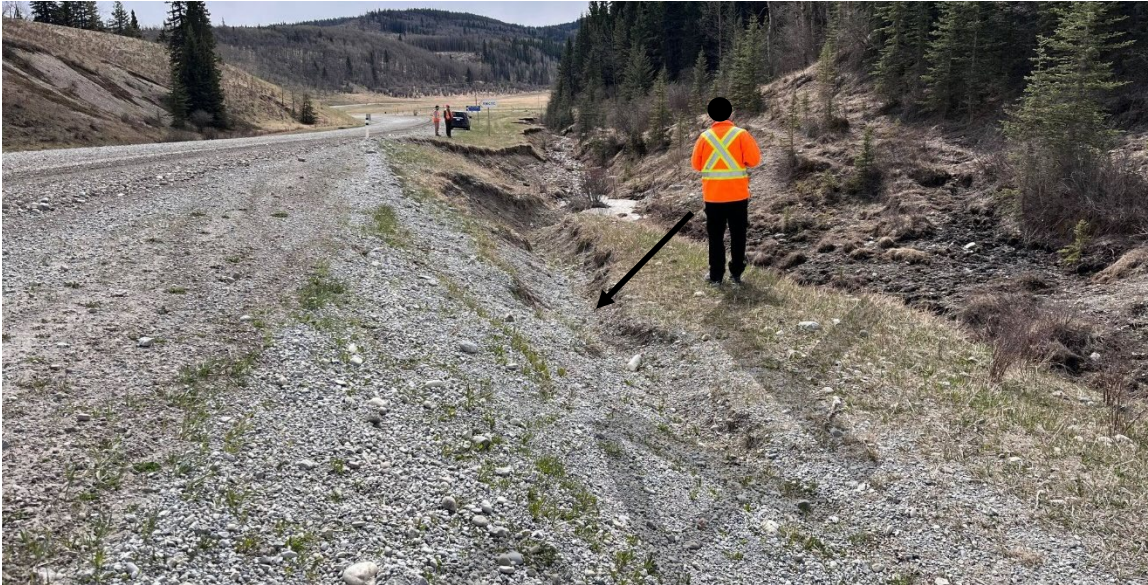
<b>COMMENTS</b>
The site is along a two-lane gravel road, oriented approximately southeast-northwest. The highway embankment is located north of a small unnamed creek flowing south (Photos 1 through 4). The north bank of the creek is eroding the shoulder of the highway embankment over a length of approximately 30 m (WP 103 to WP 104). There was minimal flow in the creek during the site inspection.
The erosion has over-steepened the highway embankment slope (approximately 1H:1V) and could lead to embankment instability (Photo 2 through 4).
Surface runoff from the highway is contributing to erosion of the creek bank/south embankment slope. A linear feature (Photo 1) (WP 105) on the south side of the highway is concentrating surface water runoff from the highway and has formed an erosion gully approximately 0.5 m to 1.0 m wide and 0.3 m deep. The erosion gully will continue to increase in size (depth and width) if not repaired. The rate of erosion will most likely be exacerbated by periods of increased or prolonged rainfall.

- Photo 1** The south highway embankment is being eroded by the unnamed creek south of the highway. The erosion has undermined the south (eastbound) ditch and has exposed a black utility cable. A linear feature (indicated by black arrow) (WP 105) is contributing to the erosion by diverting surface water runoff into the eroding area. Photo taken on May 18, 2022, facing southeast.

- Reconstruct the south embankment and creek bank and armour the creek bank with riprap. If active, the unidentified utility cable should be relocated or trenched within the east highway embankment.

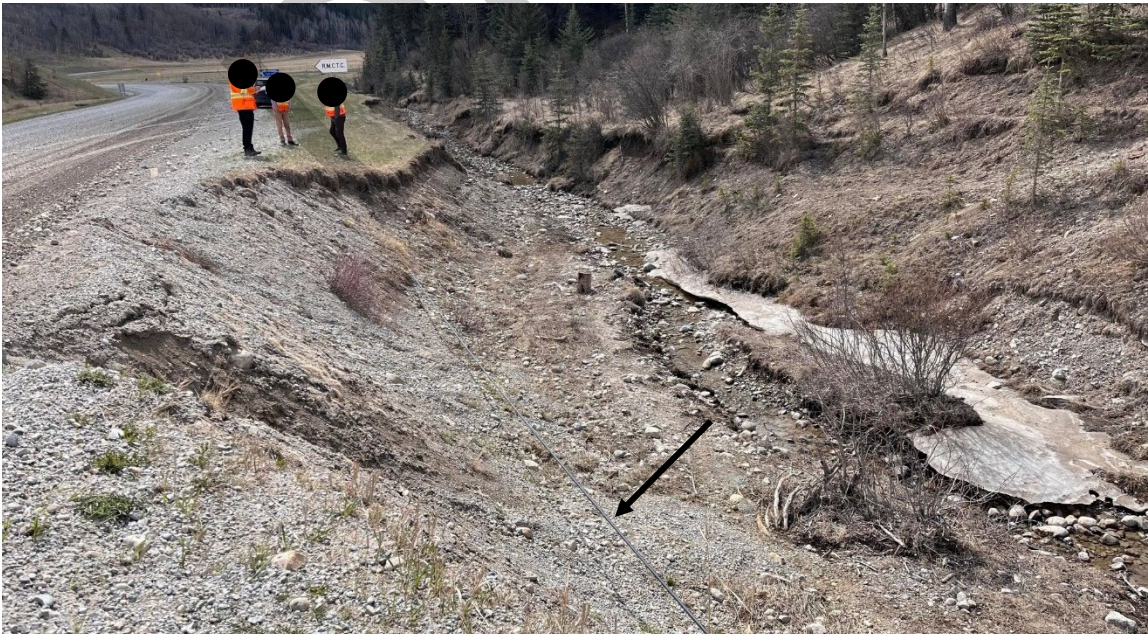
A black utility cable was observed lying on the ground surface on the south side of the highway (between the ditch bottom and edge of pavement). KCB will do a background review to assess the type and owner of the utility cable (Photo 2 and 4).

- Photo 2** The erosion has retrogressed within 2 m of the edge of the south (eastbound) lane of highway (WP 103 to WP 104). The exposed utility line is indicated by the black arrow. Photo taken May 18, 2022, facing southeast.

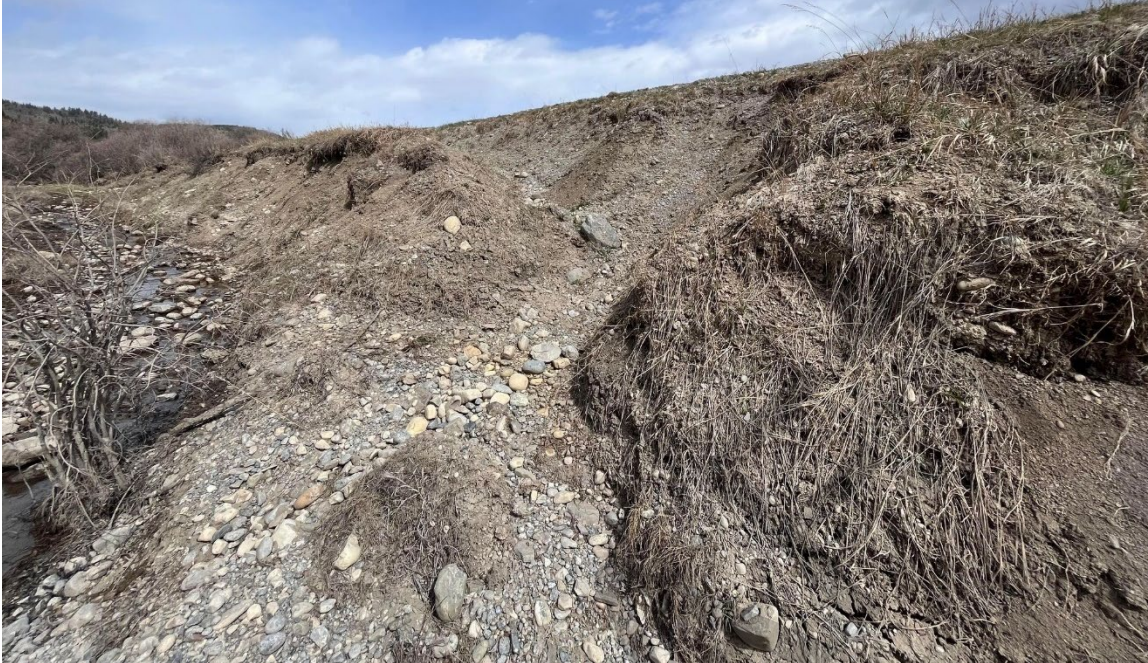
**Photo 3** The runoff from the highway has eroded a portion of the south highway embankment and north bank of the creek. Photo taken May 18, 2022, facing northwest.

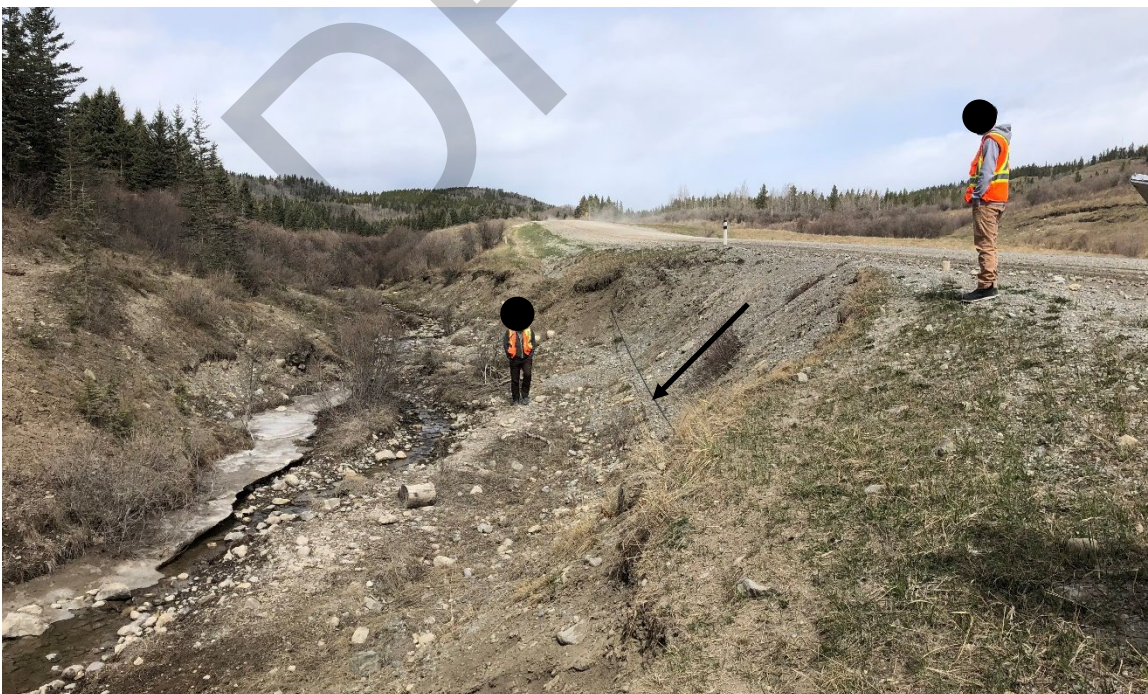
**Photo 4** The erosion of the south highway embankment has exposed a black utility cable (indicated by black arrow) and has over-steepened the highway embankment (approximately 1H:1V). Photo taken May 18, 2022, facing northwest.
