SITE NUMBER AND NAME: S077 South Ghost Erosion		HIGHWAY & KM: 40:14, 29.00	PREVIOUS INSPECTION DATE: May 18, 2022	INSPECTION DATE: May 8, 2023
LEGAL DESCRIPTION: SW 20-27-07-W5M	NAD 83 COORDINATES: UTM Northing Easting 11 5686872 642530		RISK ASSESMENT: PF: 9 CF: 3 TOTAL: 27	
Average Annual Daily Traffic (AADT): 279 (north) & 382 (south) (Reference No. 00401450)			CONTRACTOR MAINTENANCE AREA (CMA): 28

PROJECT SOUTHERN REGION GEOHAZARD RISK MANAGEMENT PROGRAM		
TITLE Site Plan S077 - South Ghost Erosion Hwy 40:14, km 29.00		
SCALE 1:1,250	PROJECT No. A05116A03	FIG No. 1

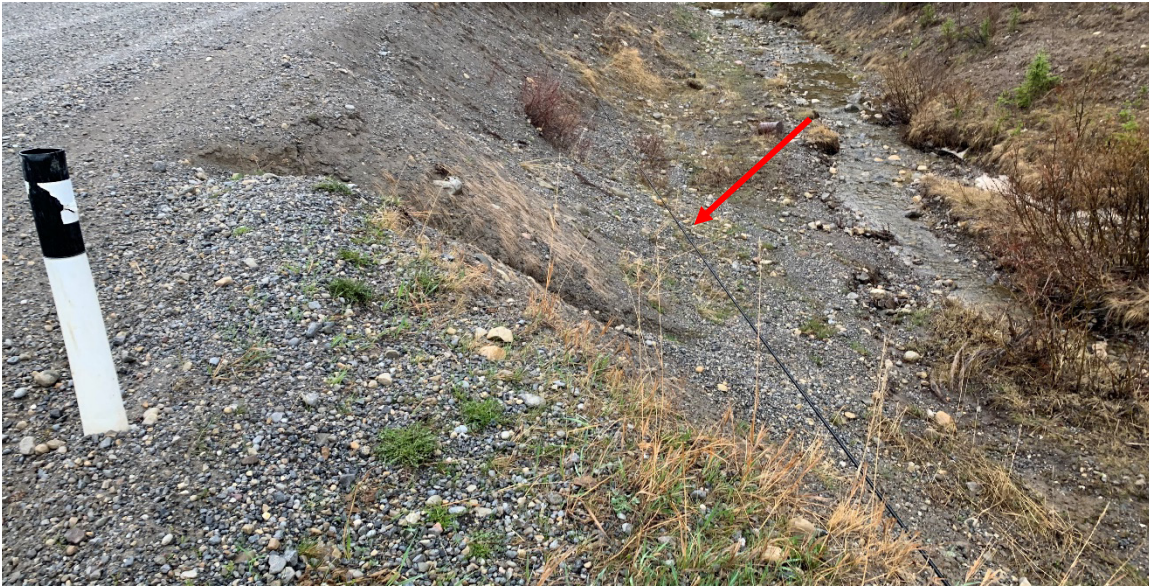
A black Telus utility cable was observed lying on the ground surface on the south side of the highway (between the ditch bottom and edge of pavement). One Call completed indicates that this line is active and owned by Telus.

Photo 1 The south highway embankment is being eroded by the unnamed creek south of the highway. The erosion has undermined the south (eastbound) ditch and has exposed a black Telus utility cable (indicated by red arrow). Photo taken on May 8, 2023, facing southeast.

- Reconstruct the south embankment and creek bank and armour the creek bank with riprap, or lock blocks. The Telus utility cable should be relocated or trenched within the east highway embankment. If a near vertical or steeply sloping repair is chosen, a guard rail should be installed along the repair area.

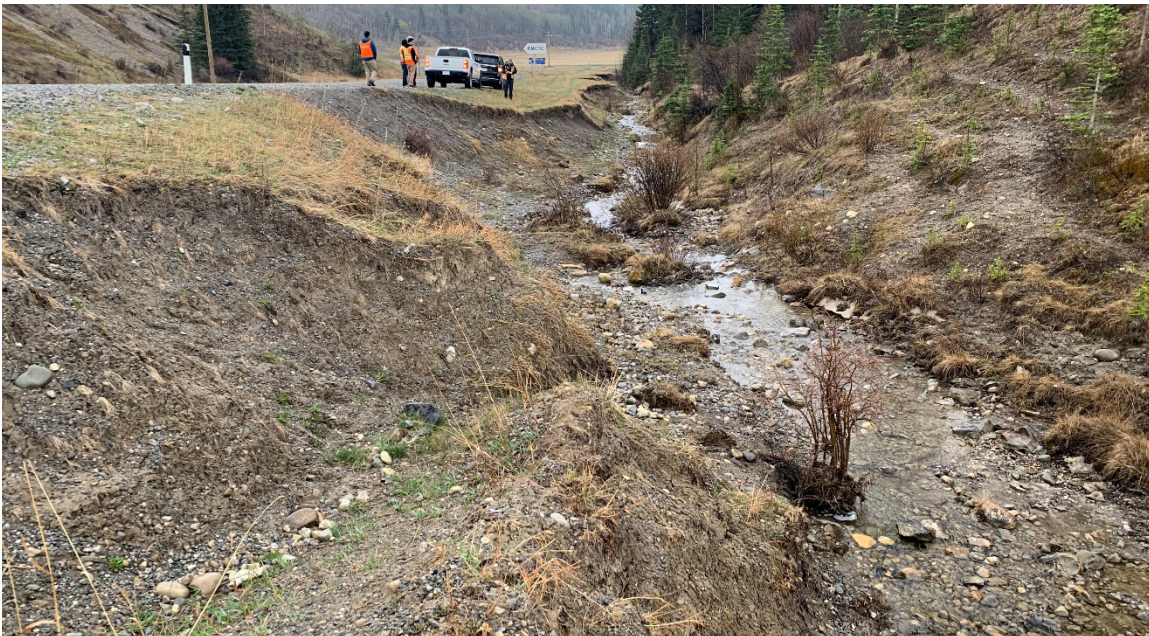
Photo 2 The erosion has retrogressed into the edge of the south (eastbound) lane of highway. Photo taken May 8, 2023, facing southeast.

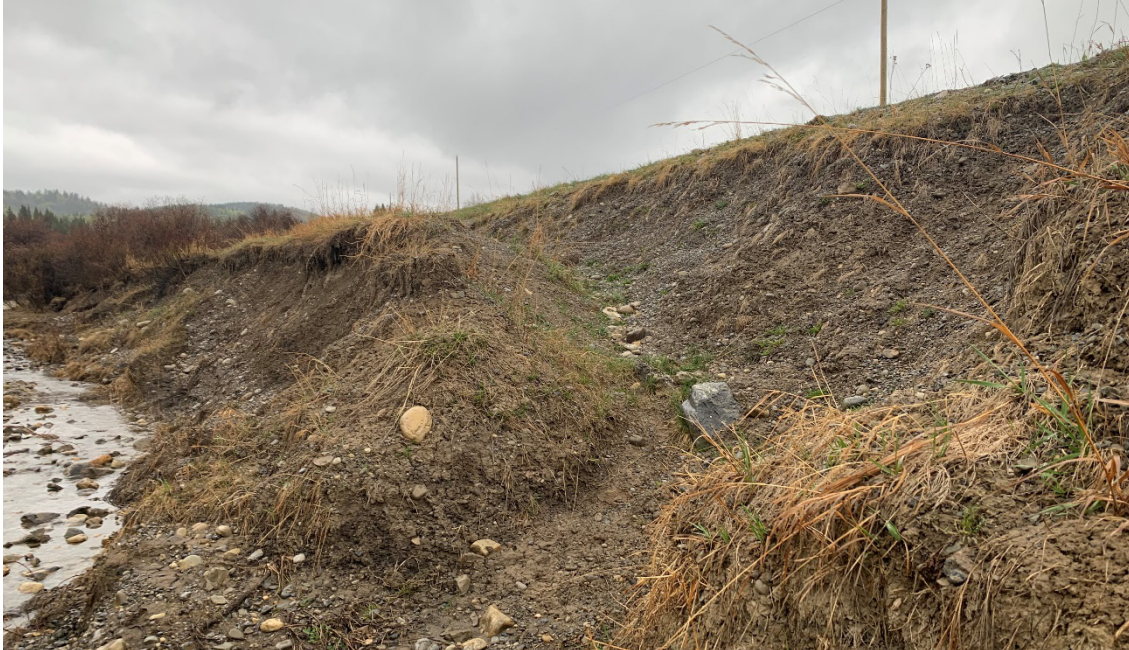
Surface runoff from the highway is contributing to erosion of the creek bank/south embankment slope. A linear feature on the south side of the highway is concentrating surface water runoff from the highway and has formed an erosion gully approximately 0.5 m to 1.0 m wide and 0.3 m deep. The erosion gully will continue to increase in size (depth and width) if not repaired. The rate of erosion will most likely be exacerbated by periods of increased or prolonged rainfall. There was limited change noted during the 2023 inspection compared to 2022.

Photo 3 The runoff from the highway has eroded a portion of the south highway embankment and north bank of the creek. Photo taken May 8, 2023, facing northwest.

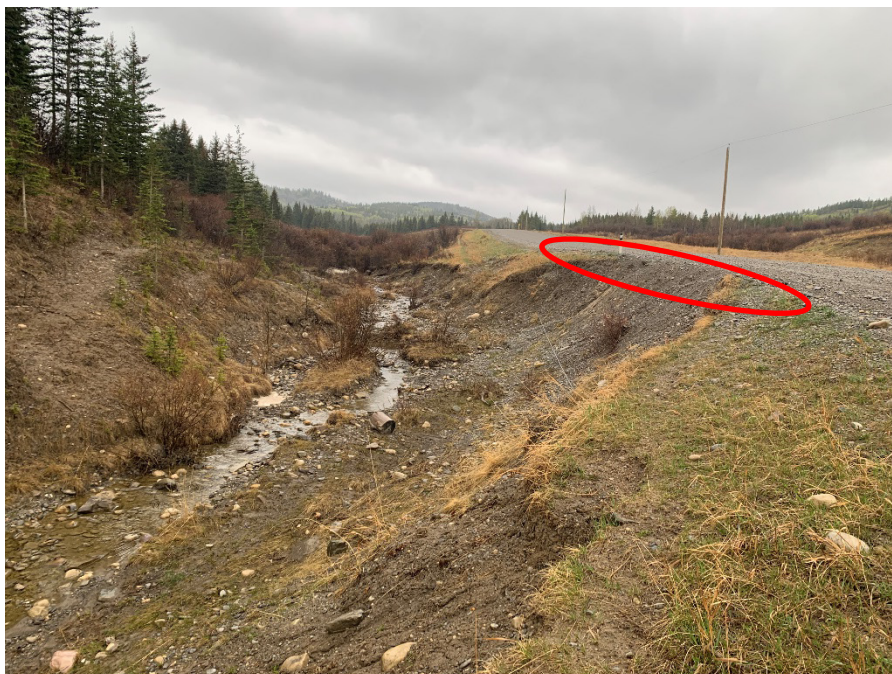
COMMENTS
The site is along a two-lane gravel road, oriented approximately southeast-northwest. The highway embankment is located north of a small unnamed creek flowing south. The north bank of the creek is eroding the shoulder of the highway embankment over a length of approximately 30 m. There was minimal flow in the creek during the site inspection.
The erosion has over-steepened the highway embankment slope (approximately 1H:1V) and could lead to embankment instability.

Photo 4 The erosion of the south highway embankment has exposed a black utility cable and has over-steepened the highway embankment (approximately 1H:1V). Erosion has retrogressed into the south shoulder for approximately 13 m along its length (Where indicated by red circle). Photo taken May 8, 2023, facing northwest.
