SITE NUMBER AND NAME: S077 South Ghost Erosion		HIGHWAY & KM: 40:14, 29.00	PREVIOUS INSPECTION DATE: May 8, 2023	INSPECTION DATE: May 27, 2024
LEGAL DESCRIPTION: SW 20-27-07-W5M	NAD 83 COORDINATES: UTM Northing Easting 11 5686872 642530		RISK ASSESMENT: PF: 9 CF: 3 TOTAL: 27	
Average Annual Daily Traffic (AADT): 175 (north) & 265 (south) (Reference No. 00401450)			CONTRACTOR MAINTENANCE AREA (CMA): 28

PROJECT
 SOUTHERN REGION GEOHAZARD RISK MANAGEMENT PROGRAM

TITLE
 Site Plan
 S077 - South Ghost Erosion
 Hwy 40:14, km 29.00

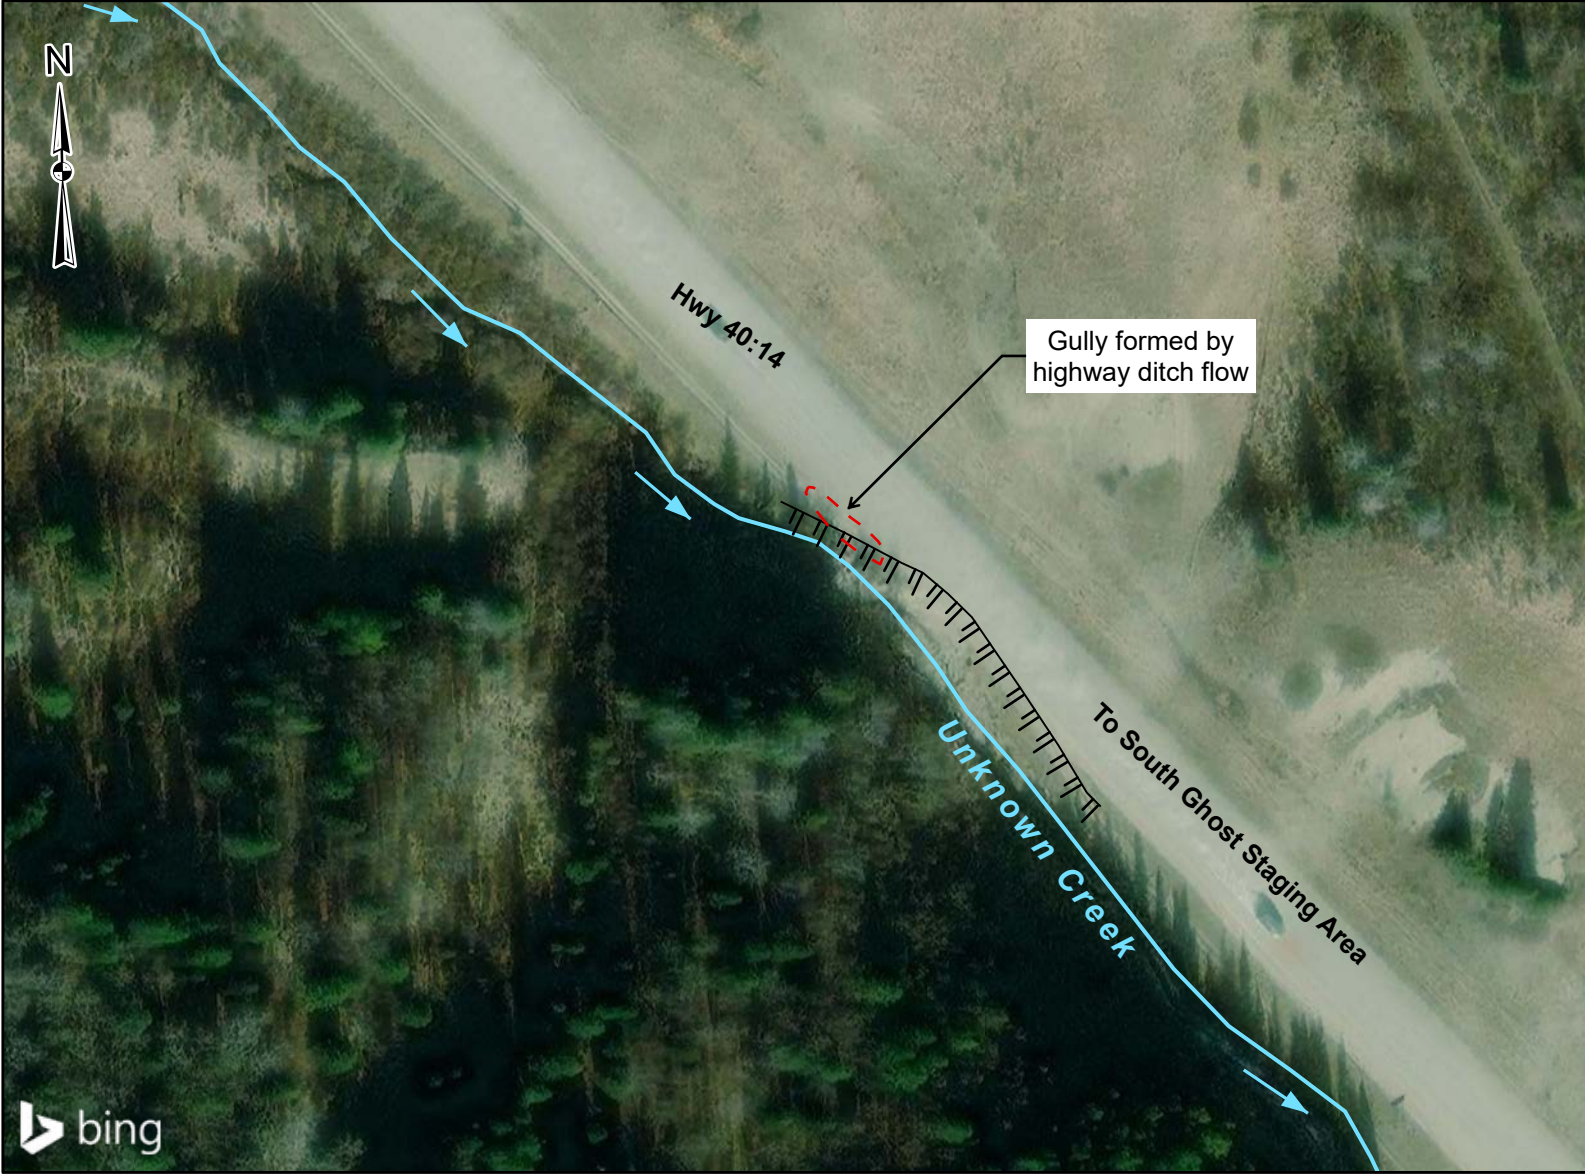
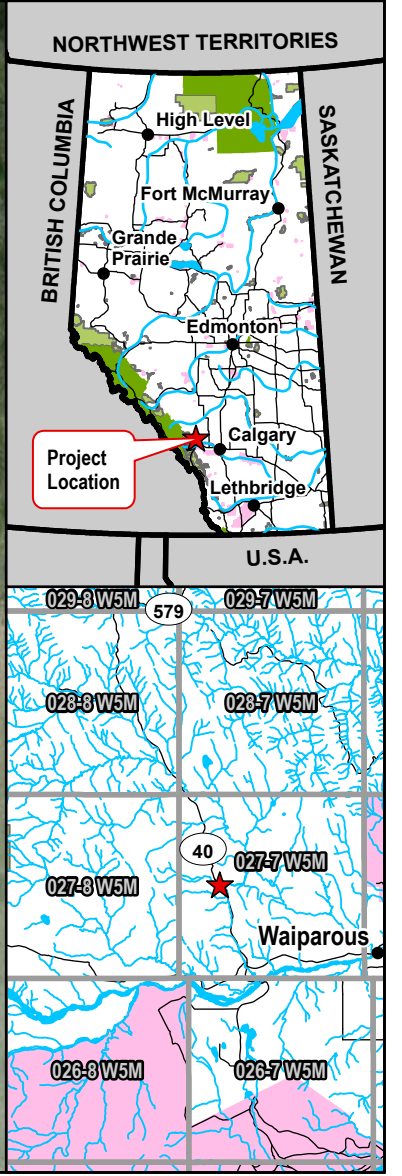
COMMENTS
The site is along a two-lane gravel road, oriented approximately southeast-northwest. The highway embankment is located north of a small unnamed creek flowing south. The east bank of the creek is eroding the shoulder of the highway embankment over a length of approximately 30 m. There was minimal flow in the creek during the site inspection.
The erosion has over-steepened the highway embankment slope (approximately 1H:1V) and could lead to embankment instability.

Surface runoff from the highway is contributing to erosion of the creek bank/west embankment slope. A linear feature on the west side of the highway is concentrating surface water runoff from the highway and has formed an erosion gully approximately 0.5 m to 1.0 m wide and 0.3 m deep. The erosion gully will continue to increase in size (depth and width) if not repaired. The rate of erosion will most likely be exacerbated by periods of increased or prolonged rainfall. There was limited change noted during the 2024 inspection compared to 2023.

- Reconstruct the west embankment and creek bank and armour the creek bank with riprap, or lock blocks. The Telus utility cable should be relocated or trenched within the east highway embankment. Erosion channel to the north of the bank erosion area should be diverted into the creek further upslope with an armoured offtake. If a near vertical or steeply sloping repair is chosen, a guard rail should be installed along the repair area.

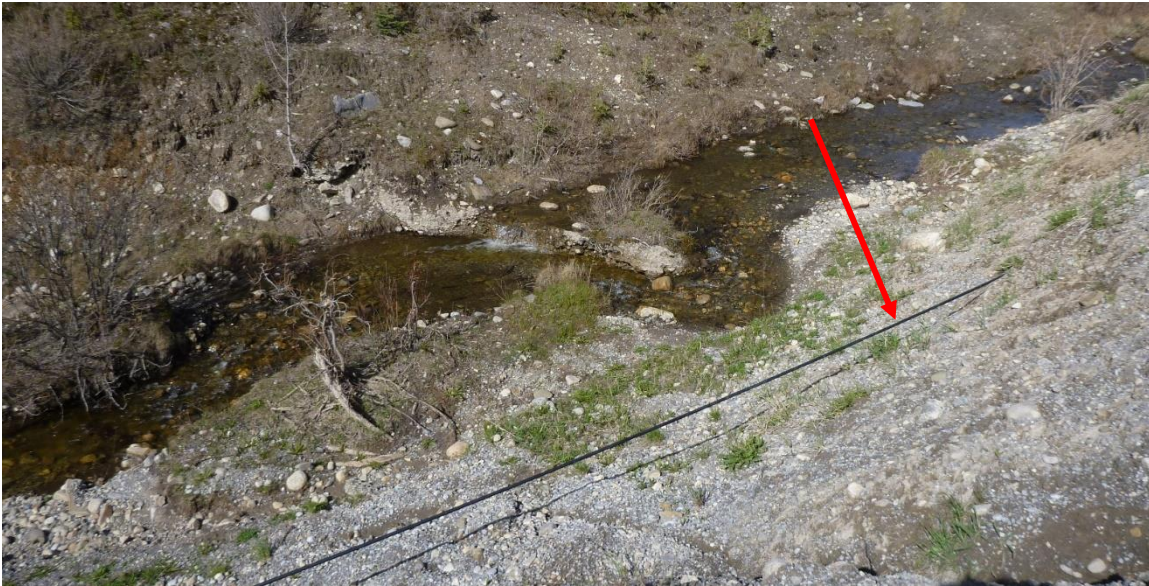
Photo 1 The west highway embankment is being eroded by the unnamed creek south of the highway. The erosion has undermined the west (southbound) ditch and has exposed a black Telus utility cable (indicated by red arrow). Photo taken on May 27, 2024, facing west.

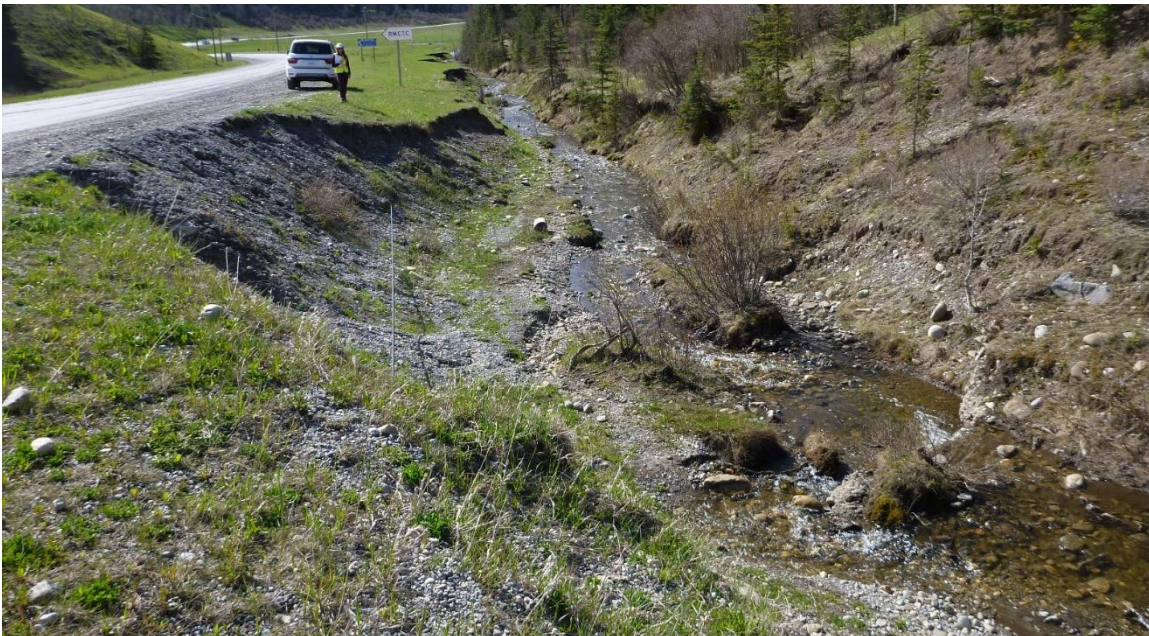
Photo 2 The erosion has retrogressed into the edge of the west (southbound) lane of highway. Photo taken May 27, 2024, facing south.

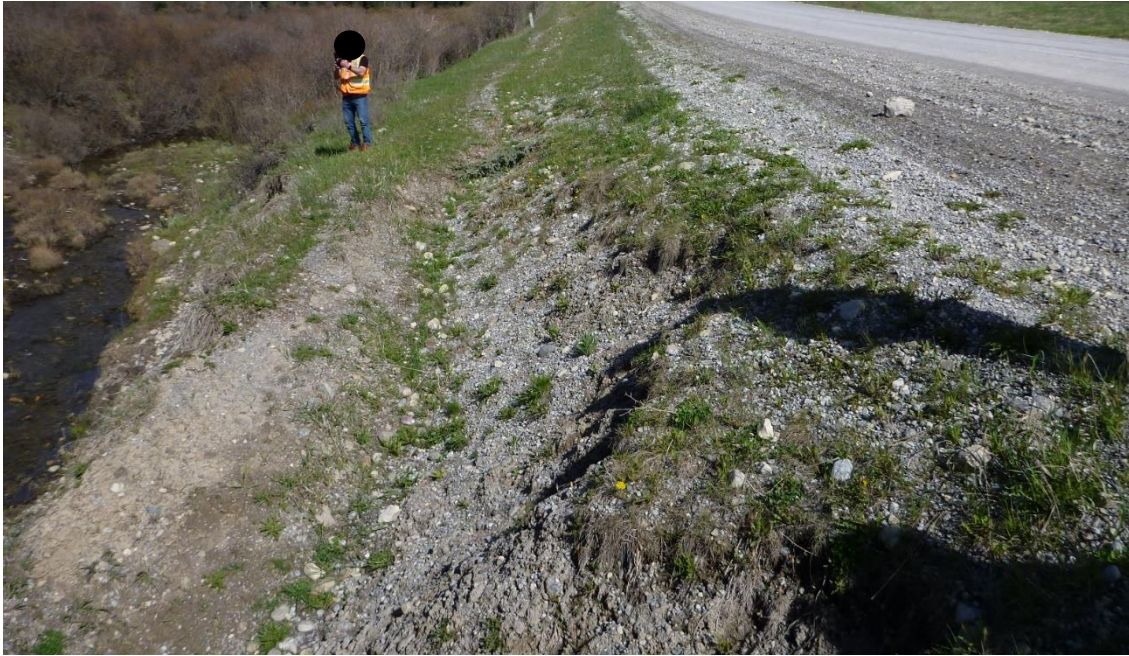
Photo 3 The runoff from the highway has eroded a portion of the west highway embankment and east bank of the creek. Photo taken May 27, 2024, facing north.

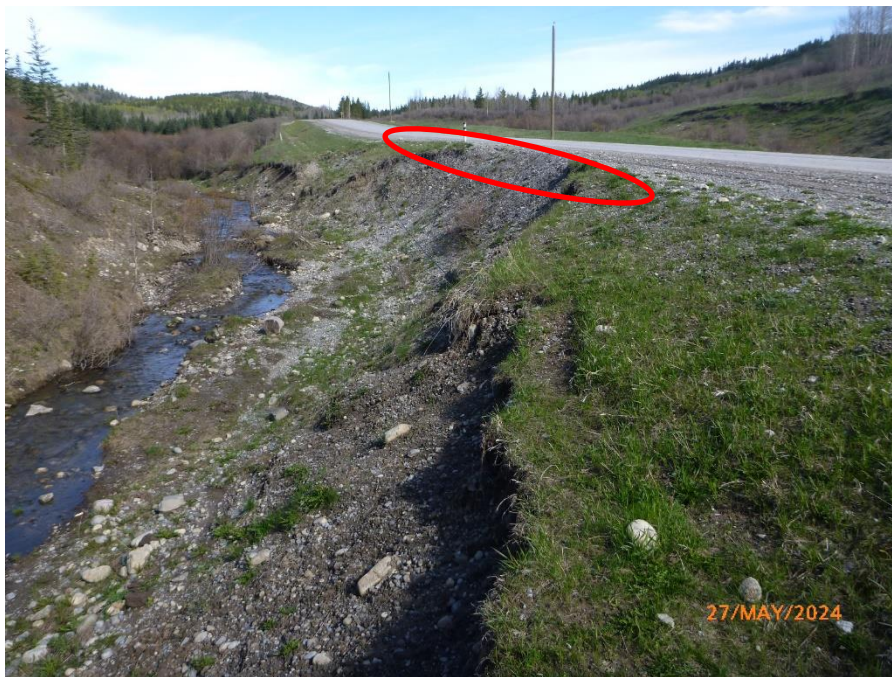
Photo 4 Erosion has retrogressed into the west shoulder for approximately 13 m along its length (indicated by red circle). Photo taken May 27, 2024, facing north.
