SITE NUMBER AND NAME: S026 Elkwater Slides		HIGHWAY & KM: 41:03, 35.169	PREVIOUS INSPECTION DATE: May 3, 2018	INSPECTION DATE: May 8, 2019
LEGAL DESCRIPTION SE-18-008-02 W4M and 16-07-008-02 W4M	NAD 83 COORDINATES: UTM Northing Easting 12 5499046 553536		RISK ASSESMENT: Site A: PF: 9 CF: 6 TOTAL: 54 (Pile wall) Site B: PF: 10 CF: 3 TOTAL: 30 (Slides)	
AVERAGE ANNUAL DAILY TRAFFIC (AADT): 710 (north), 500 (south), (Ref. No. 138060)			CONTRACTOR MAINTENANCE AREA (CMA): 23

PROJECT SOUTHERN REGION GEOHAZARD RISK MANAGEMENT PROGRAM		
TITLE Site Plan S026 - Elkwater Slides Hwy 41:03, km 35.169		
SCALE 1:4,000	PROJECT No. A05115A03	FIG No. 1

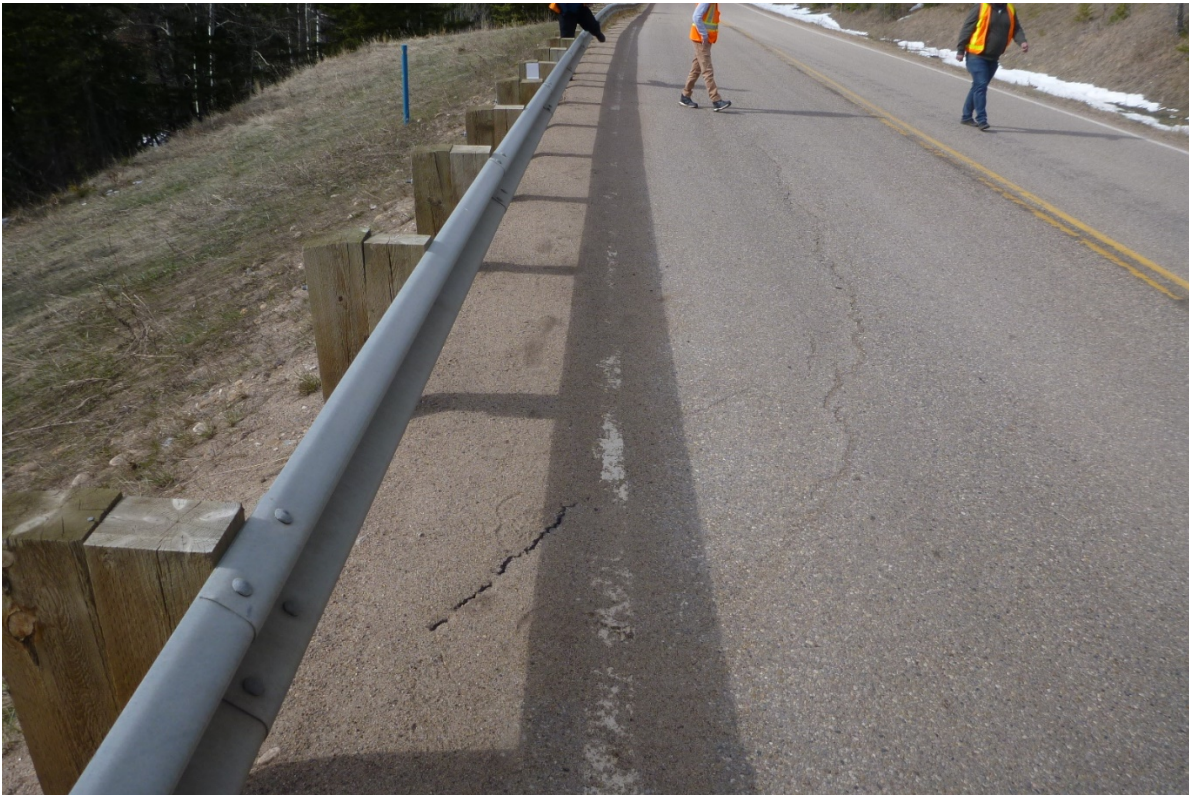
Pavement cracking upslope of the pile wall was noted at the southern end of the wall, where the wall ends. Cracking and slope movement is also present north of the northern extent of the pile wall, outflanking the pile wall.

Photo 1 Southbound lane cracking upslope of Area B pile wall. Pile wall located downslope to the west of the highway. Photo was taken facing north on May 8, 2019.

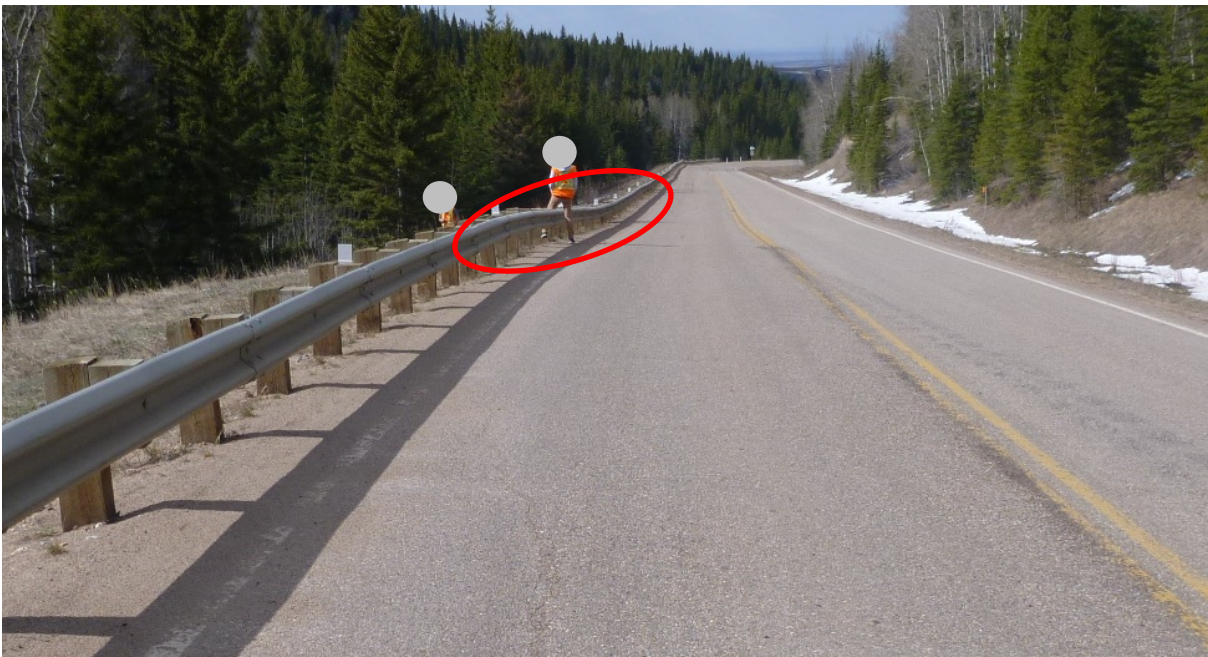
Well-developed toe roll near creek level beyond the edge of the trees below pile wall. Wet conditions present at toe of slope. Seepage and surface water runoff has resulted in exposed soils being eroded and deposited at toe of slope. The guardrail at the north edge of the pile wall has a noticeable dip.

Photo 2 Dip in guard rail at Site B. Photo taken facing north on May 8, 2019.

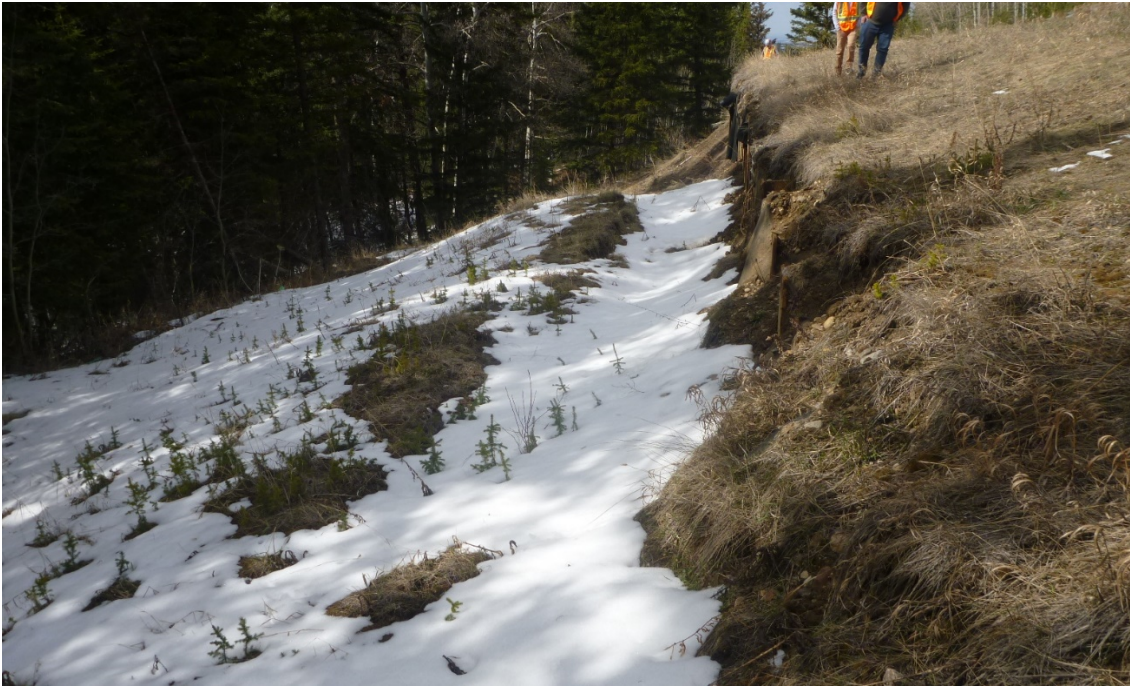
Slope movements below pile wall have exposed the piles over a length of 30 m at the north limit of the wall. The piles were measured as leaning between 0.2° and 0.6° from vertical in 2018. The upper 2 to 3 m of pile wall is exposed and unsupported. Below the exposed section of H-piles is a 2 m high section where sloughed material from between and behind the pile wall has eroded out and covered the piles. Voids are up to 0.5 m deep behind the pile wall, and erosion is ongoing.

Photo 3 Site B pile wall exposed length is approximately 30 m, with 2 to 3 m of pile wall exposed. Photo was taken facing northwest on May 8, 2019.

Site B - Candidate repairs include extending the existing H-pile wall to the north and the addition of pile wall facing (e.g., timber lagging) to minimize material loss between the piles. Drill boreholes and install two additional two slope inclinometers adjacent to the pile-wall.

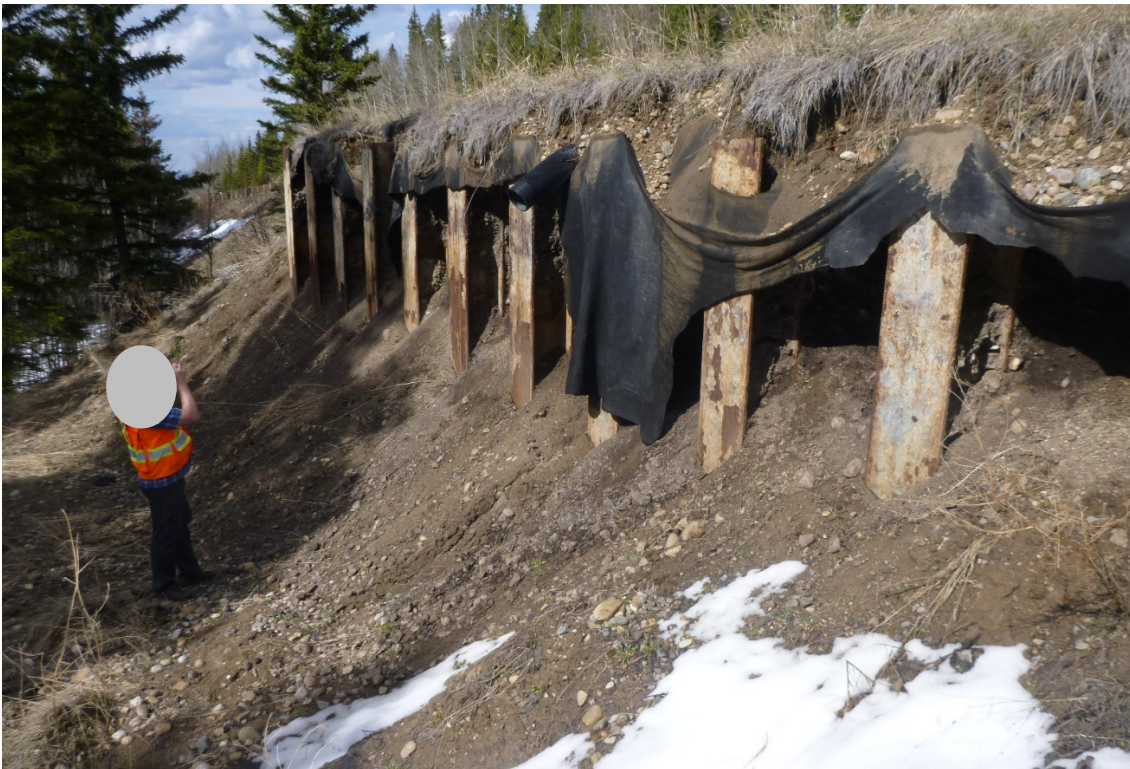
Photo 4 Exposed pile wall with 2 to 3 m of exposed H-pile and voids up to 0.5 m due to washout of material between piles. Photo taken facing north on May 8, 2019.

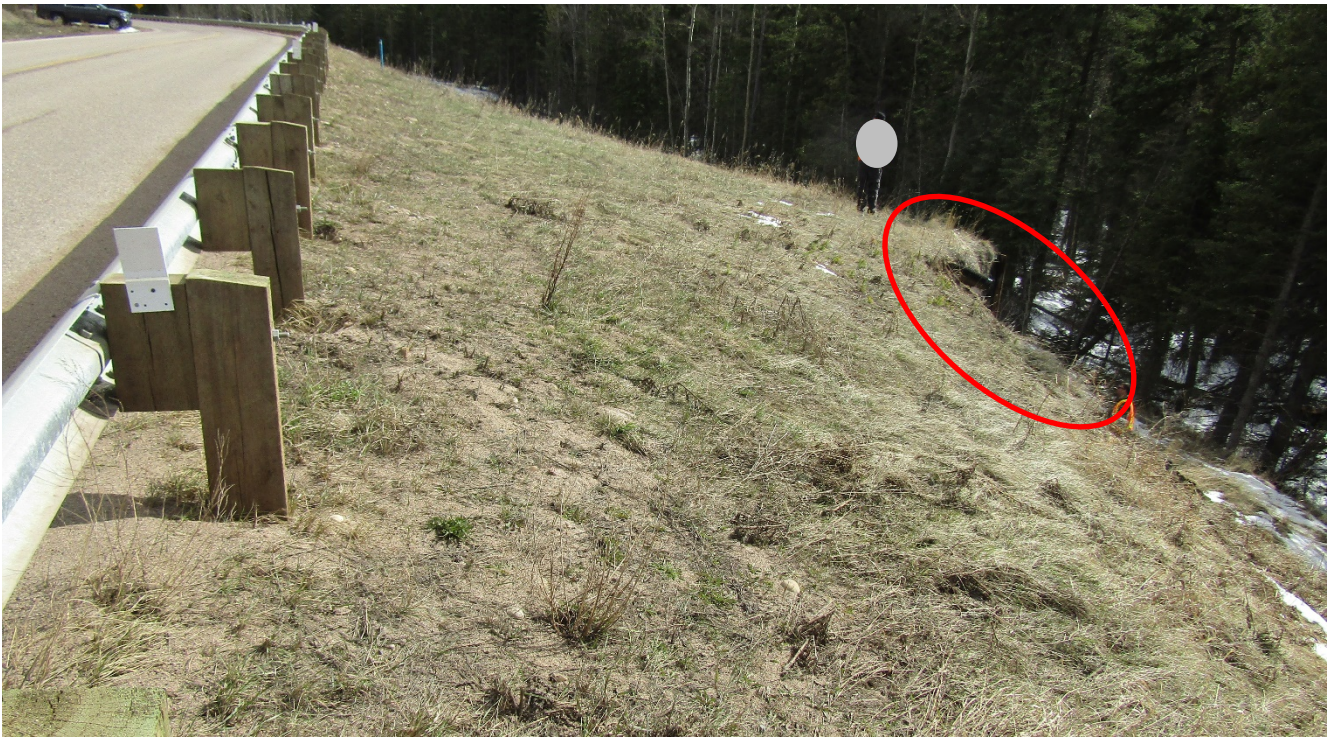
Photo 5 The Site B slide area extends past the north limit of the pile wall (red circle). Photo was taken facing downslope on May 8, 2019.

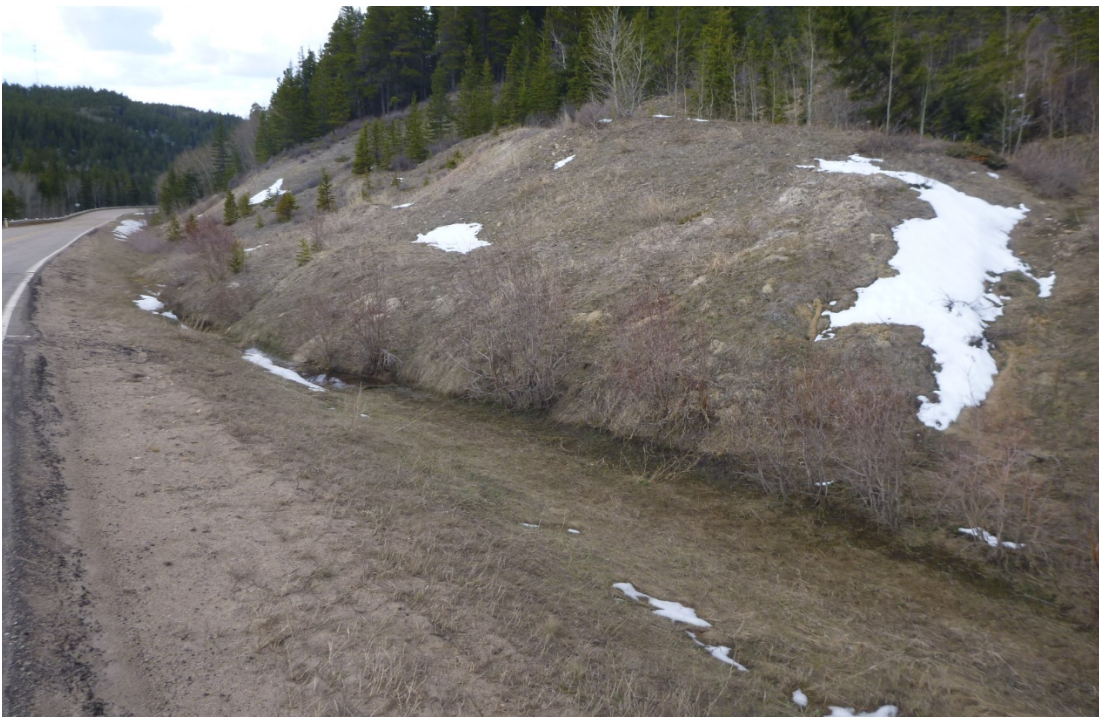
Photo 6 Back slope failure has blocked ditch, leading to standing water in ditch. Photo taken facing northeast on May 8, 2019.

Ditch drainage through the whole S026 area should be improved to minimize infiltration into the slide zones. The highway surface should continue be regraded in areas where it has deflected and cracked, to improve the smoothness of the highway through this site. Highway regrading should include milling the existing asphalt, and not placing more material which adds weight to the failure zones.

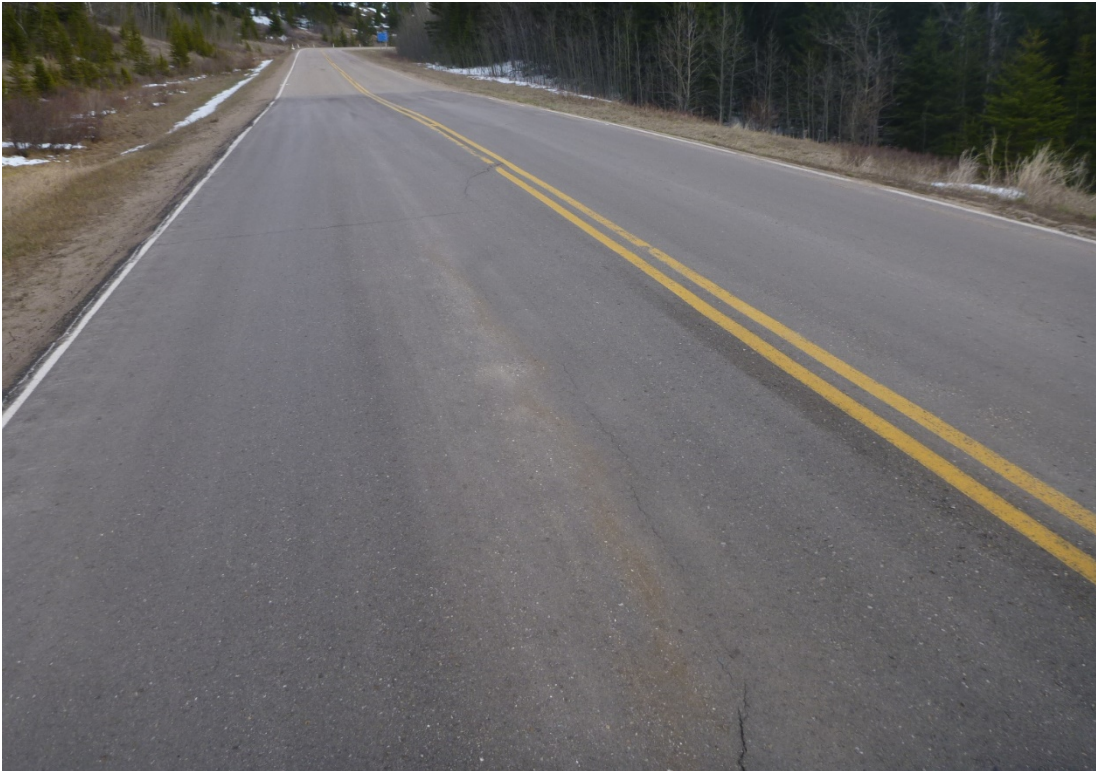
- Ongoing movement observed at the site since the 2018 inspection. Back slope slides are still active and snowplow strikes are visible on the road surface. Cracking has reflected through the recent overlay and settlement of the various slides is visible on the pavement surface.

Photo 7 Cracking has redeveloped through the pavement overlay at Site A. Photo was taken facing north on May 8, 2019.

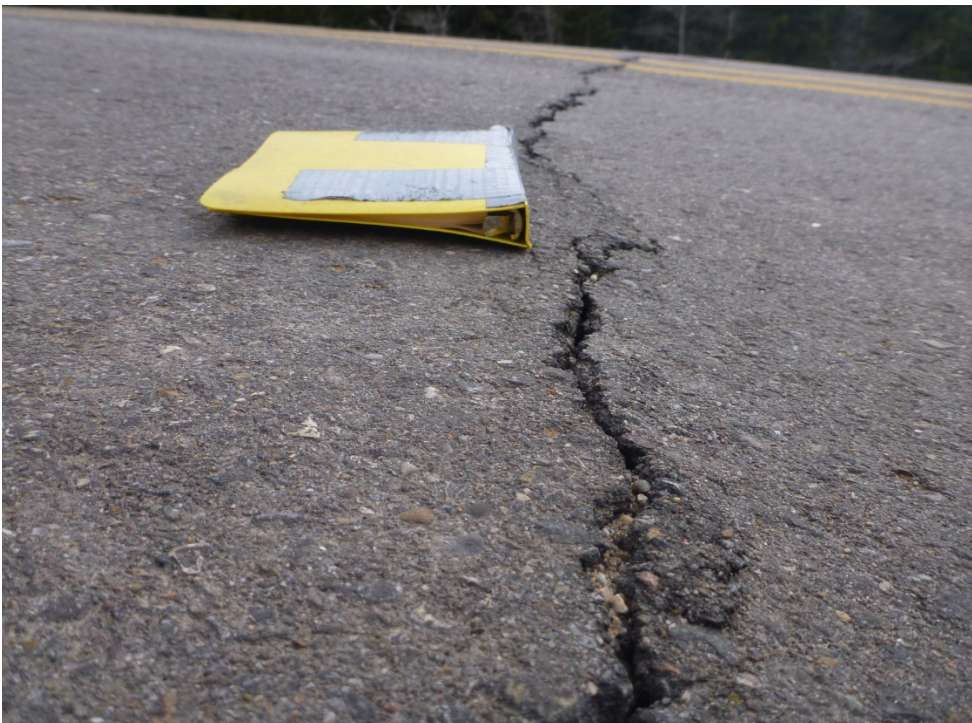
Photo 8 Pavement cracking and settlement at Site A. Photo taken on May 8, 2019.

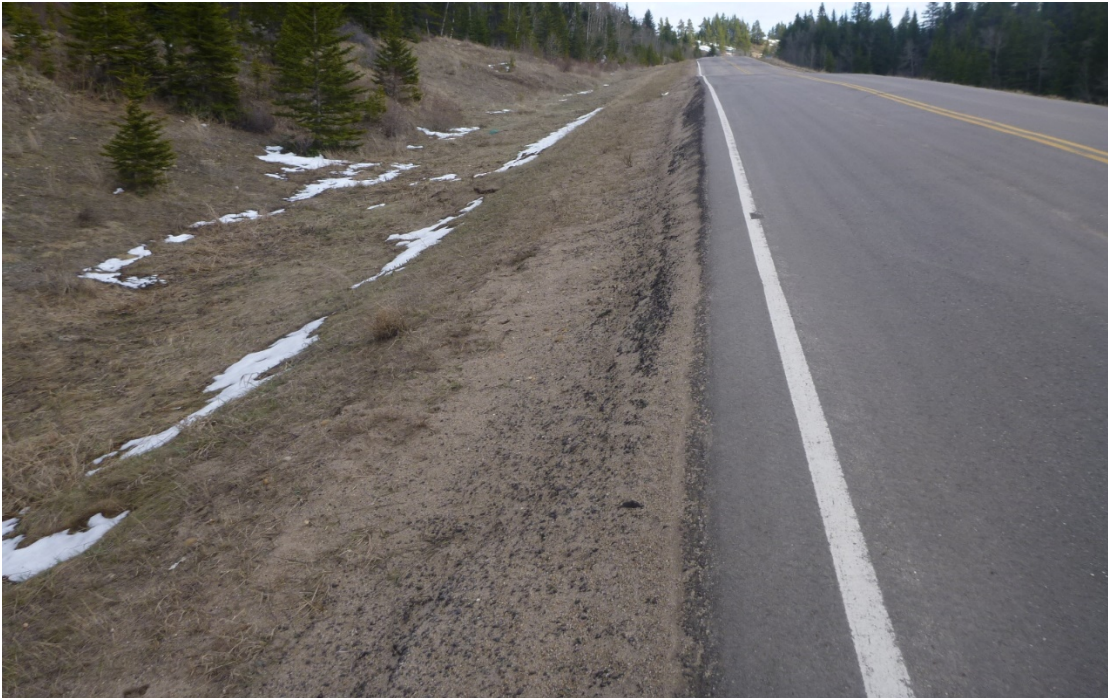
- Fill settlement up to 0.5 m at east edge of pavement. Up to 1.0 m of asphalt exposed at shoulder of highway. Guard rail, HTCB of fill placement is required at locations where steep drop offs are located at the edge of the pavement, due to the narrow shoulder outside of the lanes and to protect road users.

Photo 9 **Narrow shoulder with fill slope dropping up to 0.5 m at east edge of pavement.
Photo taken facing south on May 8, 2019.**

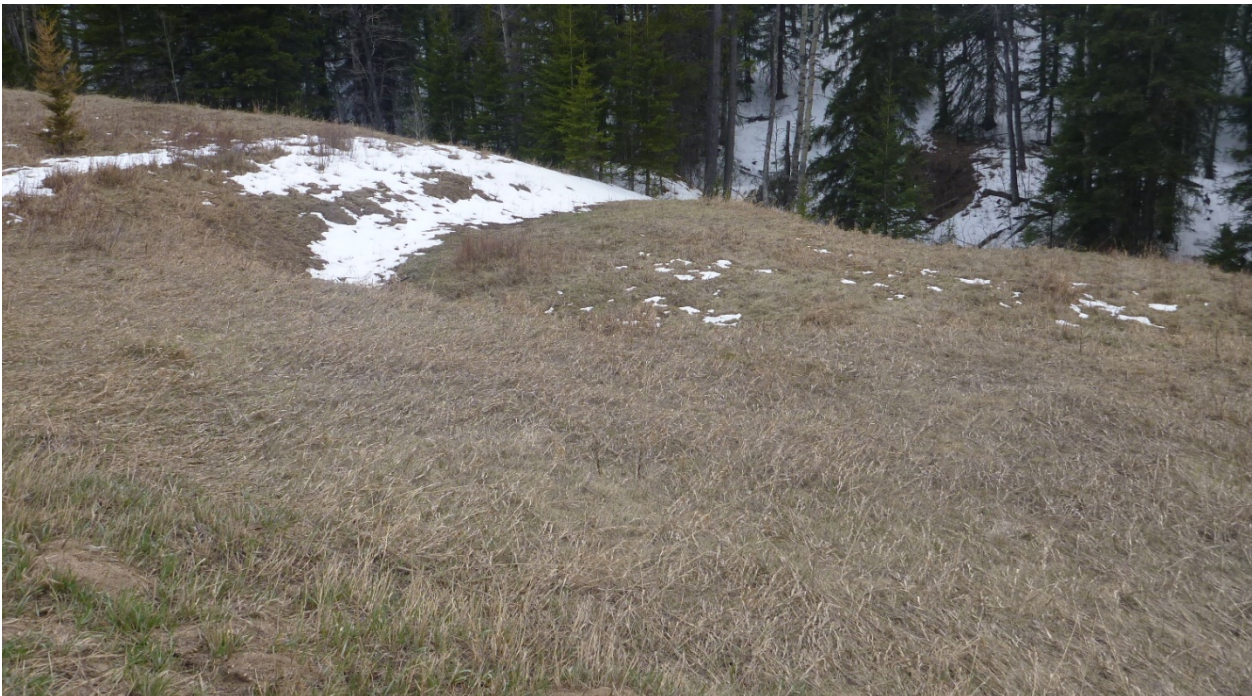
Photo 10 **Back scarp of an embankment slide area, on the west slope at Area A site. Photo
taken facing west on May 8, 2019.**

Site A – Carry out additional ground investigation, including boreholes and installation of additional geotechnical instrumentation, to assess the depth of movement in recently active areas for repair design options evaluation. Potential repair options include additional pile walls in slide areas, with drainage trenches installed at the toe of the landslide zone to lower the groundwater table and improve slope stability.
