SITE NUMBER AND NAME: S026 Elkwater Slides		HIGHWAY & KM: 41:03, 35.169	PREVIOUS INSPECTION DATE: May 8, 2019	INSPECTION DATE: July 7, 2021
LEGAL DESCRIPTION SE-18-008-02 W4M and 16-07-008-02 W4M	NAD 83 COORDINATES: UTM Northing Easting 12 5499046 553536		RISK ASSESMENT: Site A: PF: 6 CF: 4 TOTAL: 24 (Slides) Site B: PF: 7 CF: 4 TOTAL: 28 (Pile wall)	
AVERAGE ANNUAL DAILY TRAFFIC (AADT): 680 (north), 430 (south), (Ref. No. 138060)			CONTRACTOR MAINTENANCE AREA (CMA): 23

PROJECT SOUTHERN REGION GEOHAZARD RISK MANAGEMENT PROGRAM		
TITLE Site Plan S026 - Elkwater Slides Hwy 41.03; km 35.169		
SCALE 1:5,000	PROJECT No. A05116A03	FIG No. 1

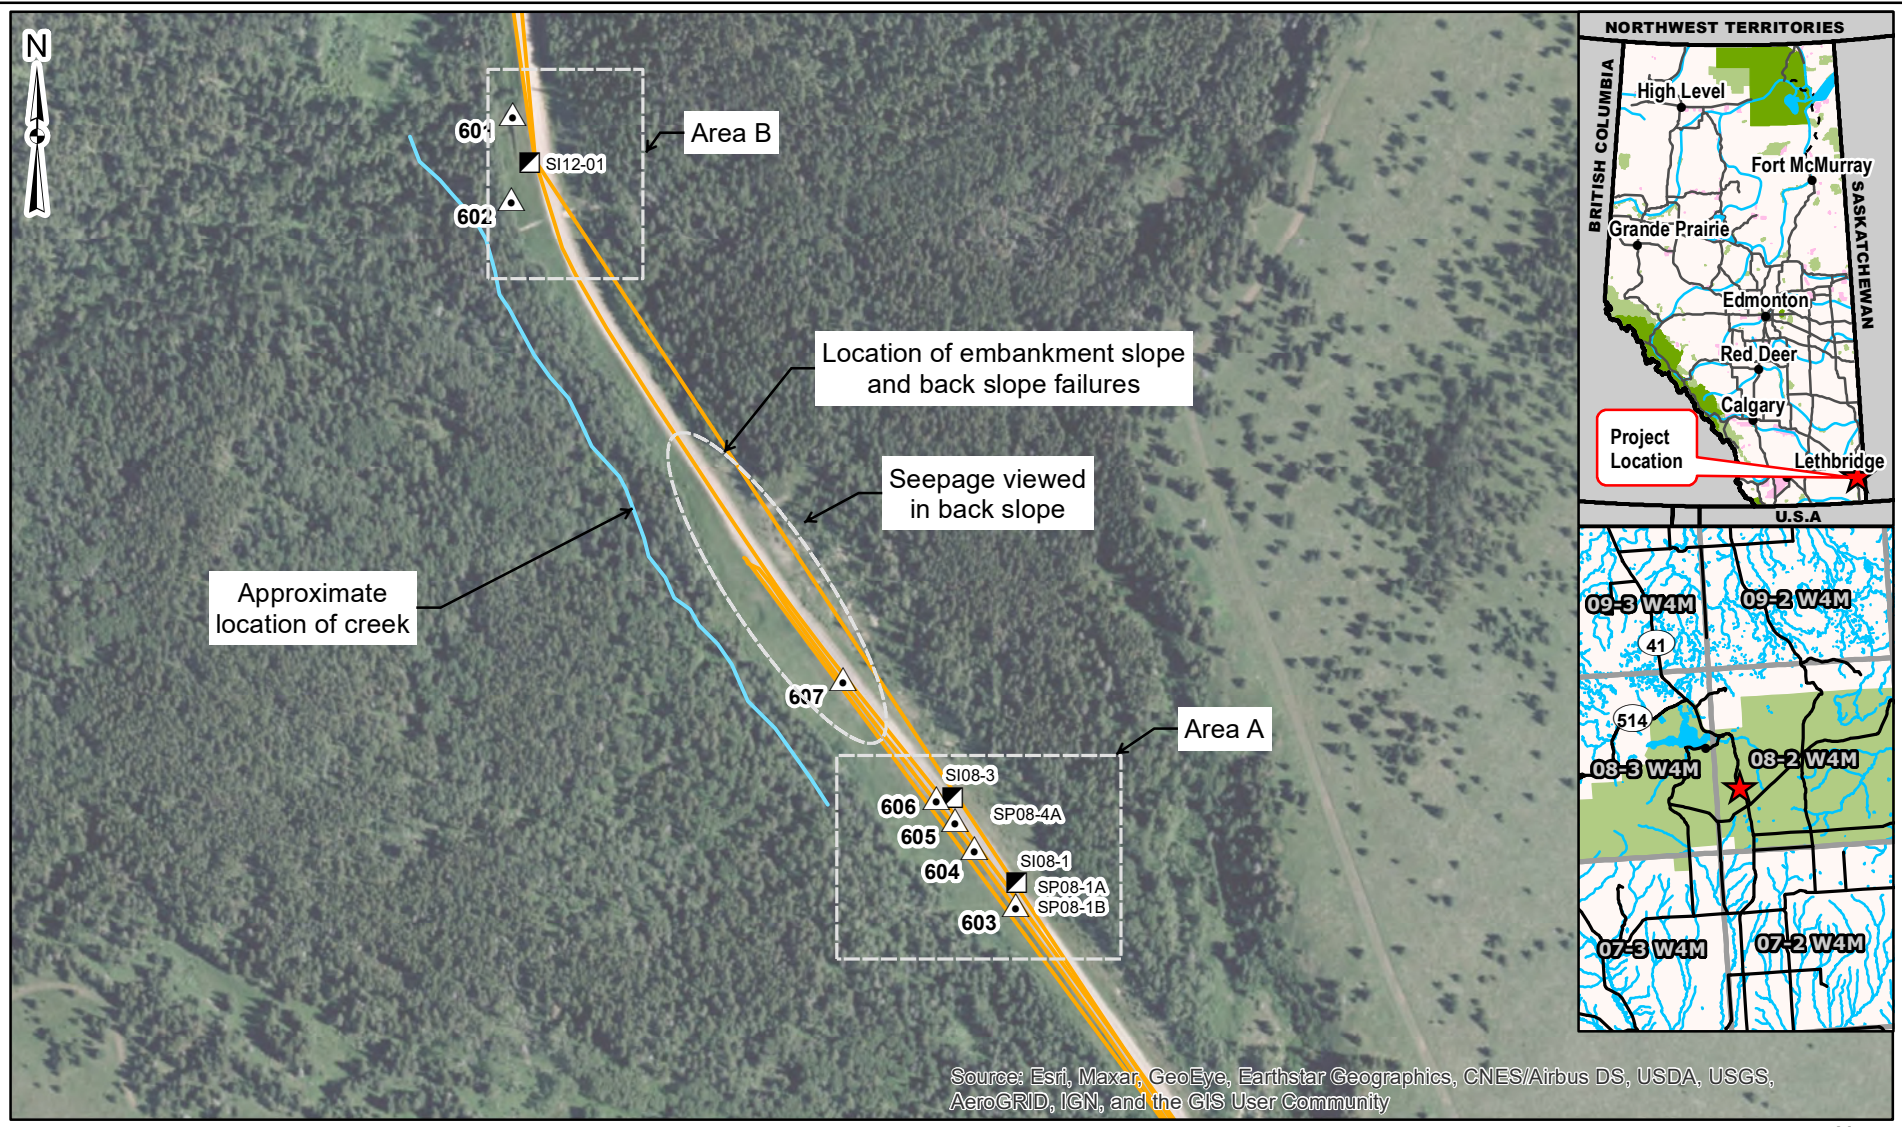
Site B: H-pile wall 60 m long constructed at Site B in 2012 (waypoints 601 and 602 mark the extents of the pile wall in Figure 1) The pile wall repair was preceded by a temporary repair consisting of slope excavation and reconstruction, and a soil nailing program.

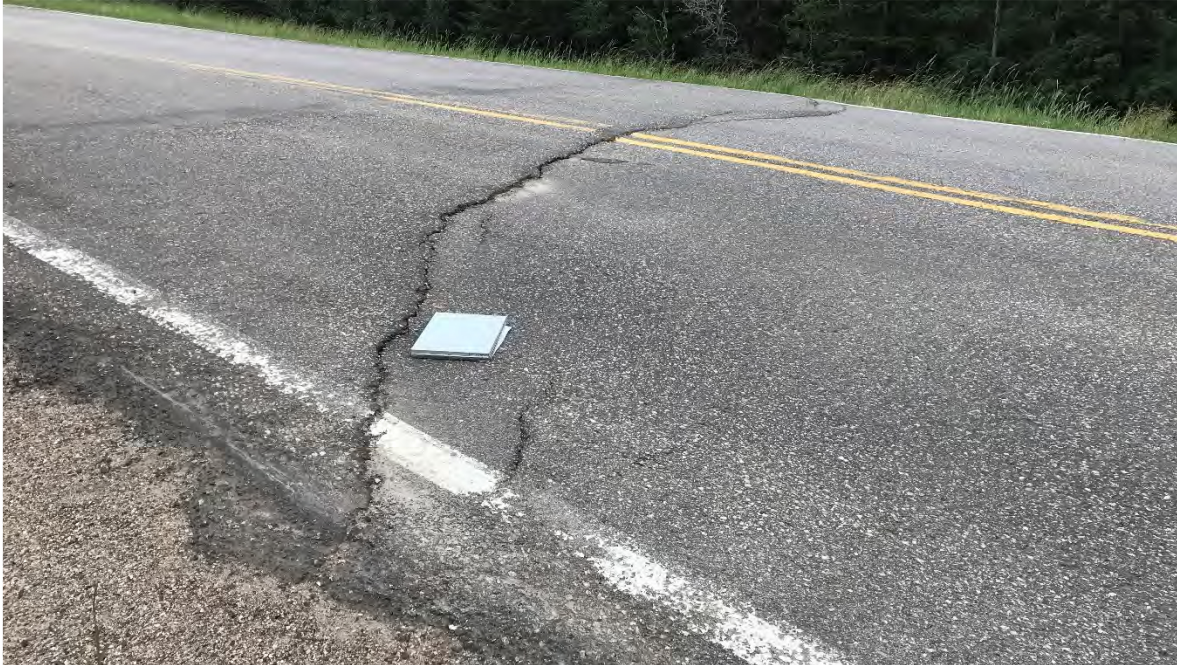
Ongoing movement observed at the site since 2018. Back slope slides are still active and snowplow strikes are visible on the road surface. Cracking has reflected through the recent overlay and settlement of the various slides is visible on the pavement surface. Deformation since 2018 is small-scale but ongoing, however there have been no sudden changes at the site.

Photo 1 **Site A: Cracking has redeveloped through the pavement overlay. Photo was taken facing south on July 7, 2021.**

Ditch drainage through the whole S026 area should be improved to minimize infiltration into the slide zones. The highway surface should continue be regraded in areas where it has deflected and cracked, to improve the smoothness of the highway through this site. Highway regrading should include milling the existing asphalt, and not placing more material which adds weight to the failure zones.

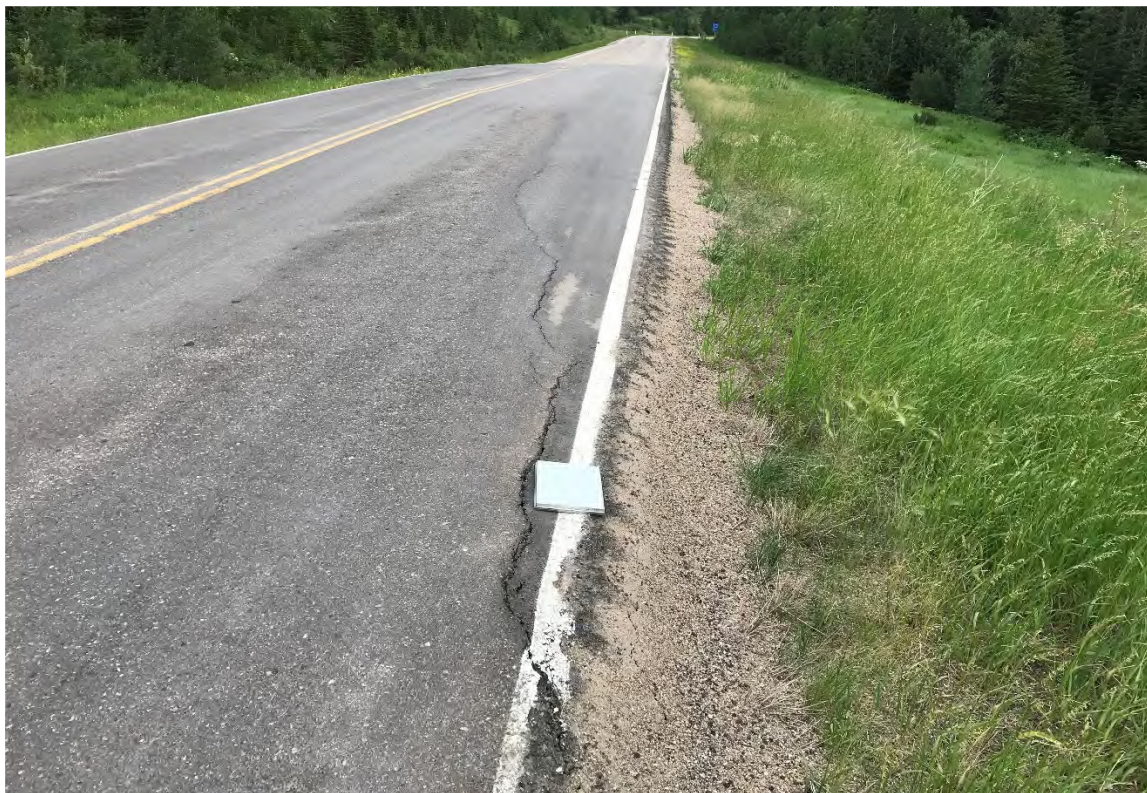
Photo 2 **Site A: Pavement cracking. Photo was taken facing southeast on July 7, 2021.**

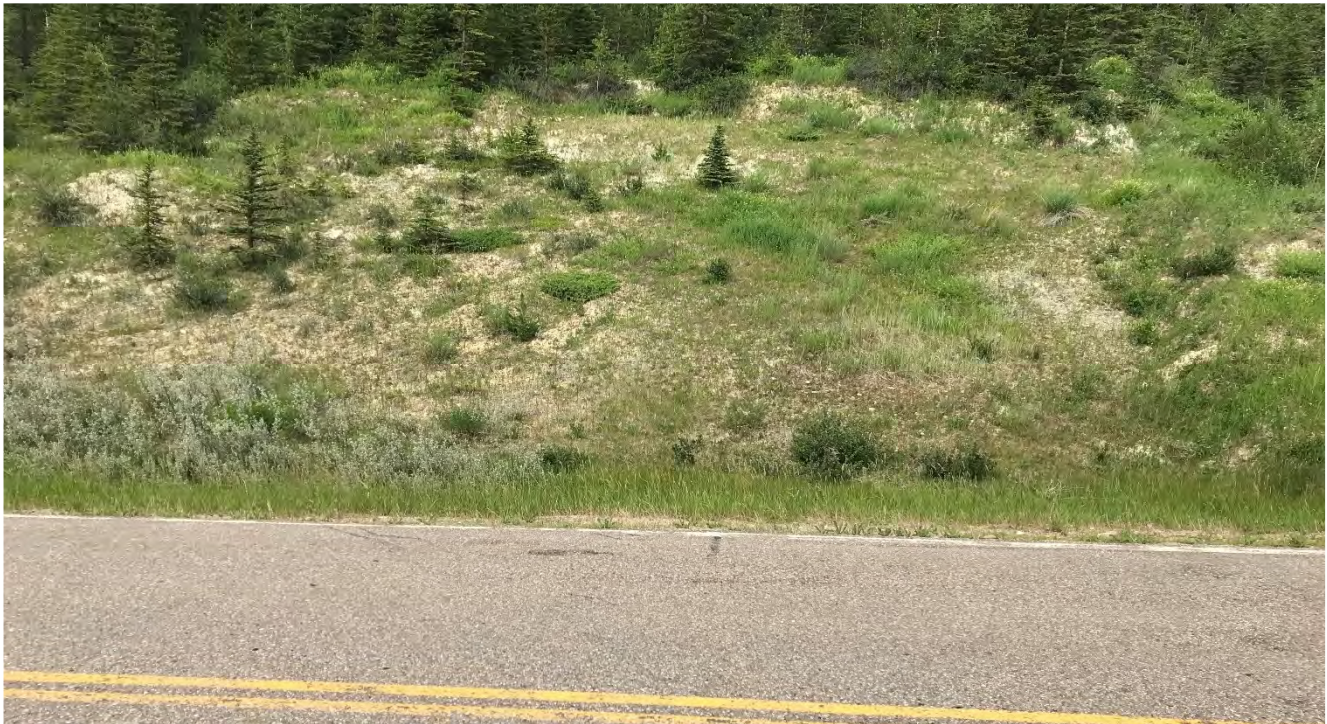
Photo 3 **Site A: Backslope instability is visible for the full length of the site. Photo was taken facing east on July 7, 2021.**

Site A – Carry out additional ground investigation, including boreholes and installation of additional geotechnical instrumentation, to assess the depth of movement in recently active areas for repair design options evaluation. Potential repair options include additional pile walls in slide areas, with drainage trenches installed at the toe of the landslide zone to lower the groundwater table and improve slope stability.

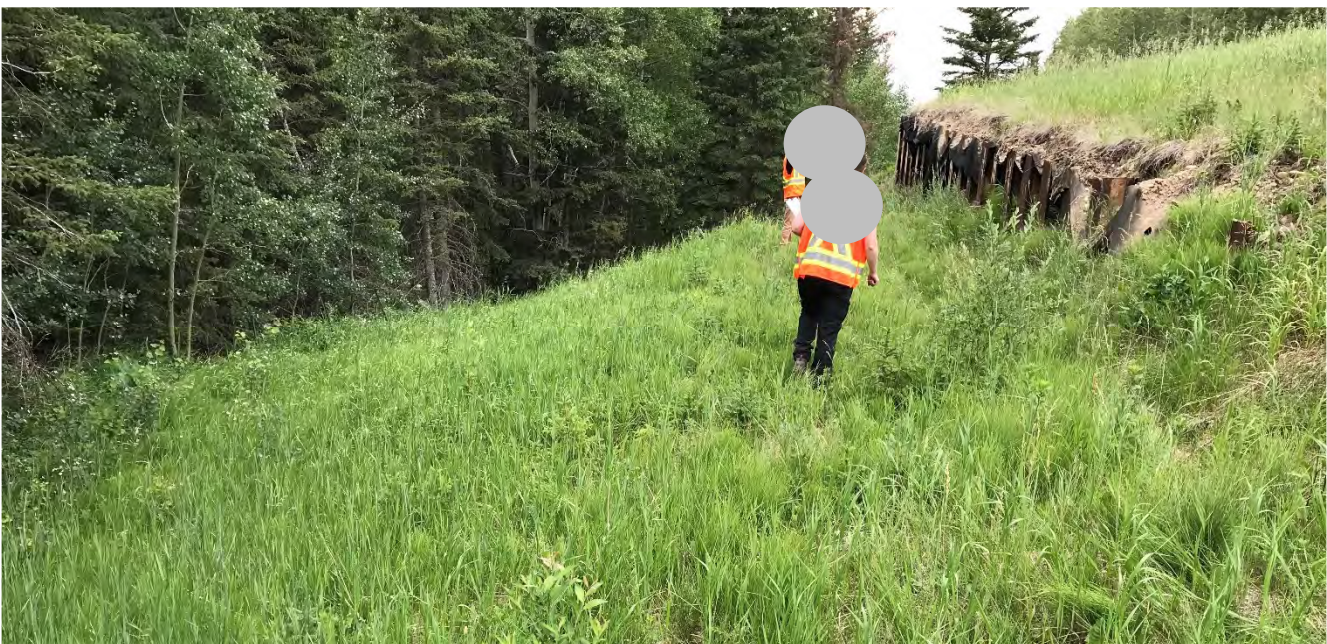
The pile wall at Site B has been exposed by soil sliding downslope of the wall. KCB monitors the wall during spring and fall instrument readings. There have been no significant changes when compared to 2019 observations. A small amount of ground cracking was observed between the highway and pile wall.

Photo 4 **Site B: Pile wall is located downslope to the west of the highway. Soil sliding downslope of the wall has exposed 2 to 3 m of steel pile over a length of approximately 30 m. Photo was taken facing northwest on July 7, 2021.**

Site B - Candidate repairs include extending the existing H-pile wall to the north and the addition of timber lagging between H-piles to minimize material loss from between the piles (this work could be completed by the HMC). Drill boreholes and install two additional two slope inclinometers adjacent to the pile-wall.

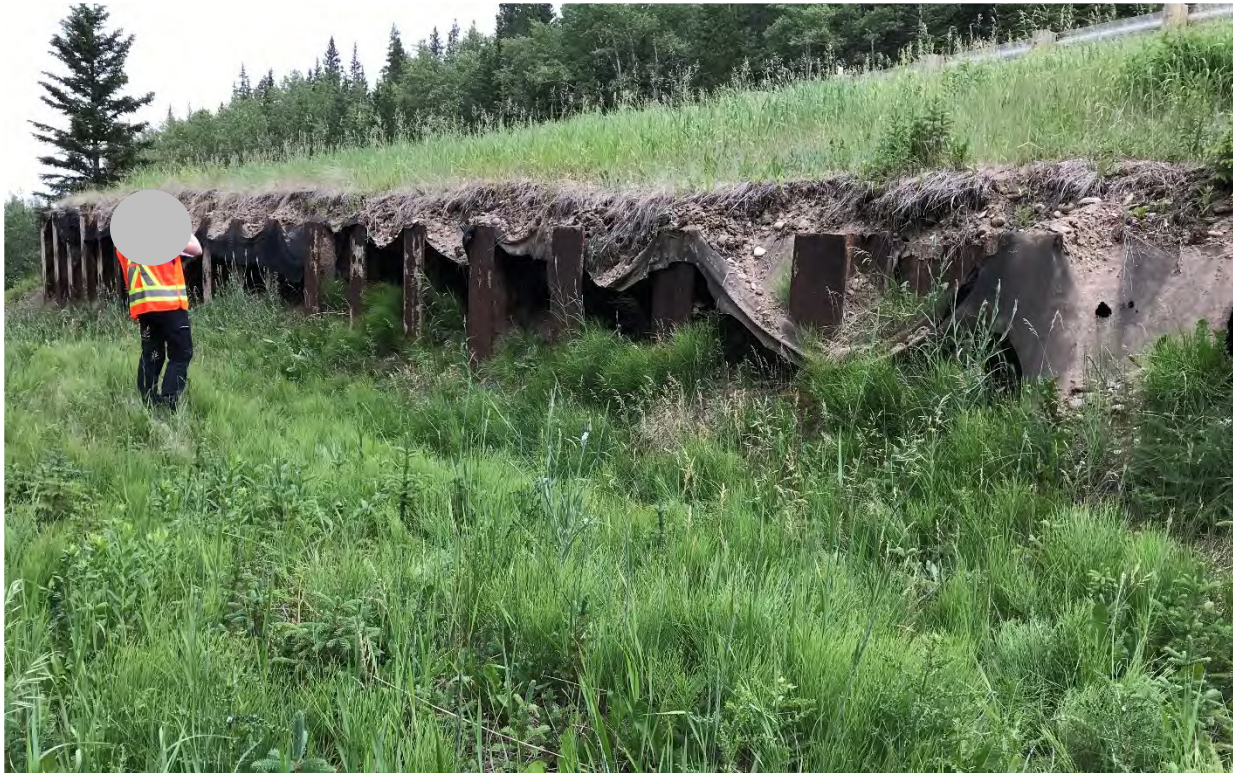
Slope movements below pile wall have exposed the piles over a length of 30 m at the north limit of the wall. The piles were measured as leaning between 0.2° and 0.6° from vertical in 2018. The upper 2 to 3 m of pile wall is exposed and unsupported. Below the exposed section of H-piles is a 2 m high section where sloughed material from between and behind the pile wall has eroded out and covered the piles. Voids are up to 0.5 m deep behind the pile wall, and erosion is ongoing. Sloughing is due to seepage and infiltration.

Photo 5 Site B: Soil sliding downslope of the wall has exposed 2 to 3 m of steel pile over a length of approximately 30 m. Photo was taken facing north on July 7, 2021.

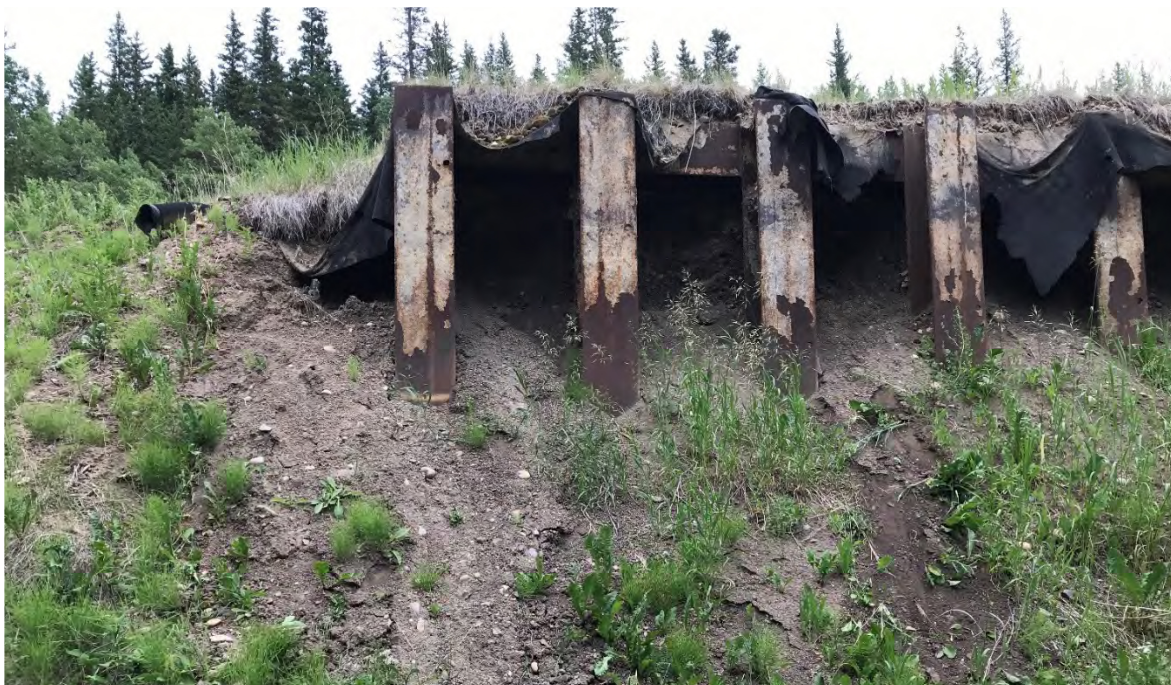
Photo 6 Site B: Erosion of material between piles has contributed to voids up to 0.5 m behind the wall. Photo taken facing north on July 7, 2021.

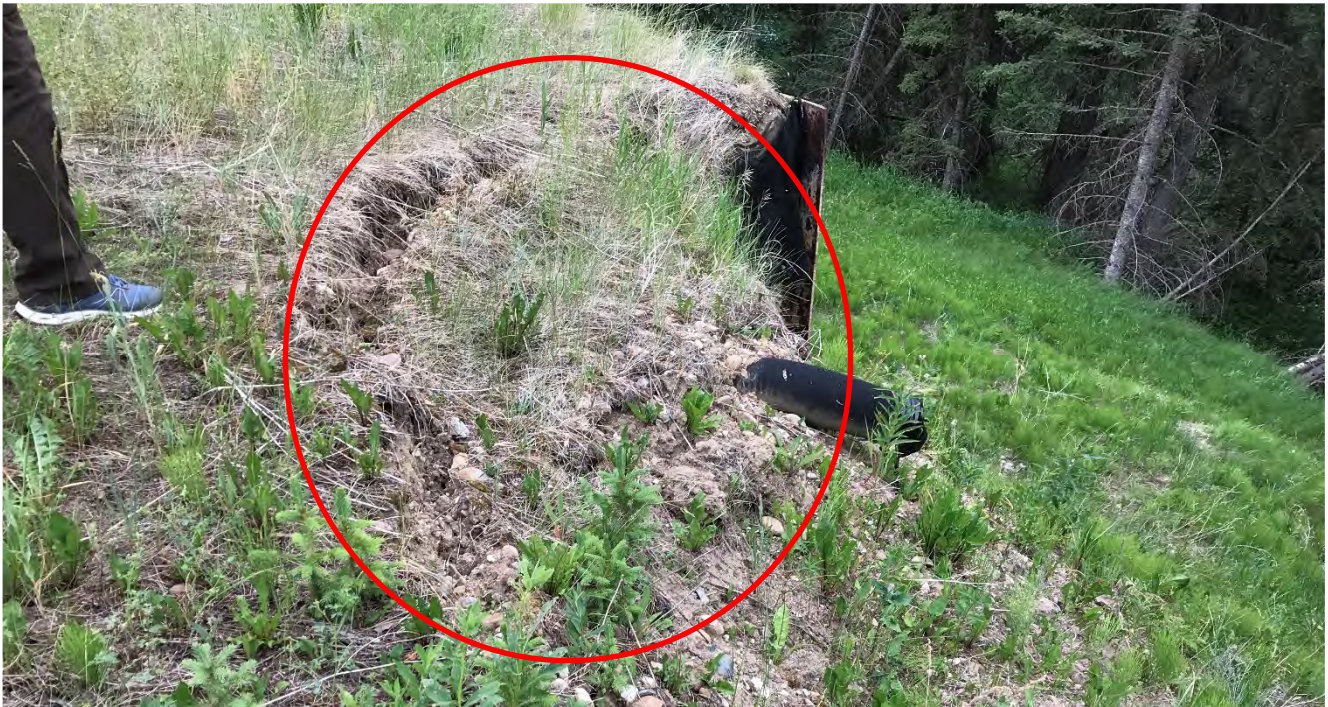
Photo 7 **Site B: Sloughing at the north limit of the pile wall (red circle). Photo was taken facing downslope on July 7, 2021.**

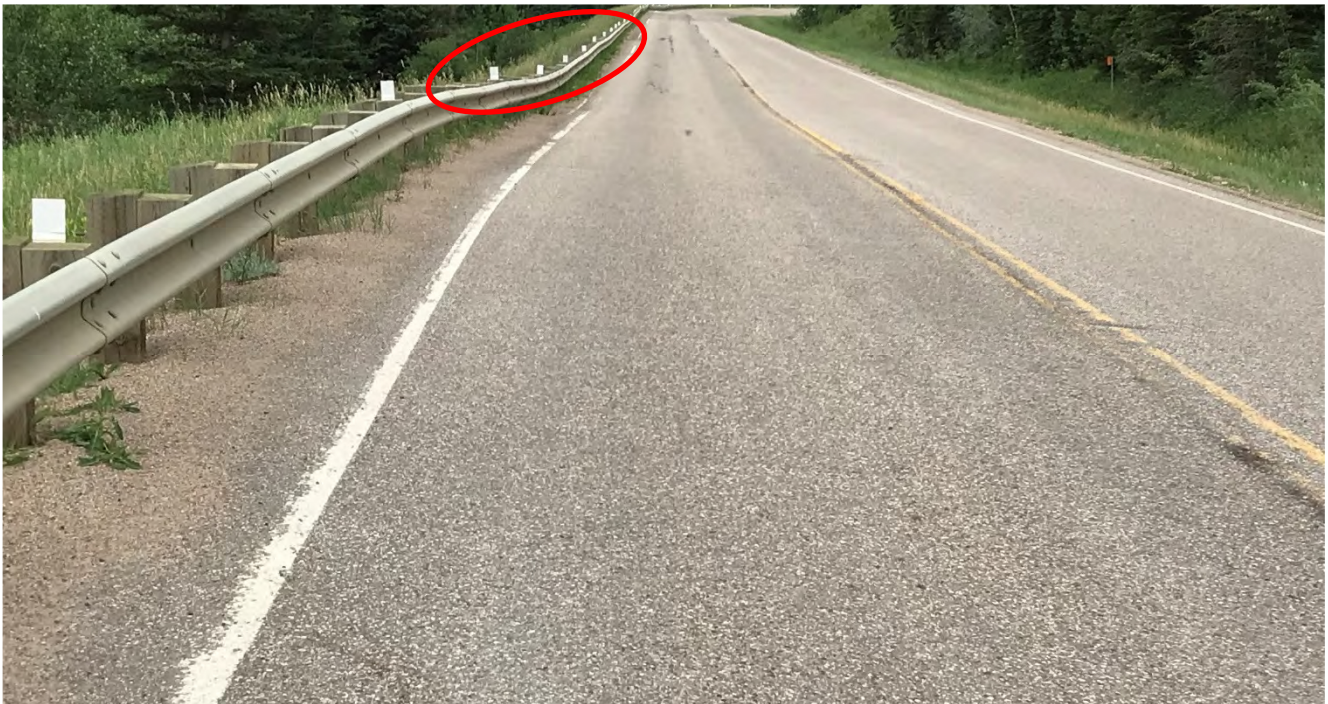
Cracking and slope movement is also present north of the northern extent of the pile wall, outflanking the pile wall. The guardrail at the north edge of the pile wall has a noticeable dip.

Photo 8 **Site B: Dip in guard rail north of the pile wall. Photo taken facing north on July 7, 2021.**
