September 21, 2022

Alberta Transportation
2nd Floor, 803 Manning Road N.E.
Calgary, Alberta
T2E 7M8

**CON0022161 Southern Region GRMP Instrumentation Monitoring
Site S026; H41:03, km 35.169 Elkwater Slides
Section C – 2022 Spring Readings**

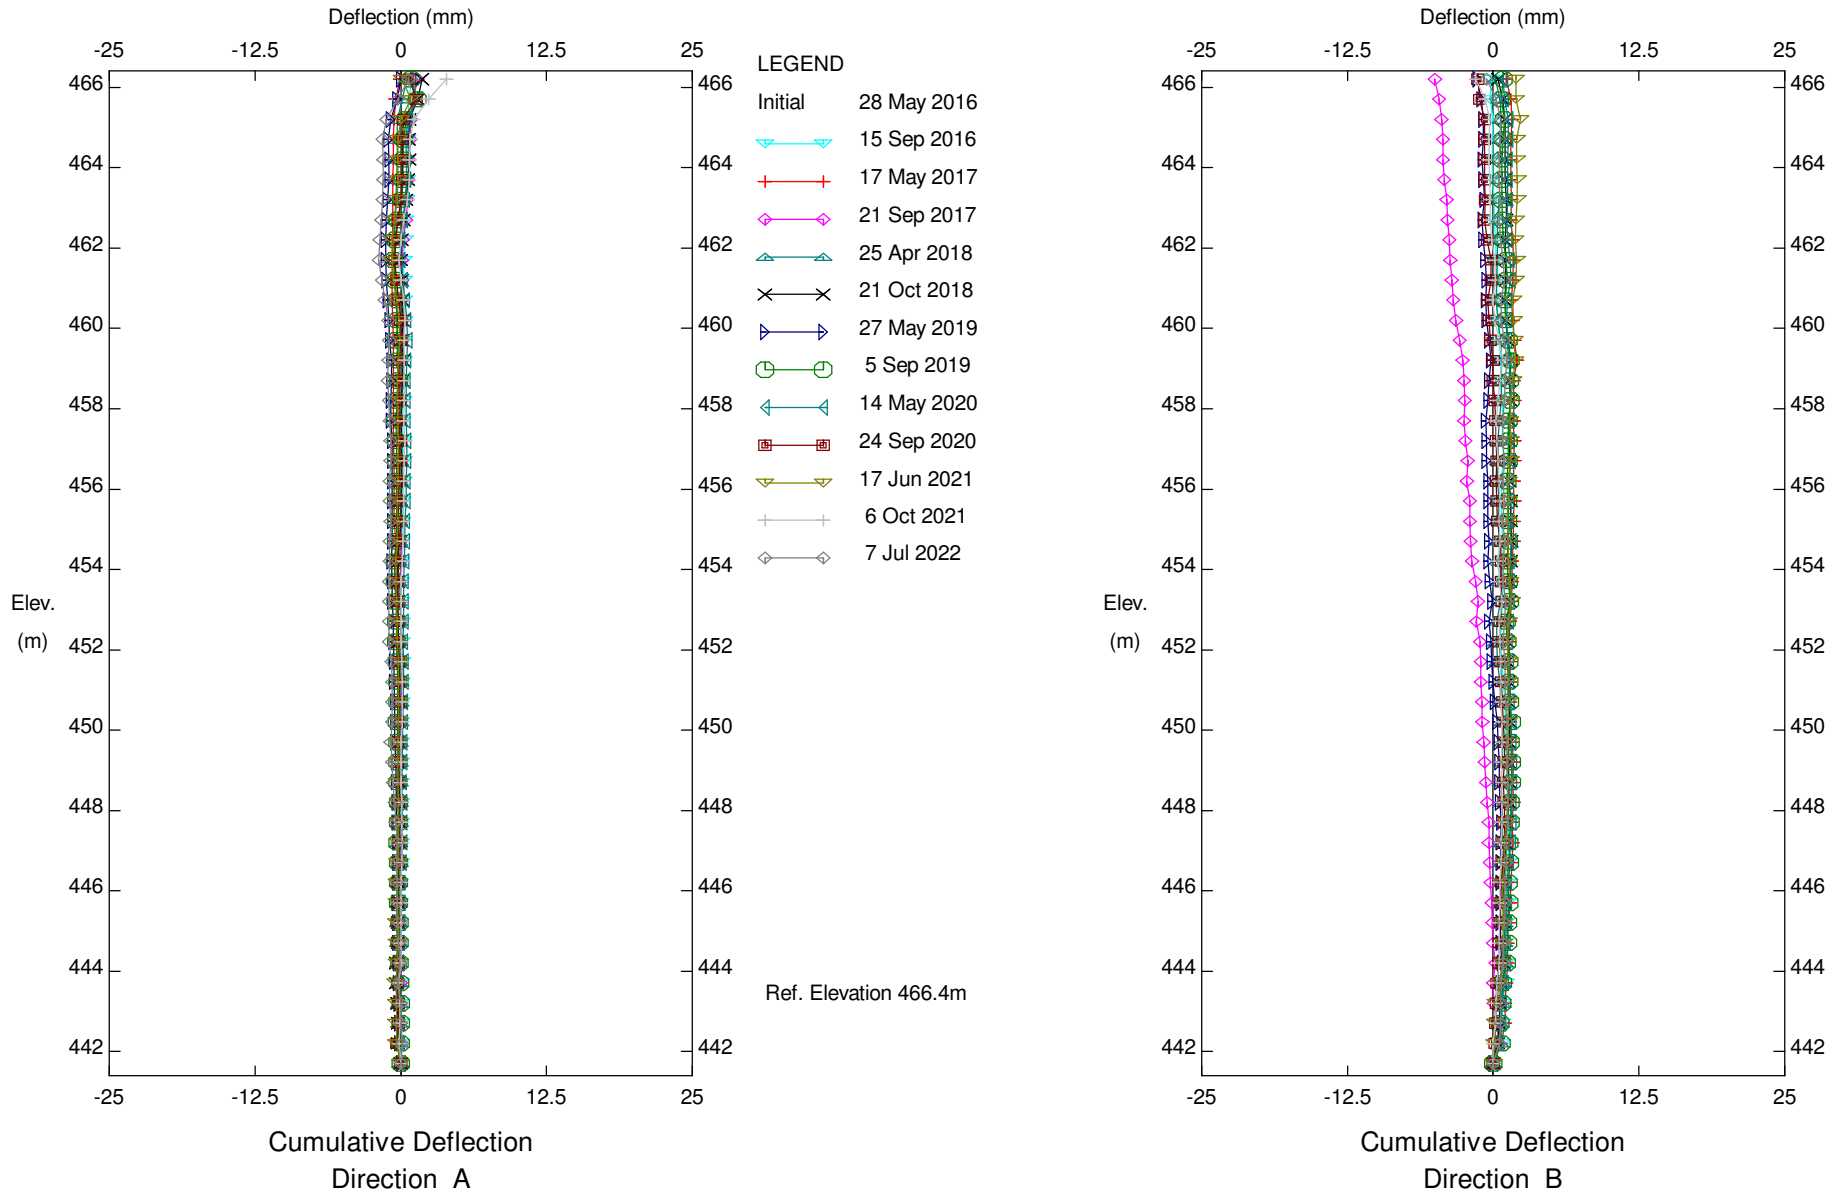
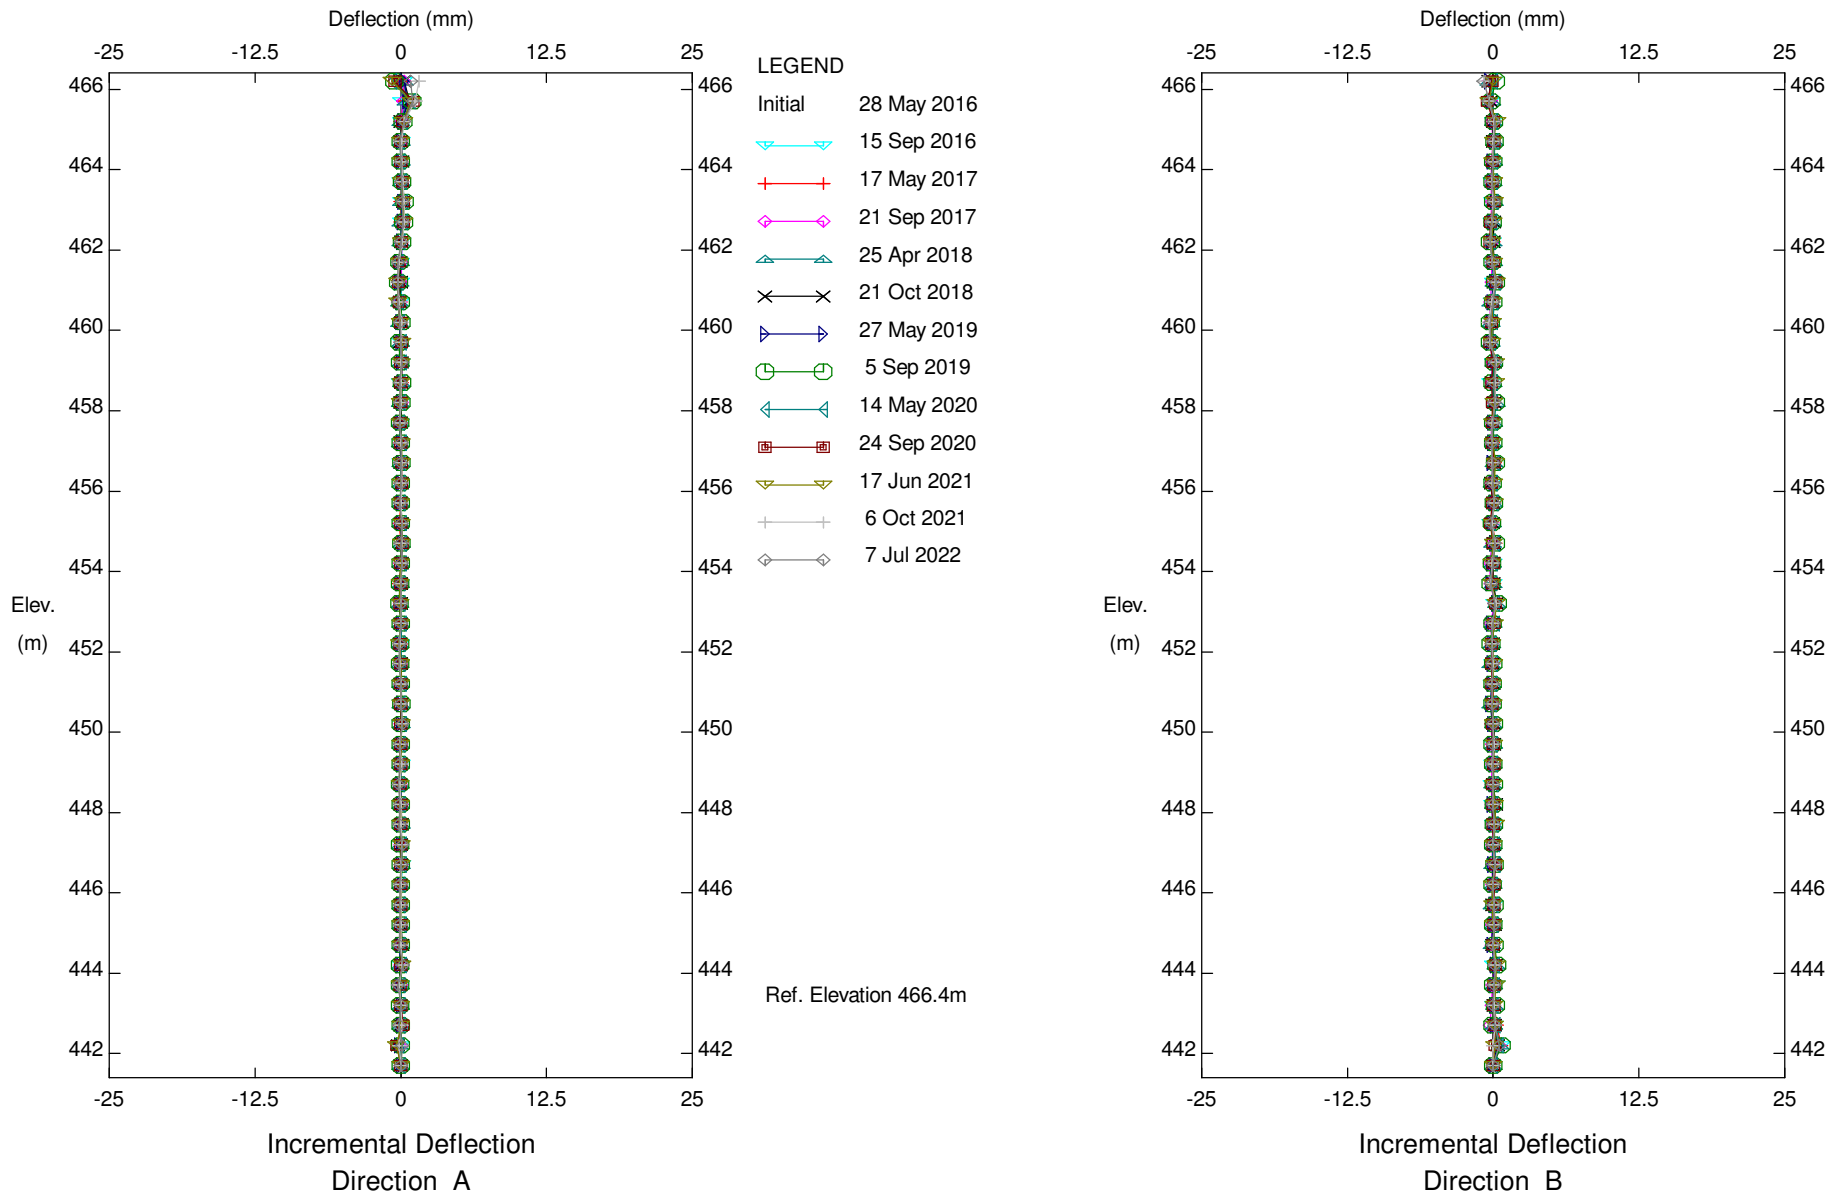
S026; H41:03, Elkwater Slides, Area A, Inclinometer SI08-1
Alberta Transportation

No discernible movement has been recorded in SI08-01 or SI08-03.

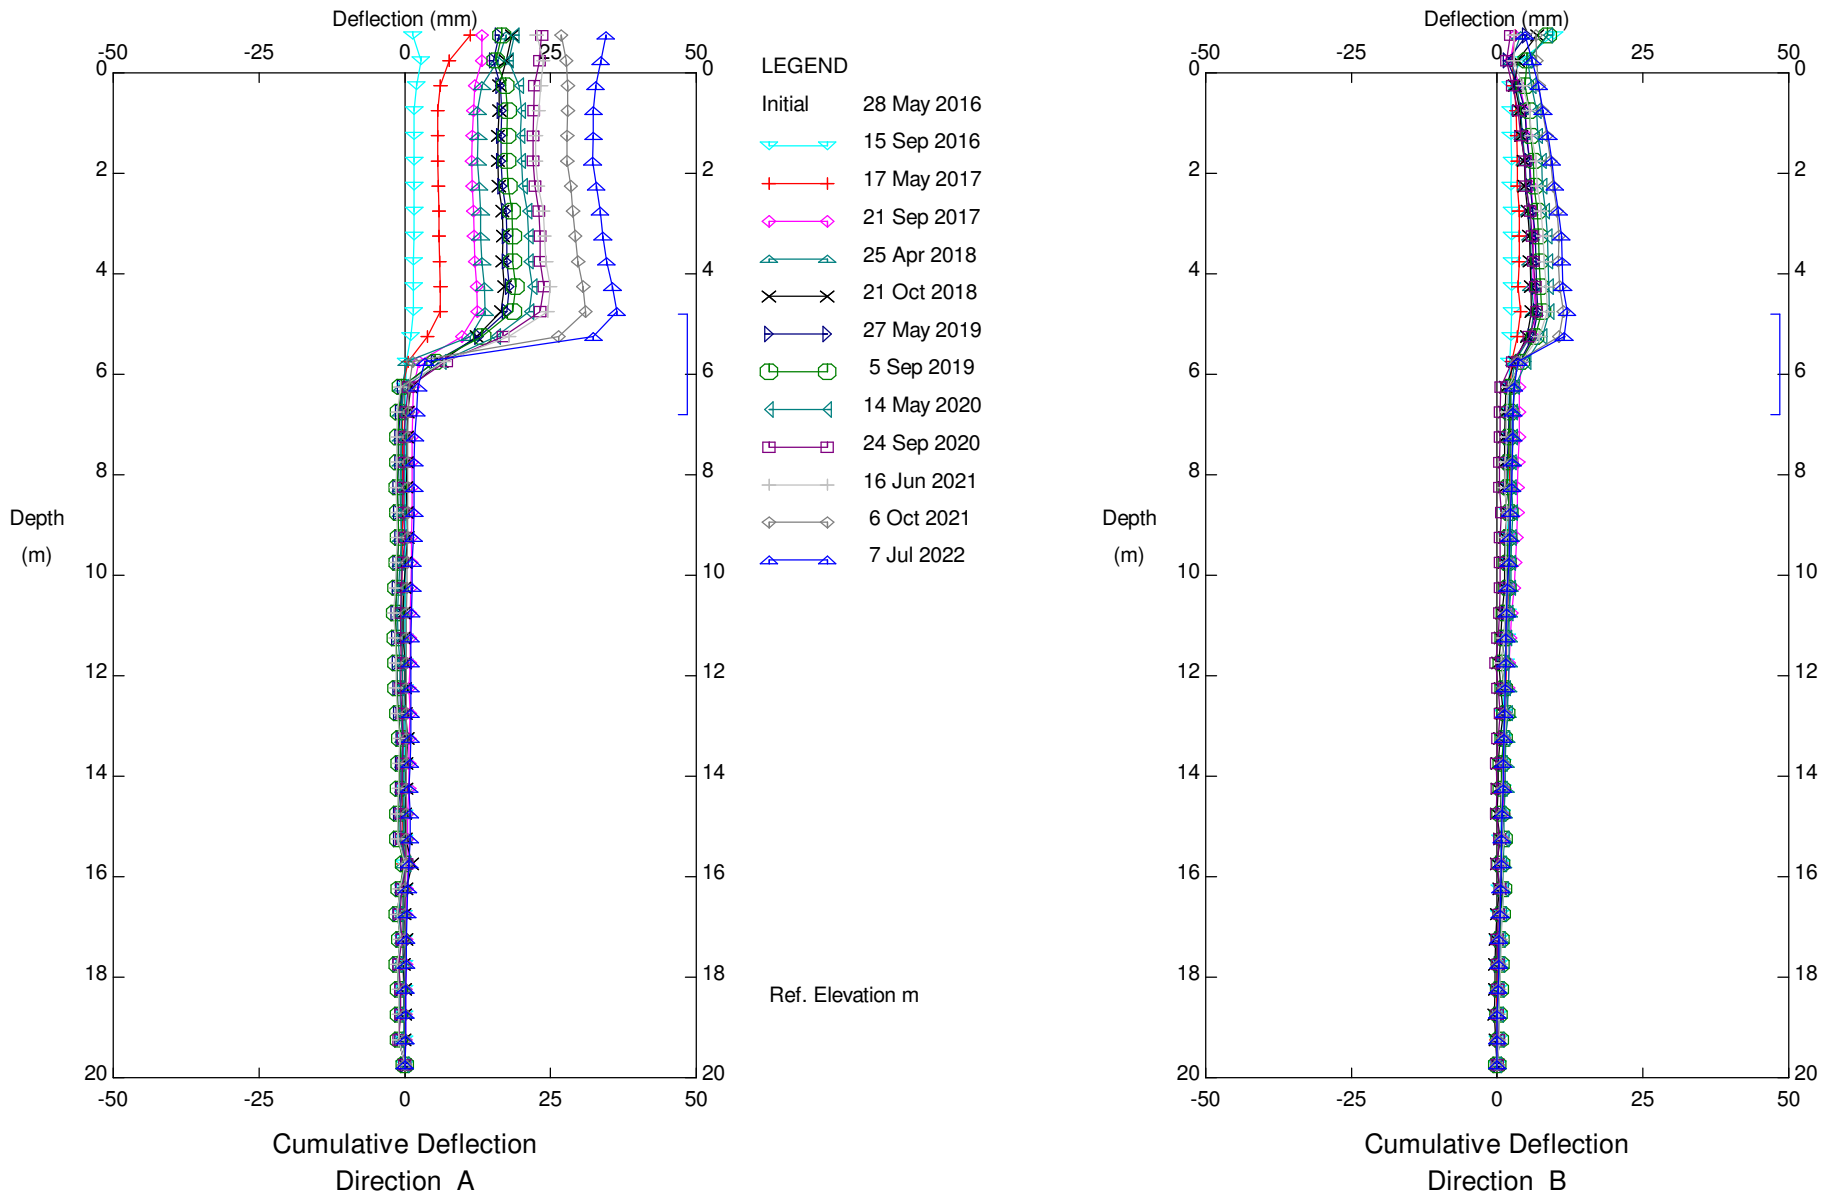
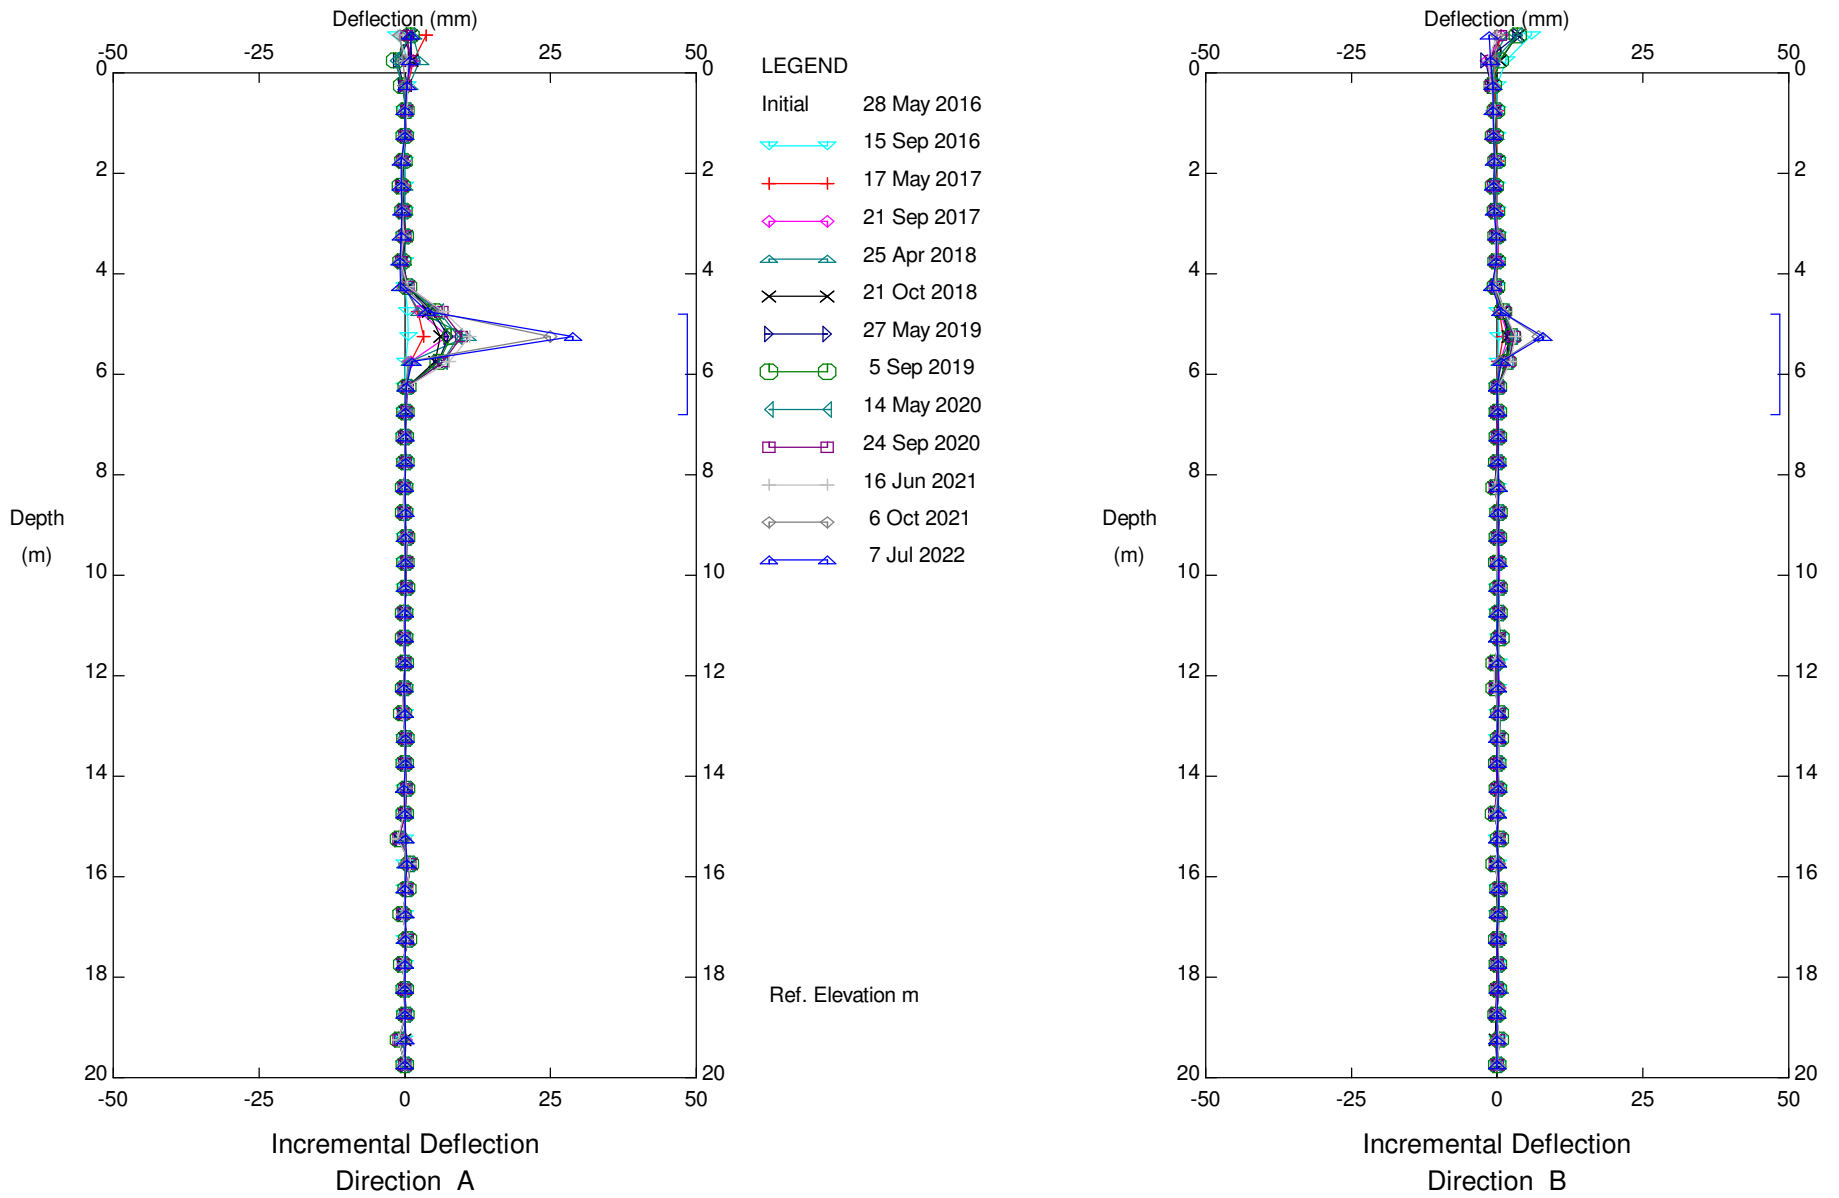
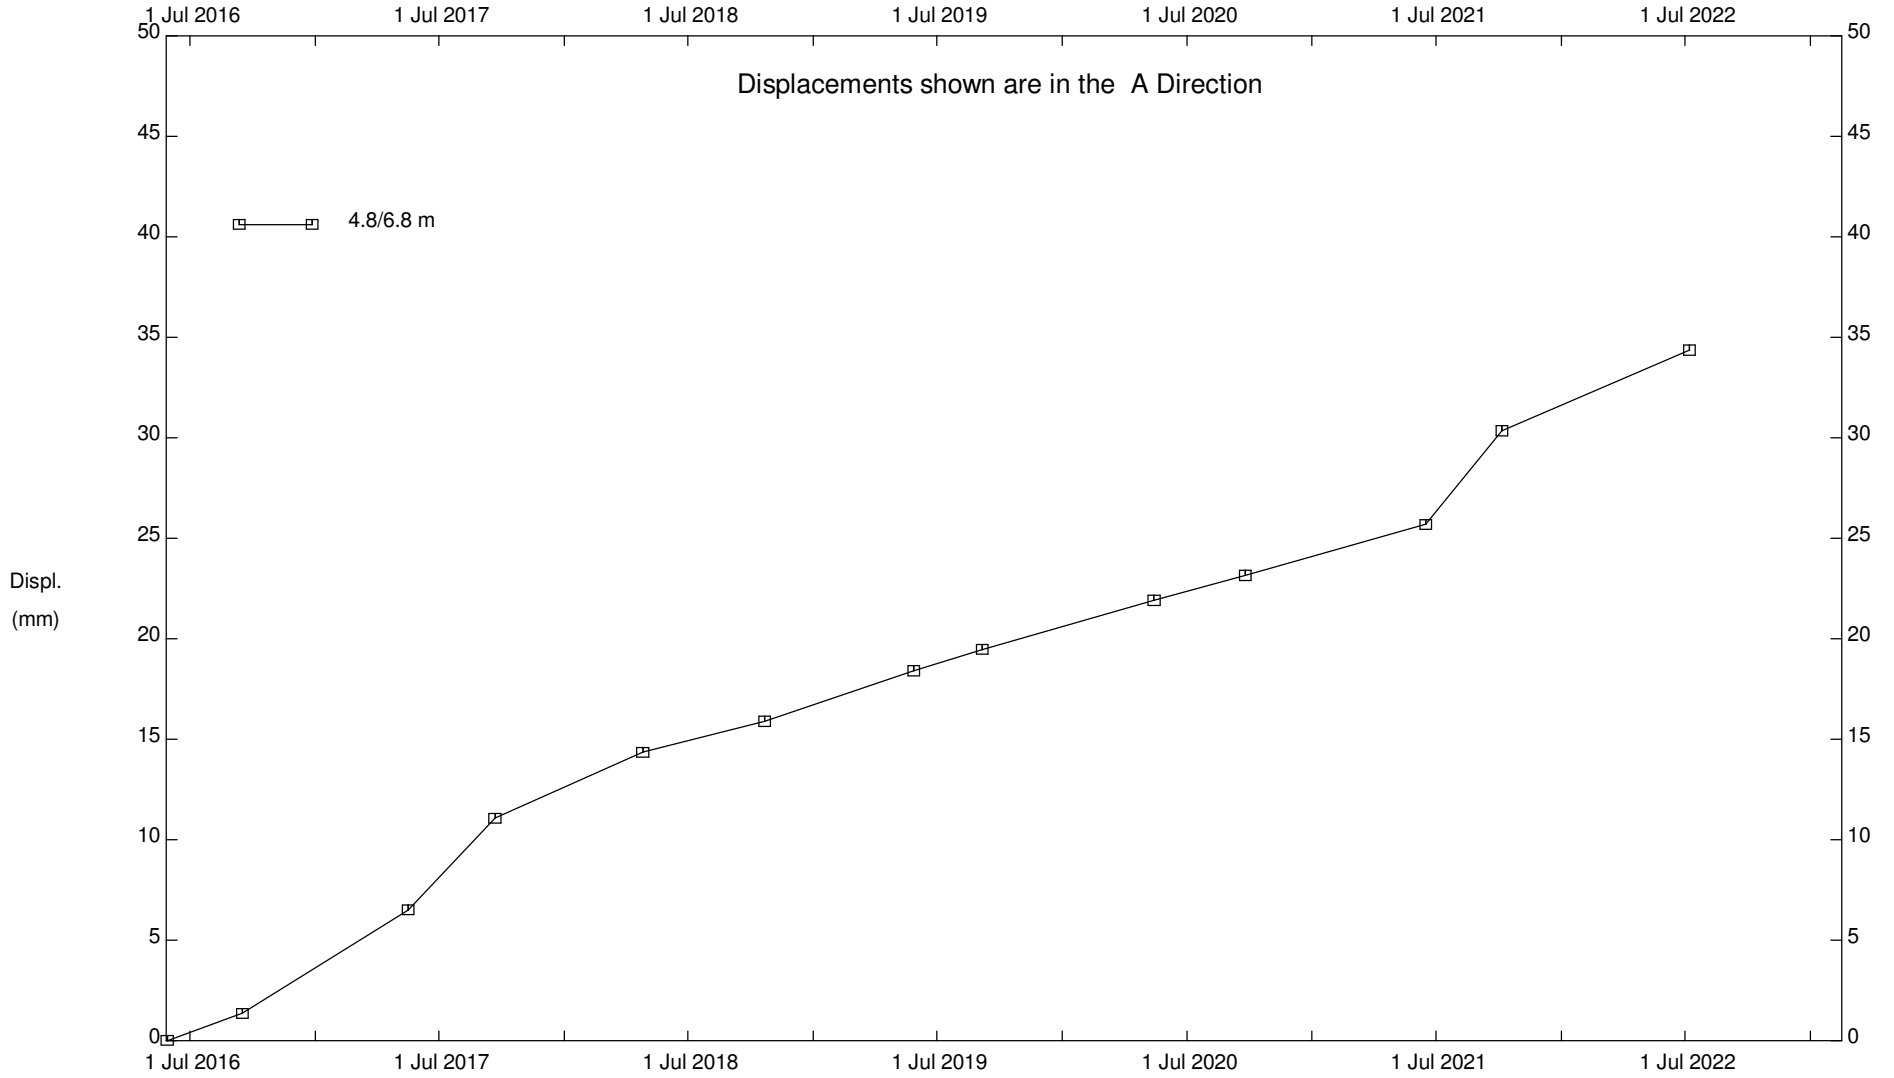
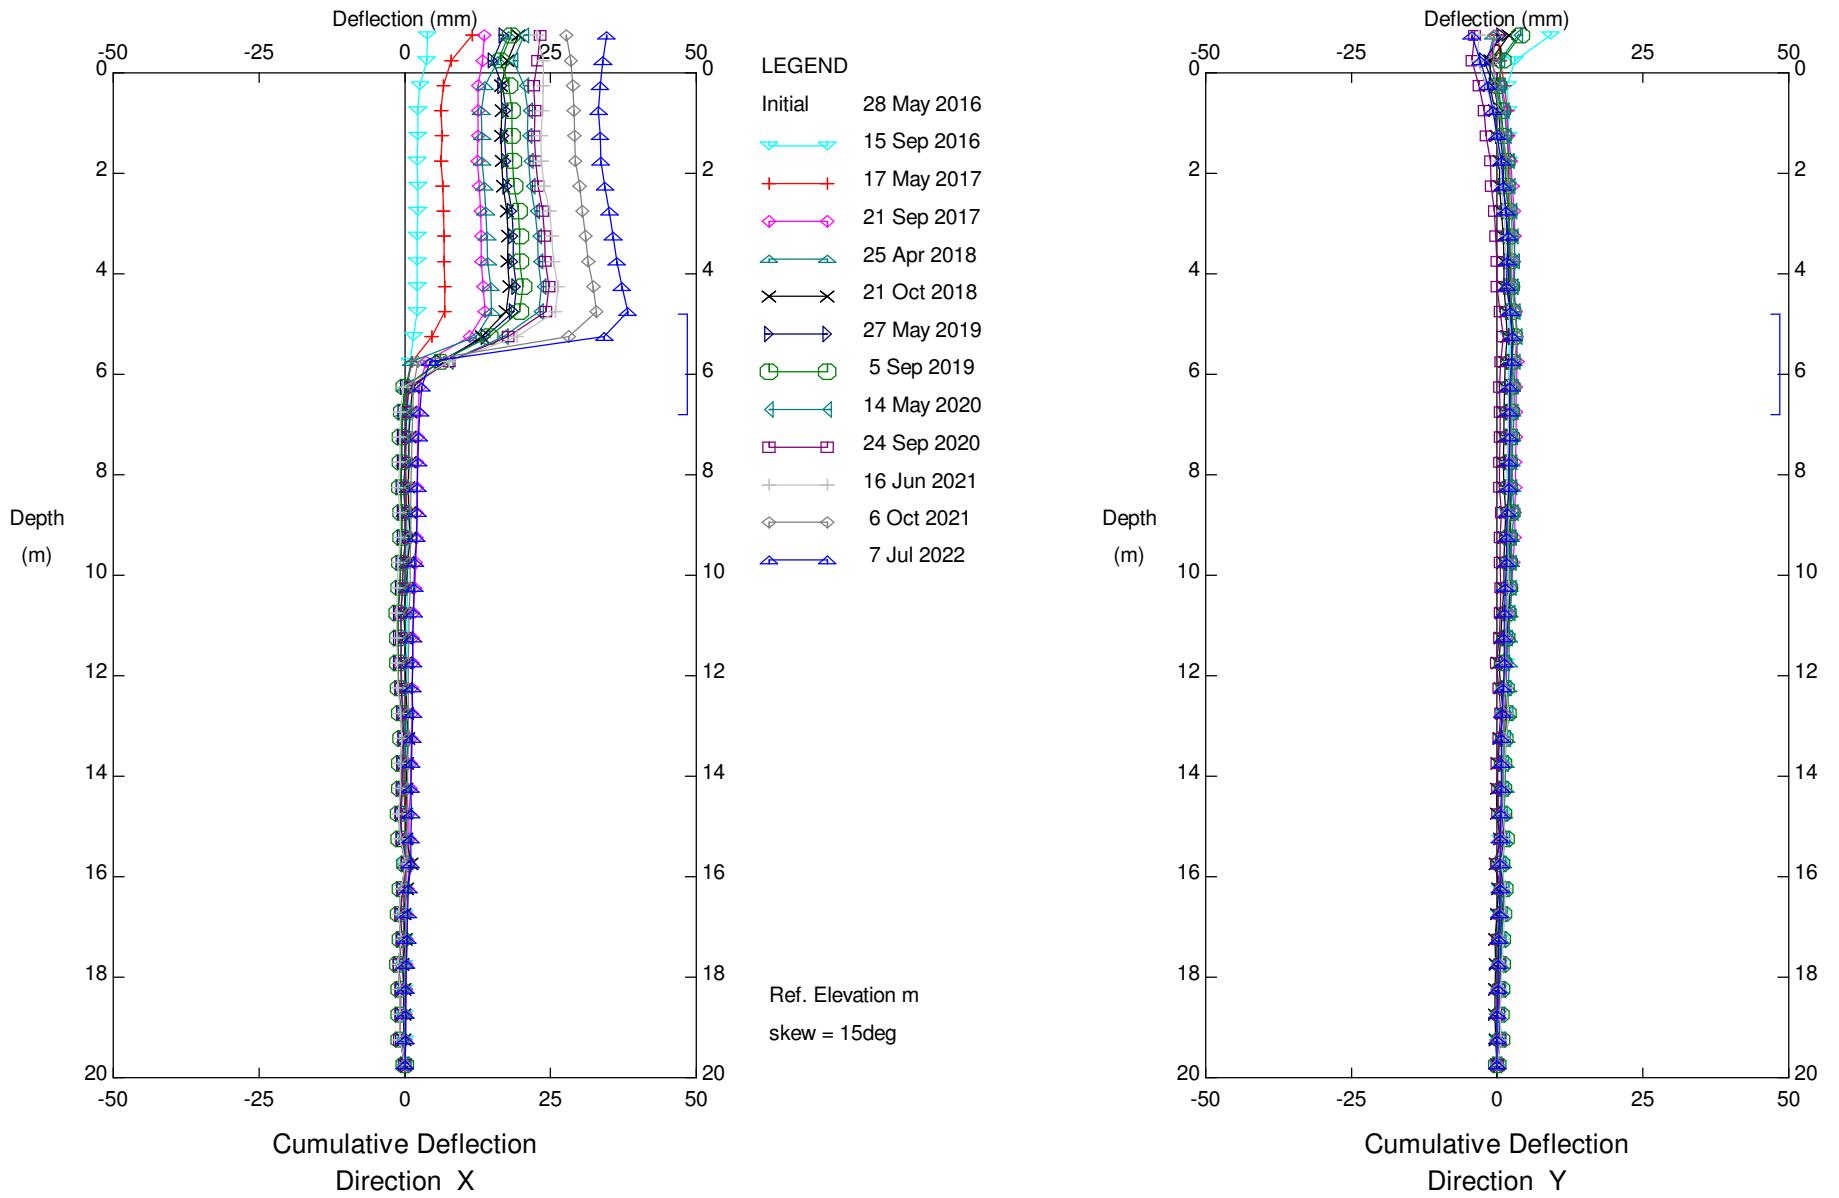
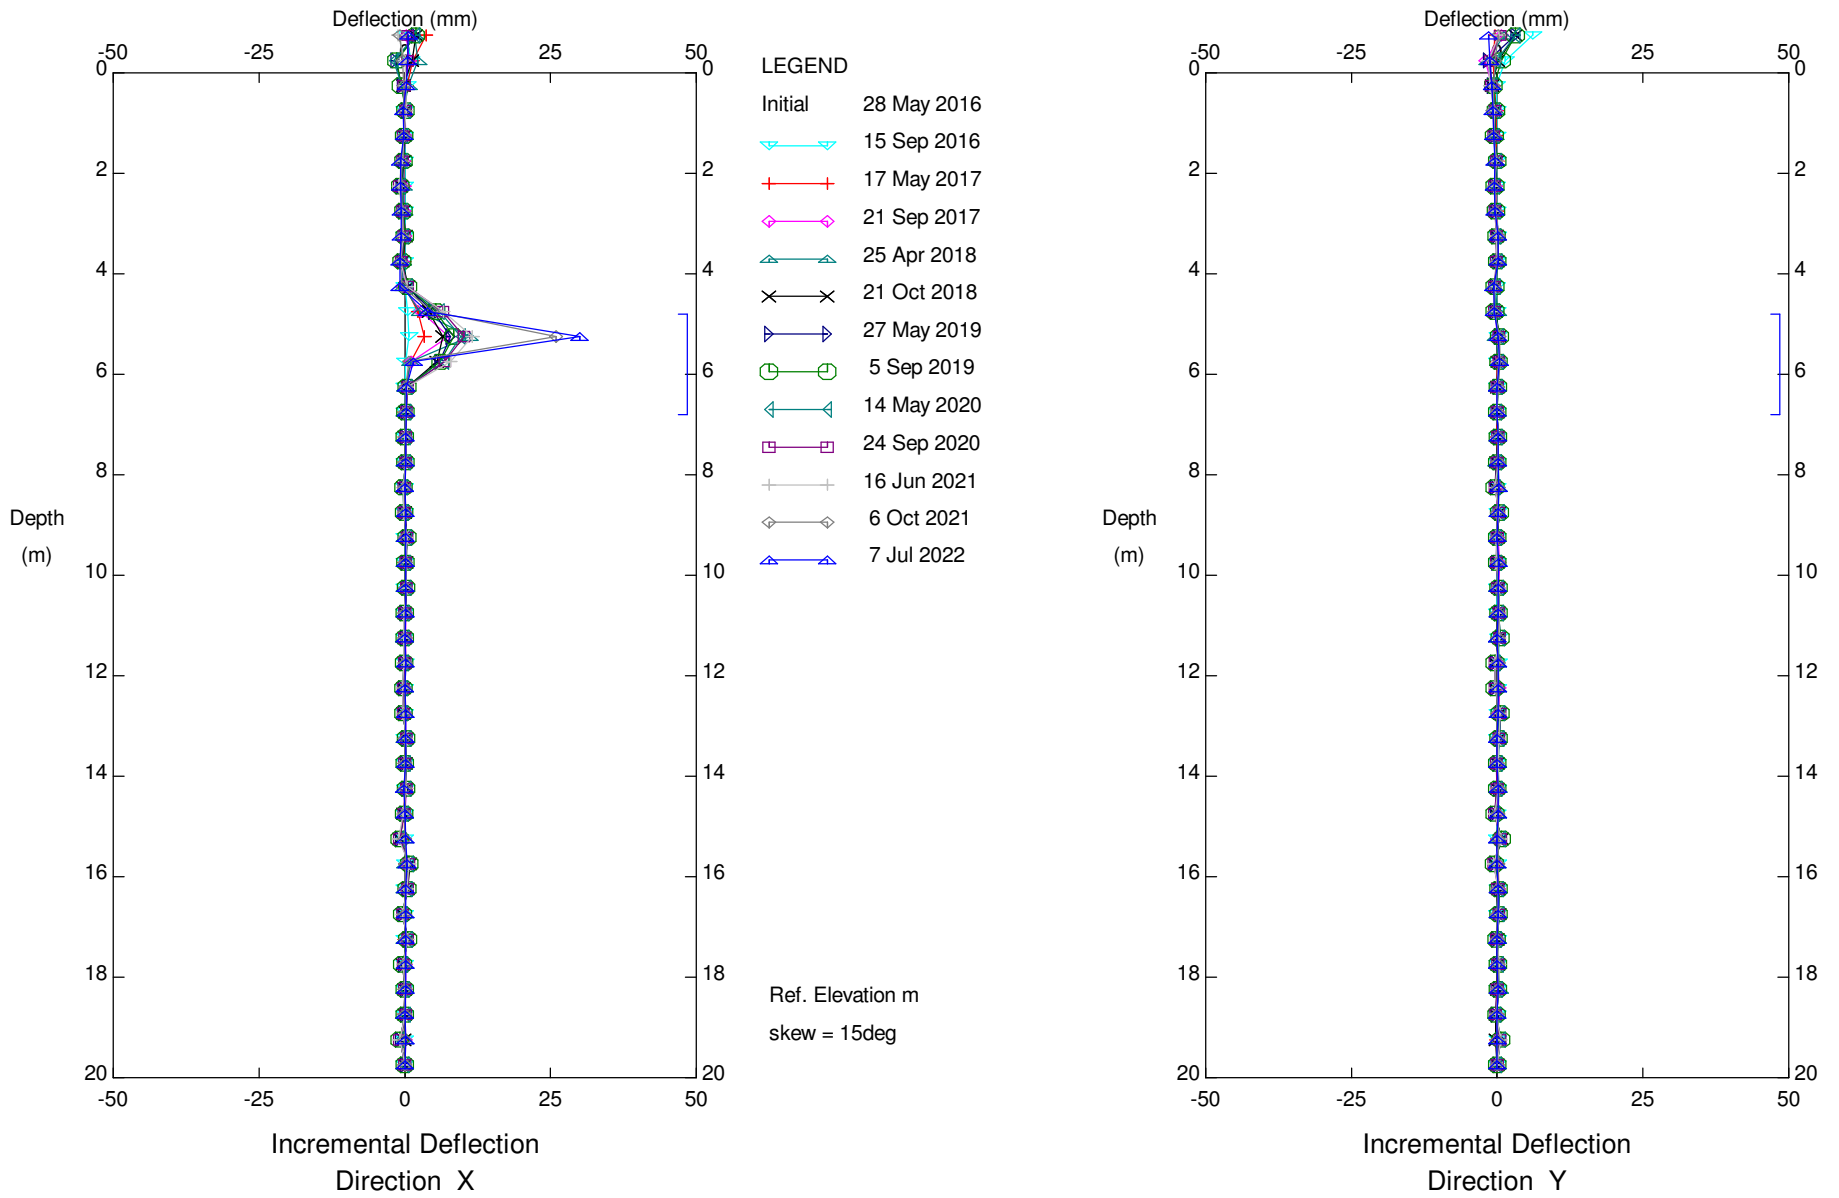
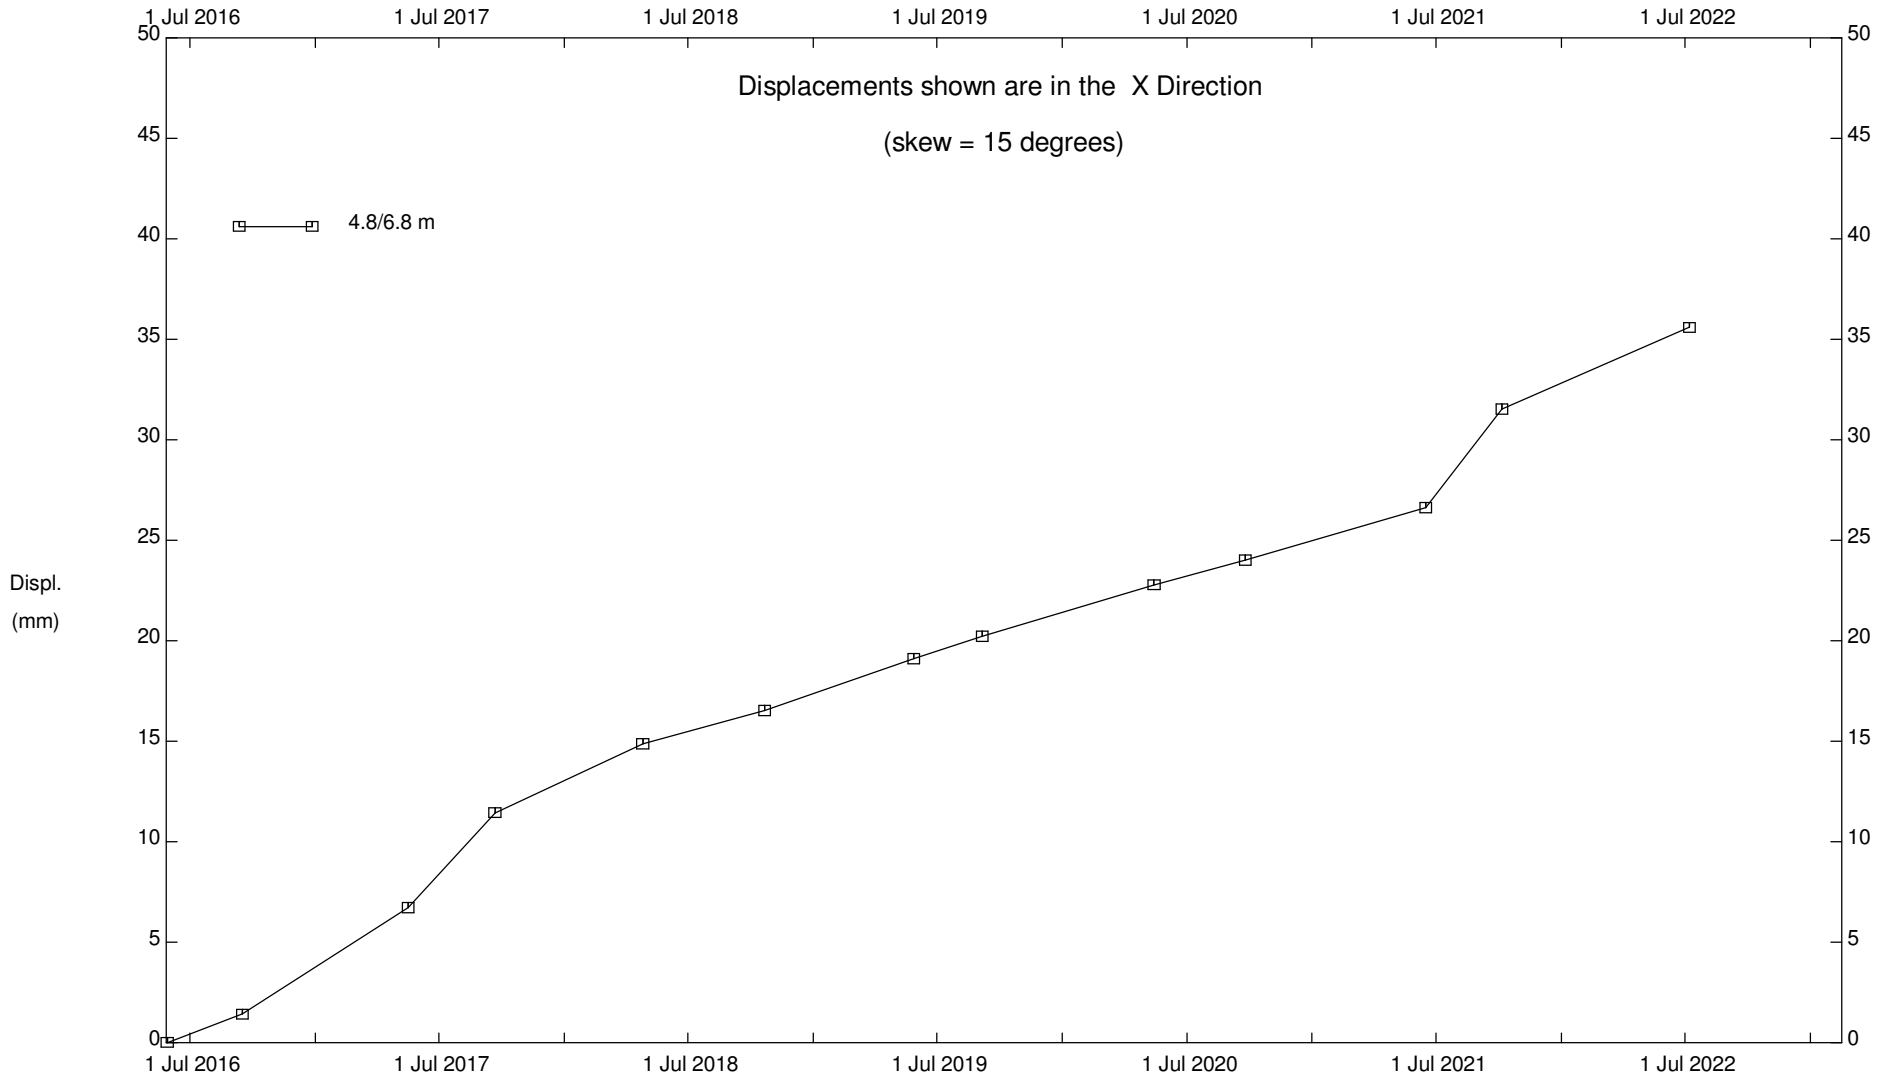
S026; H41:03, Elkwater Slides, Area B, Inclinometer SI12-01
 Alberta Transportation

Discrete movement has been recorded in SI12-01 between an approximate depth of 4.5 m and 6.5 m below ground surface.

The zone of movement recorded in SI12-01 is occurring at a similar depth to the original slide plane reported by the previous consultant prior to construction of the H-pile wall.

Since KCB took over the instrument readings in 2016, the rate of movement recorded in SI12-01 has been relatively steady (approximately 5 mm/year), except for an increased rate of movement recorded in the fall of 2017 and fall of 2021 (approximately 13.7 mm/year and 16.1 mm/year, respectively). The increased rate of movement recorded in the fall of 2021 could be due to a small data shift caused by KCB changing the SI reading equipment when the old equipment became inoperable. However, the increased rate of movement recorded in 2017 was reflective of site observations made by KCB and Alberta Transportation (AT) during the 2017 Section B inspection.

Soil sliding observed downslope of the H-pile wall, has exposed the H-piles and reduced the passive support of the H-pile wall on the downslope side. The movement recorded in SI12-01 reflects the movement of the H-pile occurring as this passive support is reduced.

No instrument repairs are required. However, an above-ground casing protector should be installed to protect SI12-01.

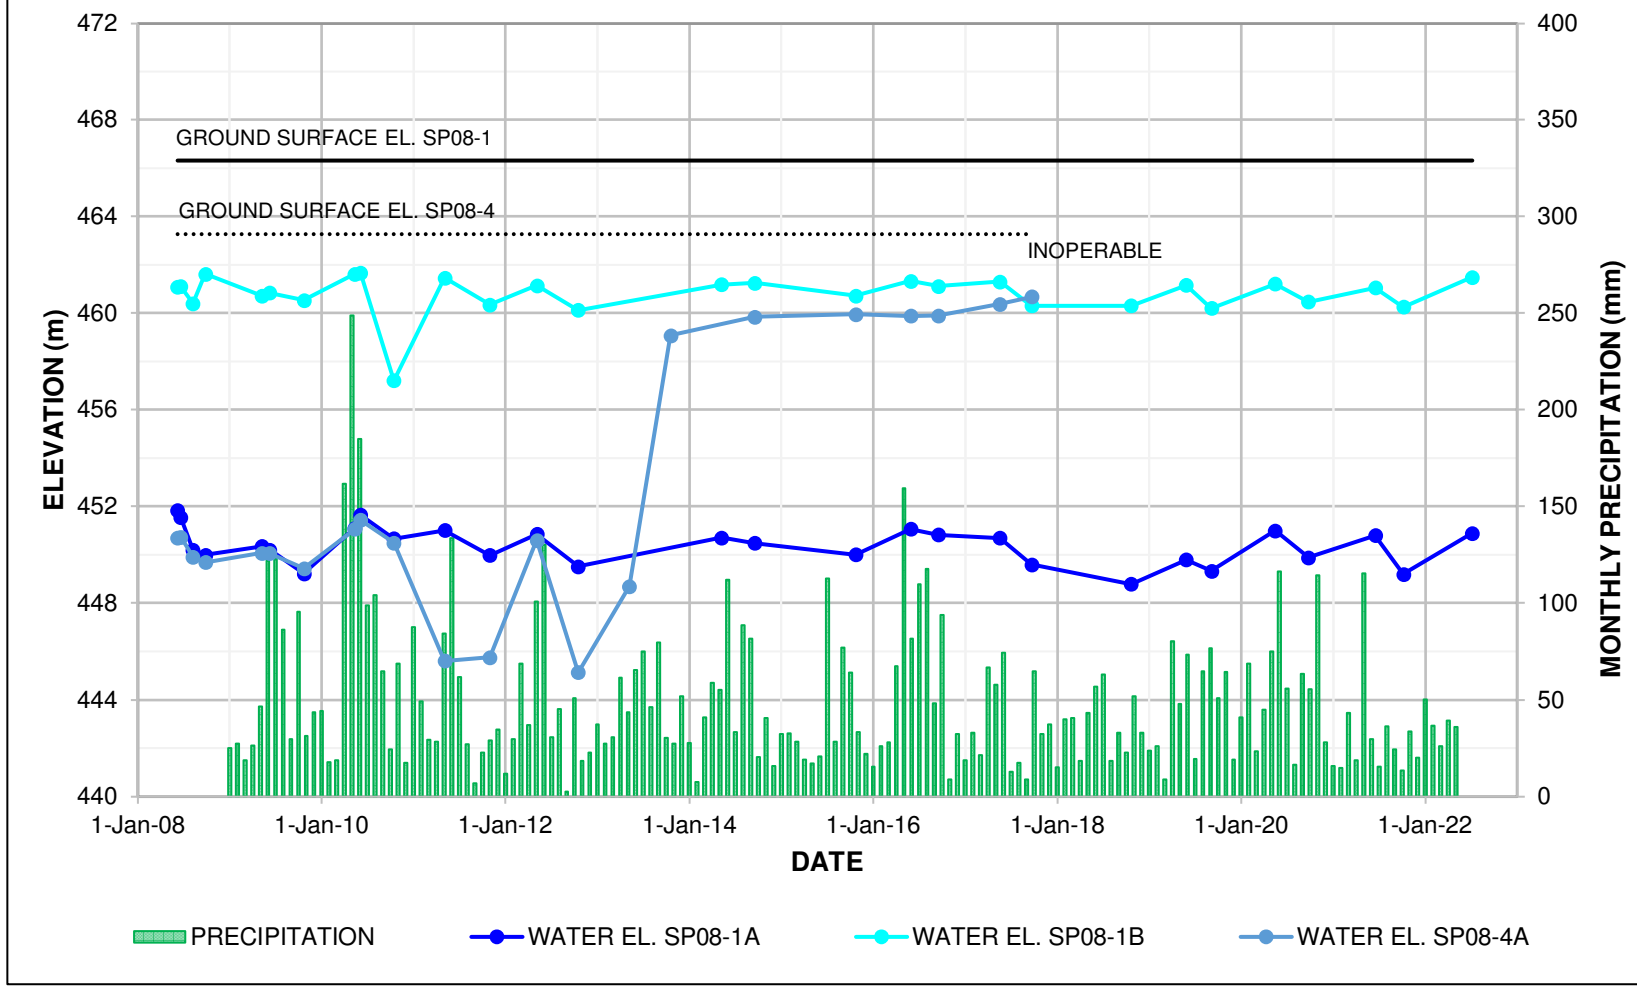
SOUTHERN REGION GEOHAZARD RISK MANAGEMENT PROGRAM	
		TITLE	
		Piezometer Data S026 - Elkwater Slide Area A Hwy 41:03, km 35.169	
SCALE	PROJECT No.	A05116A03	FIG No.

Water levels recorded in SP08-01A and SP08-01B appear to fluctuate seasonally (with the spring readings being higher than fall readings) from an approximate depth of 14.4 m to 17.5 m below ground surface and 4.5 m to 6.1 m below ground surface, respectively. The July 2022 readings were consistent with historical trends observed in these instruments, with increases of 1.7 m and 1.2 m recorded in SP08-01A and SP-01B, respectively.
