SITE NUMBER AND NAME: S026 Elkwater Slides		HIGHWAY & KM: 41:03, 35.169	PREVIOUS INSPECTION DATE: June 7, 2021	INSPECTION DATE: May 11, 2023
LEGAL DESCRIPTION SE-18-008-02 W4M and 16-07-008-02 W4M	NAD 83 COORDINATES: UTM Northing Easting 12 5499046 553536		RISK ASSESMENT: Site A: PF: 7 CF: 6 TOTAL: 42 (Slides) Site B: PF: 8 CF: 4 TOTAL: 32 (Pile wall)	
AVERAGE ANNUAL DAILY TRAFFIC (AADT): 660 (north), 400 (south), (Ref. No. 138060)			CONTRACTOR MAINTENANCE AREA (CMA): 23

PROJECT SOUTHERN REGION GEOHAZARD RISK MANAGEMENT PROGRAM		
TITLE Site Plan S026 - Elkwater Slides Hwy 41:03, km 35.169		
SCALE 1:5,500	PROJECT No. A05116A03	FIG No. 1

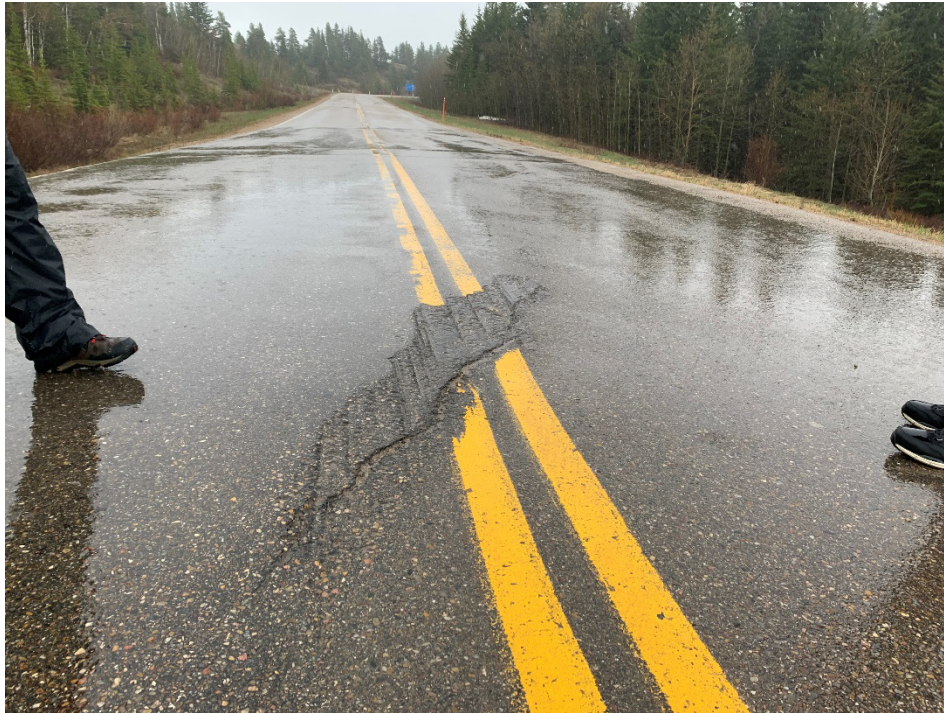
Ongoing movement observed at the site since 2018. Back slope slides are still active and snowplow strikes are visible on the road surface. Cracking has reflected through the recent overlay and settlement of the various slides is visible on the pavement surface. Deformation since 2021 is small-scale but ongoing, however there have been no sudden changes at the site.

Photo 1 **Site A: Cracking has redeveloped through the pavement overlay. Photo was taken facing south on May 11, 2023.**

Ditch drainage through the whole S026 area should be improved to minimize infiltration into the slide zones. The highway surface should continue be regraded in areas where it has deflected and cracked, to improve the smoothness of the highway through this site. Highway regrading should include milling the existing asphalt, and not placing more material which adds weight to the failure zones.

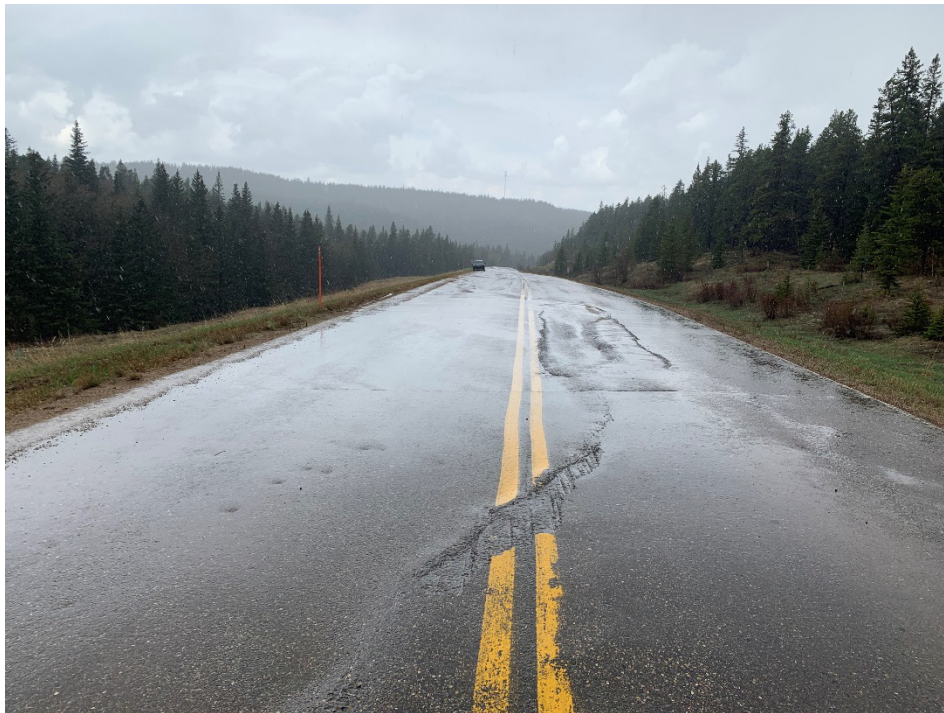
Photo 2 **Site A: Pavement cracking and settlement. Photo was taken facing north on May 11, 2023.**

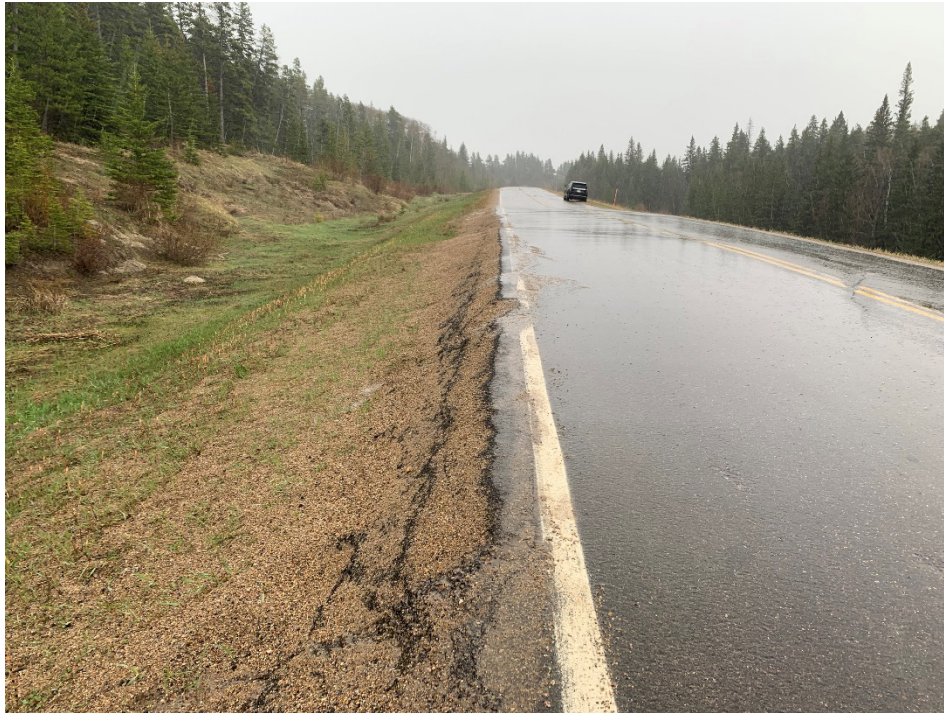
Fill settlement up to 0.5 m at east edge of pavement. Up to 1.0 m of asphalt exposed at shoulder of highway. Guard rail, HTCB or fill placement is required at locations where there are steep drop offs at the edge of the pavement, due to the narrow shoulder outside of the lanes and to protect road users.

Photo 3 Site A: East shoulder asphalt up to 1 m in height. Photo was taken facing south on May 11, 2023.

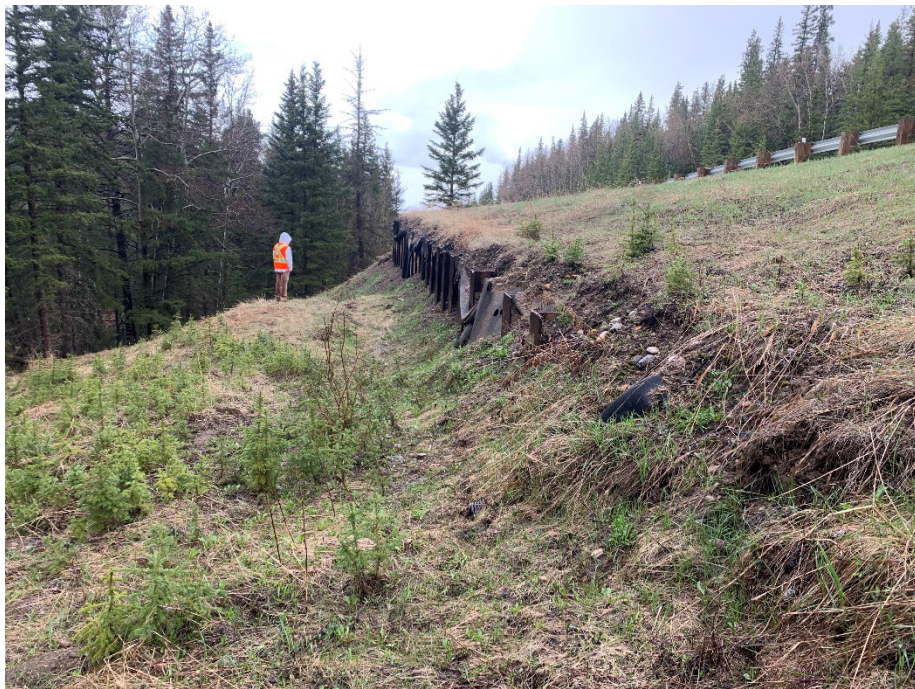
Slope movements below pile wall have exposed the piles over a length of 30 m at the north limit of the wall. The piles were measured as leaning between 0.2° and 0.6° from vertical in 2023, which note very little change from previously measured in 2021. The upper 2 to 3 m of pile wall is exposed and unsupported. Below the exposed section of H-piles is a 2 m high section where sloughed material from between and behind the pile wall has eroded out and covered the piles. Voids are up to 0.5 m deep behind the pile wall, and erosion is ongoing. Sloughing is due to seepage and infiltration.

Photo 4 Site B: Pile wall is located downslope to the west of the highway. Soil movement downslope of the wall has exposed 2 to 3 m of steel pile over a length of approximately 30 m. Photo was taken facing north on May 11, 2023.

Site B - Candidate repairs include extending the existing H-pile wall to the north and the addition of timber lagging between H-piles to minimize material loss from between the piles (this work could be completed by the HMC). Drill boreholes and install two additional two slope inclinometers adjacent to the pile-wall.

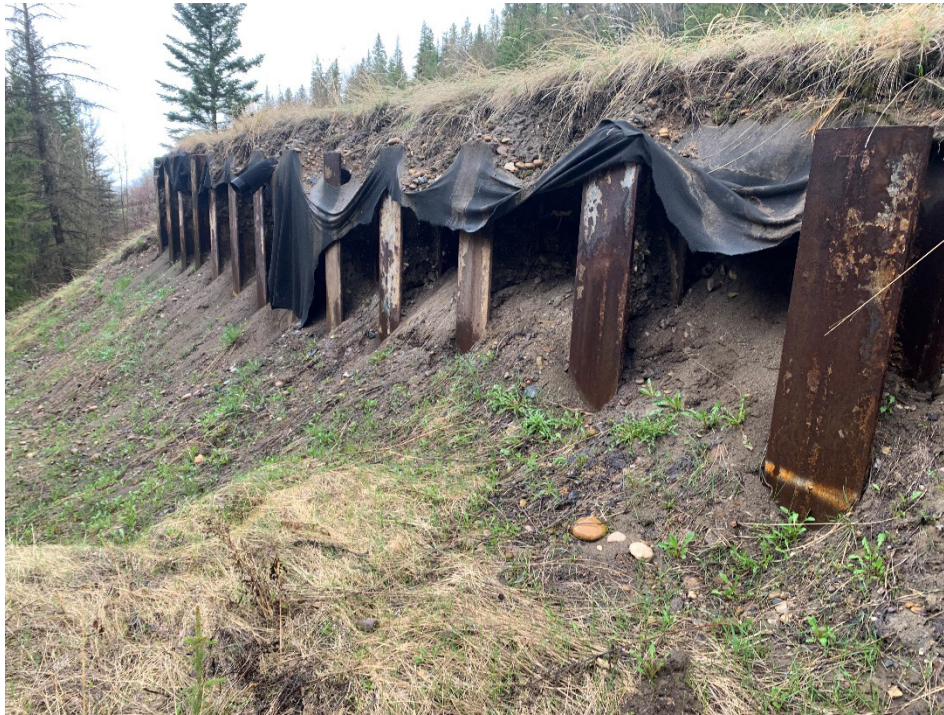
Photo 5 Site B: Exposed steel piles. Photo was taken facing northeast on May 11, 2023.

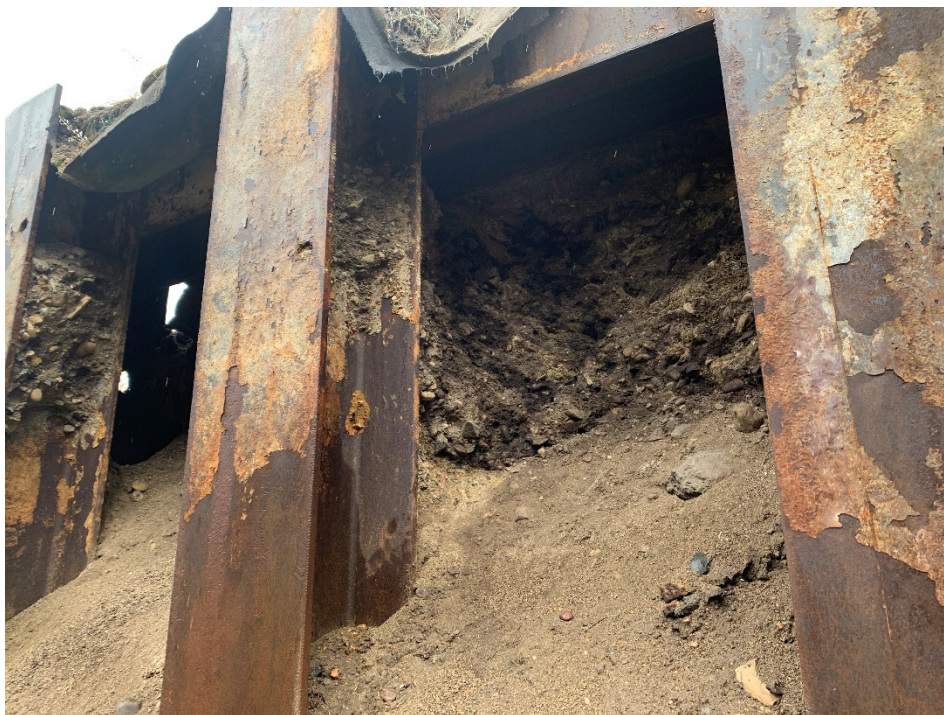
Photo 6 Site B: Erosion of material between piles has contributed to voids up to 0.5 m behind the wall. Photo taken facing northeast on May 11, 2023.

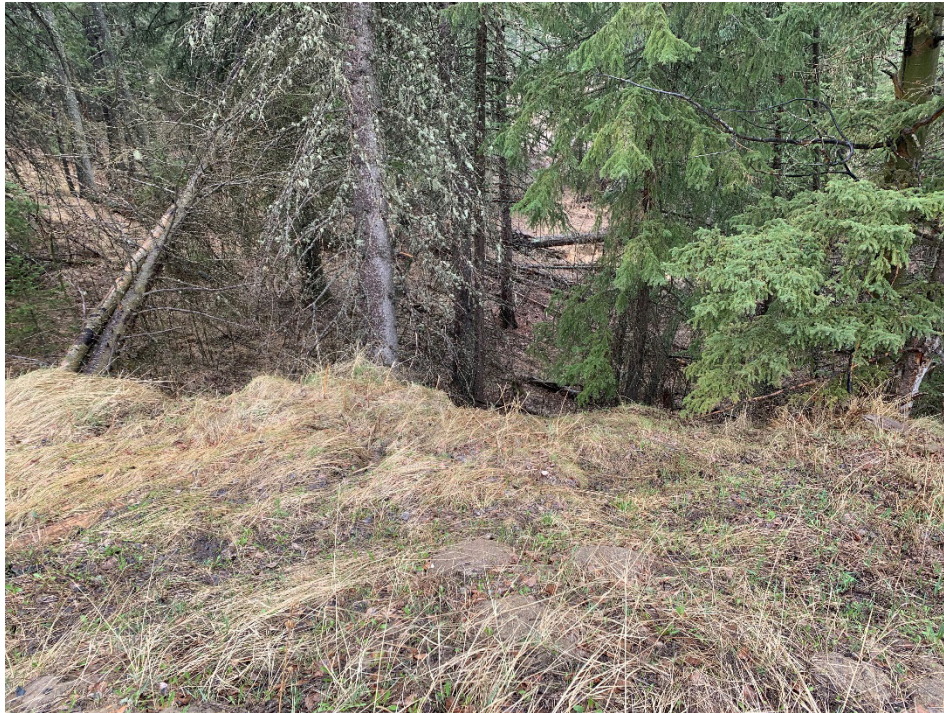
Well-developed toe roll near creek level beyond the edge of the trees below pile wall. Wet conditions present at toe of slope. Seepage and surface water runoff has resulted in exposed soils being eroded and deposited at toe of slope.

Photo 7 **Site B: South slope below the pile wall. Photo was taken facing west, downslope on May 11, 2023.**

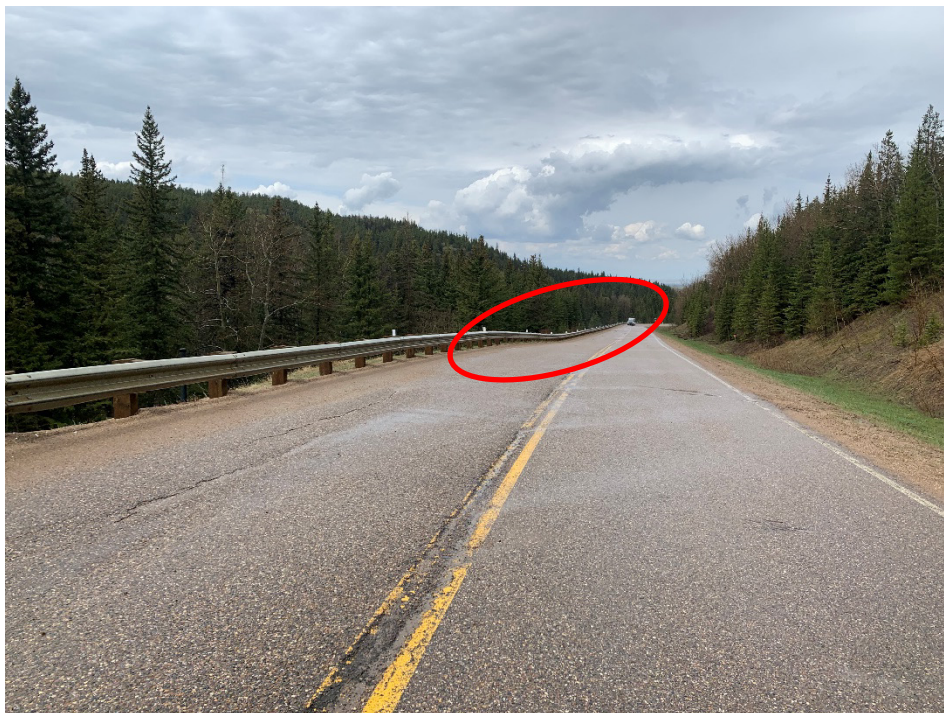
Cracking and slope movement is also present north of the northern extent of the pile wall, outflanking the pile wall. The guardrail at the north edge of the pile wall has a noticeable dip.

Photo 8 **Site B: Dip in guard rail north of the pile wall. Photo taken facing north on May 11, 2023.**
