November 29, 2024

Alberta Transportation and Economic Corridors
2nd Floor, 803 Manning Road N.E.
Calgary, Alberta
T2E 7M8

**CON0022161 Southern Region GRMP Instrumentation Monitoring
Site S026; H41:03, km 35.169 Elkwater Slides
Section C – 2024 Fall Readings**

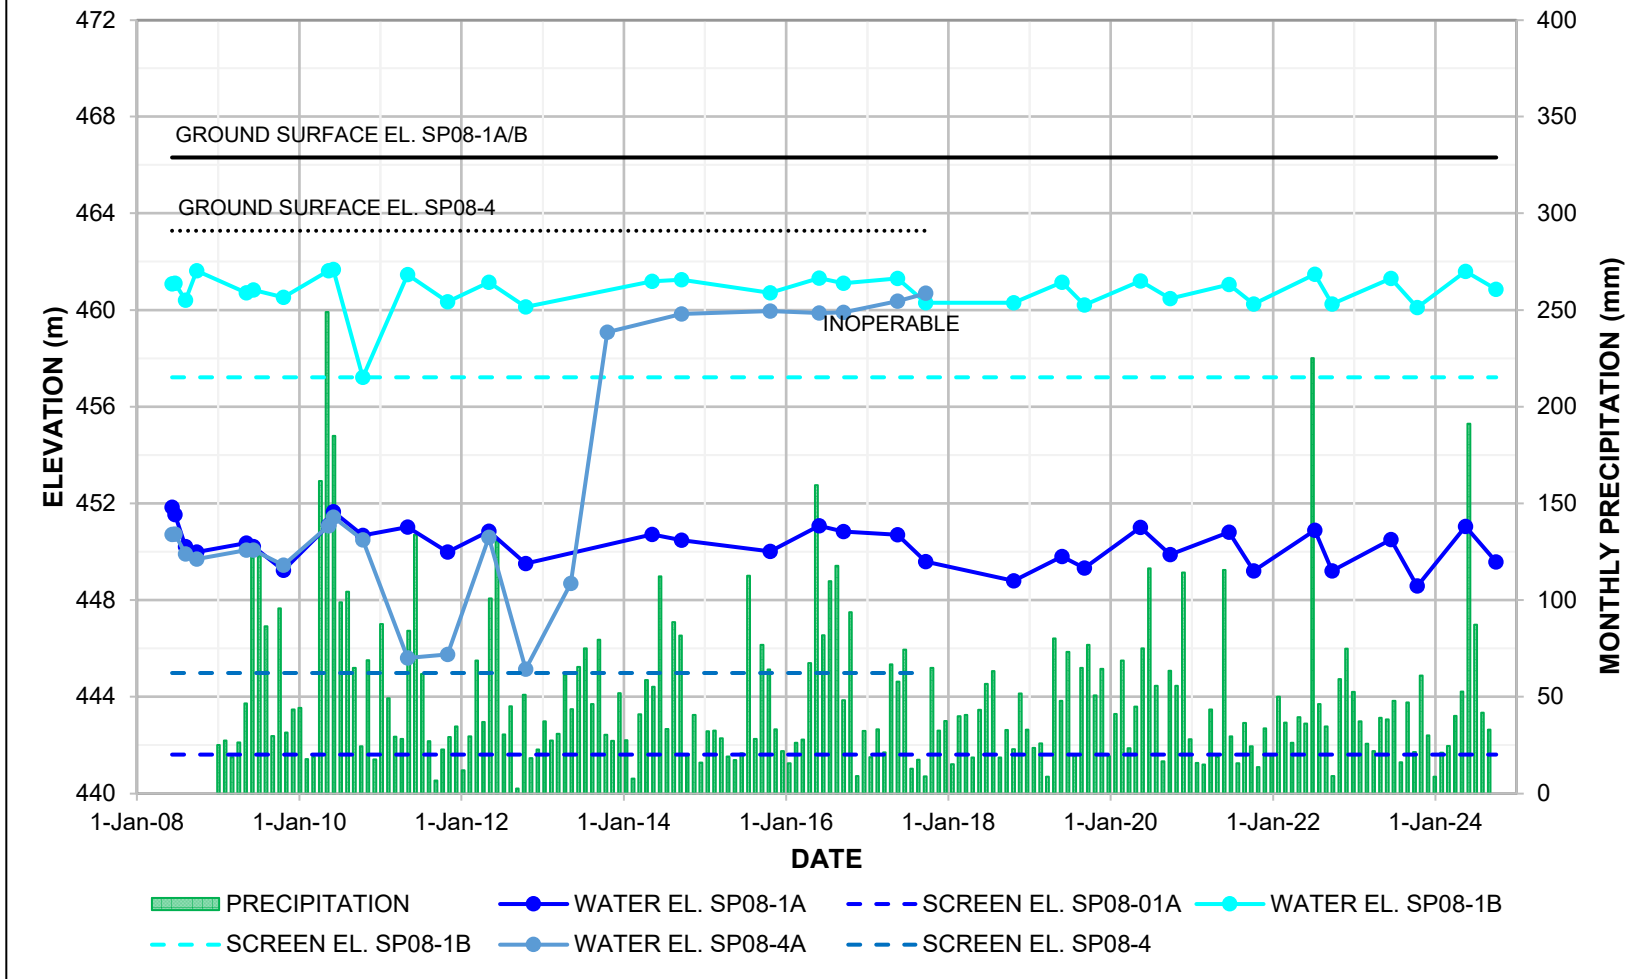
SP08-1A, SP08-1B, AND SP08-4A

Water levels recorded in SP08-01A and SP08-01B appear to fluctuate seasonally (with the spring readings being higher than fall readings) from an approximate depth of 14.4 m to 17.5 m below ground surface and 4.5 m to 6.1 m below ground surface, respectively. The September 2024 readings were consistent with historical trends observed in these instruments, with decreases of 1.4 m and 0.7 m recorded in SP08-01A and SP-01B, respectively. The spring 2024 report noted the water levels recorded were the highest recorded since installation, which based on the precipitation data, corresponds with a large amount of precipitation (191 mm) in May 2024.

- A data logger could be installed in one or more of the SPs to assess for short-term fluctuations (e.g., increases and decreases) in groundwater level that could be occurring in response to periods of heavy or prolonged rainfall or freshet infiltration between readings.
- A geotechnical site investigation (drilling and instrument installations) to assess the depth of movement in recently active slide areas to support repair design. Two additional SIs should be installed in Area B, one upslope of the H-pile wall near its south end and one adjacent to the highway north of the H-pile wall, to monitor for movement.

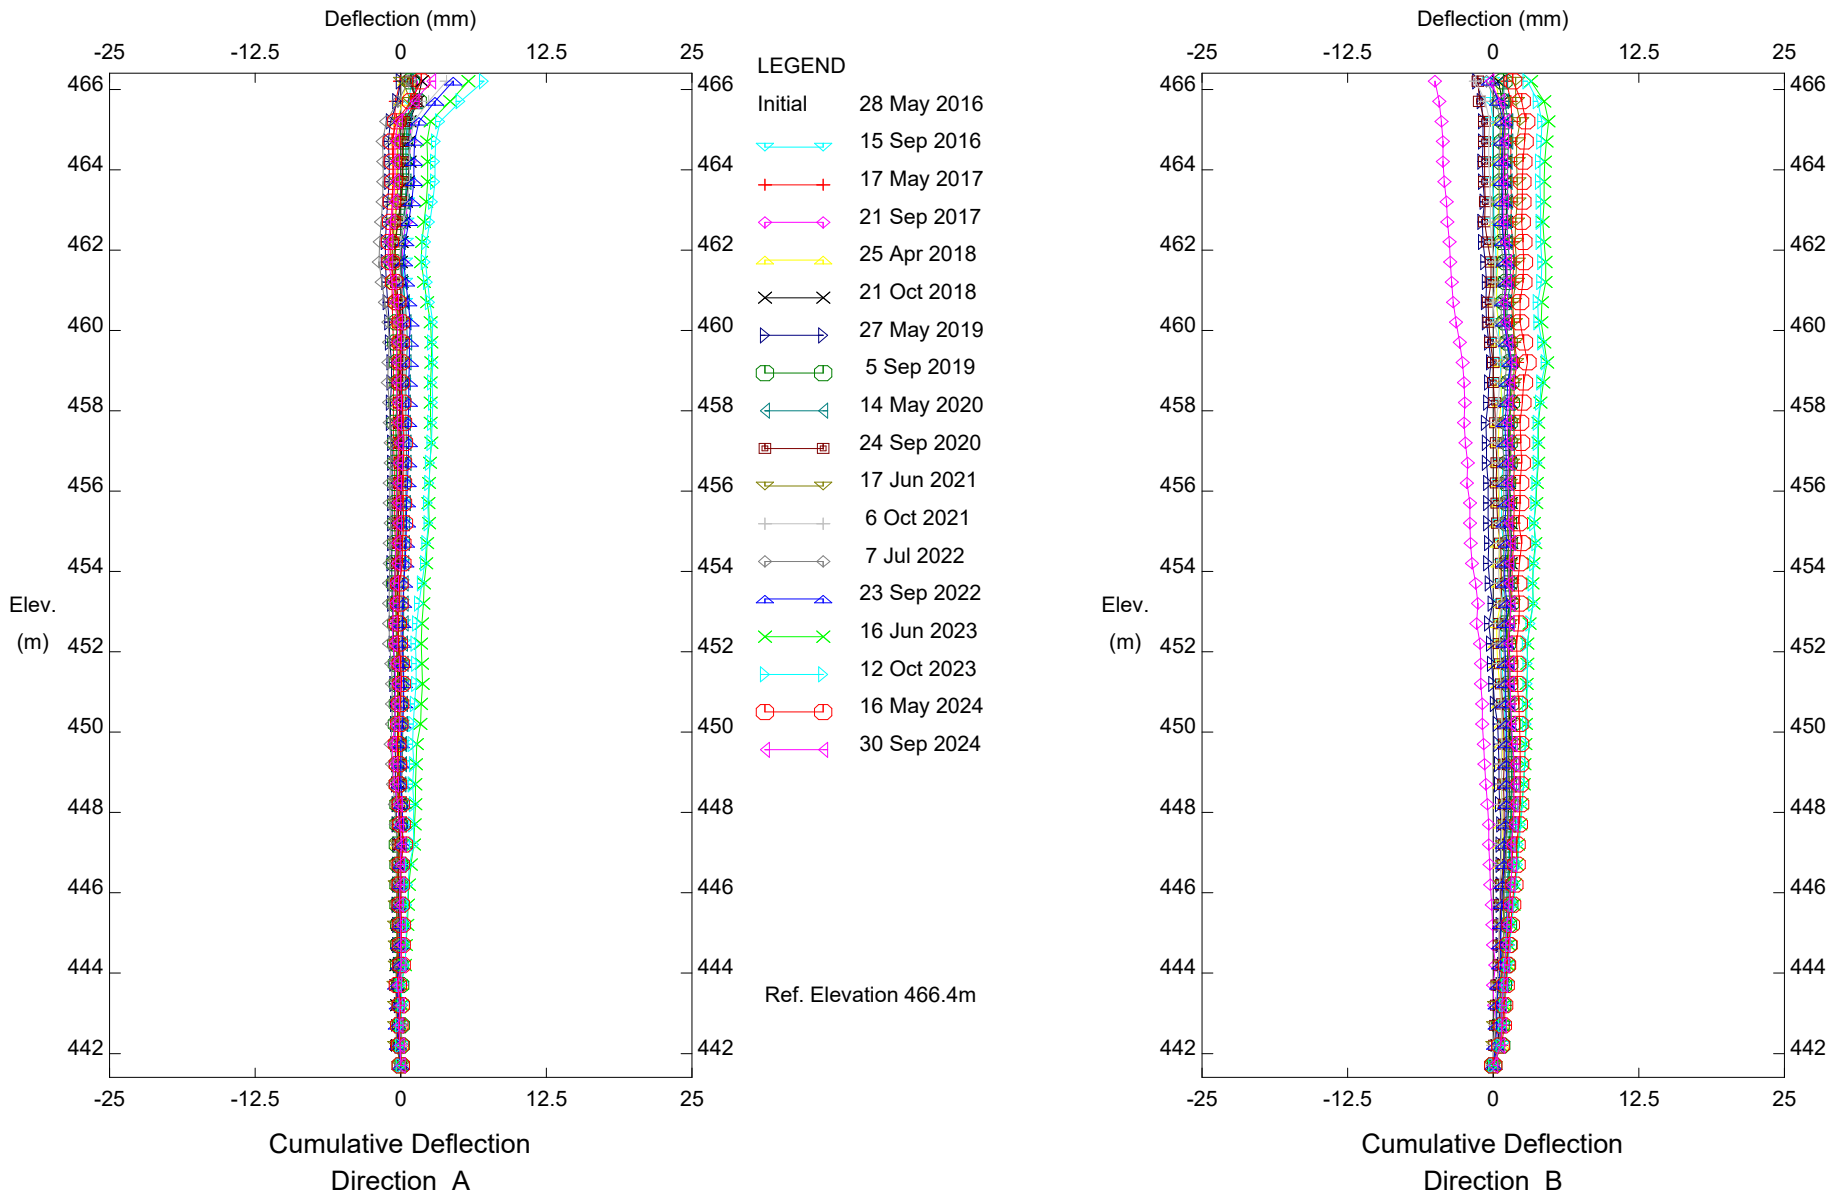
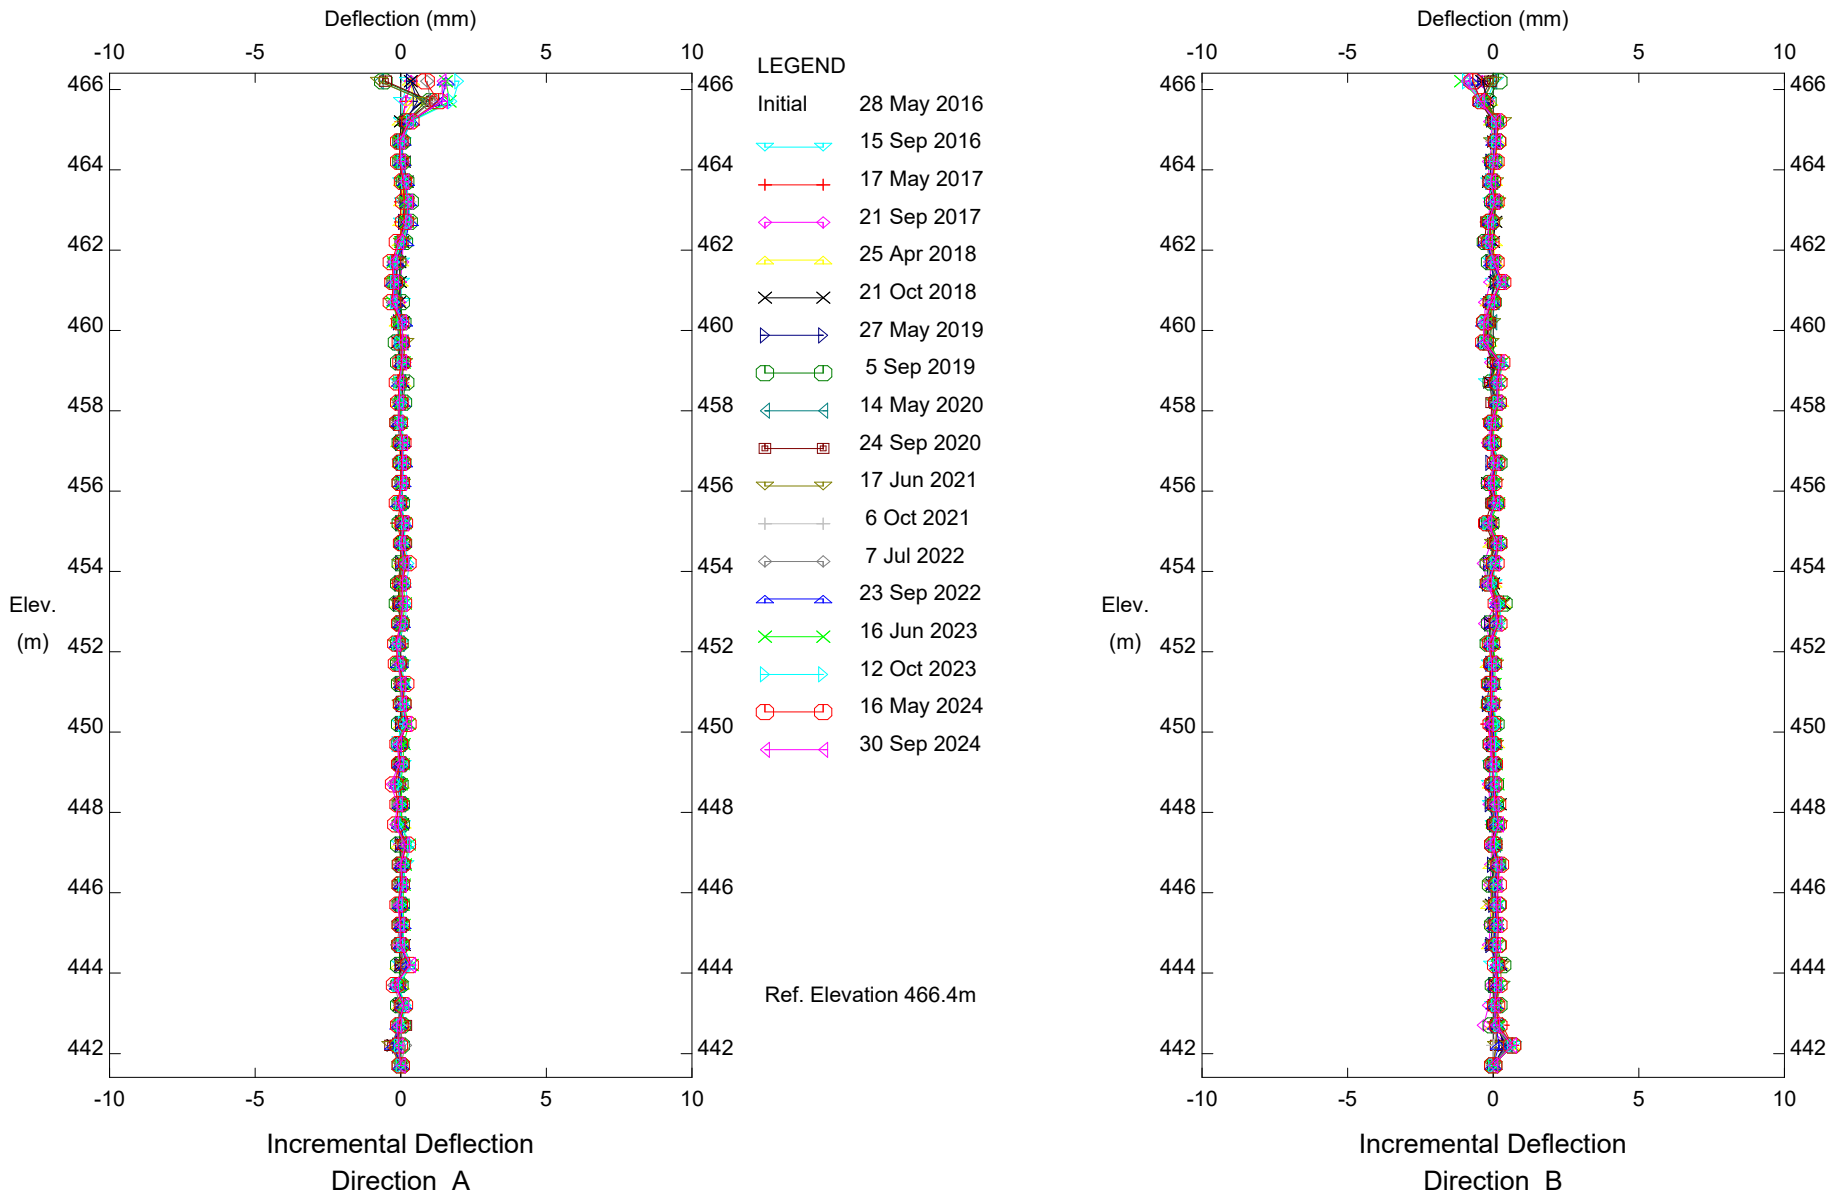
S026; H41:03, Elkwater Slides, Area A, Inclinometer SI08-1

No discernible movement has been recorded in SI08-01 or SI08-03.

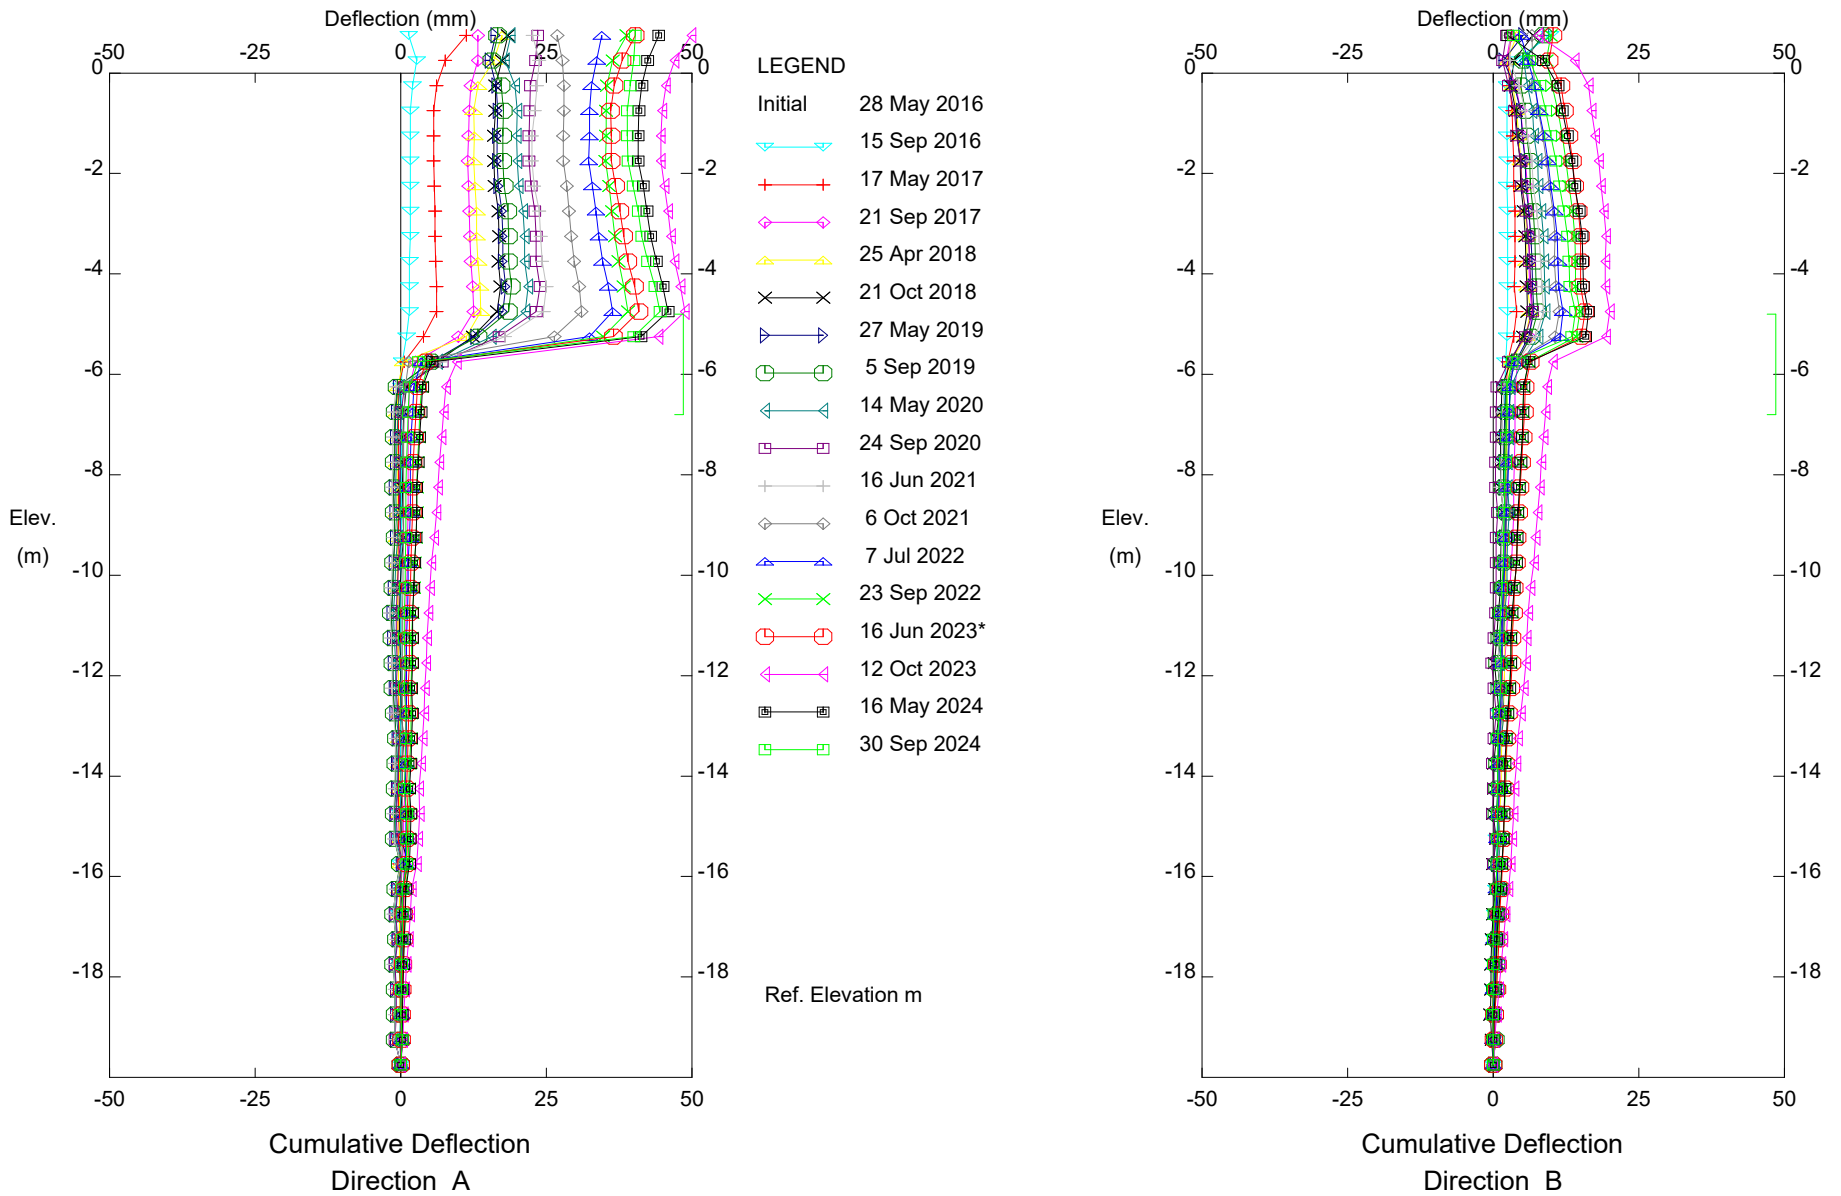
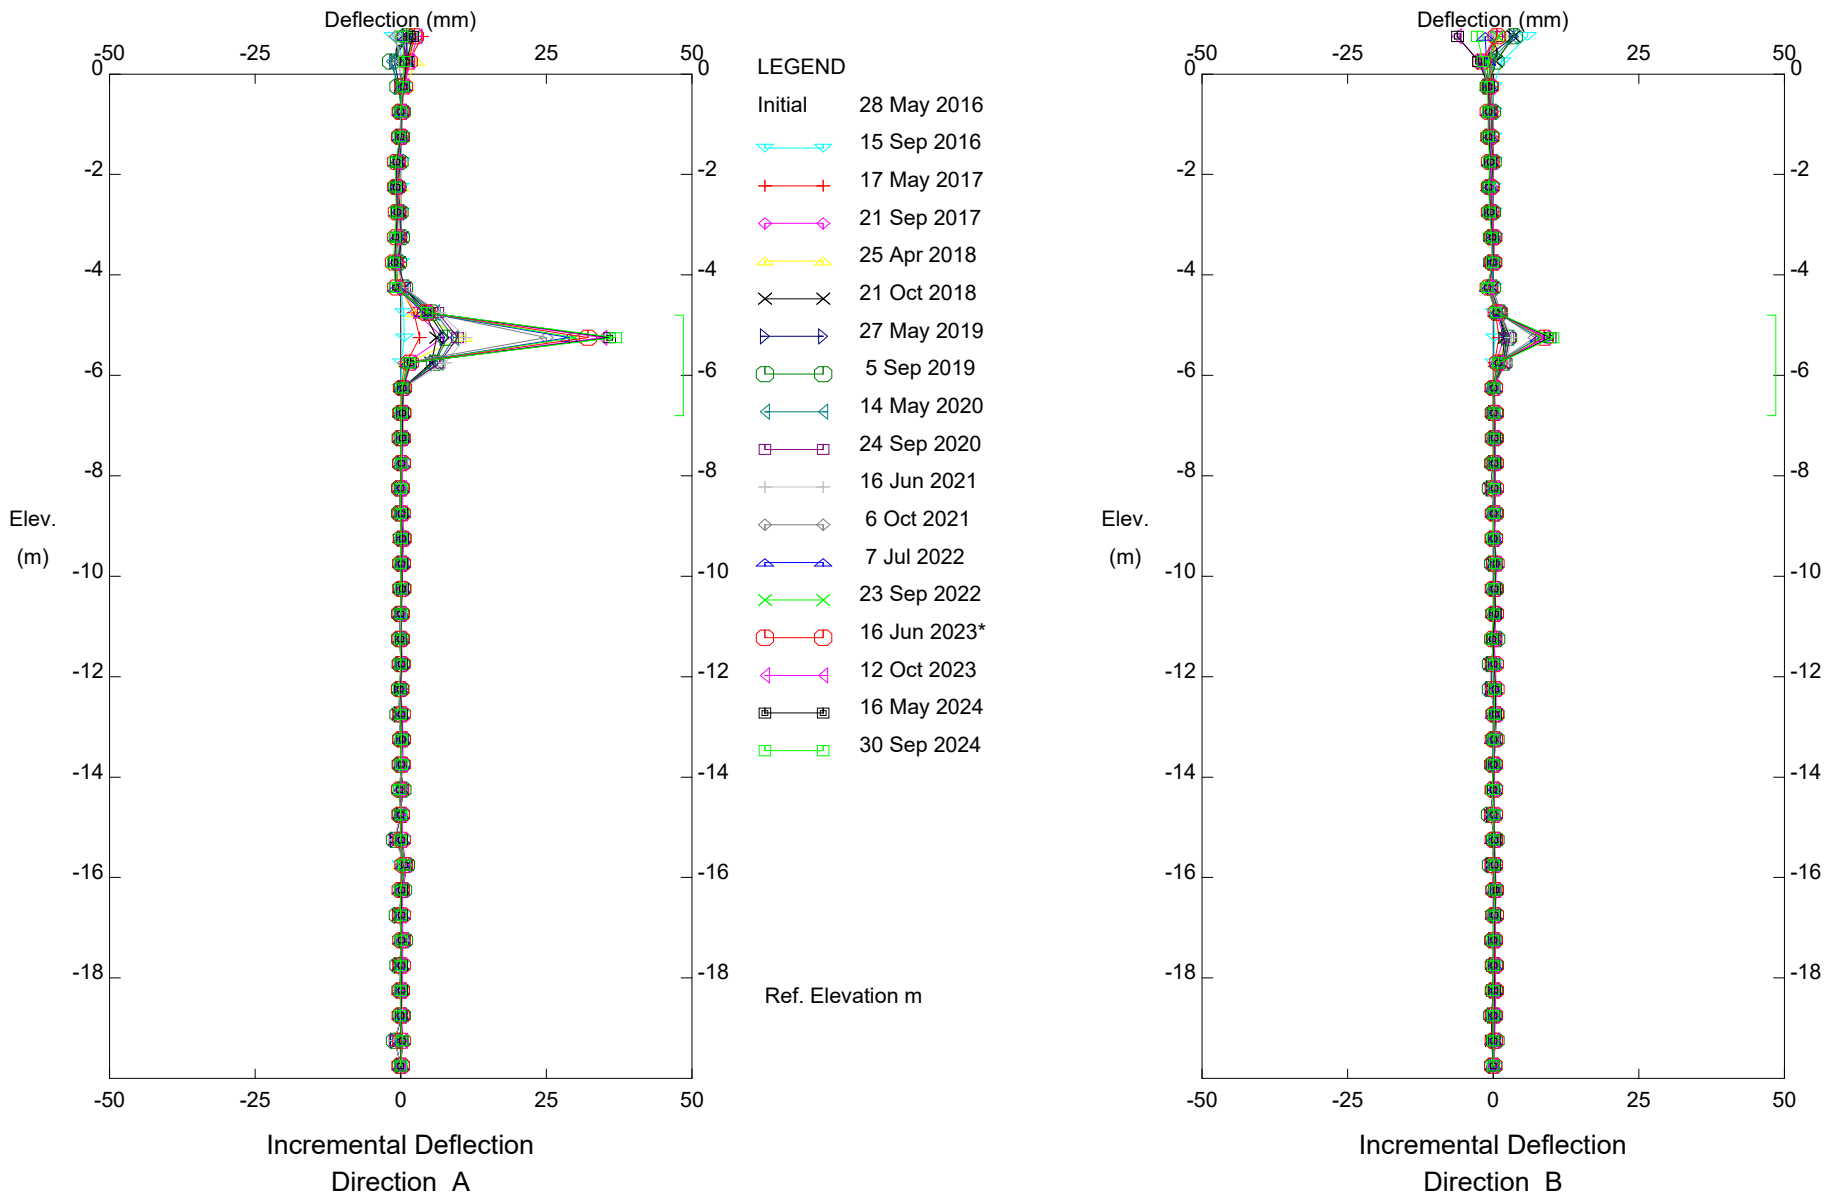
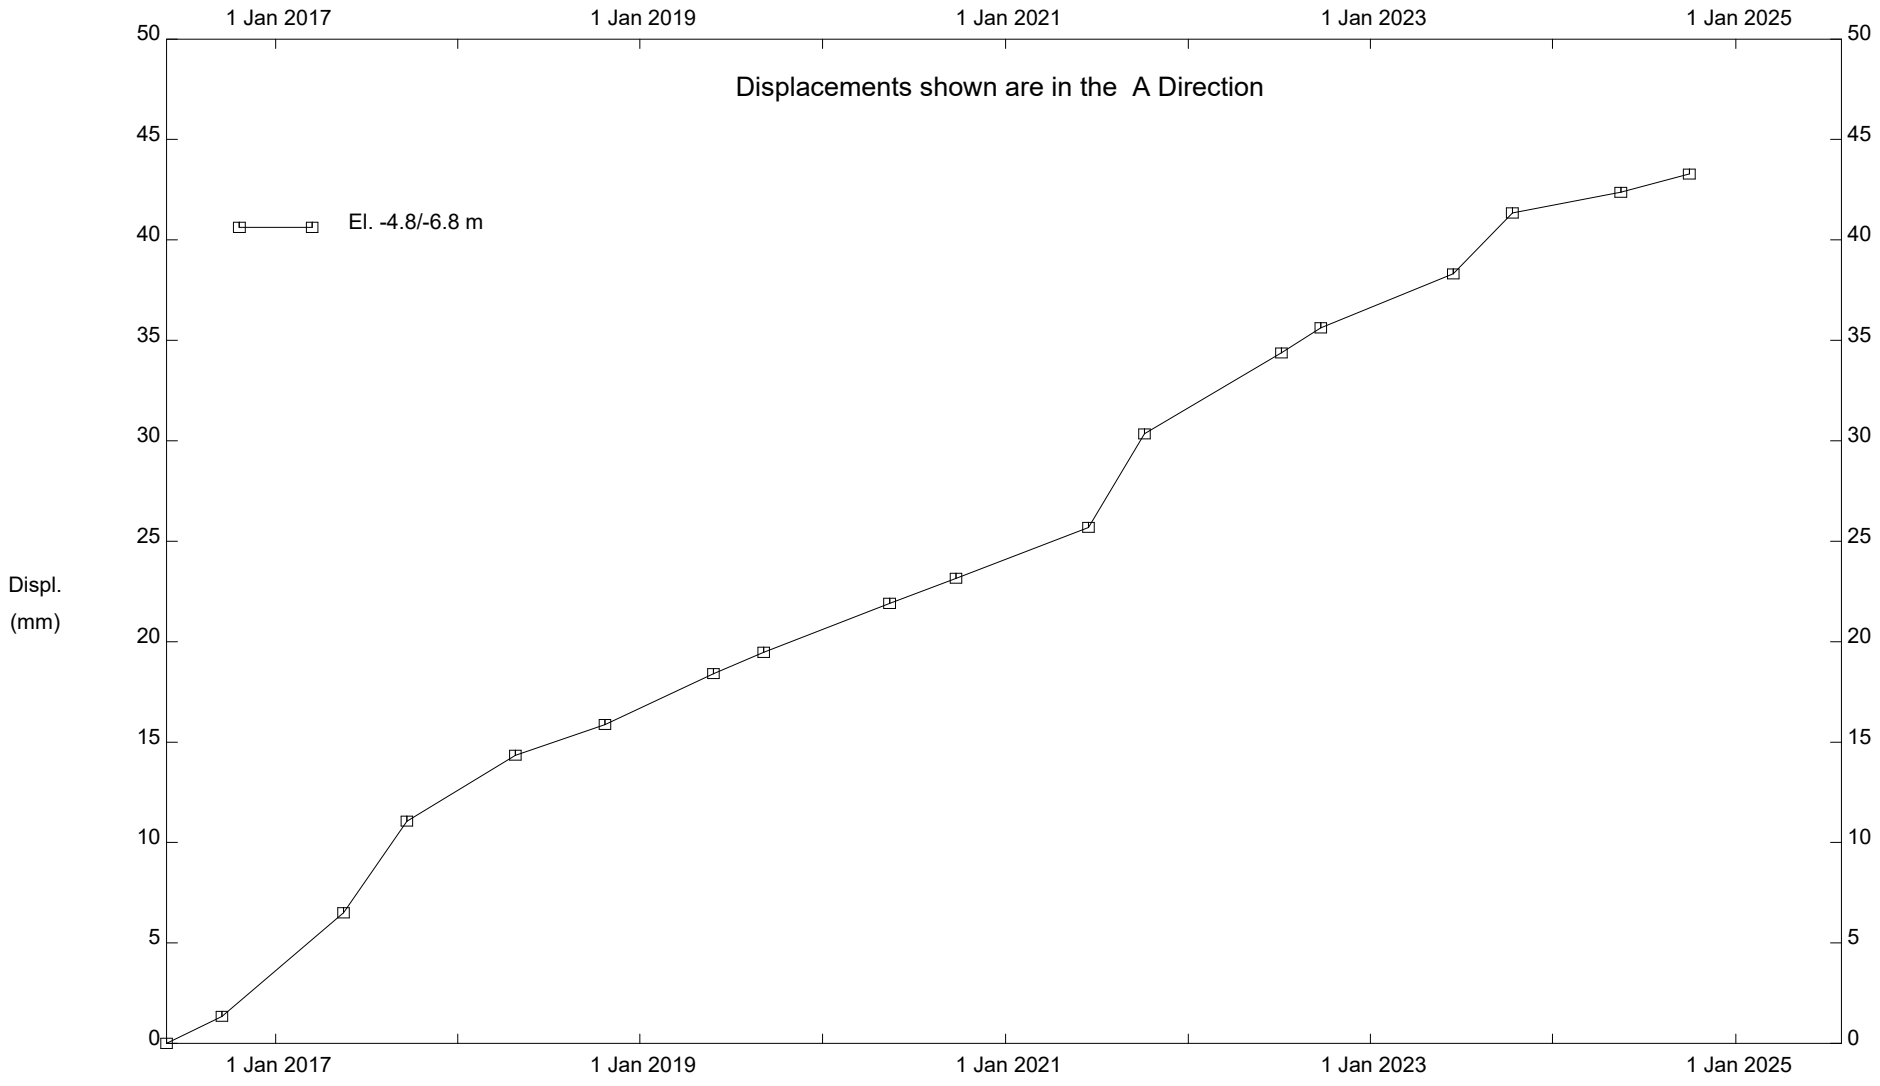
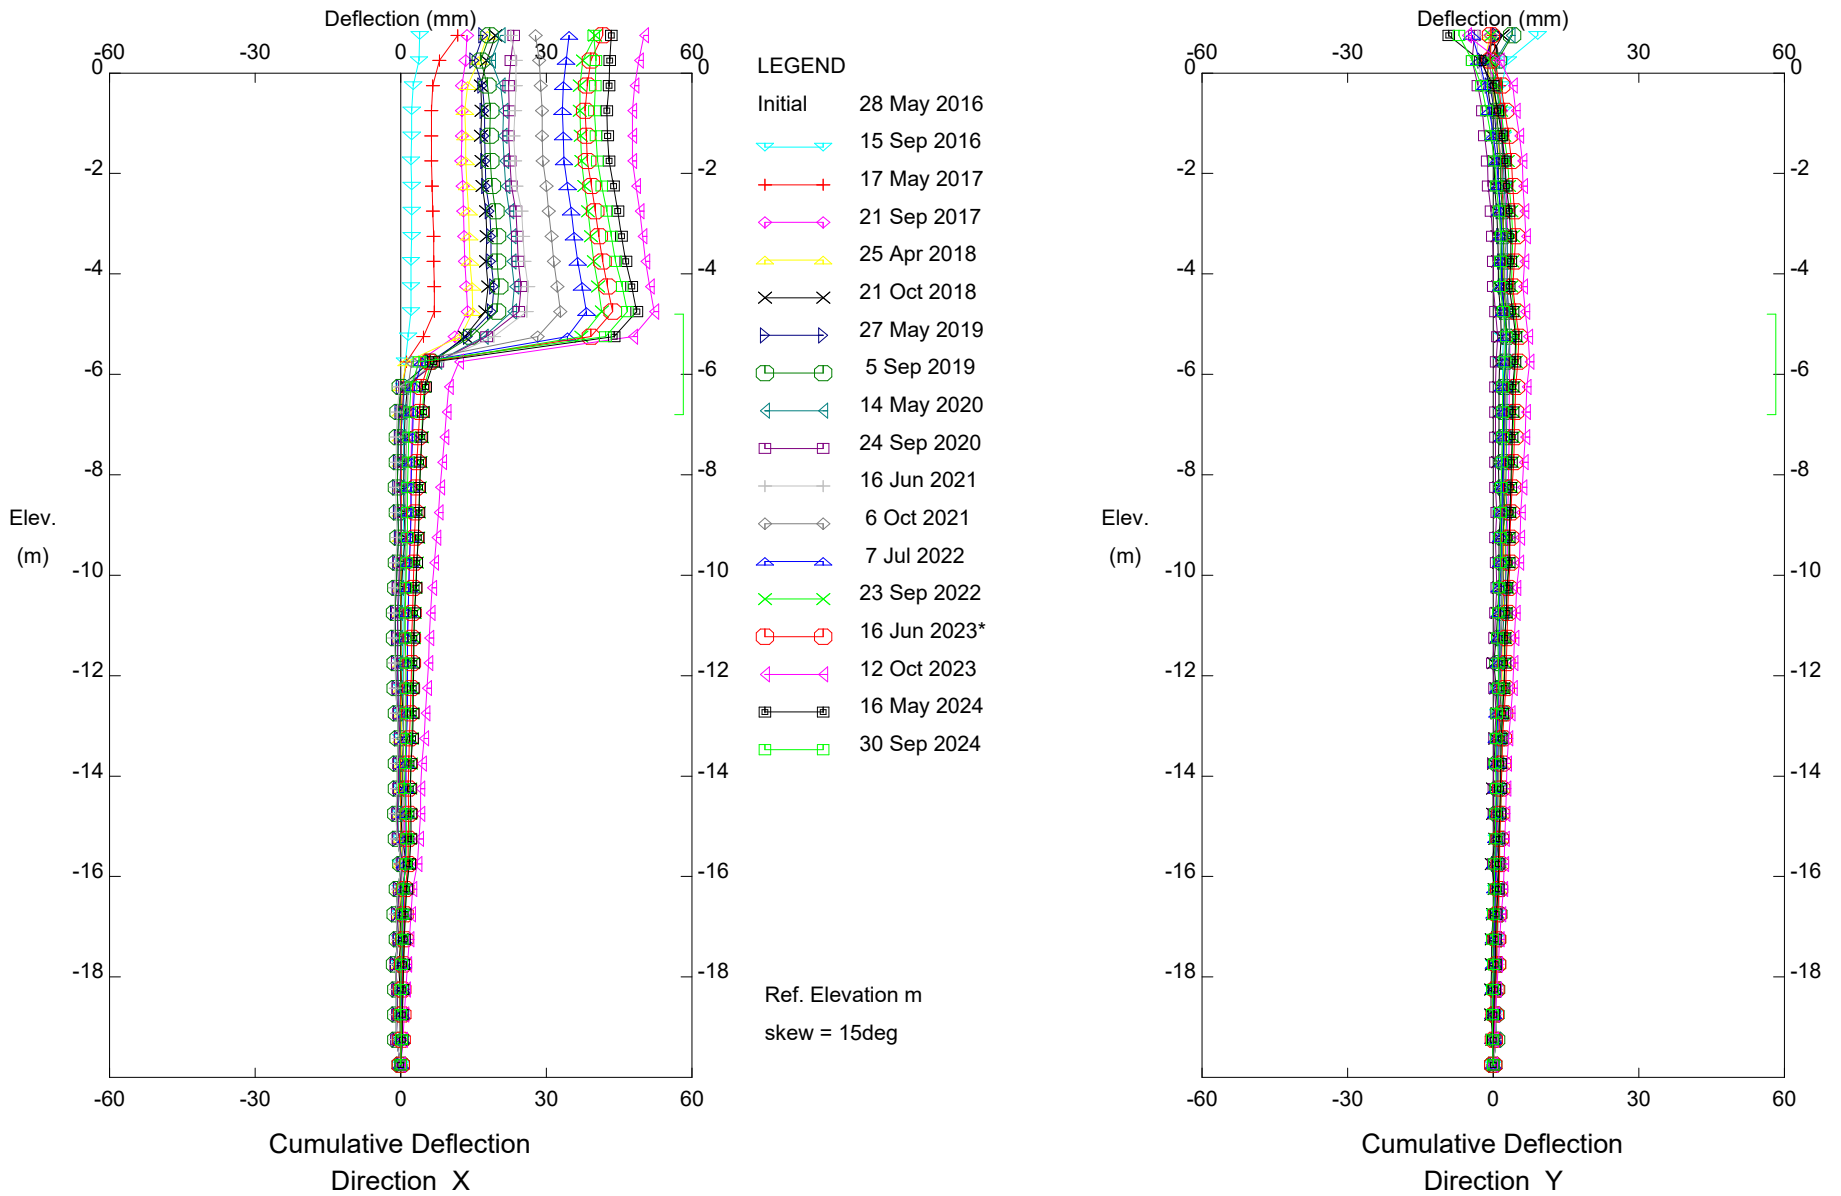
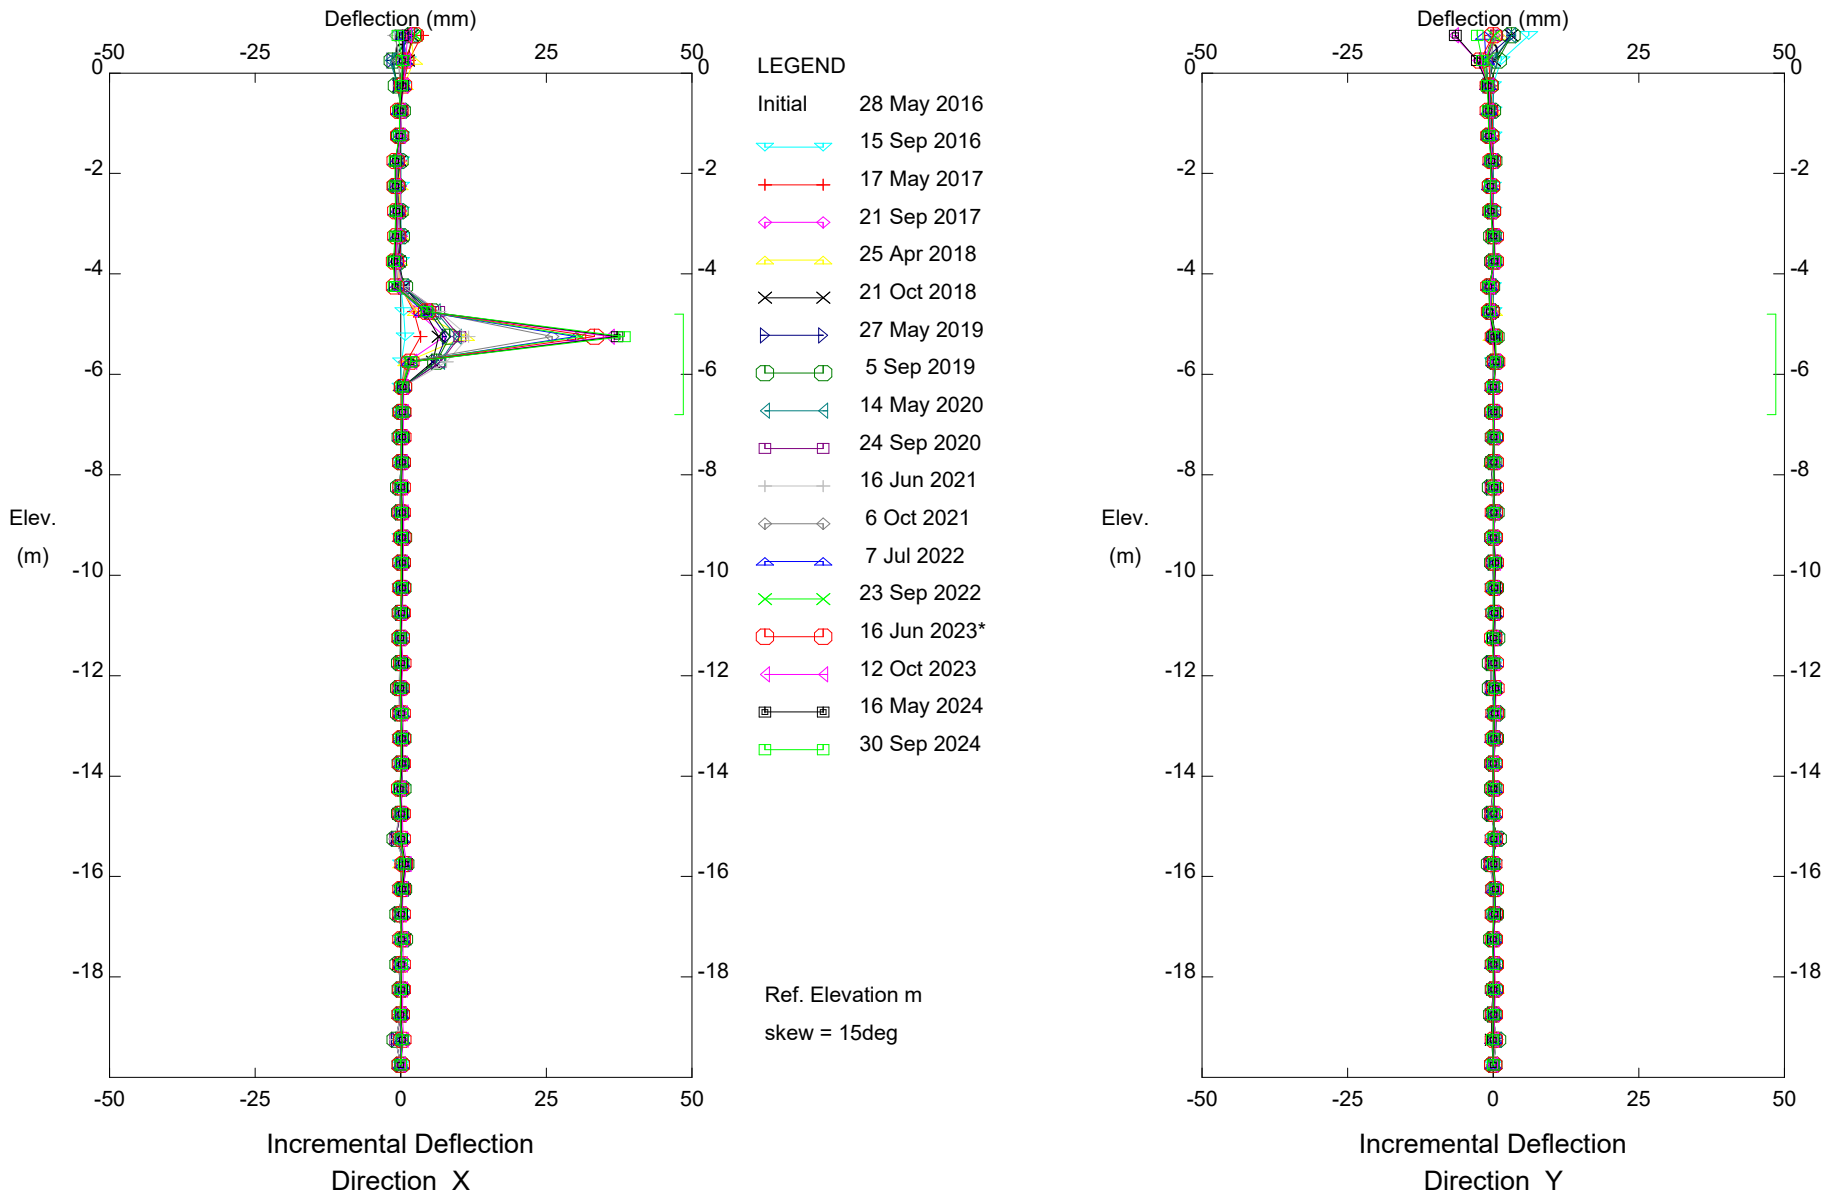
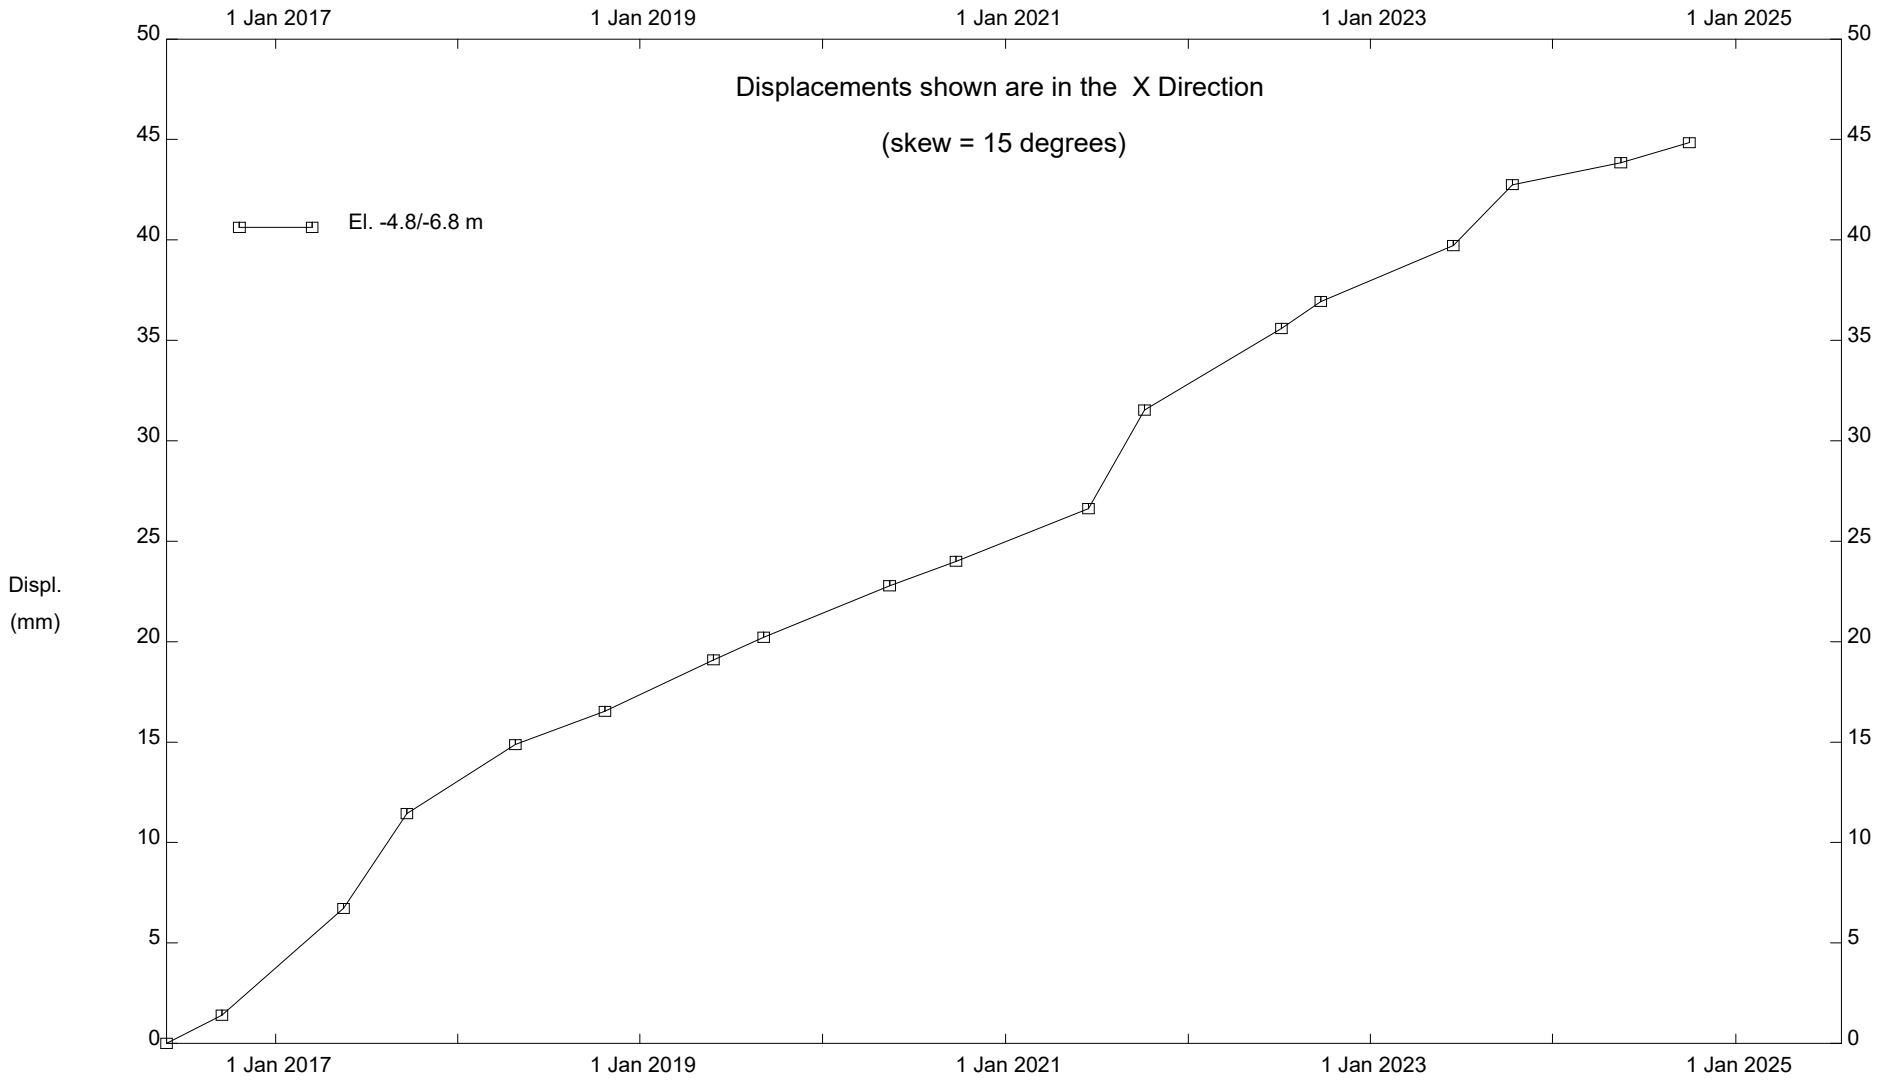
S026; H41:03, Elkwater Slides, Area B, Inclinometer SI12-01

Discrete movement has been recorded in SI12-01 between an approximate depth of 4.5 m and 6.5 m below ground surface.

The zone of movement recorded in SI12-01 is occurring at a similar depth to the original slide plane reported by the previous consultant prior to construction of the H-pile wall.

Since KCB took over the instrument readings in 2016, the rate of movement recorded in SI12-01 has been relatively steady (approximately 5 mm/year), except for an increased rate of movement recorded in the fall of 2017 and fall of 2021 (approximately 13.7 mm/year and 16.1 mm/year, respectively). The increased rate of movement recorded in the fall of 2021 could be due to a small data shift caused by KCB changing the SI reading equipment when the old equipment became inoperable. However, the increased rate of movement recorded in 2017 was reflective of site observations made by KCB and Alberta Transportation and Economic Corridors (TEC) during the 2017 Section B inspection.

Soil sliding observed downslope of the H-pile wall has exposed the H-piles and reduced the passive support of the H-pile wall on the downslope side. The movement recorded in SI12-01 reflects the movement of the H-pile occurring as the passive support is reduced.

Instrument readings should include measurements and photographs of the length of the H-pile exposed on the downslope side of the H-pile wall to monitor ongoing slope movements and erosion downslope of the H-pile wall.
