July 10, 2024

Alberta Transportation and Economic Corridors  
2<sup>nd</sup> Floor, 803 Manning Road N.E.  
Calgary, Alberta  
T2E 7M8

**CON0022161 Southern Region GRMP Instrumentation Monitoring  
Site S026; H41:03, km 35.169 Elkwater Slides  
Section C – 2024 Spring Readings**

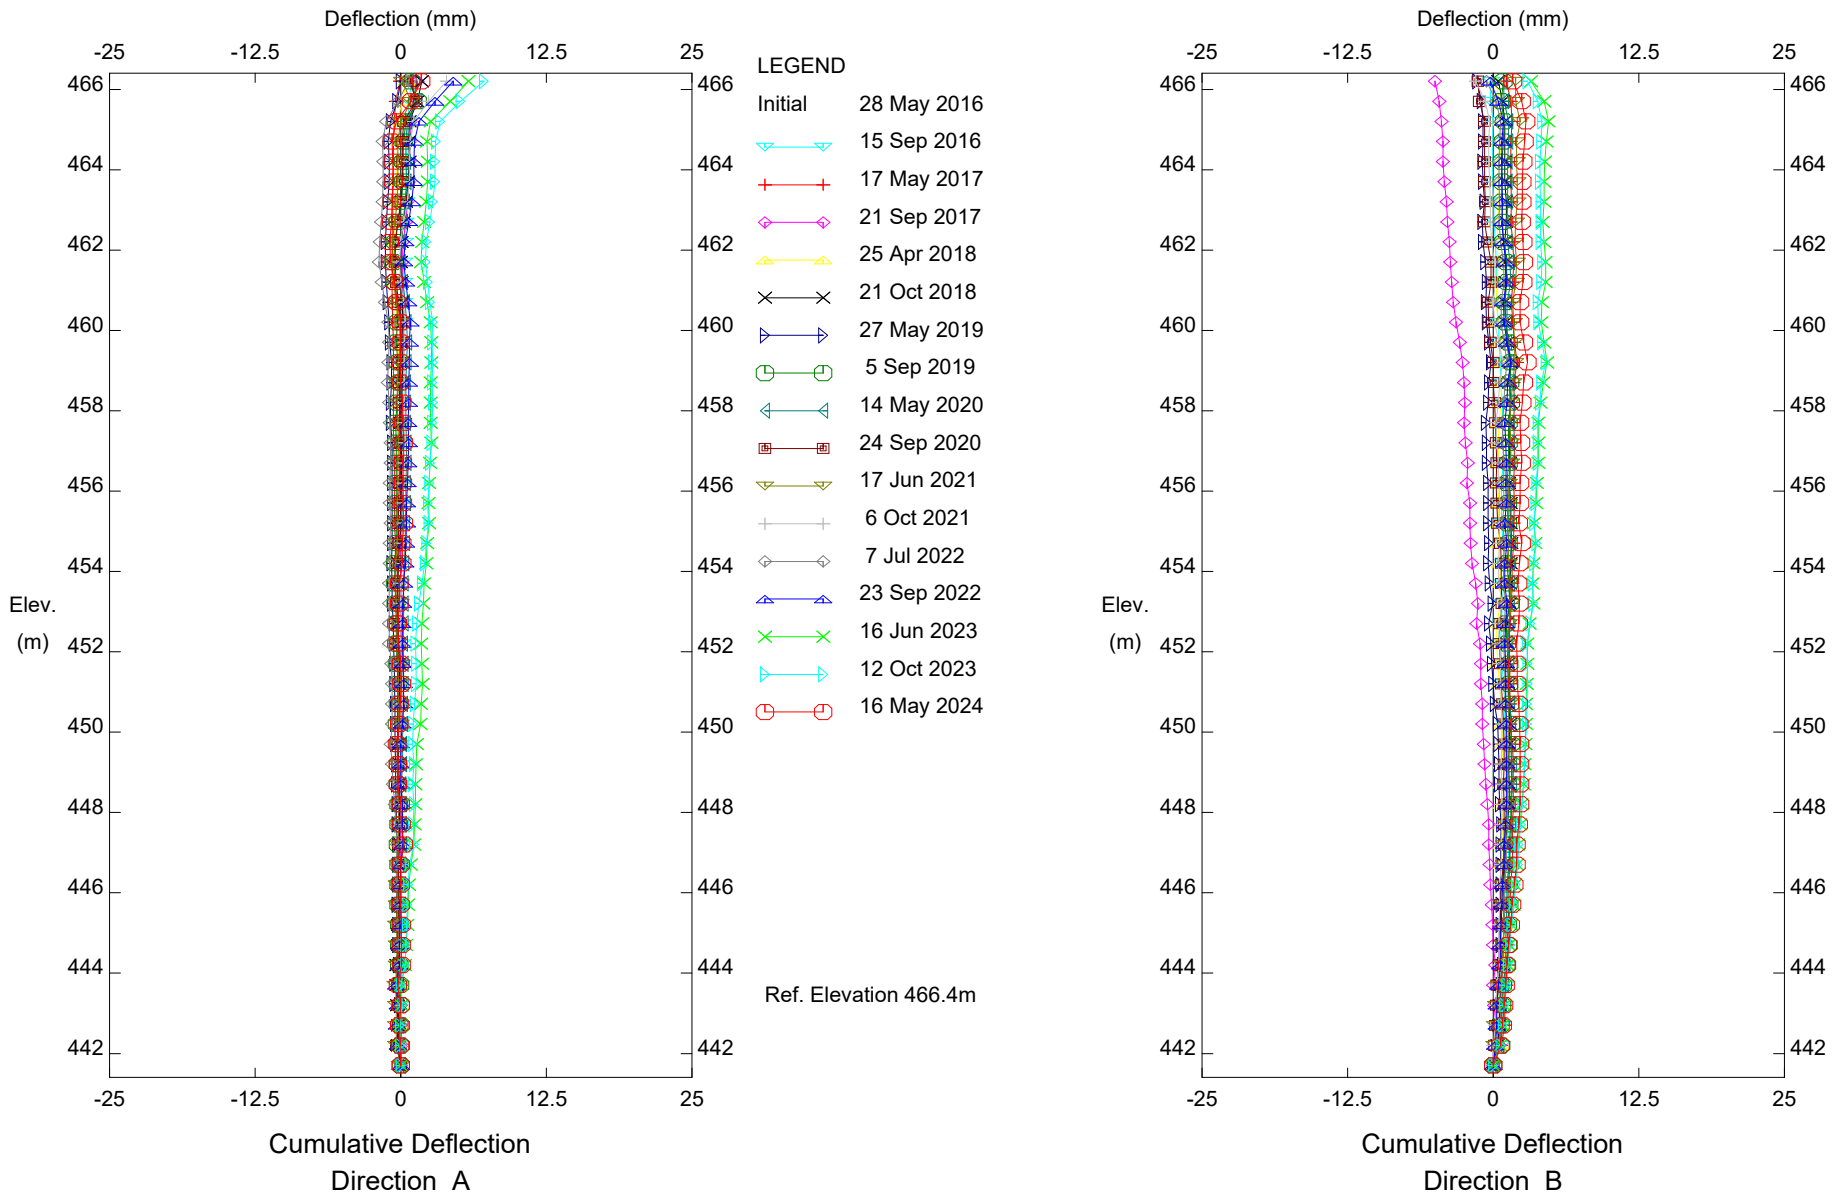
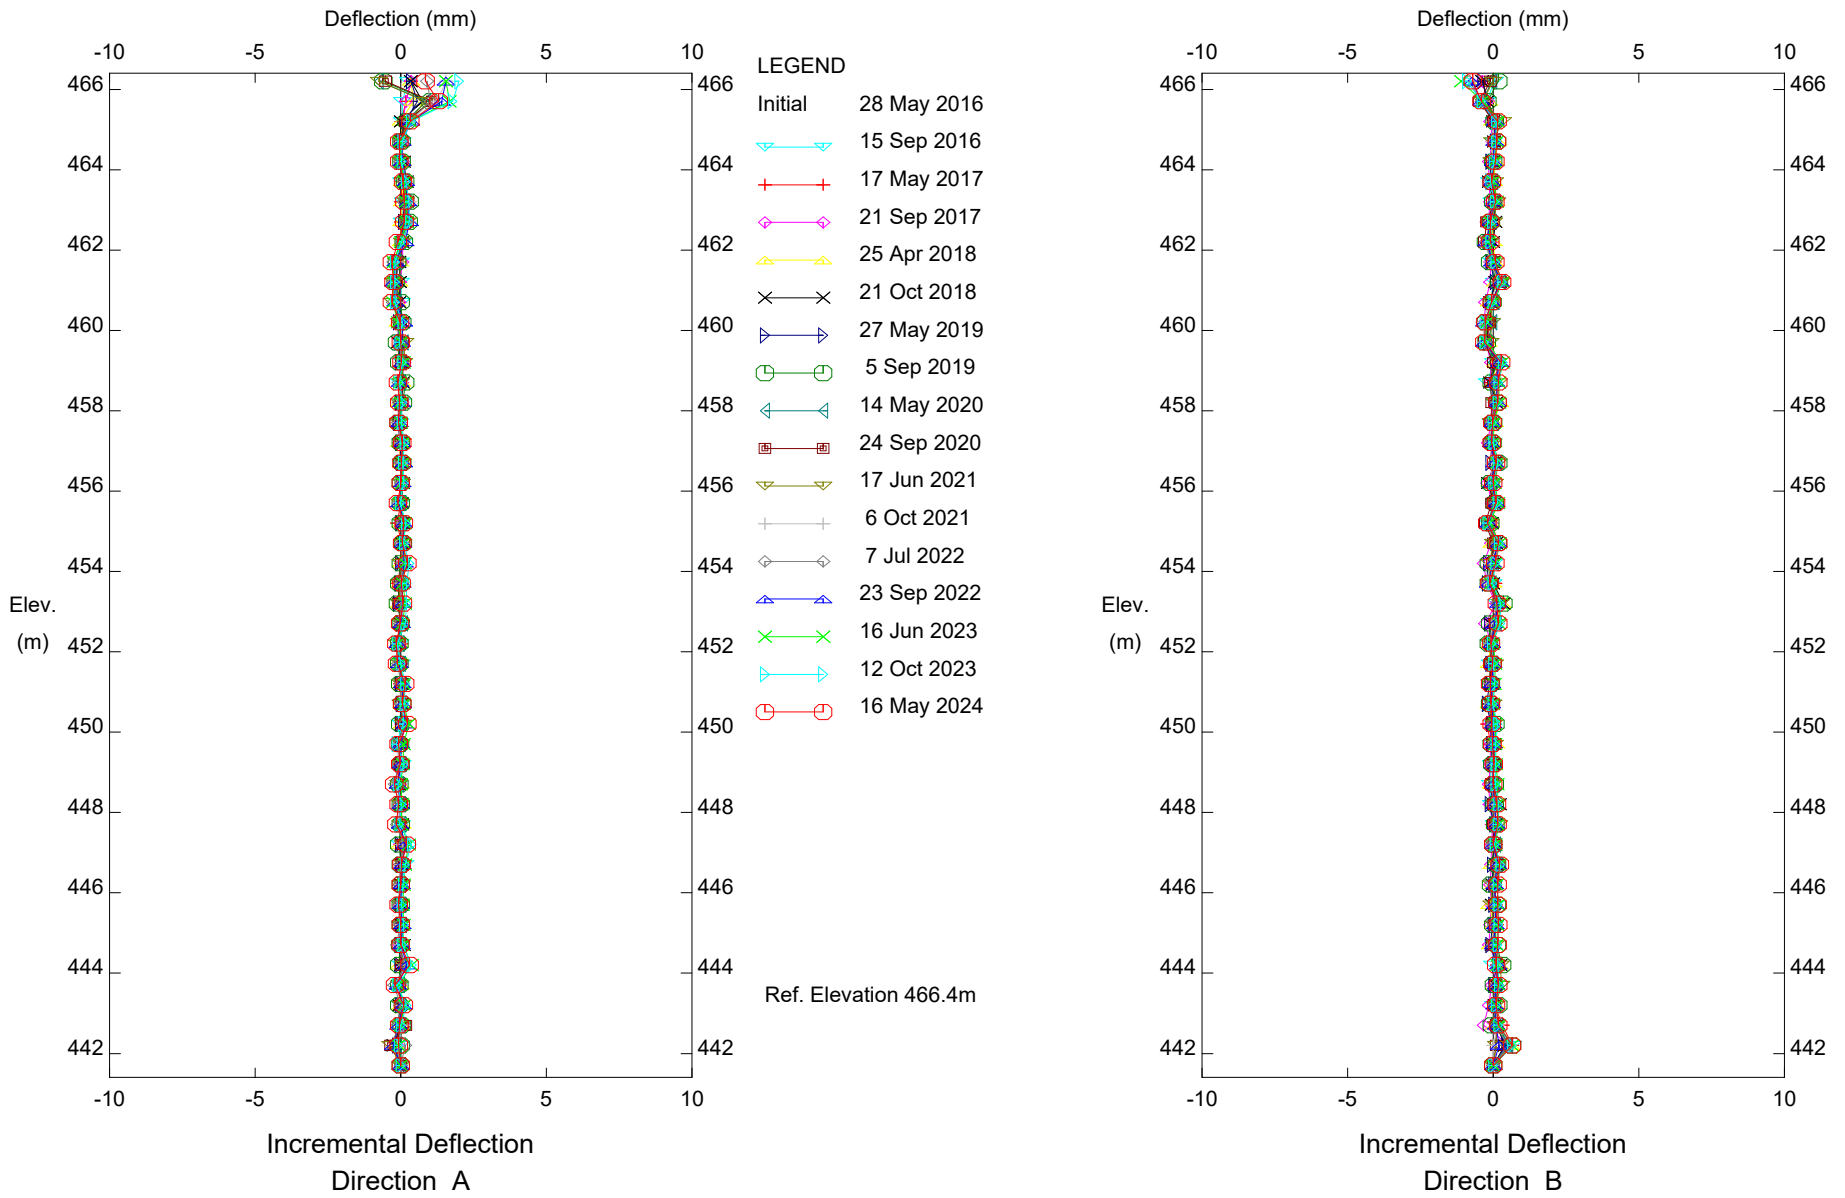
S026; H41:03, Elkwater Slides, Area A, Inclinometer SI08-1  
 Alberta Transportation

No discernible movement has been recorded in SI08-01 or SI08-03.

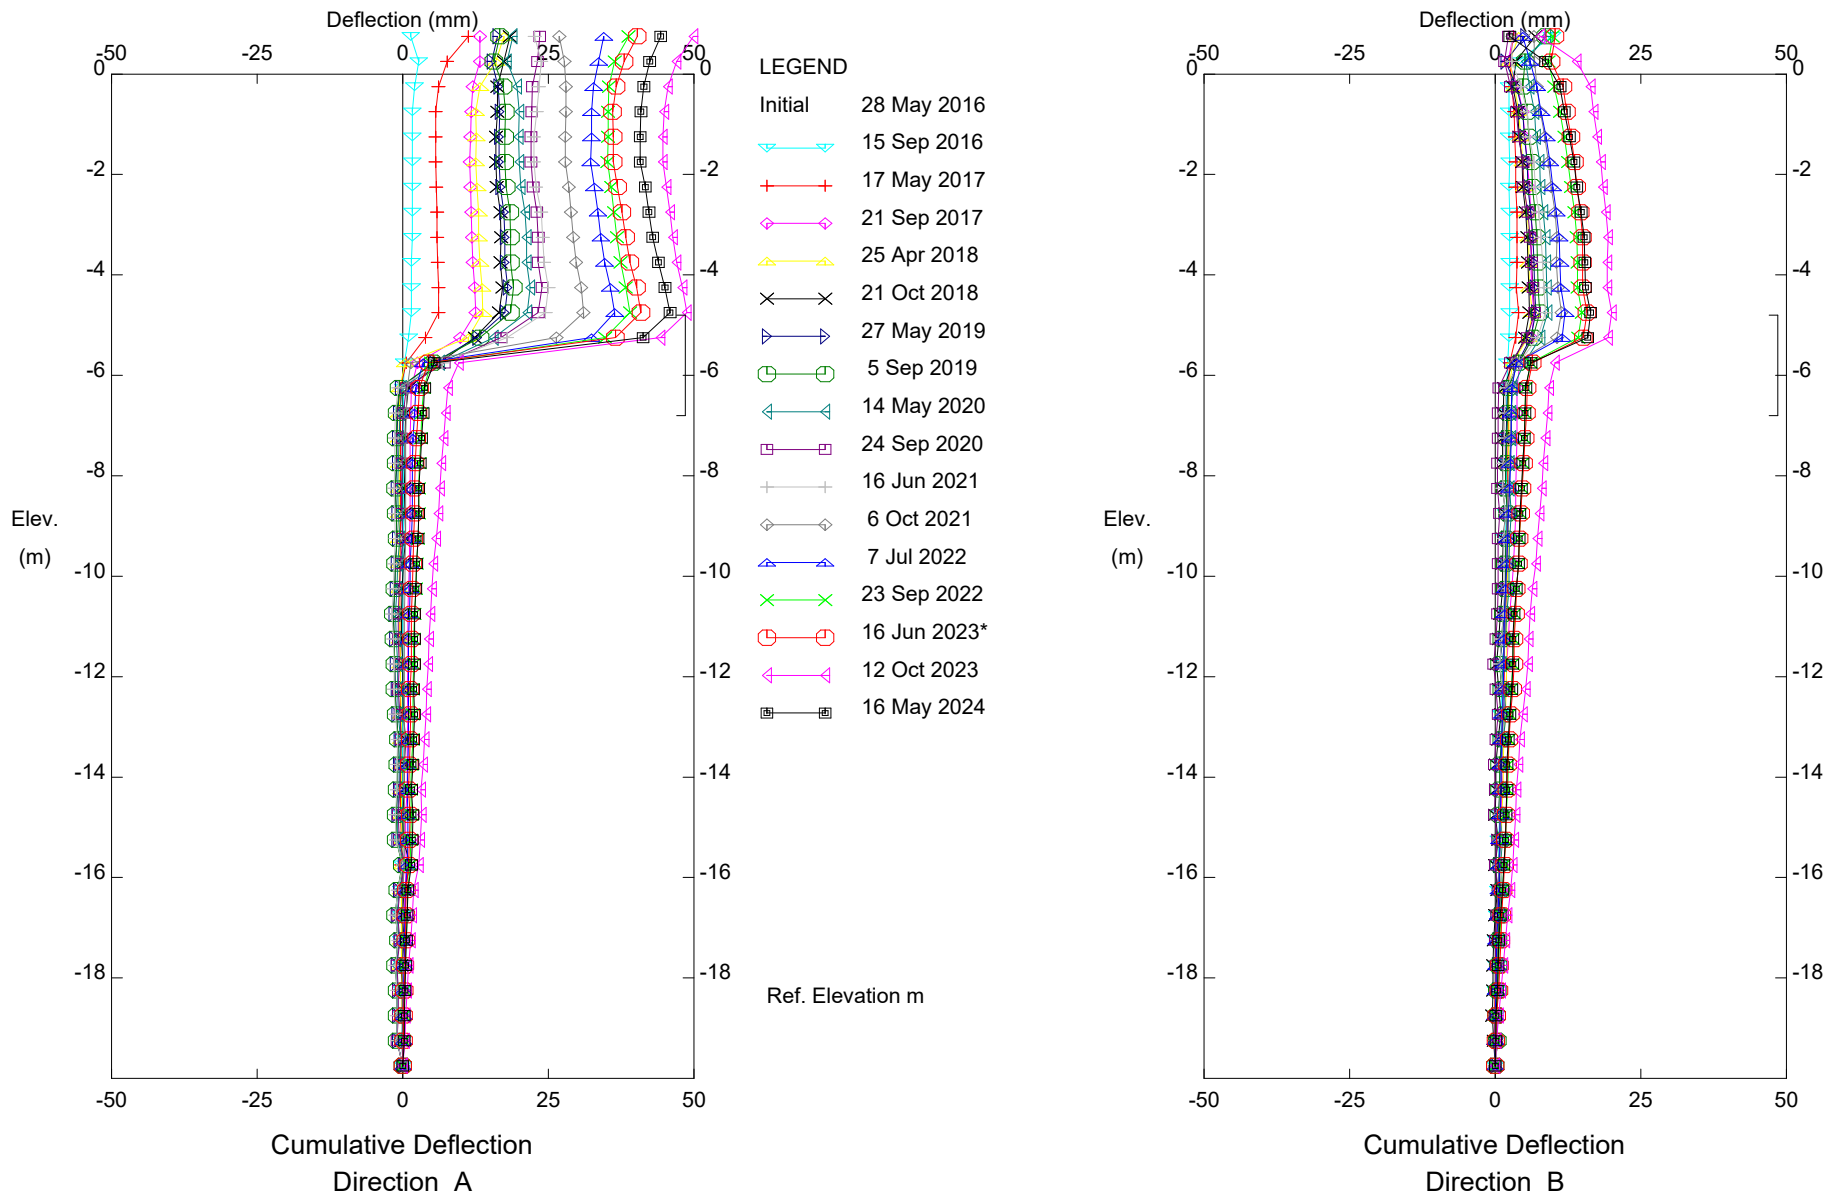
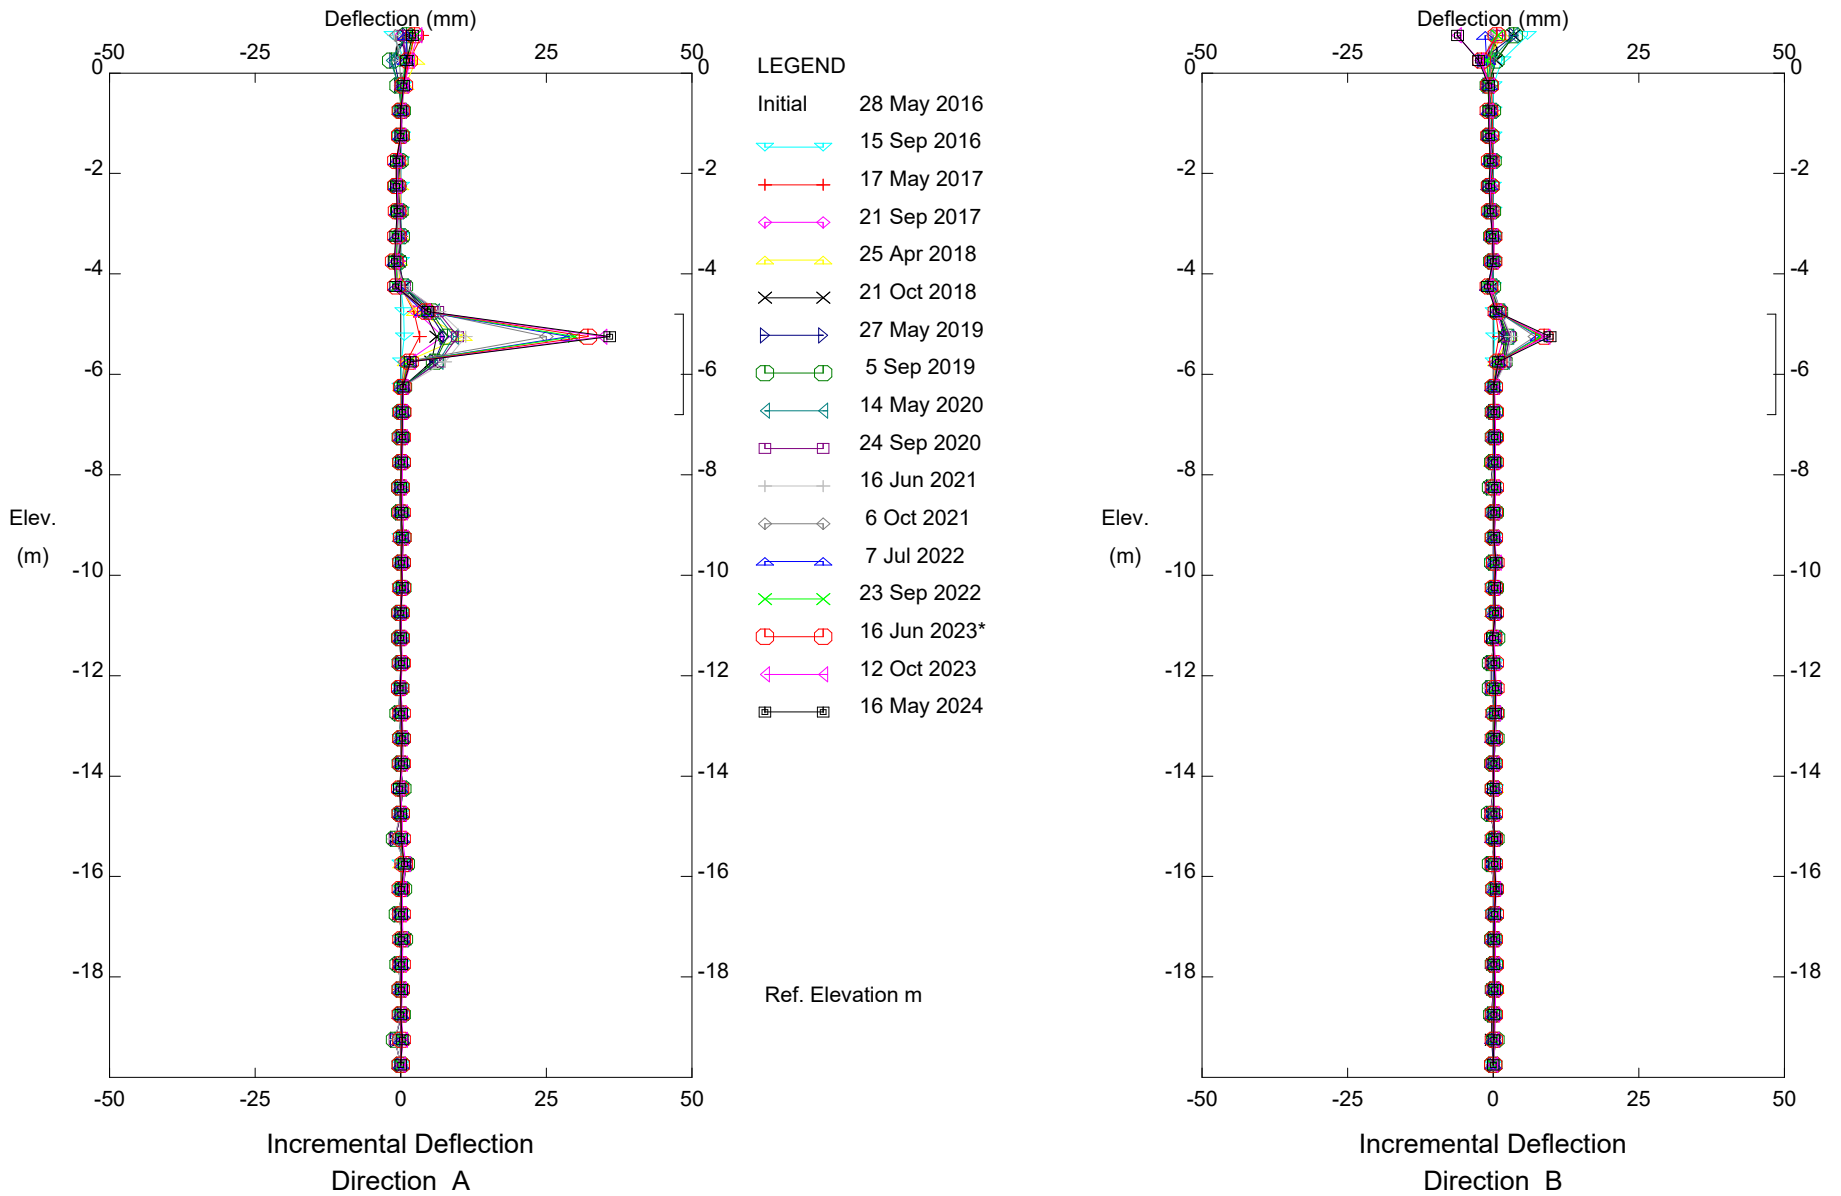
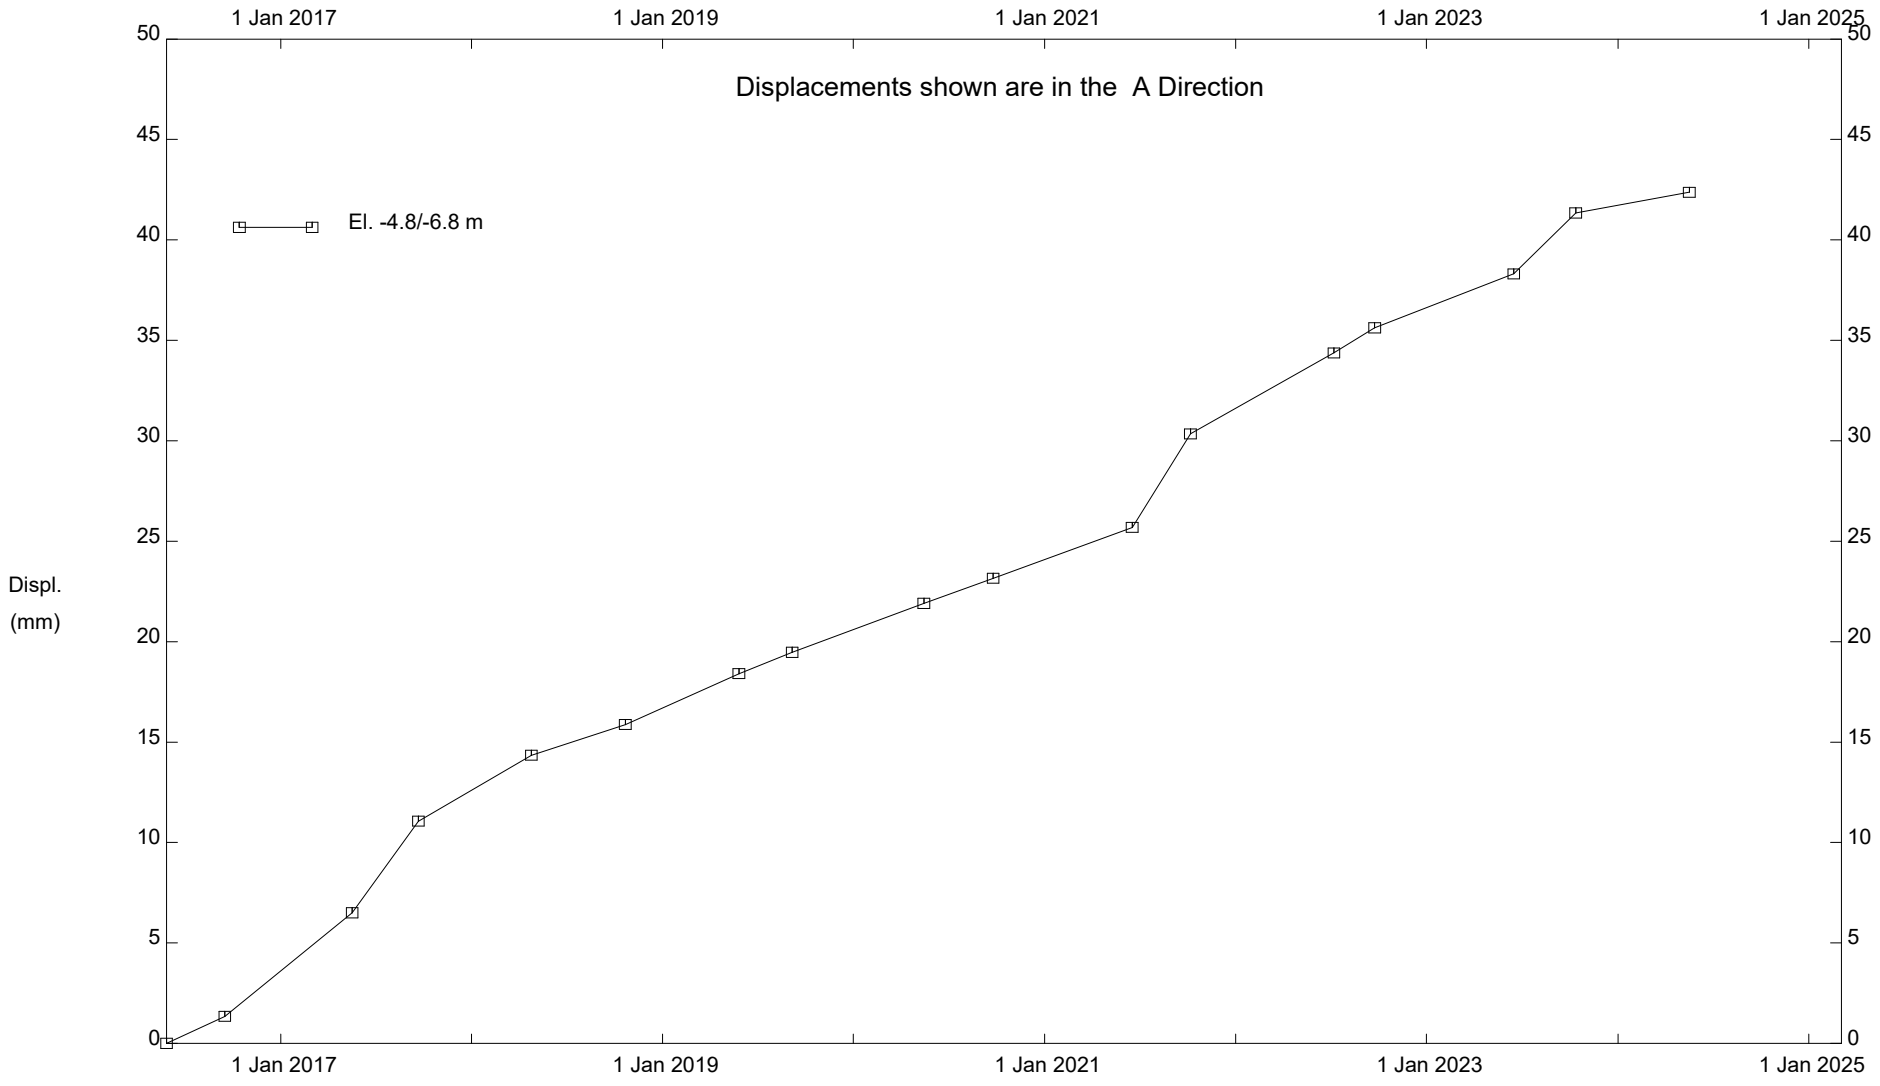
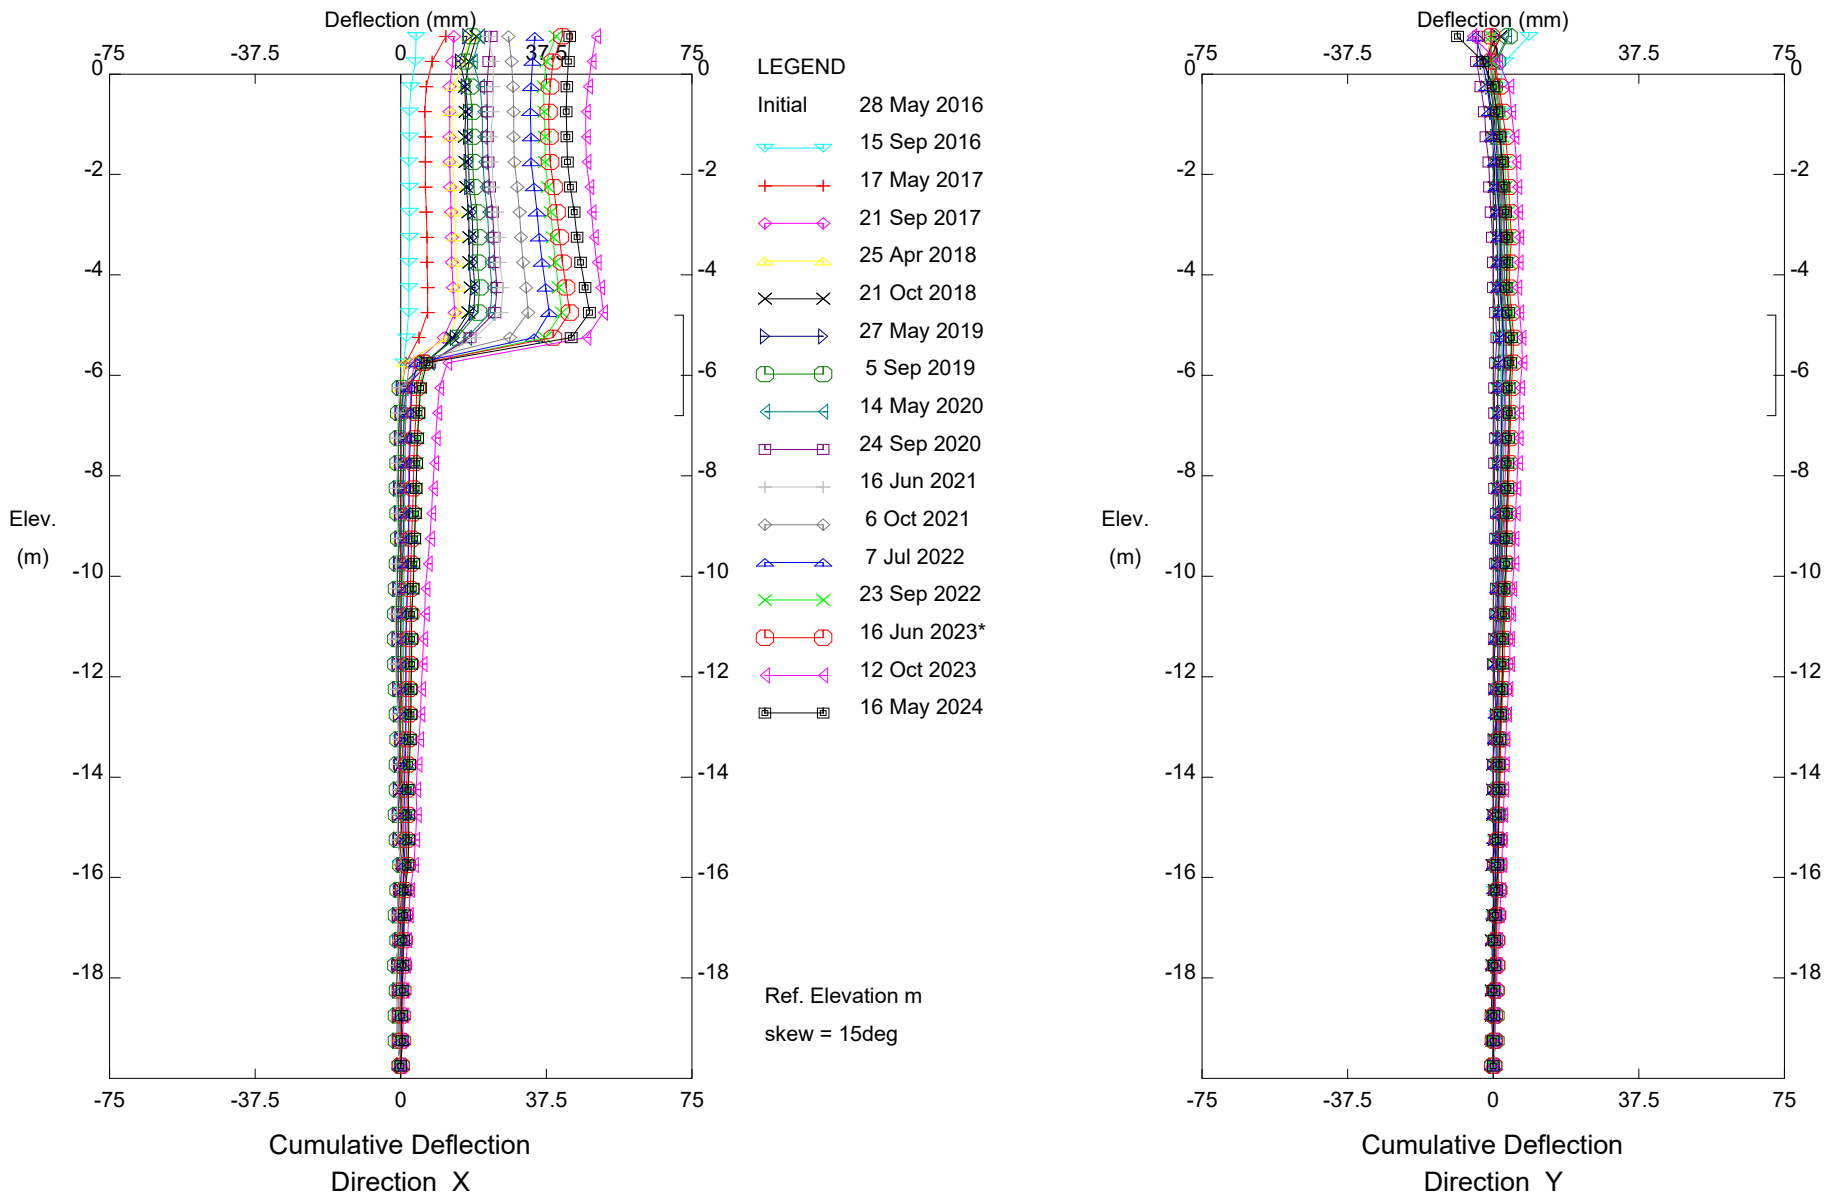
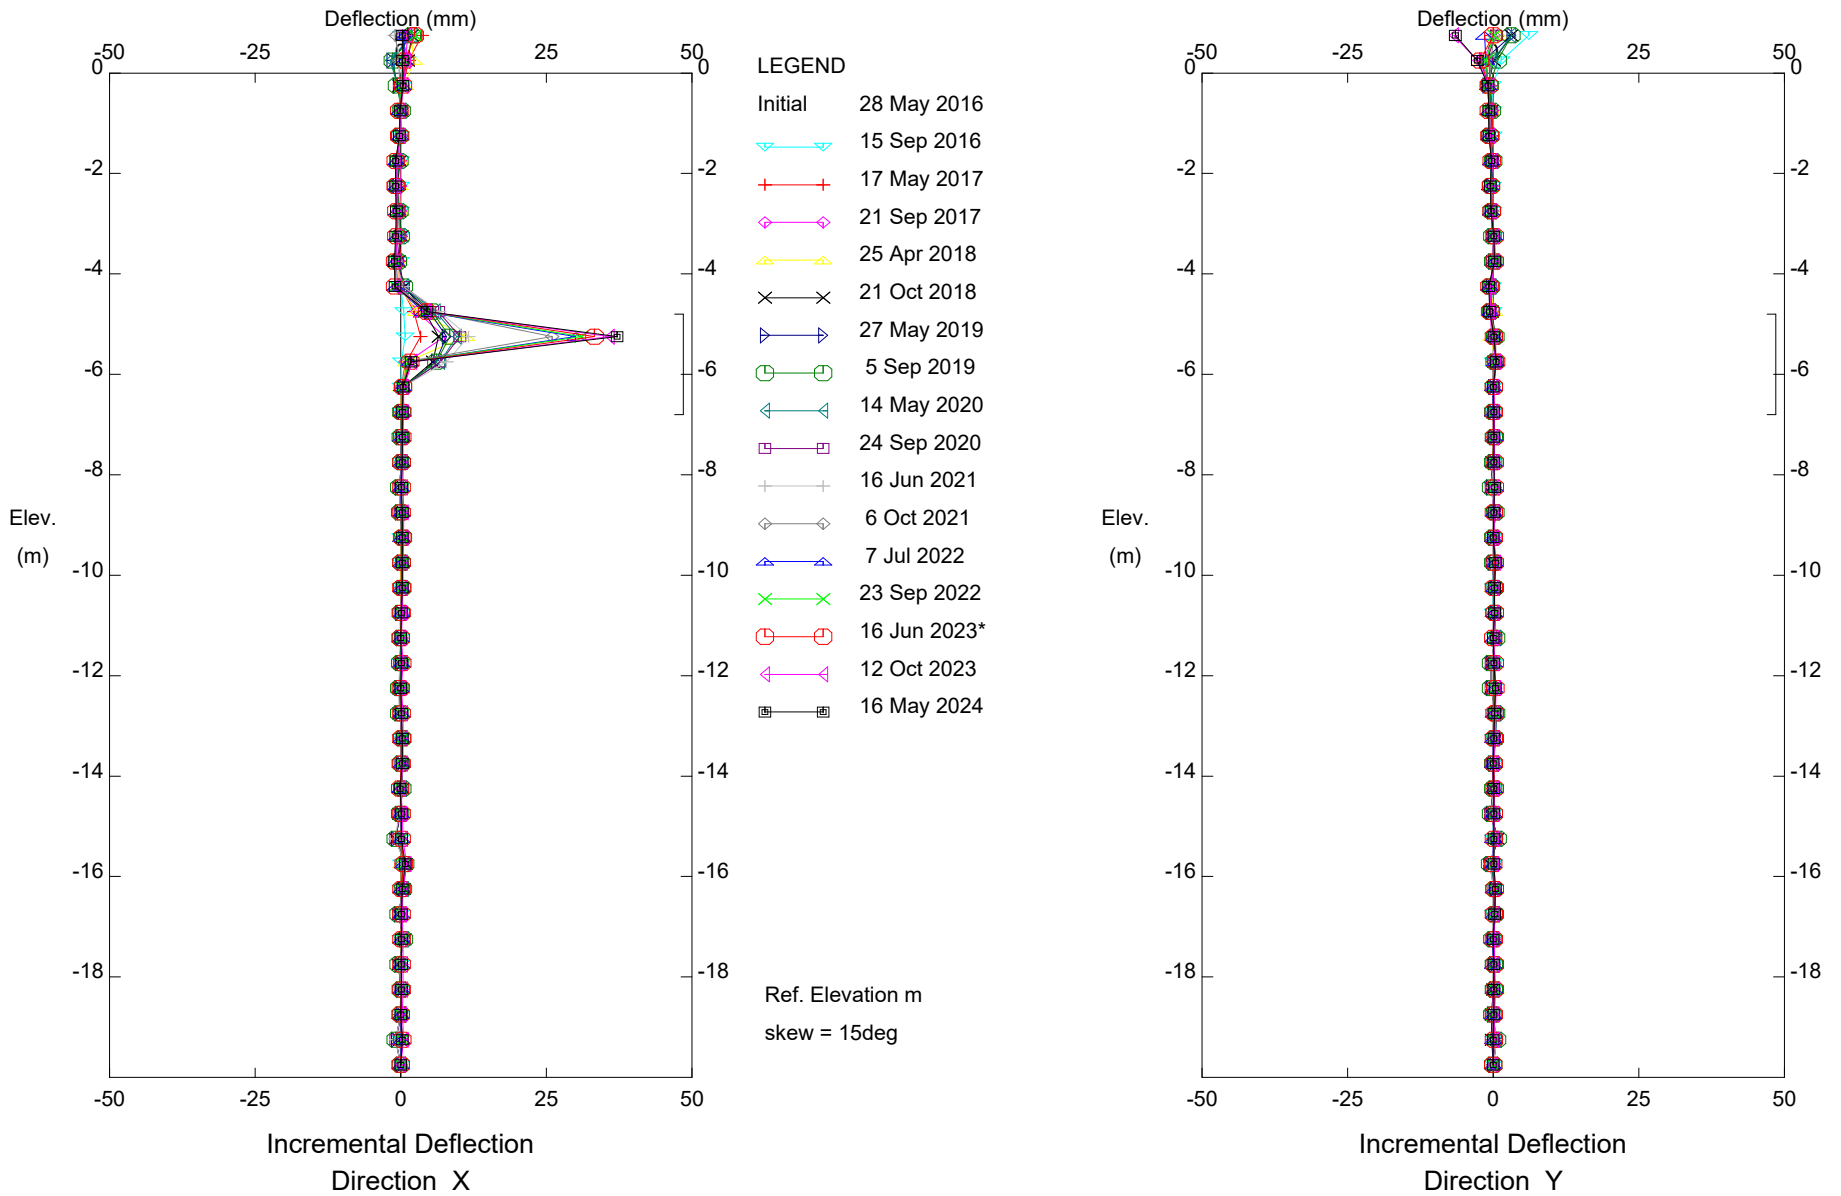
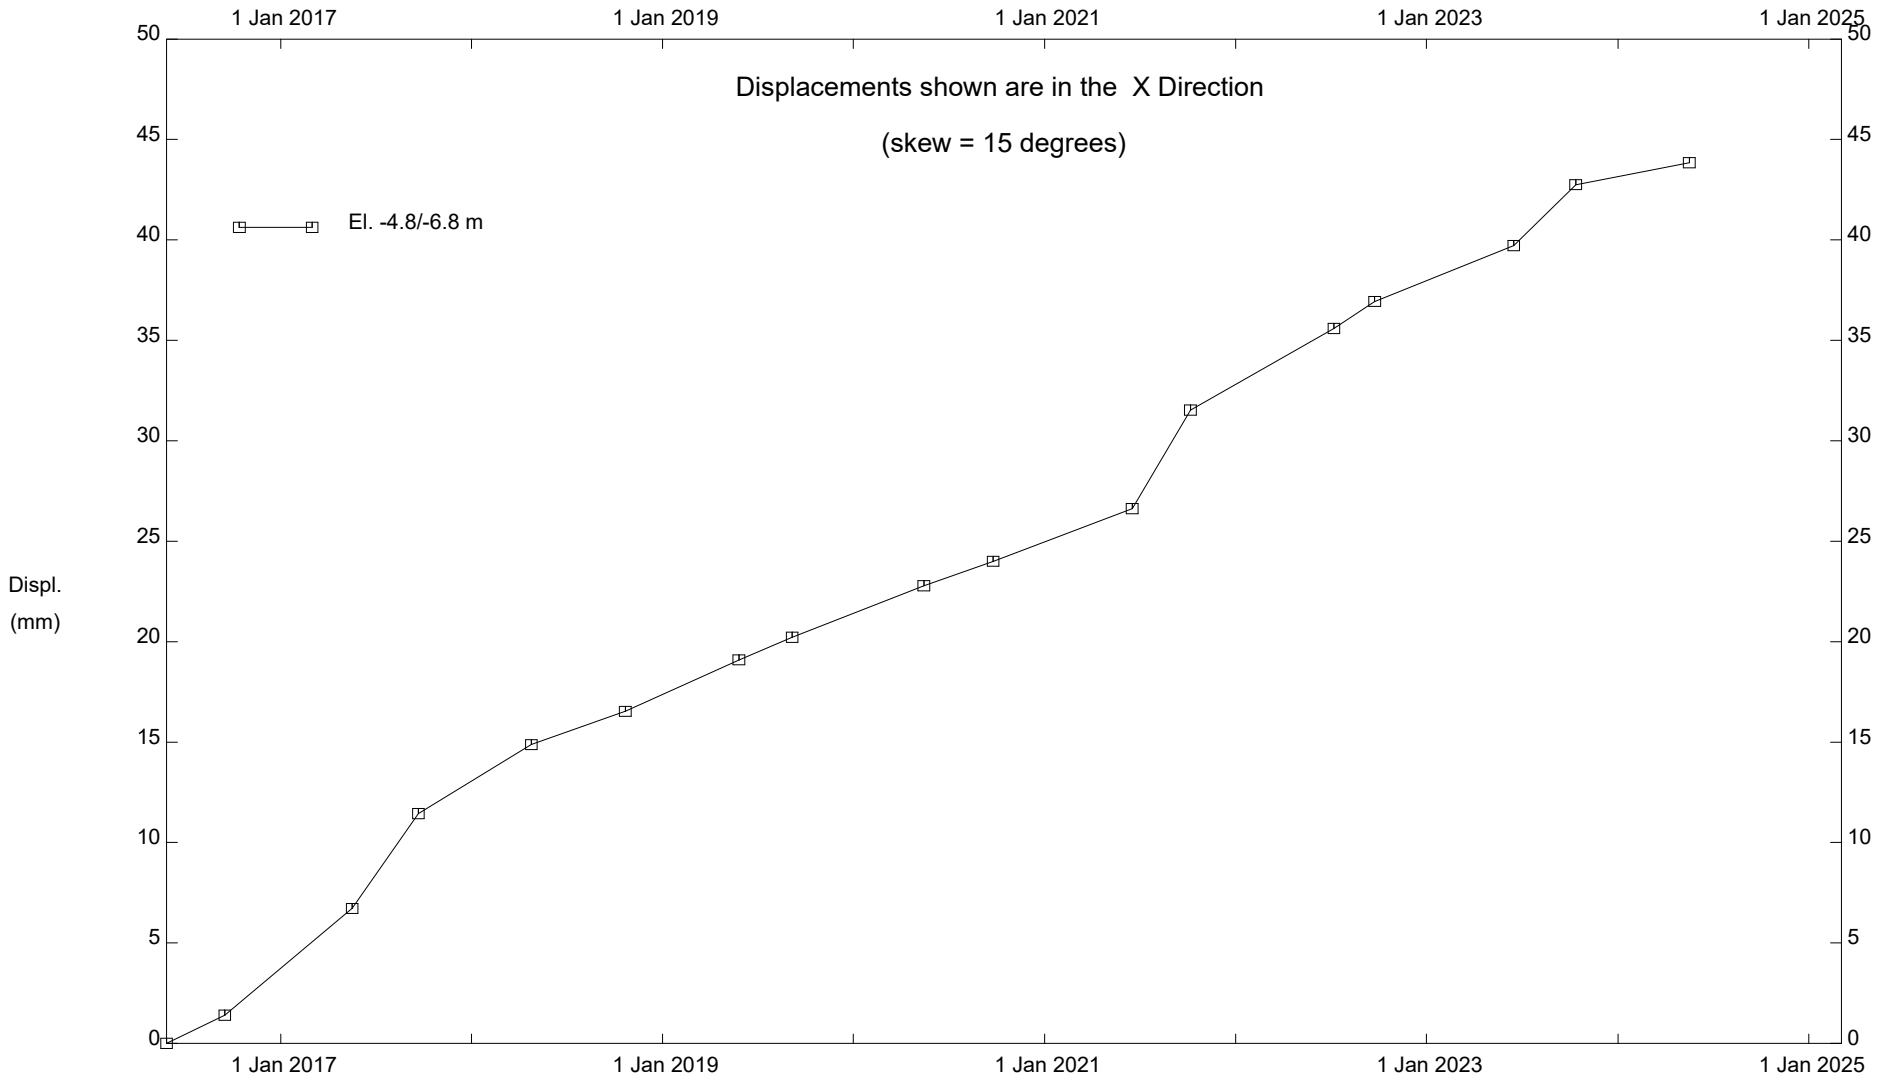
S026; H41:03, Elkwater Slides, Area B, Inclinometer SI12-01

Discrete movement has been recorded in SI12-01 between an approximate depth of 4.5 m and 6.5 m below ground surface.

The zone of movement recorded in SI12-01 is occurring at a similar depth to the original slide plane reported by the previous consultant prior to construction of the H-pile wall.

Since KCB took over the instrument readings in 2016, the rate of movement recorded in SI12-01 has been relatively steady (approximately 5 mm/year), except for an increased rate of movement recorded in the fall of 2017 and fall of 2021 (approximately 13.7 mm/year and 16.1 mm/year, respectively). The increased rate of movement recorded in the fall of 2021 could be due to a small data shift caused by KCB changing the SI reading equipment when the old equipment became inoperable. However, the increased rate of movement recorded in 2017 was reflective of site observations made by KCB and Alberta Transportation (AT) during the 2017 Section B inspection.

Soil sliding observed downslope of the H-pile wall has exposed the H-piles and reduced the passive support of the H-pile wall on the downslope side. The movement recorded in SI12-01 reflects the movement of the H-pile occurring as the passive support is reduced.

Instrument readings should include measurements and photographs of the length of the H-pile exposed on the downslope side of the H-pile wall to monitor ongoing slope movements and erosion downslope of the H-pile wall.

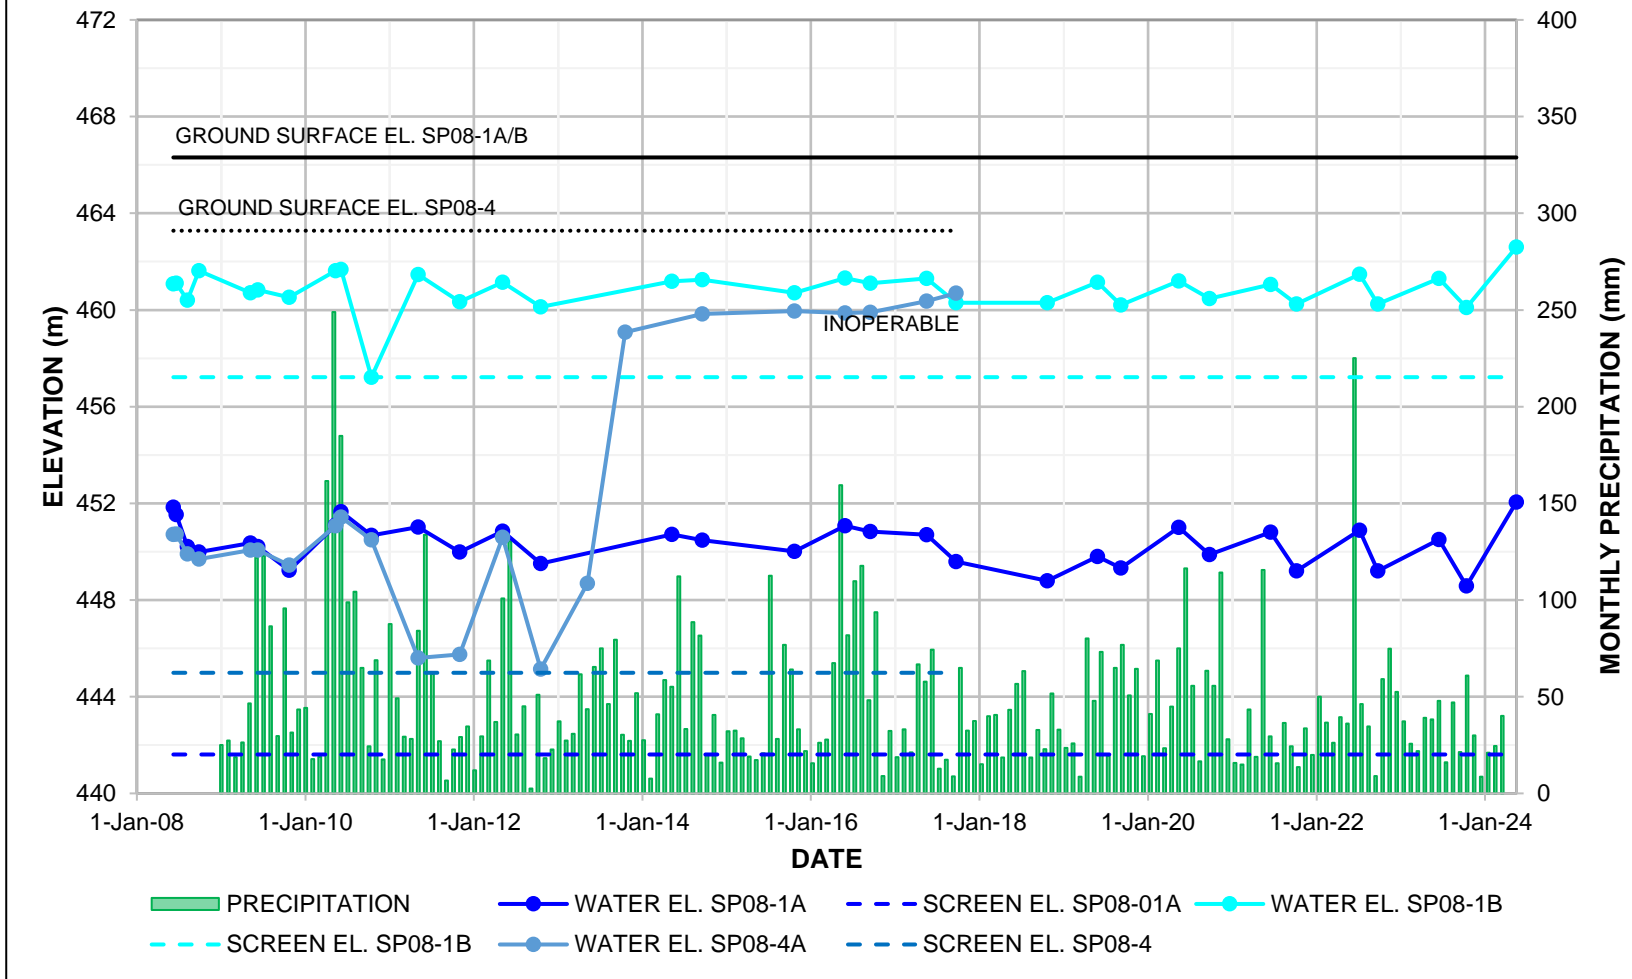
### SP08-1A, SP08-1B, AND SP08-4A

Water levels recorded in SP08-01A and SP08-01B appear to fluctuate seasonally (with the spring readings being higher than fall readings) from an approximate depth of 14.4 m to 17.5 m below ground surface and 4.5 m to 6.1 m below ground surface, respectively. The May 2024 readings were consistent with historical trends observed in these instruments, with increases of 2.4 m and 1.5 m recorded in SP08-01A and SP-01B, respectively. The spring 2024 readings are the highest that have been recorded since installation. Spring 2024 was wetter than previous years, but at the time of writing this report, rainfall data was only available until the end of March 2024. Once available, the rainfall data will be compared to the spring piezometer readings to assess water level trends based on increased rainfall.
