S13 – SHEEP RIVER SITE

Alberta Transportation
Southern Region Geohazard Assessment
Annual Assessment Report
June 2004

PROJECT: SOUTHERN REGION GEOHAZARD ASSESSMENT

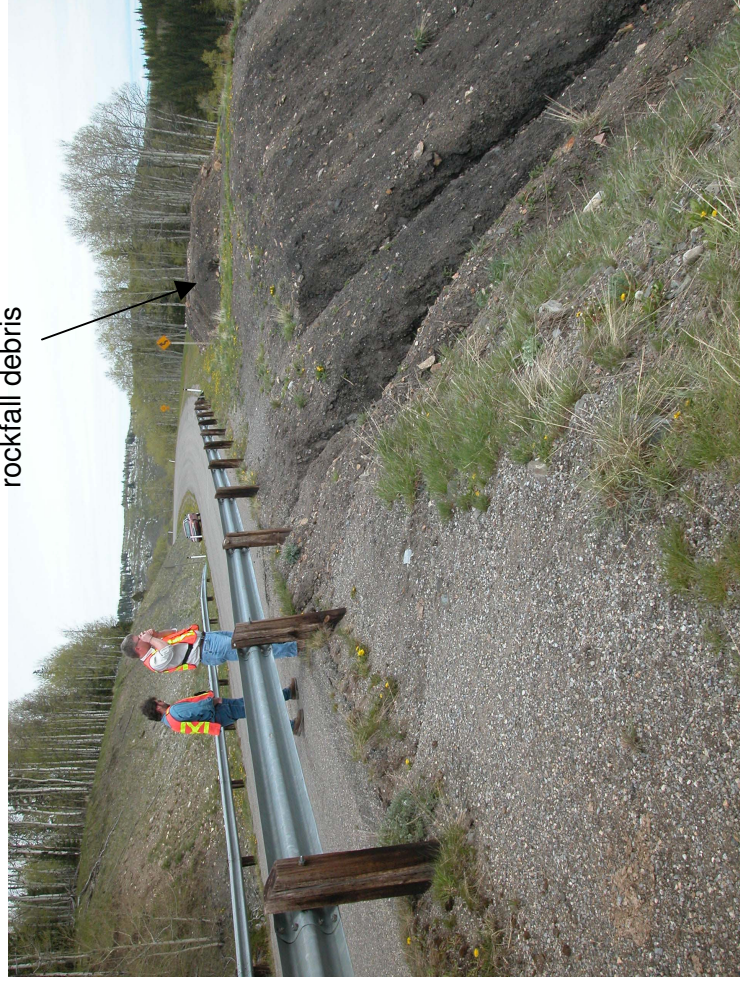
Stockpile of
rockfall debris

Photo S13-3 (lower left) – May 2004 – facing east across the site, showing the relative position of the gully erosion in the fill embankment slope face and the guardrail/road surface. Note the pile of rockfall debris that has been hauled from a site to the east and stockpiled here for later disposal into the gully downstream of the road.

The occasional bulldozing/end-dumping of rockfall debris into the gully should be stopped. Aside from any environmental regulatory issues related to this practice, there is the potential that large rocks in the debris could strike and damage the exposed portion of the culvert at the base of the fill embankment.

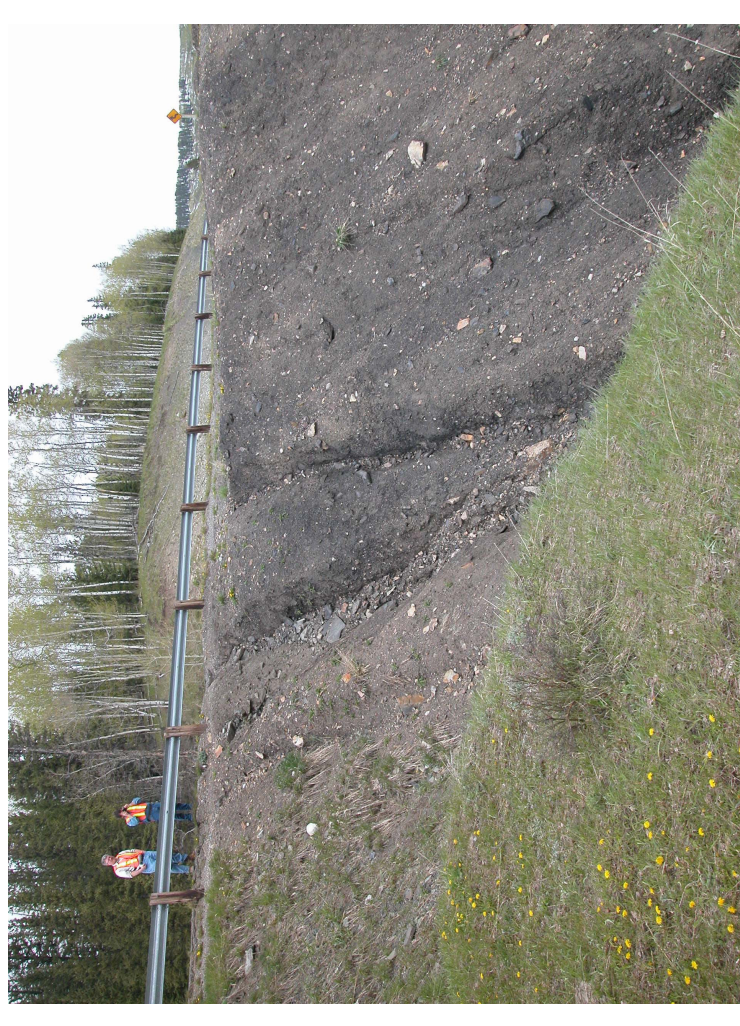
The surface erosion of the fill embankment slope face below the road is continuing but does not appear to have worsened significantly since the 2003 assessment. The retrogression of one of the erosion gullies into the eastbound lane of the road is still evident but does not appear to have advanced significantly since the 2003 assessment.

Photo S13-4 (lower right) – May 2004 – facing upslope/northeast towards the road. Note the gully erosion visible in the fill embankment slope face below the guardrail.

The gullying on the fill slope below the road should be mitigated by improved control of the runoff from the road surface. AMEC recommends the following to achieve this (see Figure 2-S13 in Appendix S13 for a schematic illustration):
