## SOUTHERN REGION GRMP SITE INSPECTION FORM

SITE NUMBER AND NAME: S056-III West Gorge Creek, west of		HIGHWAY & KM: Sheep River Road		PREVIOUS INSPECTION DATE:	INSPECTION DATE: May 6, 2019			
Turner Valley		N/A						
LEGAL DESCRIPTION: 07-35-019-05 W5M					RISK ASSESSMENT: PF: 9 CF: 4 TOTAL: 36			
MONTHLY AVERAGE DAILY 360 (west), 300 (east). (Ref. N		CONTRACTOR MAINTENANCE AREA (CMA): 27

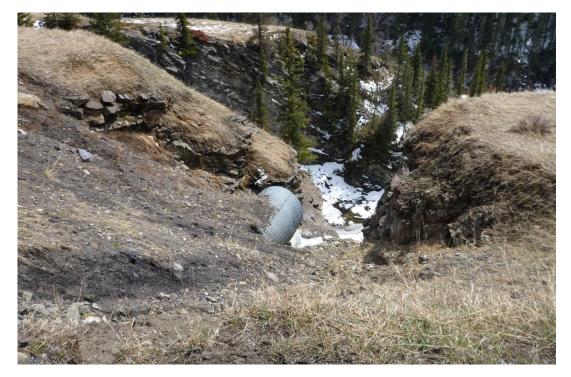
Photo 1 Slope erosion due to surface water runoff, adjacent to existing culvert. Photo was taken facing south on May 6, 2019.

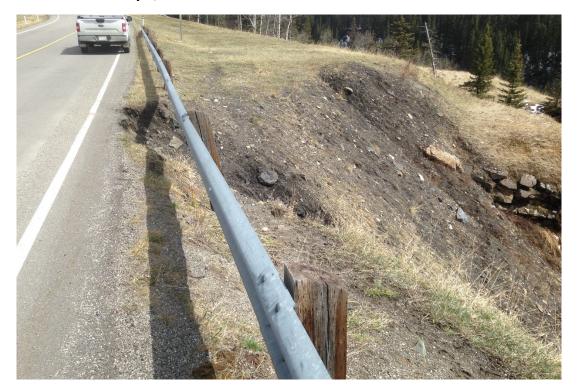
Photo 2 Ongoing slope retrogression impacting the highway. Photo was taken facing east on May 6, 2019.

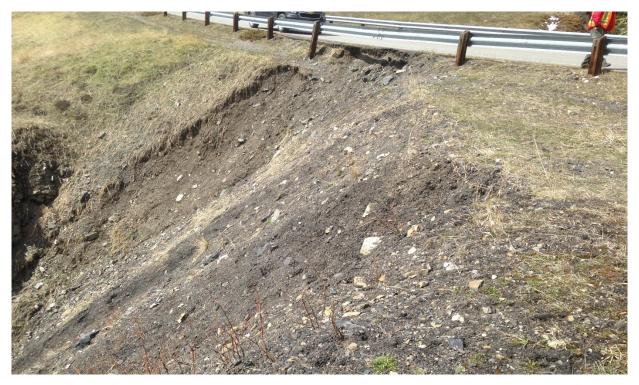
## Photo 3 Back scarp of slope failure. Photo was taken facing northwest on May 6, 2019.

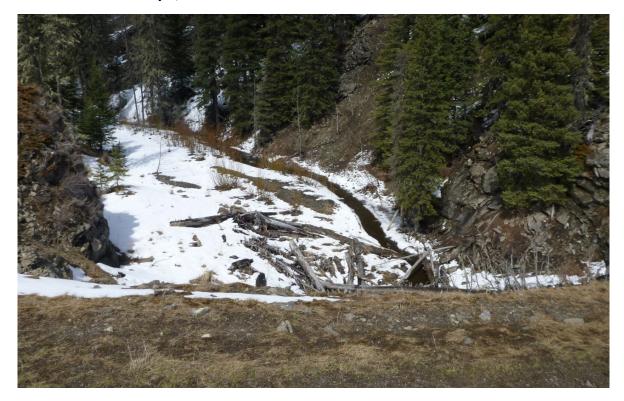
Photo 4 Debris and vegetation at upstream entrance to culvert. Photo was taken facing north on May 6, 2019.
