SOUTHERN REGION GRMP SITE INSPECTION FORM

SITE NUMBER AND NAME:	HIGHWAY & KM:	PREVIOUS	INSPECTION DATE:	
S056-II West Gorge Creek,	Sheep River Road	INSPECTION DATE:	July 5, 2021	
West of Turner Valley	-	June 8, 2020	ou.y 0, 202 :	
LEGAL DESCRIPTION:	NAD 83 COORDINATES:	RISK ASSESSMENT:		
01-32-019-05 W5M	UTM Northing Easting	PF: 9 CF: 10 T	OTAL: 90	
	11 5613067 666206			
MONTHLY AVERAGE DAILY	TRAFFIC (MADT): May 2020	CONTRACTOR MAINTENANCE AREA (CMA):		
390 (west), 382 (east). (Ref. N	lo. 55460220)	27

Site Plan S056-II West Gorge Creek Site II Sheep River Road

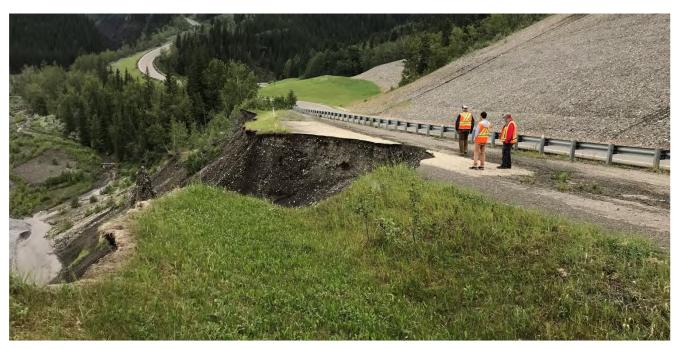
Photo 1 Realigned highway on the right-hand side of the picture due to slope instability impacting the old road. Photo was taken facing southwest on July 5, 2021.

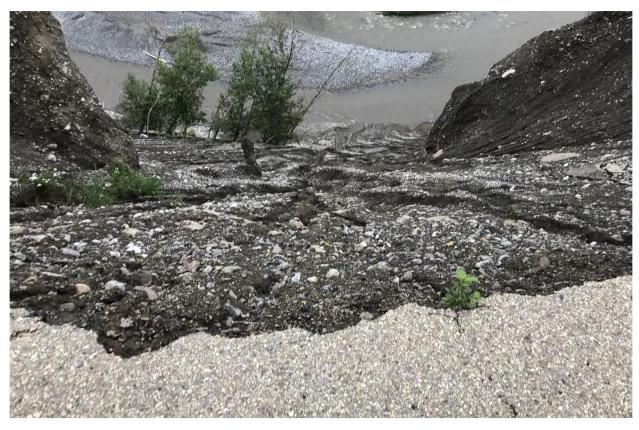
Ongoing slope erosion due to surface runoff, frost and seepage, leading to undermining of the crest of the slope. No current impact to the realigned highway. Site will be monitored moving forward.

Undermining of the old pavement is leading to the old highway surface cracking and dropping away. Current edge erosion slope is 4.9 m from the safety barrier. Slope erosion was visible east of the main erosion feature.

Photo 2 Ongoing slope retrogression. Photo was taken facing south on July 5, 2021.

- Annual inspections to monitor slide retrogression; and
- Hydroseeding of the cut slope north of the highway to minimize runoff erosion.

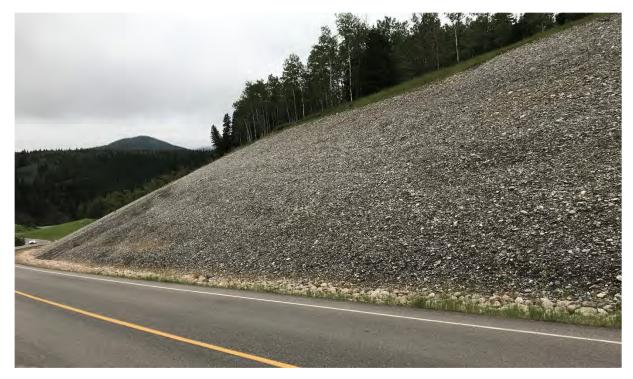
Cut slope to the north of the highway is poorly vegetated and should be seeded to reduce surface water runoff erosion. A proposal has been submitted to AT for evaluation of hydroseed mixes to promote vegetation.

Photo 3 Unvegetated cut slope from highway realignment. Photo was taken facing west on July 5, 2021.
