SITE NUMBER AND NAME: S056-II West of Gorge Creek Steep Slope Slides		HIGHWAY & KM: 25002:02 8.196	PREVIOUS INSPECTION DATE: July 5, 2021	INSPECTION DATE: May 16, 2022
LEGAL DESCRIPTION: 01-32-19-05 W5M	NAD 83 COORDINATES: UTM Northing Easting 11 5613067 666206		RISK ASSESSMENT: PF: 8 CF: 10 TOTAL: 80	
MONTHLY AVERAGE DAILY TRAFFIC (MADT): May 2020 390 (west) & 382 (east) (Reference No. 55460220)			CONTRACTOR MAINTENANCE AREA (CMA): 27

PRIMARY SITE ISSUE: Slope failure on the south side of the highway due to surface runoff and river erosion at the slope toe. The highway is located at the crest of a steep valley slope above Sheep Creek River. The highway was realigned in 2014 due to slope instability, and slide retrogression is continuing.

PROJECT SOUTHERN REGION GEOHAZARD RISK MANAGEMENT PROGRAM		
TITLE Site Plan S056-2 - West of Gorge Creek Steep Slope Slides Hwy 25002:02, km 8.196		
SCALE 1:1,500	PROJECT No. A05116A03	FIG No. 1

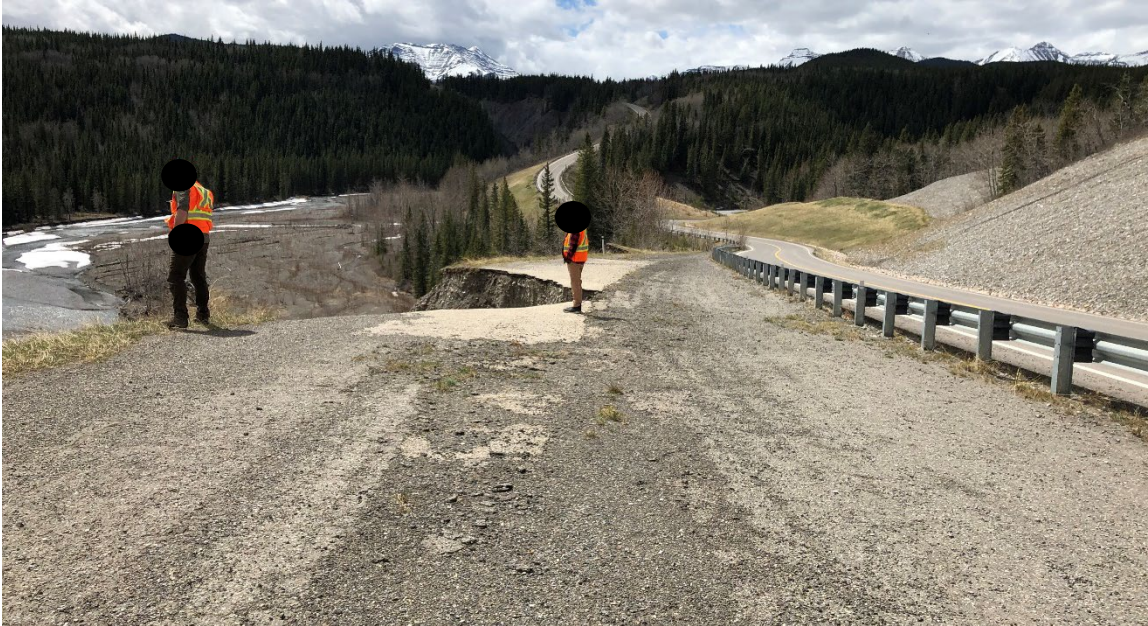
Photo 1 The highway was realigned/shifted north in 2014 (right-hand side of the photo) since the slide was impacting the south (eastbound) lane of the old highway. Photo taken May 16, 2022, facing southwest.

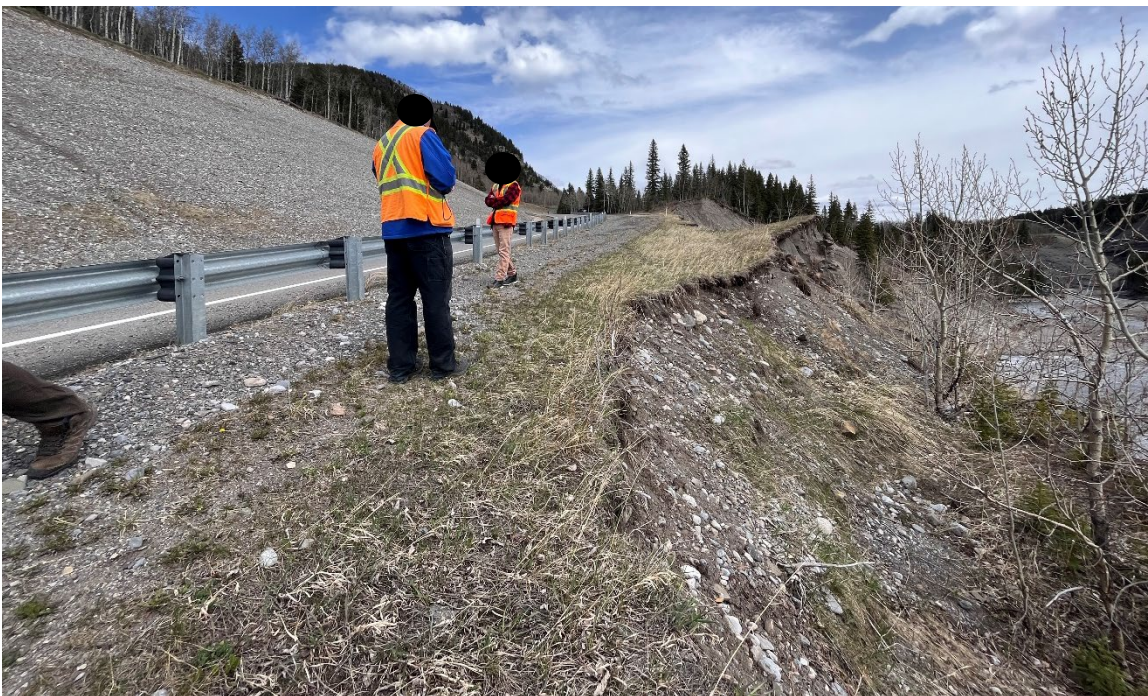
Undermining of the old pavement is leading to the old highway surface cracking and dropping away. Current edge erosion slope is approximately 3.3 m from the guardrail (approximately 5.4 m in 2019 and 5.0 m in 2020) (WP 87). Slope erosion was visible east of the main erosion feature. The edge of the eroding slope is approximately 6 m from the edge of pavement at WP 88.

Photo 2 The head scarp is retrogressing towards the highway and is approximately 3 m from the edge of pavement. Photo was taken May 16, 2022, facing east-northeast.

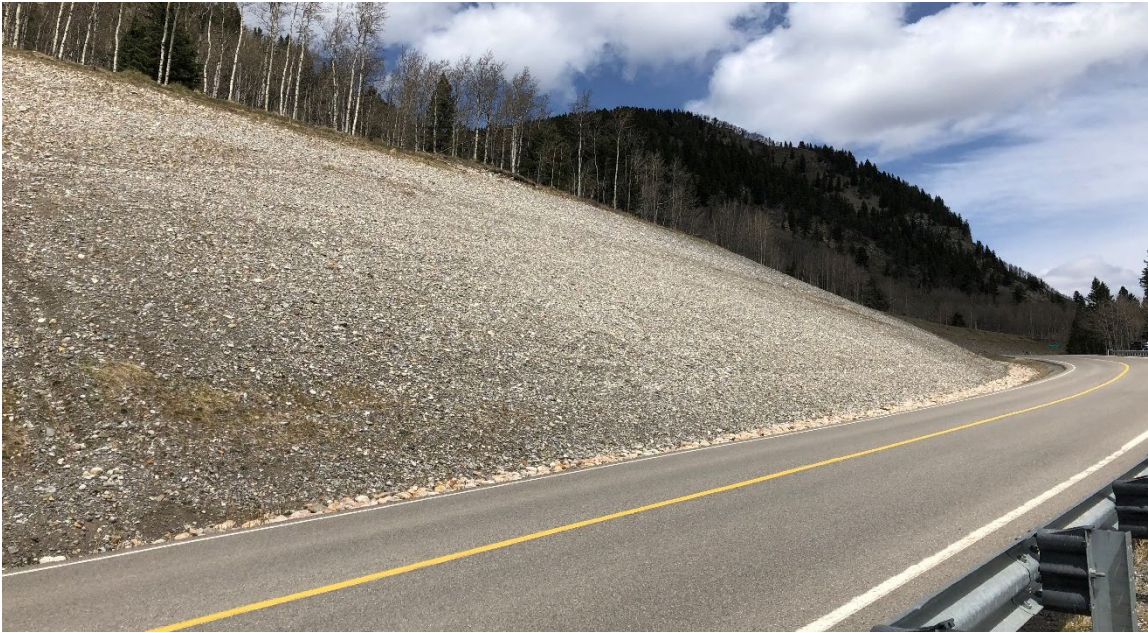
Cut slope to the north of the highway is poorly vegetated and should be seeded to reduce surface water runoff erosion. During the 2022 inspection, some riling was observed along the slope. A proposal was issued AT for review and comment in January 2019 for evaluation of hydro-seed mixes to promote vegetation.

Photo 3 The cut slope from highway realignment is unvegetated. Photo was taken May 16, 2022, facing east.

- The site should be inspected by AT's MCI and annually as part of the Southern Region GRMP Section B inspections.
- The cut slope should be hydro-seeded to promote vegetation growth using a suitable seed mix.

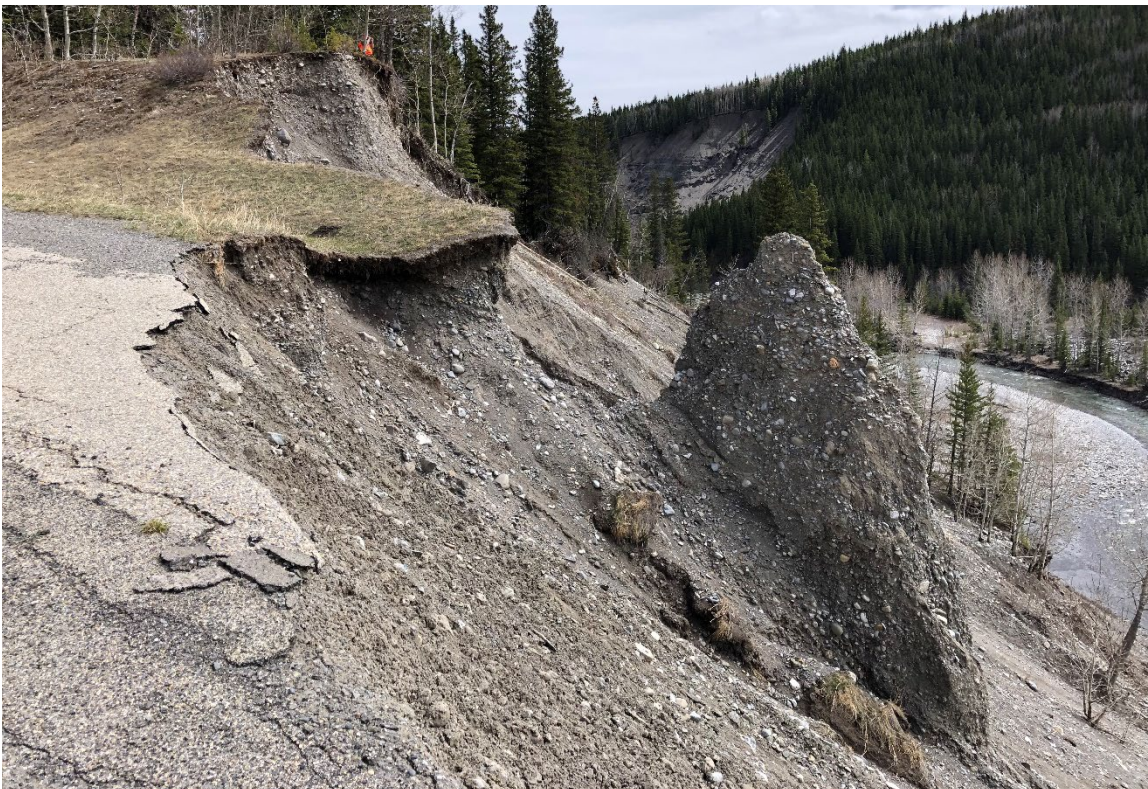
A large block failure near the top of the slope does not appear to have changed significantly since the 2021 inspection (WP 87) (Photo 4).

Photo 4 A large block has failed and dropped downslope (WP 87). The block does not appear to have changed significantly since the 2021 inspection. Photo taken May 16, 2022, facing east.
