SITE NUMBER AND NAME: S042-I & -II Spray Lakes Rockfall Barrier		HIGHWAY & KM: 742:02, 10.799 & 10.968	PREVIOUS INSPECTION DATE: July 6, 2020	INSPECTION DATE: July 6, 2021
LEGAL DESCRIPTION: SW-25-024-11 W5M 13-24-024-11 W5M	NAD 83 COORDINATES: UTM Northing Easting 11 5658604 611006		RISK ASSESSMENT: PF: 13 CF: 4 TOTAL: 52 (Small rockfalls) PF: 7 CF: 7 TOTAL: 49 (Large rockfalls)	
AVERAGE ANNUAL DAILY TRAFFIC (AADT): 1220 (west), 1540 (east), (Ref. No. 70000698)			CONTRACTOR MAINTENANCE AREA (CMA): 28

PROJECT
 SOUTHERN REGION GEOHAZARD RISK MANAGEMENT PROGRAM

TITLE
 Site Plan
 S042 - Spray Lakes Rockfall
 Hwy 742:02; km 30.434

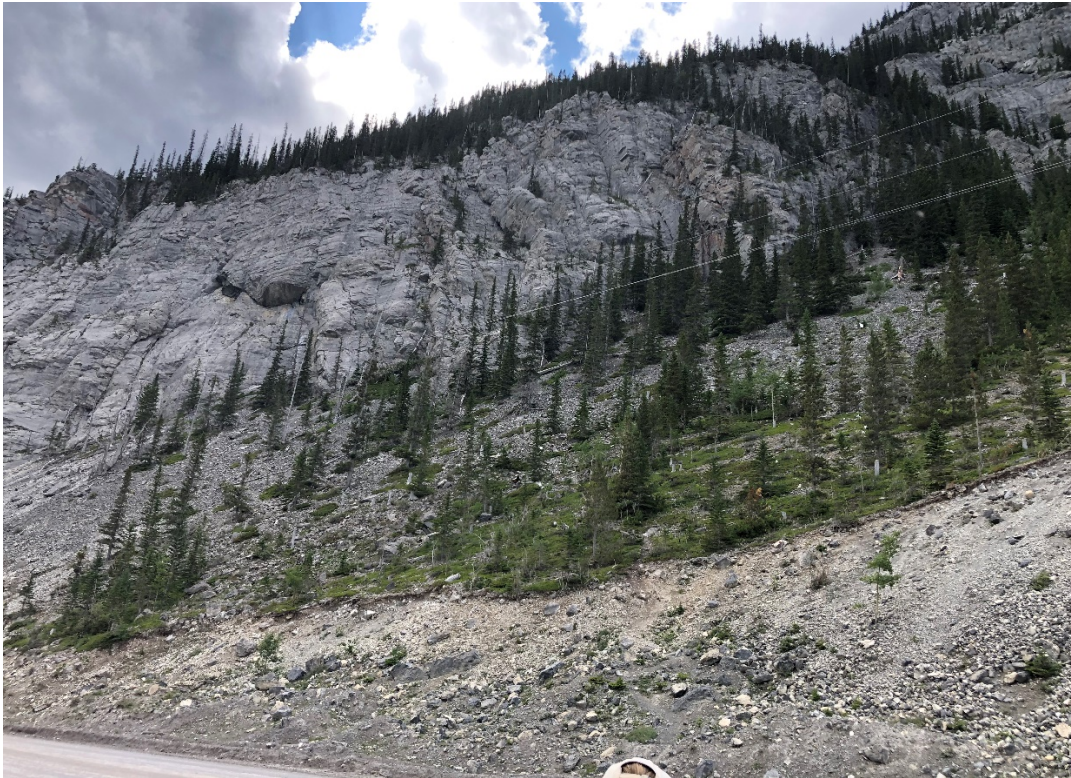
Photo 1 Source area for rockfall, north of highway. Photo taken facing northwest on July 6, 2021.

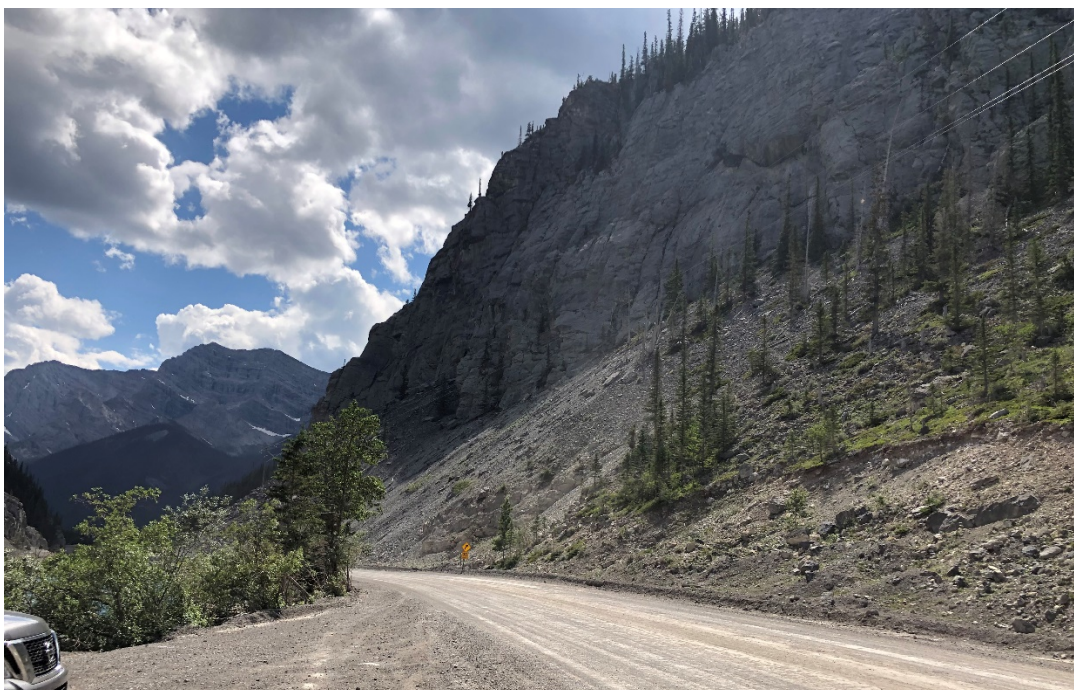
Photo 2 Rock slope north of the highway. Photo was taken facing west on July 6, 2021.
