SITE NUMBER AND NAME: S042-I Spray Lakes Rockfall Barrier		HIGHWAY & KM: 25291:02, 30.434	PREVIOUS INSPECTION DATE: July 6, 2021	INSPECTION DATE: May 17, 2022
LEGAL DESCRIPTION: SW-25-024-11 M5	NAD 83 COORDINATES: UTM Northing Easting 11 5658604 611006		RISK ASSESSMENT: Small rockfall: PF: 13 CF: 4 TOTAL: 52 Large rockfall: PF: 7 CF: 7 TOTAL: 49	
AVERAGE ANNUAL DAILY TRAFFIC (AADT): 1220 (west) & 1540 (east) (Reference No. 70000698)			CONTRACTOR MAINTENANCE AREA (CMA): 28

PROJECT SOUTHERN REGION GEOHAZARD RISK MANAGEMENT PROGRAM		
TITLE Site Plan S042 - Spray Lakes Rockfall Barrier Hwy 25291:02, km 30.434		
SCALE 1:8,000	PROJECT No. A05116A03	FIG No. 1

Inspection Photographs

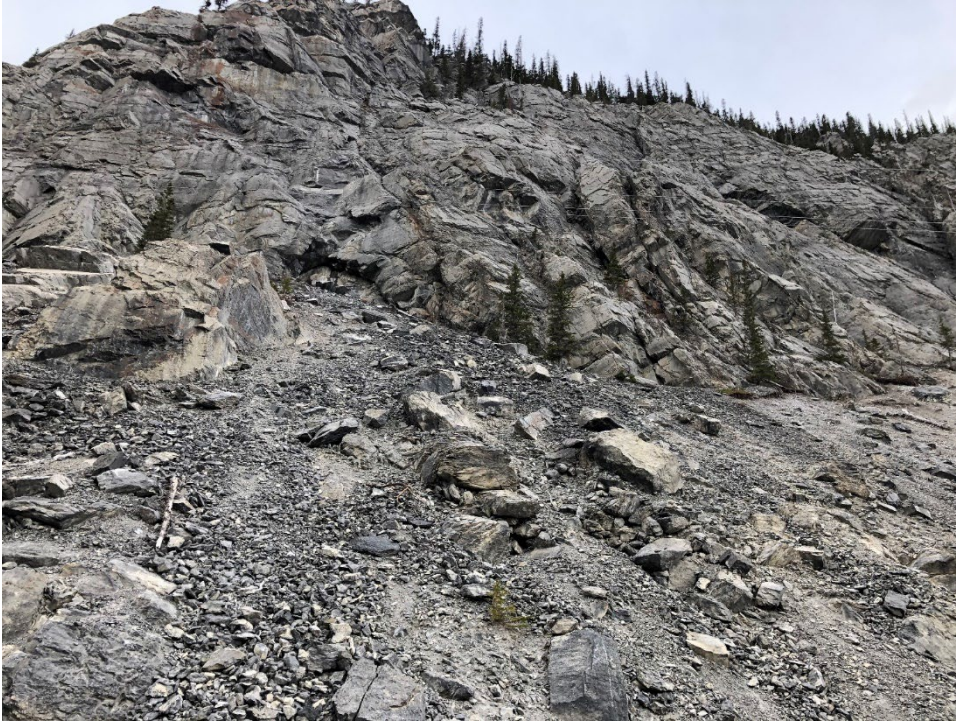
Photo 1 Source area for rockfall, north of highway. Photo taken May 17, 2022, facing north.

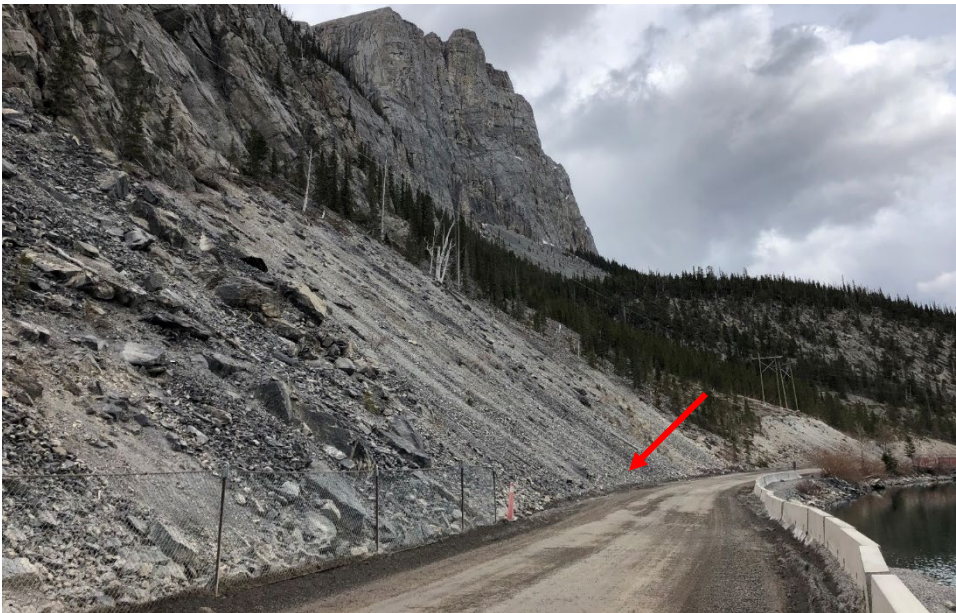
Photo 2 Location north of the highway where the installation of a wire mesh should be completed to mitigate the rockfall hazard (indicated by red arrow). Photo taken May 17, 2022, facing northeast.

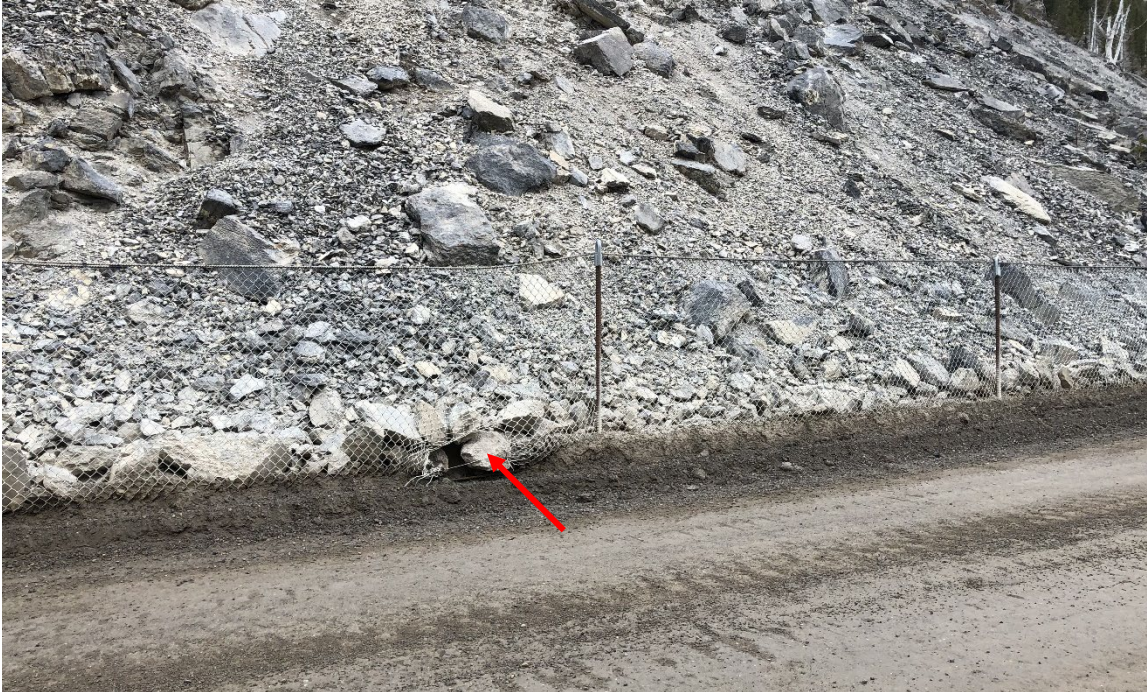
Photo 3 The bottom portion of the rock slope north of the highway and rock fence located at the toe of the slope. The tear in the rock fence (indicated by red arrow) appears larger since the 2021 inspection. Photo was taken May 17, 2022, facing northwest.

- A LiDAR/radar survey should be completed to monitor the location and frequency of rockfalls, as well as any potential continued dilation of larger volumes of rock. The rock fence should be cleared and the fence mesh repair. Regular maintenance should be completed. Additional road signage is recommended to warn road users of risk of fallen rocks on highway.
- KCB submitted a design report to AT in March 2021. Repair options include installation of a rockfall fence, rock slope scaling, installation of a mesh attenuation curtain, and ongoing monitoring. At the closest point, the powerline appears to be 3 m to 5 m away from the rock slope, which could restrict drape mesh placement locations.
- The proposed design for rockfall hazard mitigations should be submitted for regulatory/permitting review which will likely lead to public consultation.

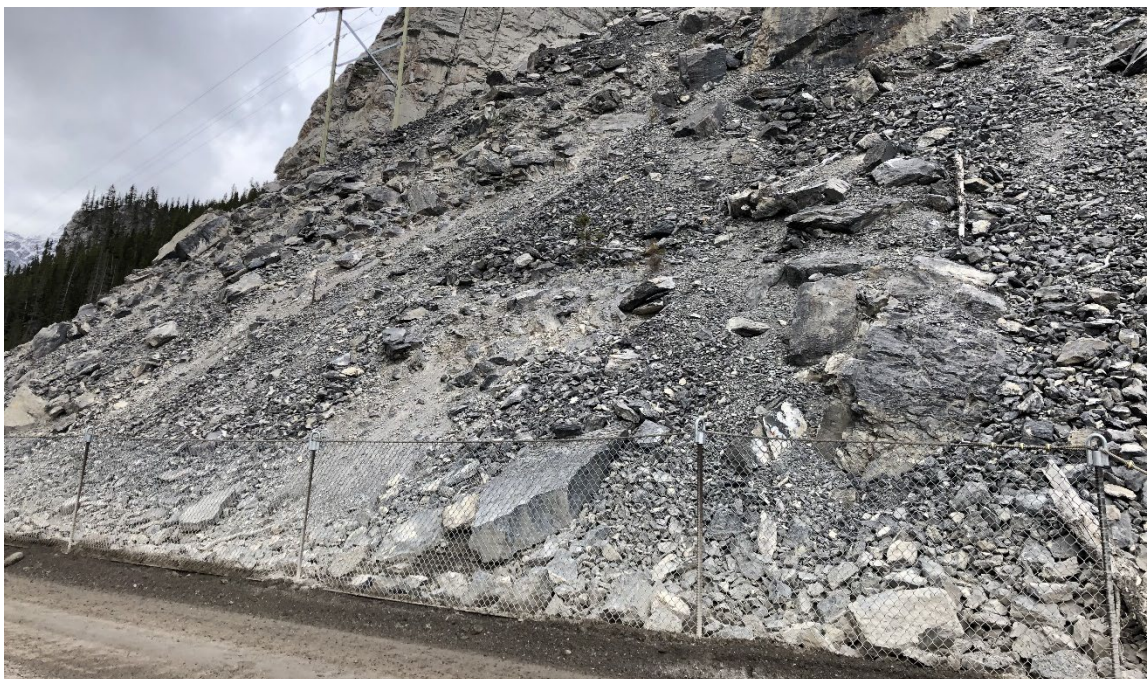
- On May 6, 2019, a rockfall event with a total volume estimated to be between 0.3 m³ and 0.5 m³ was reported to AT. Small rockfalls appear to be ongoing since fresh unweathered rockfall debris with sharp edges were observed in the ditch, indicating recent detachment from the slope.
- There were no significant changes to the rock slope between the 2021 and 2022 inspections (Photo 1 and 2).
- The tear in the fence mesh (first observed during the 2020 inspection) appears to have enlarged between the 2021 and 2022 inspections (Photo 3).
- Rockfall debris is accumulating behind the existing rockfall fence at the toe of the slope (Photo 4).

Photo 4 Rock slope north of the highway. Debris has accumulated behind the rock fence since and requires removal. No significant change since the 2021 inspection. Photo taken May 17, 2022, facing southwest.
