September 2, 2016

Alberta Transportation  
2<sup>nd</sup> Floor, 803 Manning Road NE  
Calgary, Alberta  
T2E 7M8

**CON0017609 Southern Region GRMP - Call-Out Reports**  
**S049 - Hwy 504:02-01 Embankment and Foundation Earth Slide (km 23.917)**

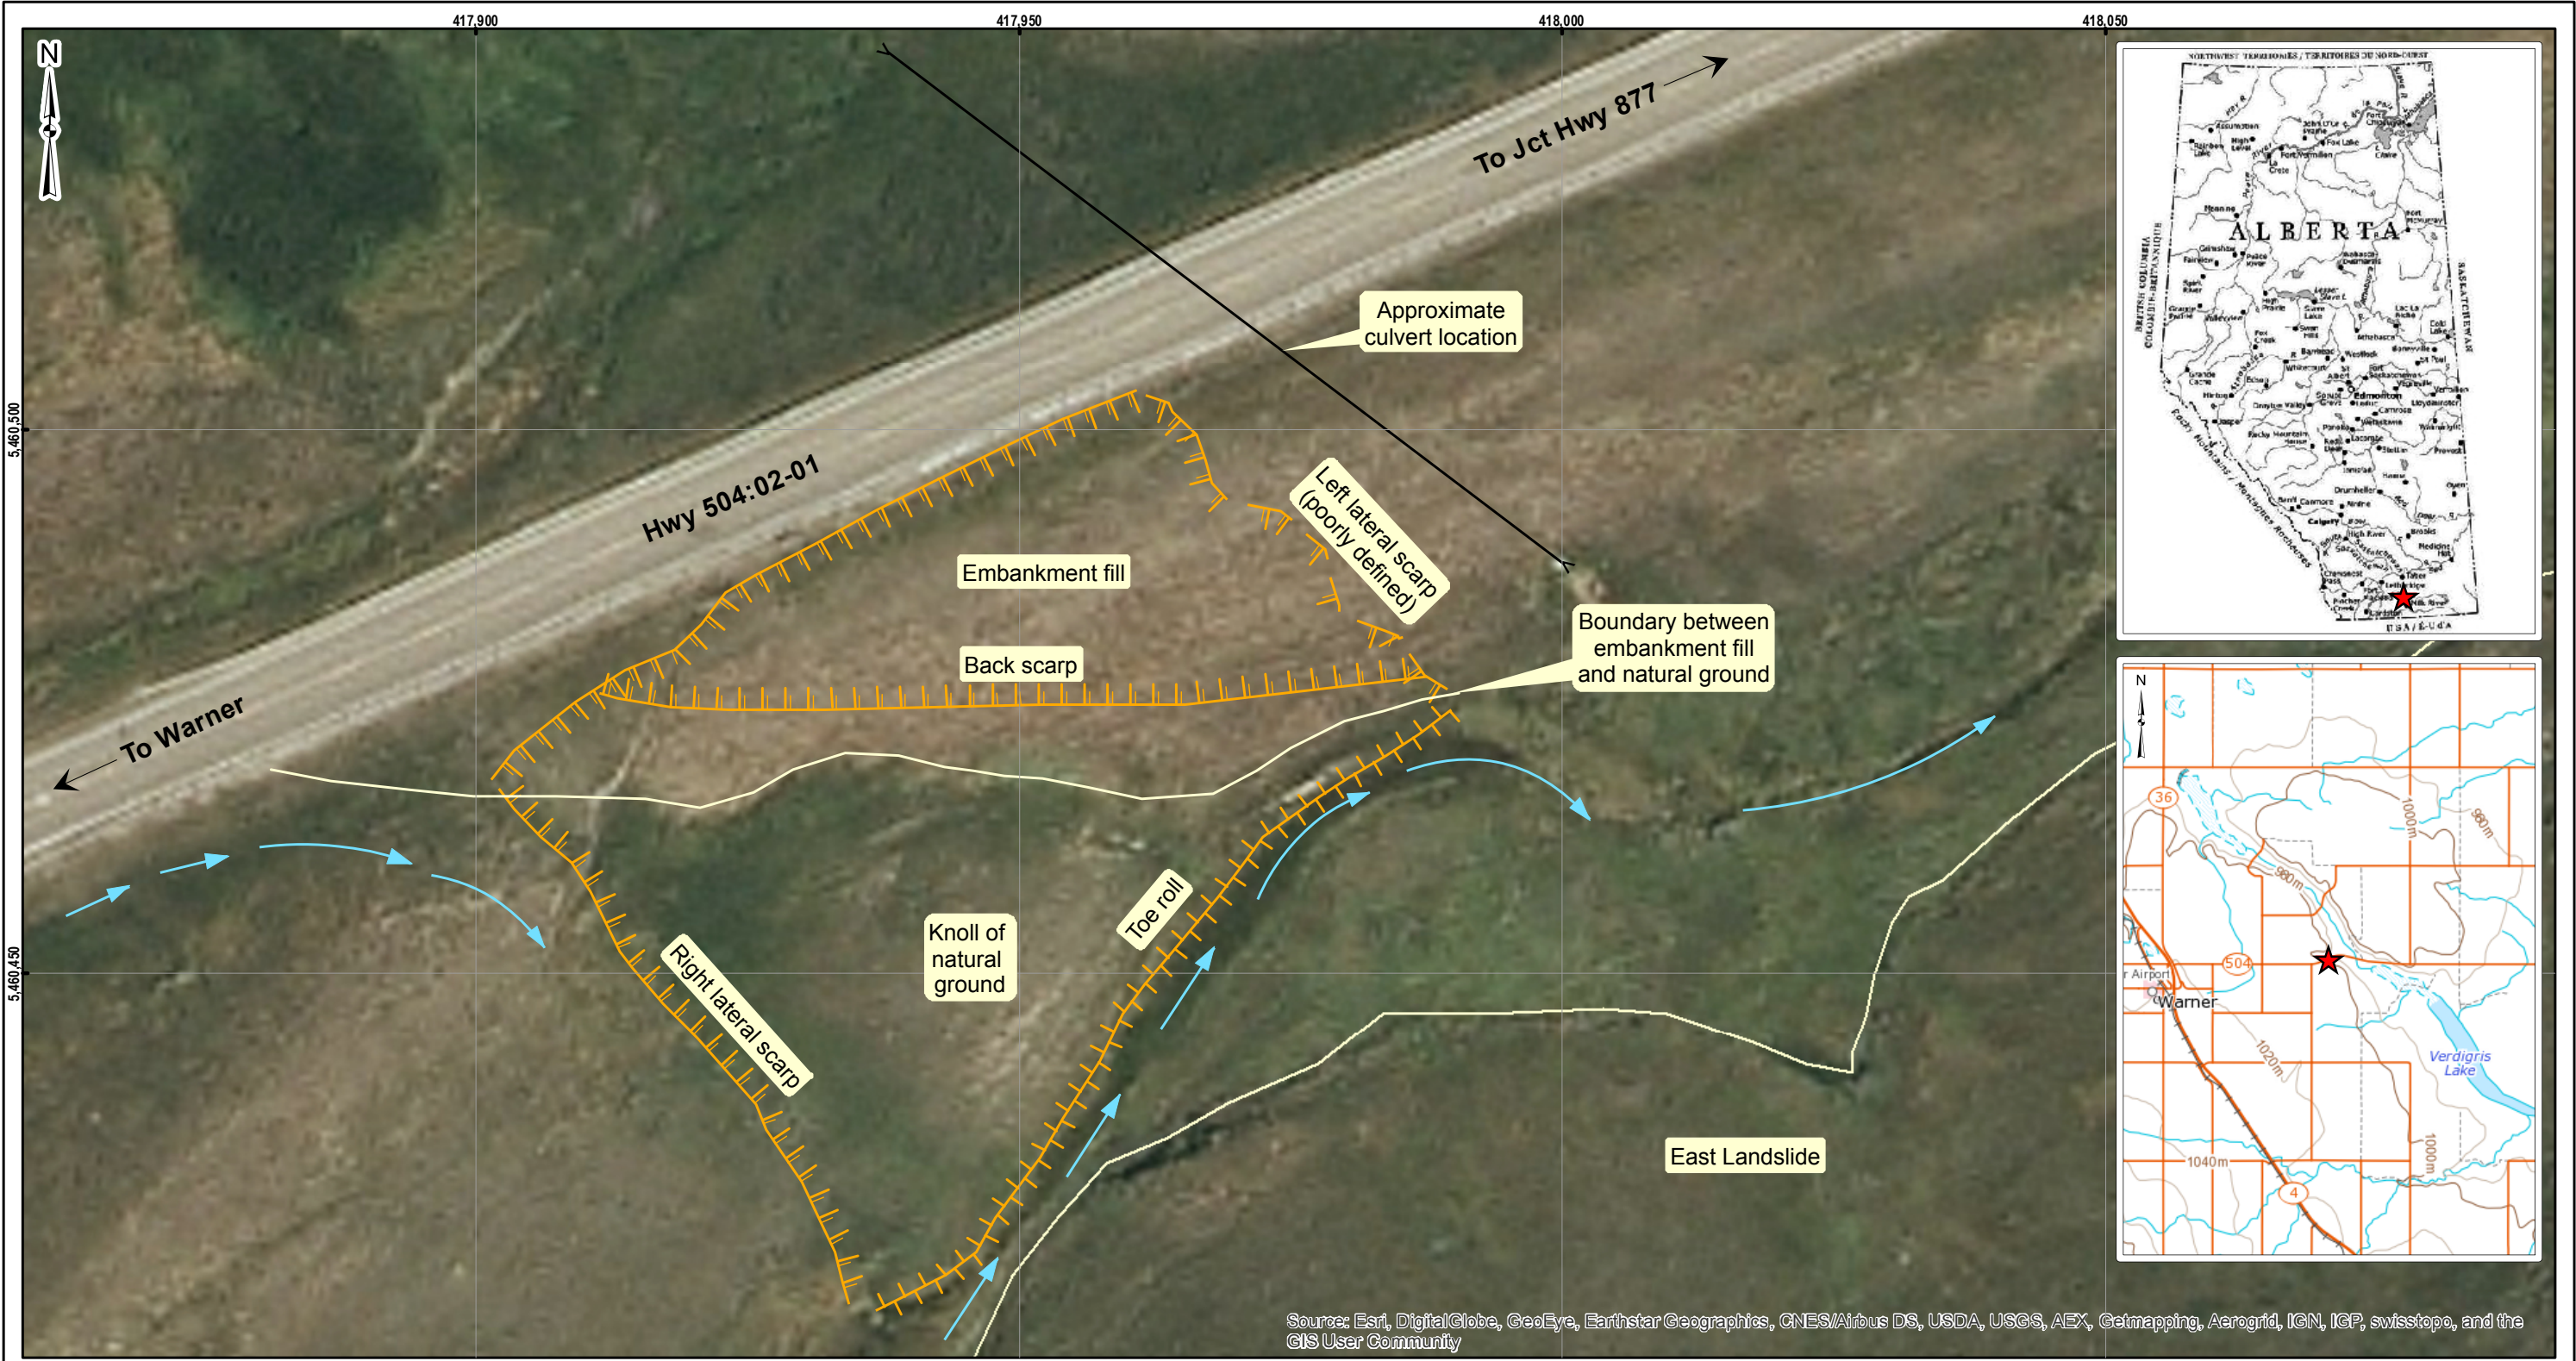
PROJECT	SOUTHERN REGION GEOHAZARD RISK MANAGEMENT PROGRAM	
TITLE	Call-Out Site Plan S050 - Embankment Earth Slide and Damaged Culvert Hwy 549:02-01, km 4.831	
SCALE	PROJECT No.	FIG No.
1:600	A05115A03	2

Figure 1 illustrates the basic arrangement of the various features observed at the site during the June 16th, 2016 site inspection. The following observations were made during the site visit:

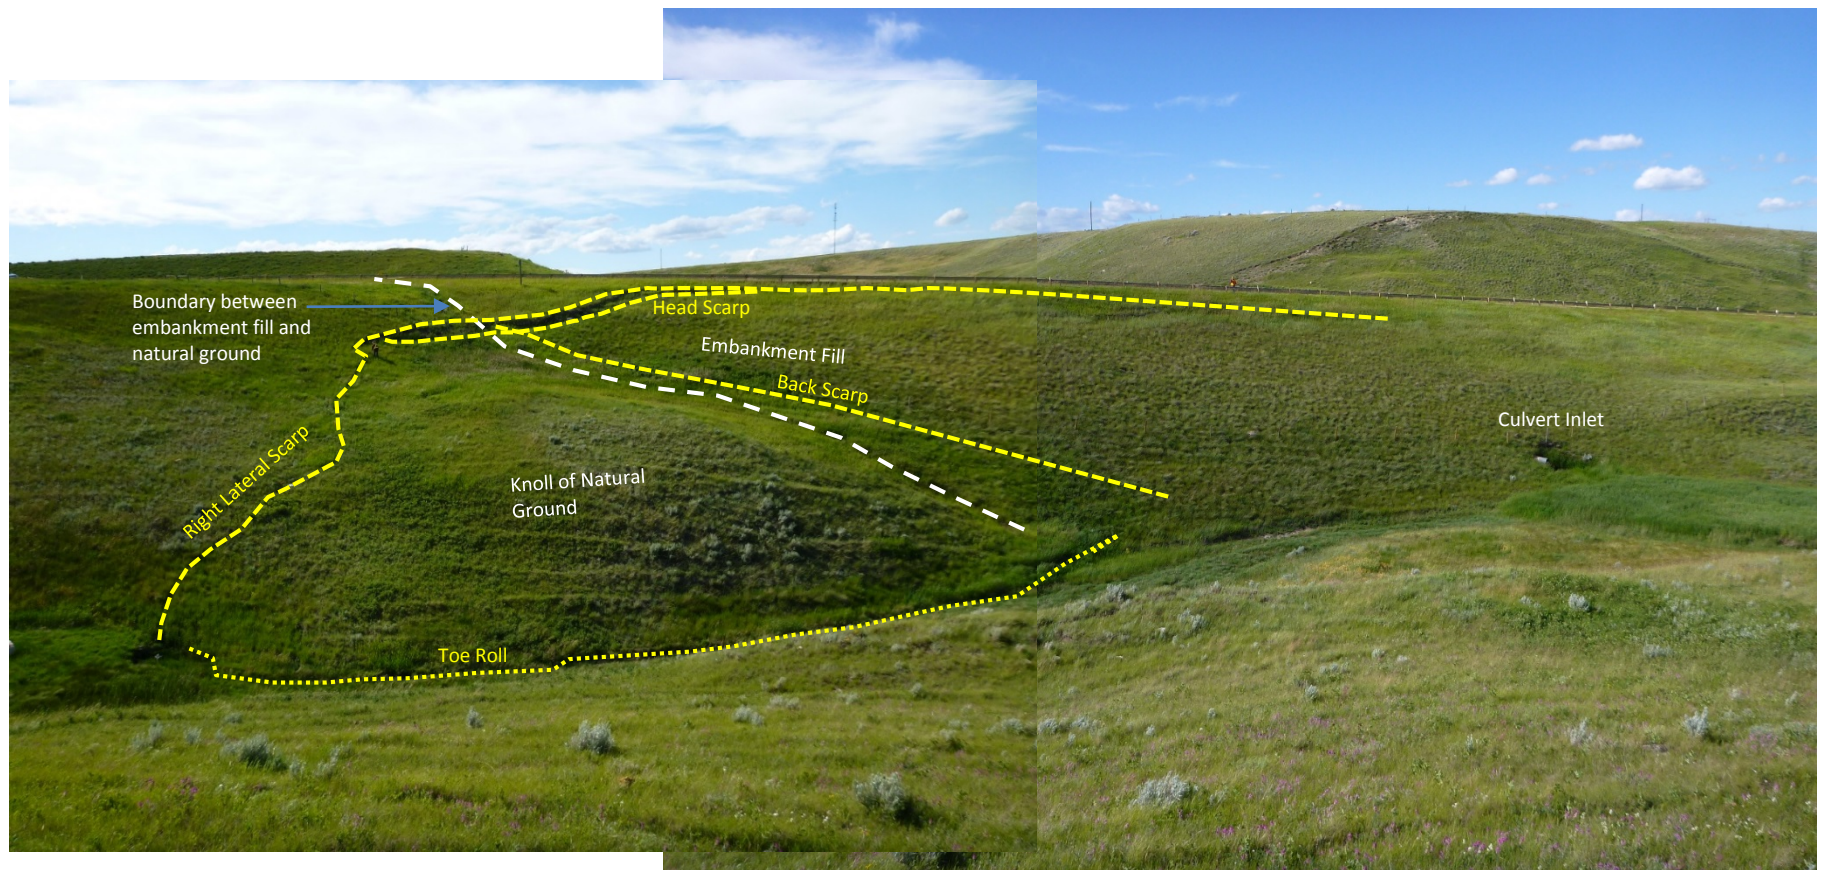
The presence of a back scarp as shown in Photo 1, infers that a reverse graben has formed providing further evidence of translational slide movement. Translational landslides are usually controlled by a horizontal weak layer at depth. Also of note is that the head scarp is significantly higher (undergone more movement) at the west end and essentially pinches out towards the east corresponding to the location where the embankment fill is at its full height. This supports the premise that the slide is controlled by the natural deposits and has likely mobilized on a pre-existing rupture surface in a horizontal weak layer. Additional evidence supporting the inference of a pre-existing horizontal rupture surface in a weak layer is the observation of an even larger translational landslide in the opposing north facing slope as illustrated in Photo 4. It is suggested that the knoll of natural ground, shown in Photo 1 is a pre-existing toe graben of a post-glacial translational landslide. The knoll was apparently utilized by the road builder to buttress the southwest corner of the abutment of the embankment. Sometime later the load introduced by the embankment fill may have contributed to reactivate the slide on the pre-existing rupture surface.

**Photo 1** High embankment slope instability, translational slide. Presence of back scarp infers a reverse graben has formed which is evidence of translational slide movement usually along a horizontal weak layer at depth. Higher head scarp at west end indicates slide is exhibiting hinged movement, dropping more at the west end where more of the slide mass involves natural ground and a pre-existing basal rupture surface exists and is controlling movement. Photos northward taken June 16, 2016.

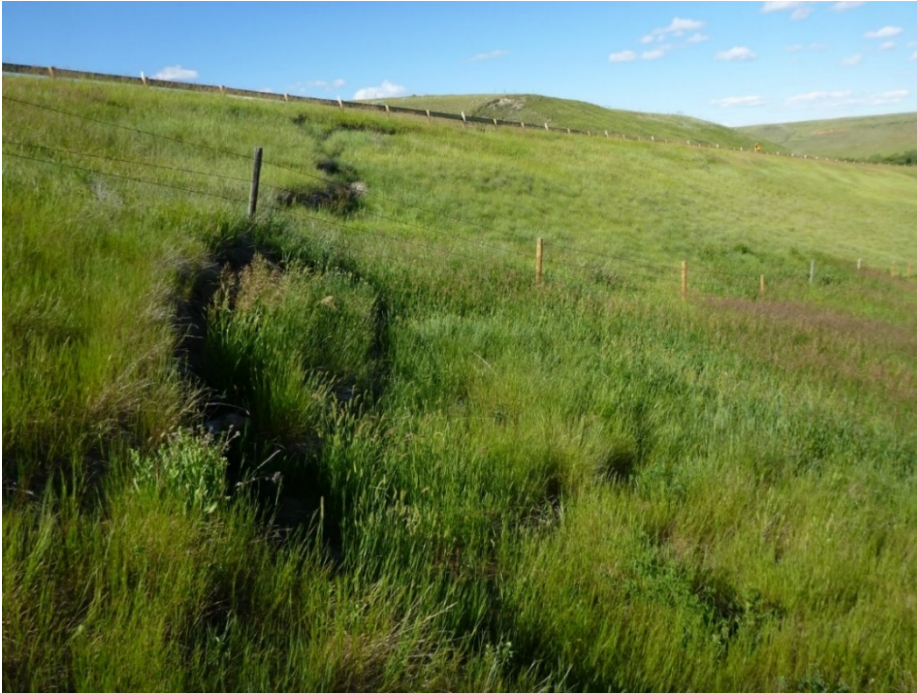
- The pre-existing head scarp at the west end, including the right lateral scarp, appears to have undergone significant recent, predominantly, downward movement in the order of 0.2 to 1.0 m. The amount of movement on the head scarp diminishes towards the east abruptly pinching out near where the embankment is at full height.

**Photo 2** View up right lateral scarp. Photo towards north east on June 16, 2016.

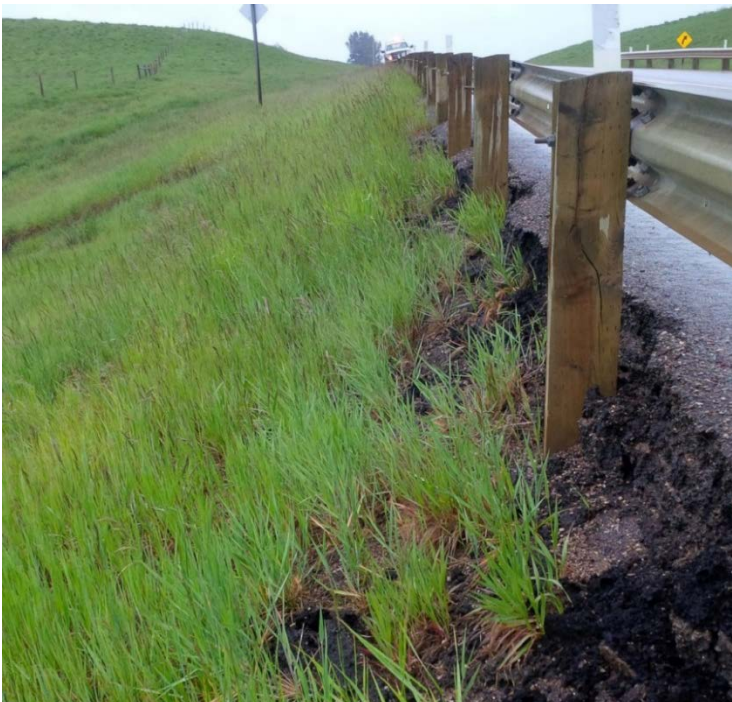
- Photo 3 illustrates retrogression or movement of the head scarp which resulted in some minor damage along the south edge of the pavement that also undermined the guard rail.

**Photo 3** Head scarp right at edge of pavement. Loss of pavement ~ 15 m length and guardrail was pulled into lane by maintenance. Photo towards west on June 16, 2016.

In the short term the MCI should continue to monitor the retrogression of the head scarp towards the highway and install hazard signs and a speed reduction if the head scarp encroaches further into the pavement due to ongoing movement of the slide. Monitoring of the site should be coordinated with adverse weather conditions such as rapid snow melt, intense rainfall, or significant antecedent rainfall. To avoid water entering cracks in the slide mass, runoff from the paved surface into the slide area should be intercepted and directed eastward by construction of an asphalt curb along the north edge of the pavement and the scarps should be sealed off at surface by grading them closed or by inserting clay plugs at surface using a track excavator. If the head scarp drops any further on the north edge, such that it presents a danger to road users and mitigation measures, a temporary barriers should be installed until the landslide repair is completed.

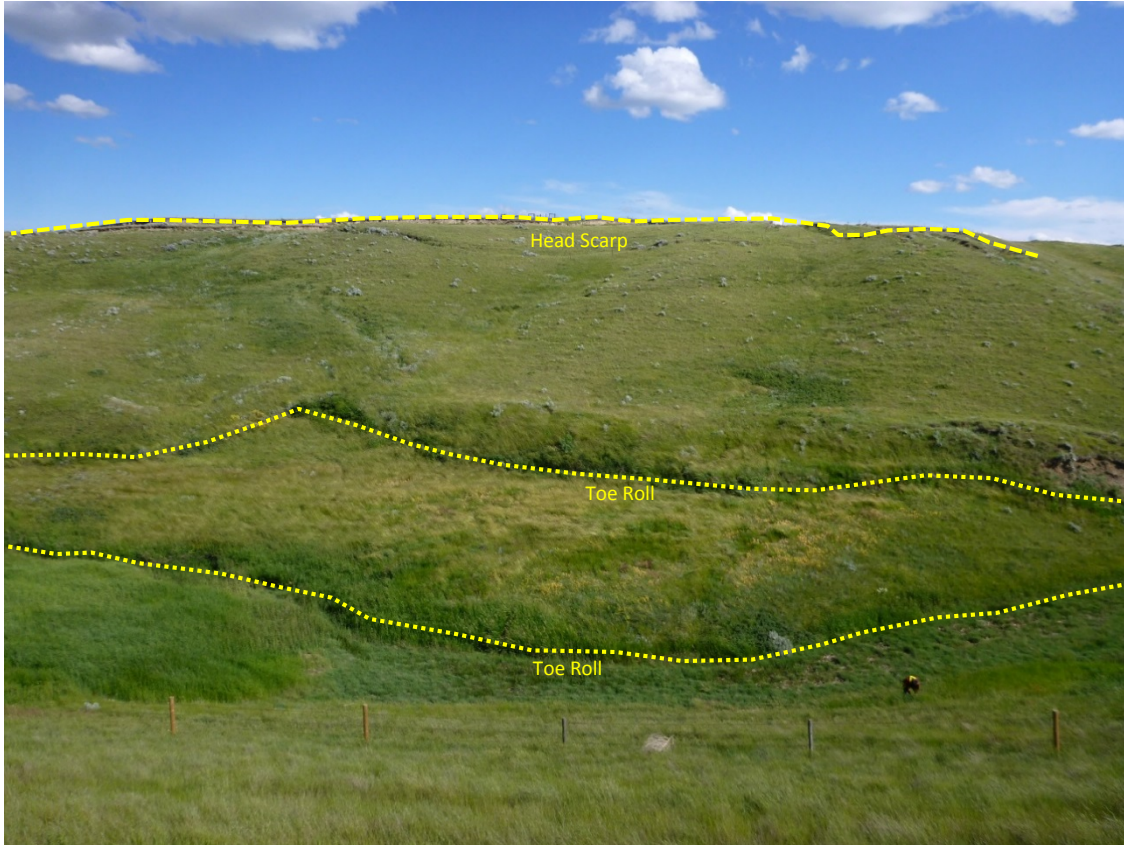
The embankment at the subject site crosses a large south-west north-east trending gully that has post-glacially down-cut through these deposits. The gully flows 0.5 m north-east into a large glacial outwash channel. Large deep seated translational landslides are evident on the right bank of the gully, one directly opposite the subject landslide, the East Landslide, and a second approximately

0.3 km upstream, the West Landslide. Both appear to have resulted in landslide dams in the past remnants of which are still present today (see ponding upstream of East Landslide).

**Photo 4** Large translational landslide on north facing slope south of the subject site. The supports the hypothesis that a horizontal weak layer is controlling translational slide movement in the vicinity. Photo towards south on June 16, 2016.
