SITE NUMBER AND NAME: <b>S049 Hoot and Howl Slide</b>		HIGHWAY & KM: 504:02, 5.072	PREVIOUS INSPECTION DATE: May 3, 2018	INSPECTION DATE: <b>June 9, 2020</b>
LEGAL DESCRIPTION: 03-17-004-16 W4M	NAD 83 COORDINATES: UTM Northing Easting 12 5460493 417931		RISK ASSESMENT: PF: 8 CF: 3 TOTAL: 24	
AVERAGE ANNUAL DAILY TRAFFIC (AADT): 250 (east), (Ref. No. 7000054)			CONTRACTOR MAINTENANCE AREA (CMA): 24

PROJECT SOUTHERN REGION GEOHAZARD RISK MANAGEMENT PROGRAM		
TITLE Site Plan S049 - Embankment Earth Slide Hwy 549:02-01, km 4.831		
SCALE 1:600	PROJECT No. A05115A03	FIG No. 1

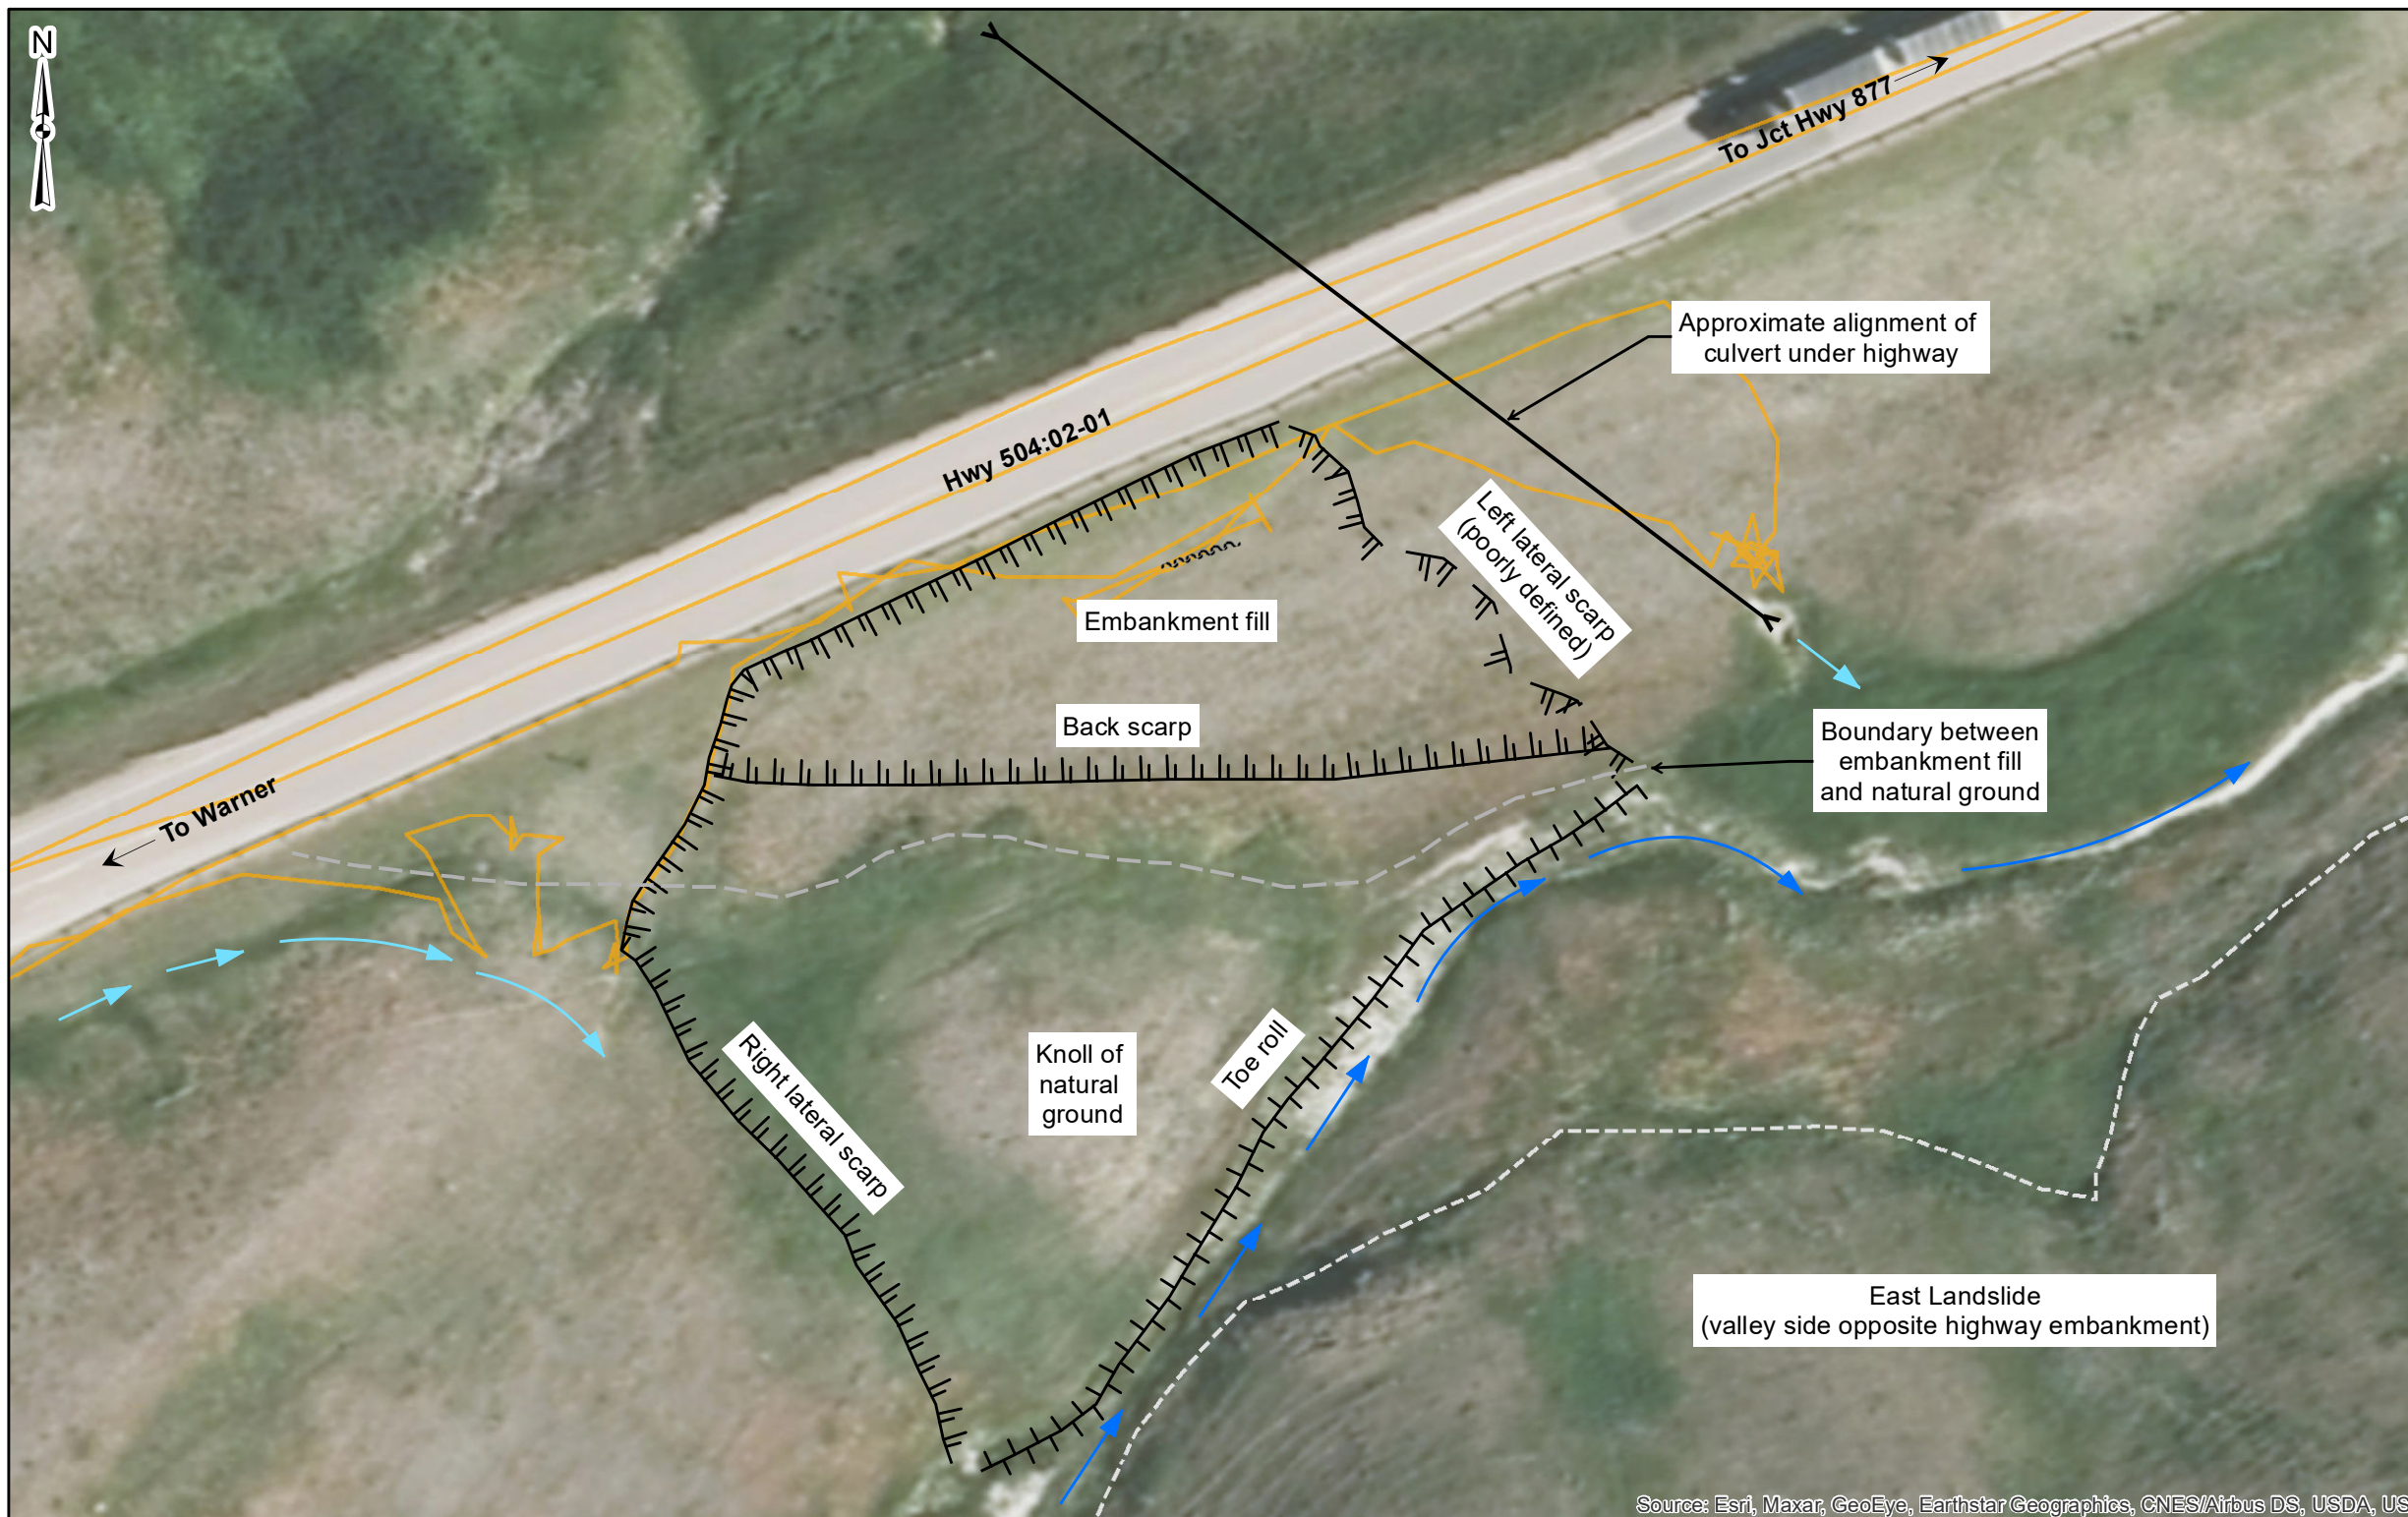
SUMMARY OF SITE INSTRUMENTATION:  None  LAST READING DATE: N/A	INSPECTED BY: Chris Morgan (KCB) Margot Lederman (KCB) Alex Frotten (AT) Roger Skirrow (AT)
PRIMARY SITE ISSUE: Large translational earth slide on the south embankment of the highway. Approximately 18 m of guard rail on the south side of the highway is being undermined by the evolving head scarp.	
APPROXIMATE DIMENSIONS: Approximately 20 m of highway is being impacted by the head scarp. The landslide is approximately 50 to 70 m wide in the middle of the embankment.	
DATE OF ANY REMEDIAL ACTION: Guard rail repaired.

ITEM	CONDITION EXISTS		DESCRIPTION AND LOCATION	NOTICABLE CHANGE FROM LAST INSPECTION	
	YES	NO		YES	NO
Pavement Distress	x		Some undermining of the south shoulder at the guard rail, pavement edge is spalling.	x	
Slope Movement	x		Translational slide with open back scarp approximately 1/3 the way down the slope.	x	
Erosion	x		Some erosion below fence line		x
Seepage		x			x
Culvert Distress		x			x

<b>COMMENTS</b>
Guard rail has dipped in the area where it is being undermined, up to 50 mm deflection. The pavement edge is cracking due to slope movement and asphalt pieces are rolling down the slope. Extra deep guard rail posts should be installed in this area to allow guard rail to be at the required height.
No significant changes were noted since the 2018 site visit. Site was well vegetated at the time of the 2020 visit.
Culvert through the embankment just west of the observed slide movement shows no distress.
There is a well-developed toe roll at the toe of the slope. There is no evidence of upward movement at the toe, which indicates translational, not rotational, slide movement.
A berm appears to be present at the toe of the slope adjacent to the slide area and culvert. However, the berm is also located the opposite side of the embankment and appears to be an old roadway.
Drainage could be improved at the site to redirect surface water away from the head scarp.

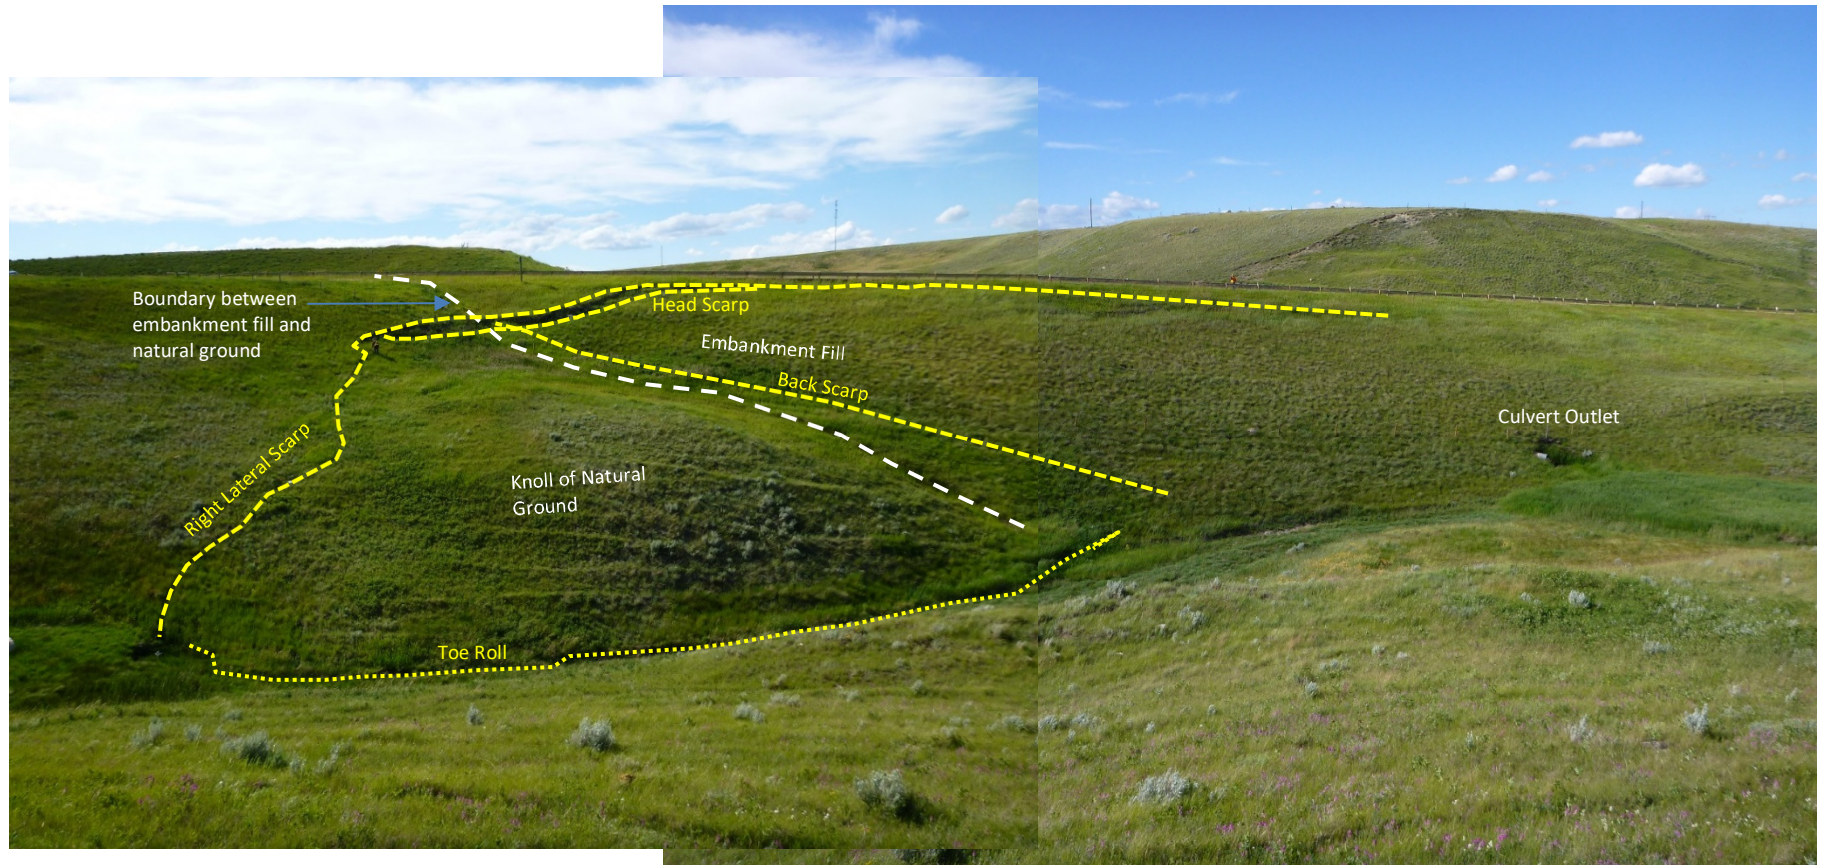
**Photo 1** High embankment slope instability, translational slide. Presence of back scarp infers a reverse graben has formed which is evidence of translational slide movement usually along a horizontal weak layer at depth. Higher head scarp at west end indicates slide is exhibiting hinged movement, dropping more at the west end where more of the slide mass involves natural ground and a pre-existing basal rupture surface exists and is controlling movement. Photos northward taken June 16, 2016.

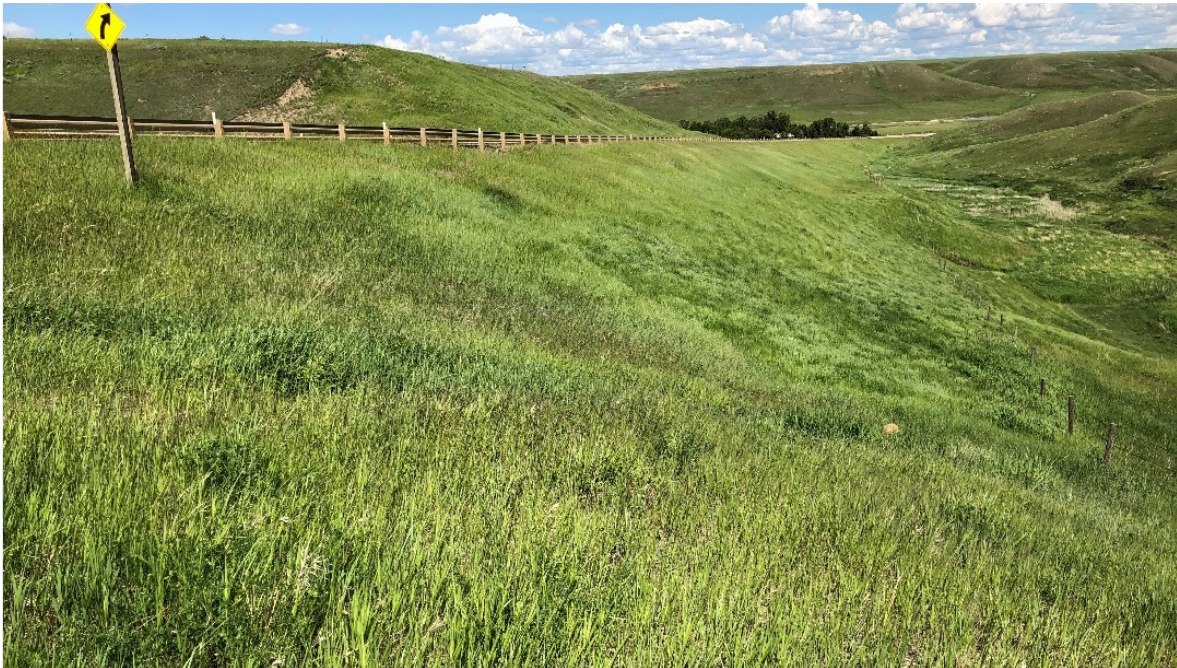
**Photo 2** View east across the slide zone. Long grass obscures visible features. Photo taken on June 9, 2020.

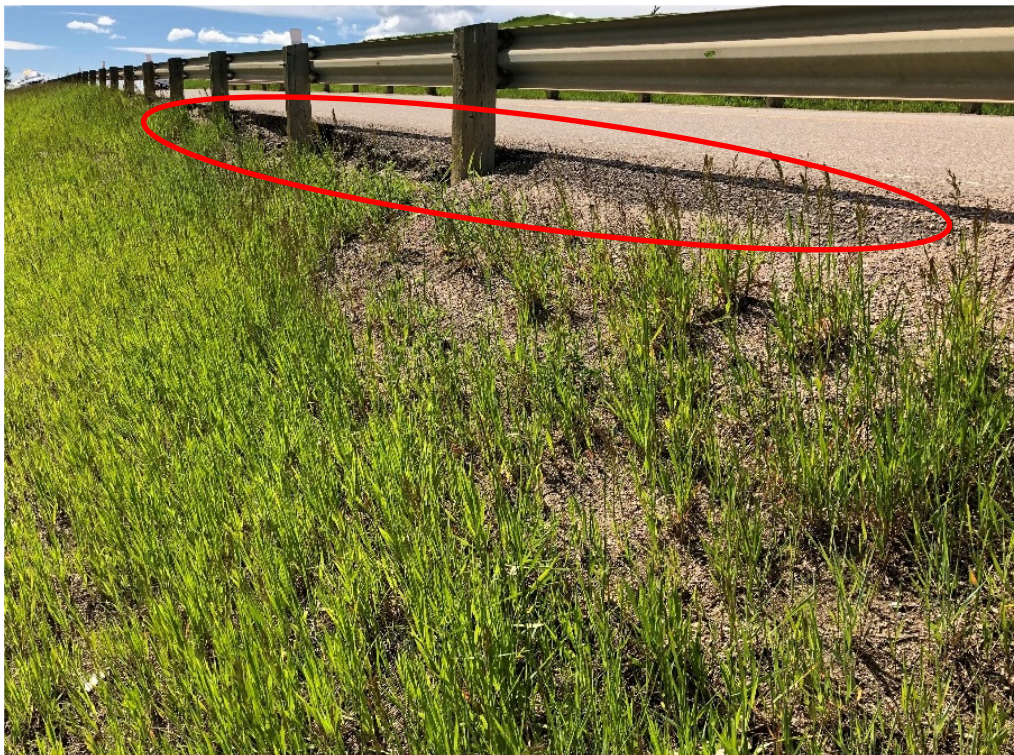
**Photo 3** Head scarp at the edge of the pavement. Loss of pavement support over approximately 18 m length. Photo taken facing east on June 9, 2020.

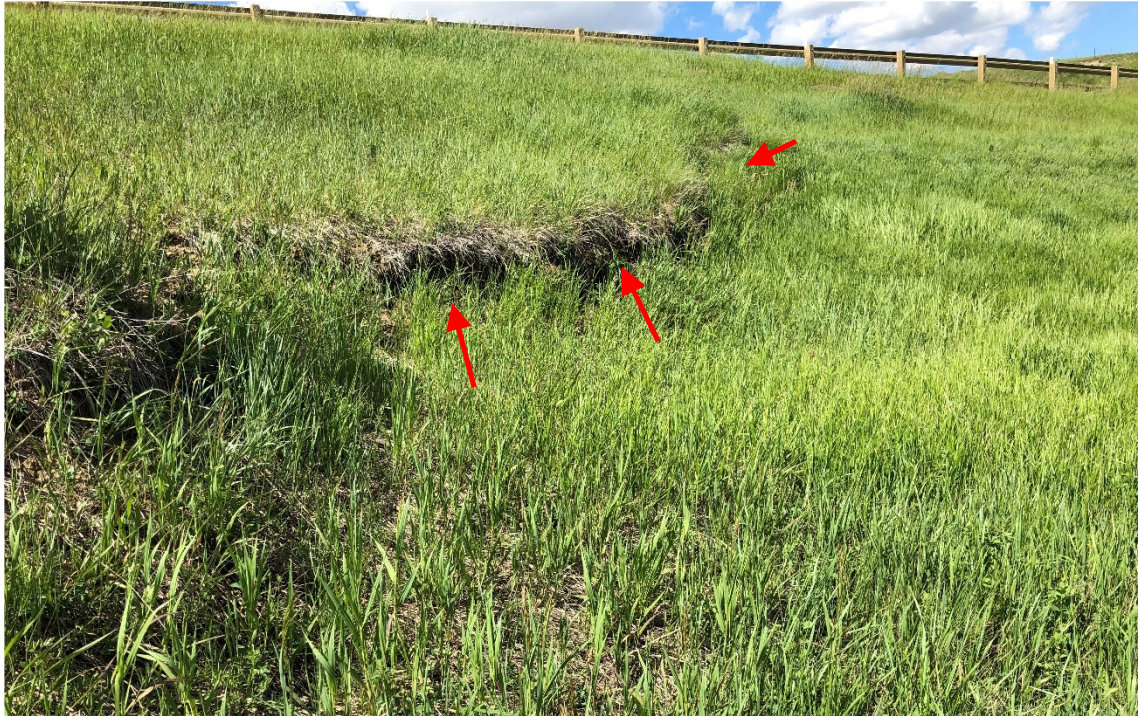
**Photo 4** Head scarp on right flank. Photo taken facing northeast on June 9, 2020.

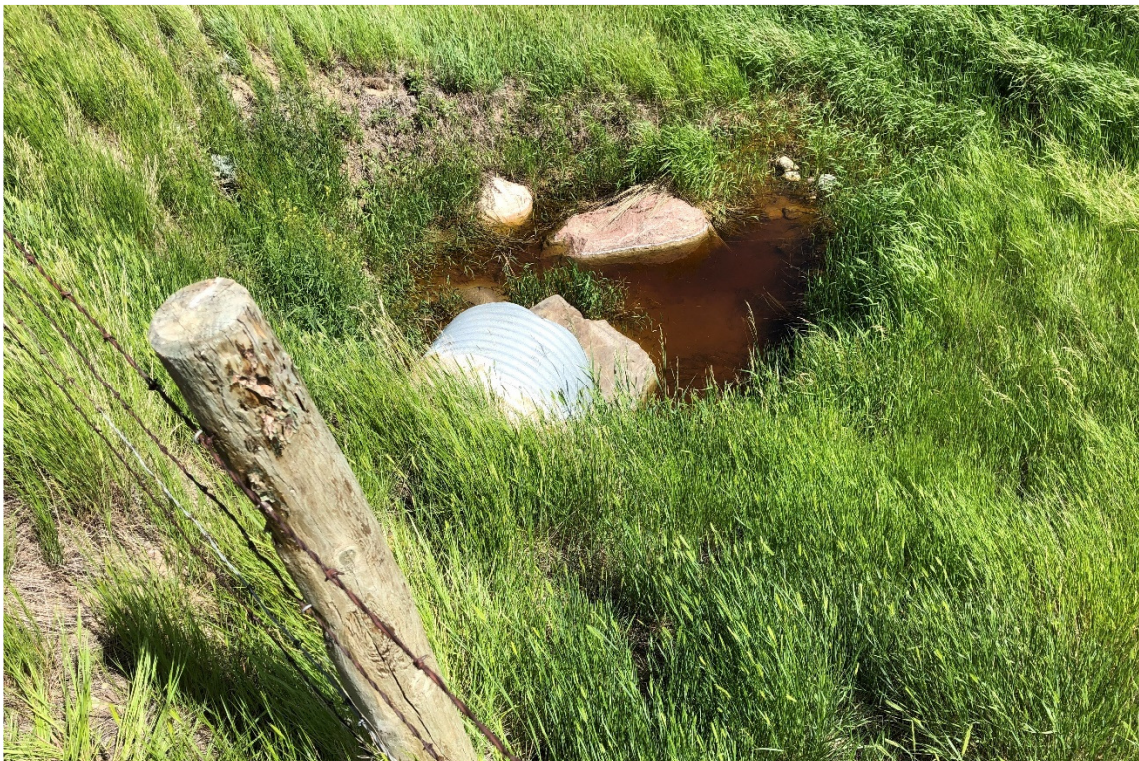
**Photo 5** Culvert under the highway embankment on left flank of slide zone. Photo taken facing south on June 9, 2020.
