SITE NUMBER AND NAME: S049 Hoot and Howl Slide		HIGHWAY & KM: 504:02, 5.090	PREVIOUS INSPECTION DATE: June 9, 2020	INSPECTION DATE: May 19, 2022
LEGAL DESCRIPTION: 03-17-04-16 W4M	NAD 83 COORDINATES: UTM Northing Easting 12 5460493 417931		RISK ASSESMENT: PF: 8 CF: 3 TOTAL: 24	
AVERAGE ANNUAL DAILY TRAFFIC (AADT): 250 (east) (Reference No. 7000054)			CONTRACTOR MAINTENANCE AREA (CMA): 24

PROJECT SOUTHERN REGION GEOHAZARD RISK MANAGEMENT PROGRAM		
TITLE Site Plan S049 - Hoot and Howl Slide Hwy 504:02, km 5.090		
SCALE 1:800	PROJECT No. A05116A03	FIG No. 1

Inspection Photographs

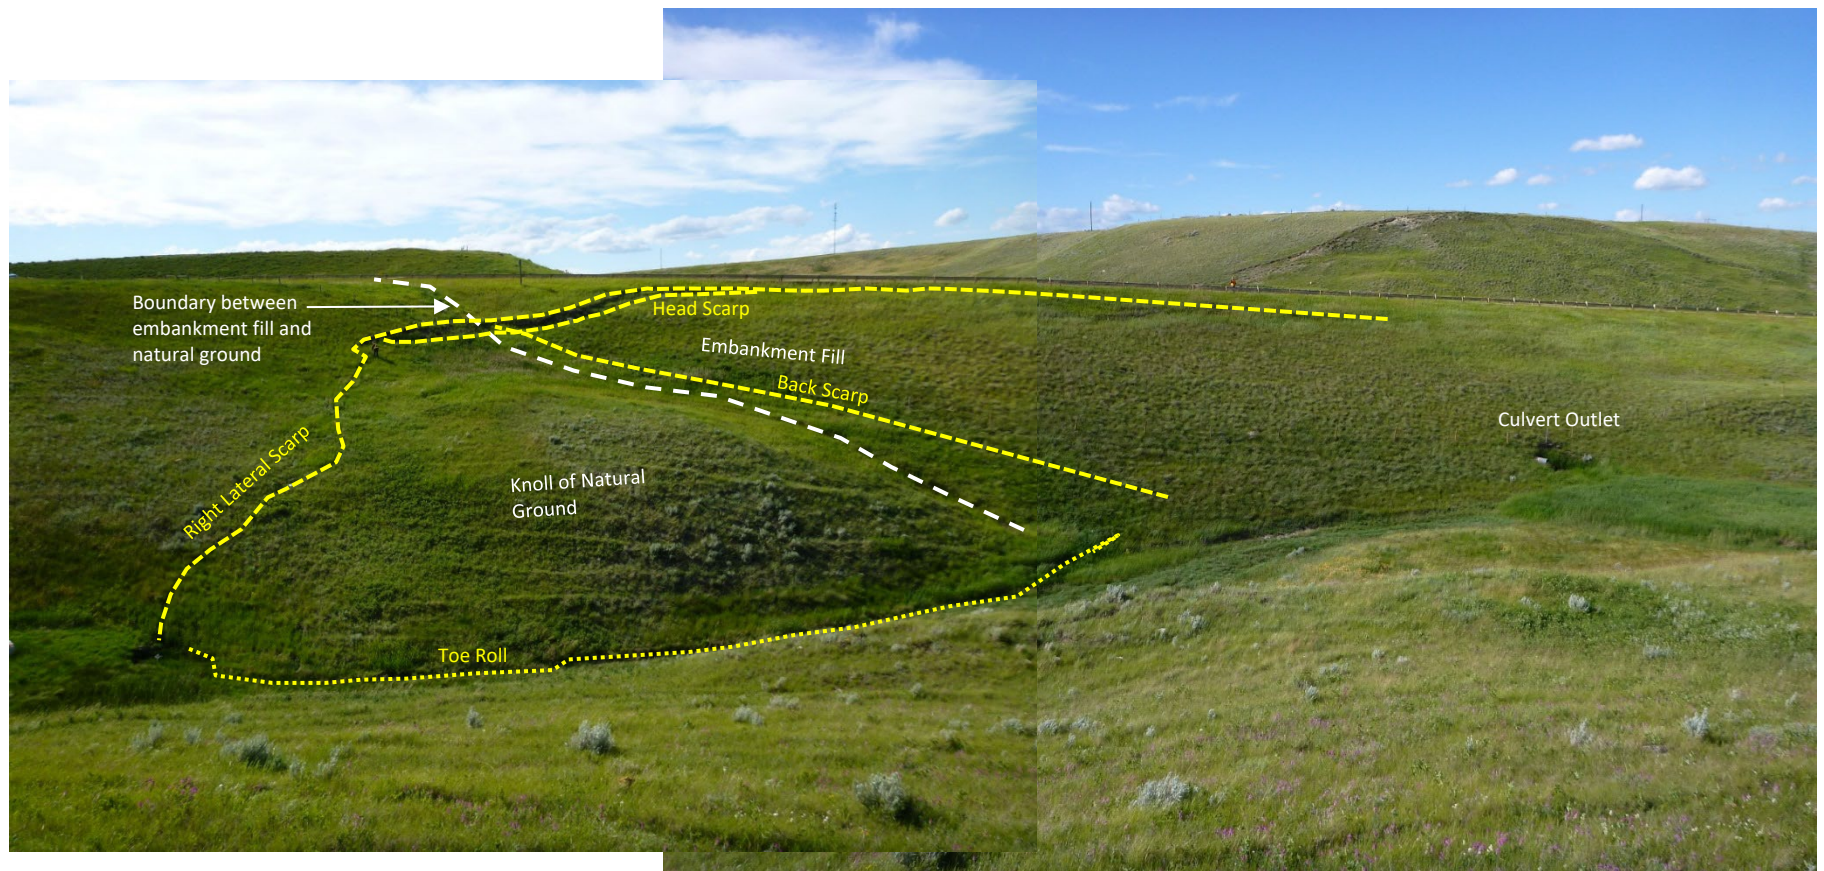
COMMENTS
No significant changes were observed between the 2021 and 2022 inspection. No significant changes have been observed at the site since 2018 (overall site shown in Photos 1 and 2)
The site is well vegetated (Photos 1 through 7).
The creek at the toe of the slope was dry during the 2022 inspection.
Approximately 50 mm of settlement has been observed in the guardrail, where it is being undermined (Photo 7).
The pavement edge is cracking due to slope movement and asphalt pieces are rolling down the slope.
The CSP culvert (oriented approximately northwest-southeast) located west of the slide zone is in good condition without any signs of distress from the slide movement (Photo 6). The culvert inlet is slightly rusted and may have some debris inside. Minor erosion was noted at the outlet and standing water was observed during previous inspections.

Photo 1 High embankment slope instability, translational slide. Presence of back scarp infers a reverse graben has formed which is evidence of translational slide movement usually along a horizontal weak layer at depth. Higher head scarp at west end indicates slide is exhibiting hinged movement, dropping more at the west end where more of the slide mass involves natural ground and a pre-existing basal rupture surface exists and is controlling movement. Photos taken June 16, 2016, facing northward.

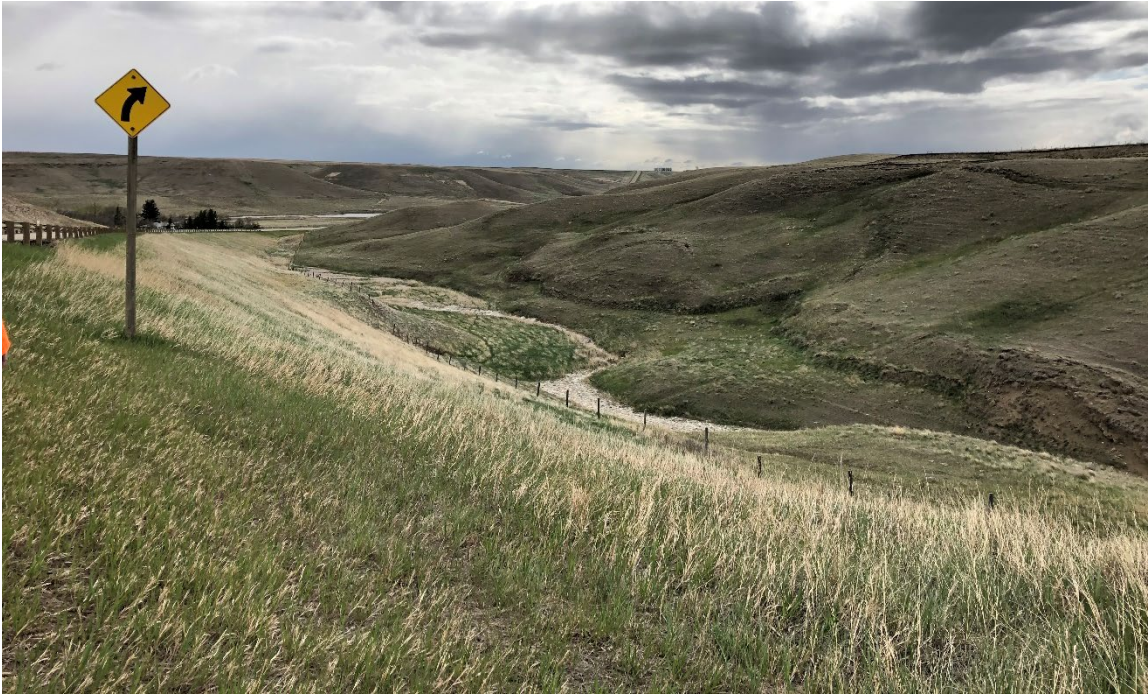
Photo 2 View east across the slide zone. Tall grass is obscuring the visible slide features.
Photo taken May 19, 2022, facing east.

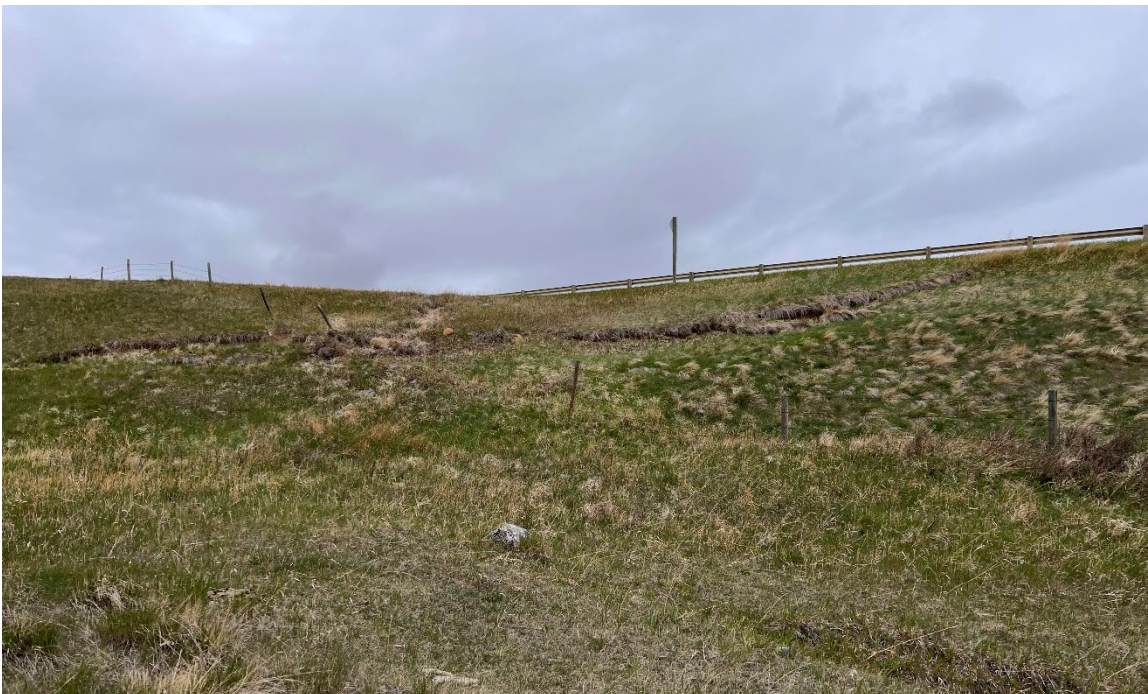
The right (west) flank of the scarp shows visible movement toward the creek and the slide appears to be extending further upslope (Photos 3 and 4). An erosion gully from the highway ditch is feeding into the right flank. There is no visible feature of a left flank.

Photo 3 Head scarp on right flank. Photo taken on May 19, 2022, facing northwest.

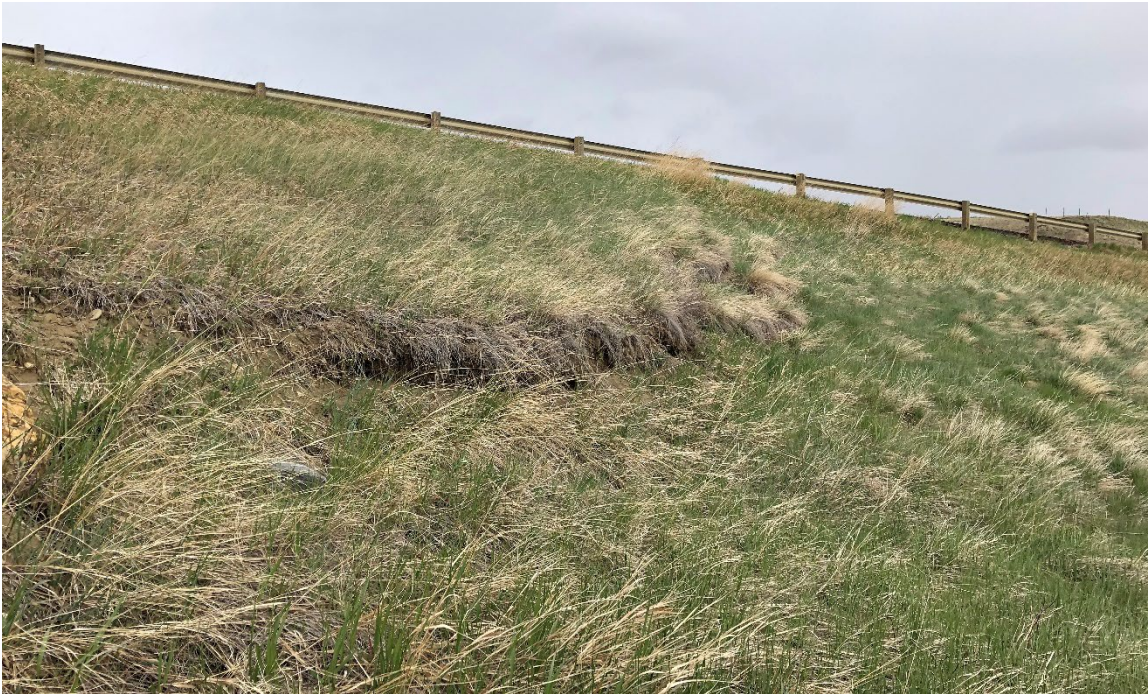
Photo 4 Head scarp near the right flank of the slide zone. Photo taken May 19, 2022, facing northeast.

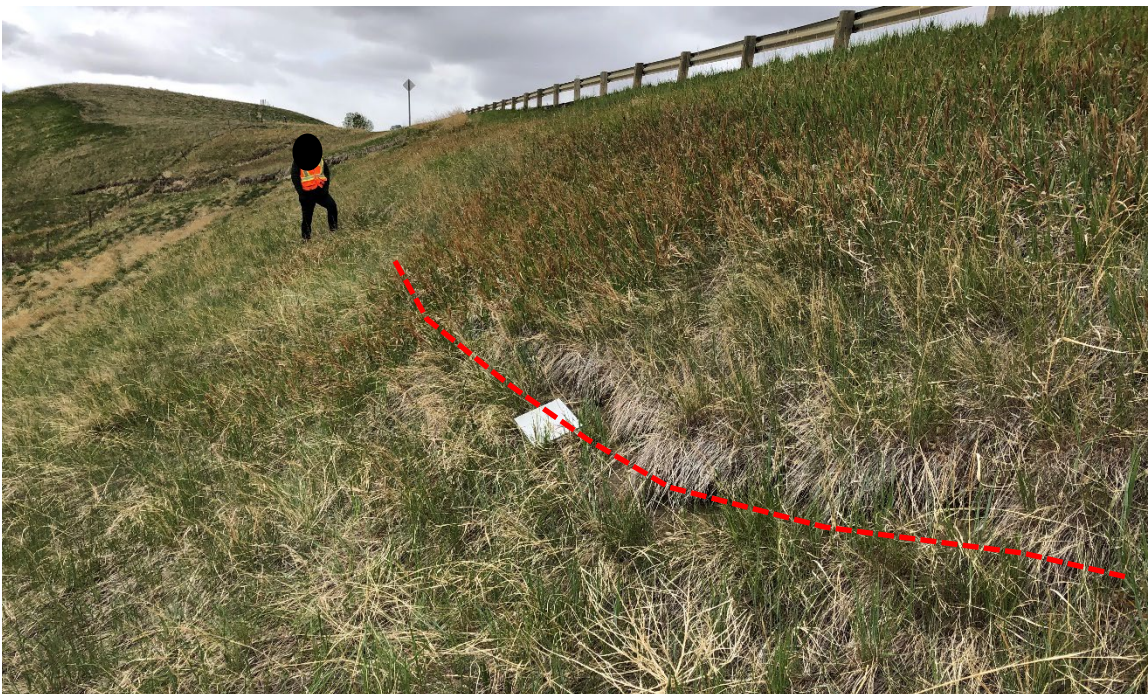
During the 2022 inspection, a tension crack approximately 23 m long and 2 m below the pavement elevation (WP 106) appears to drop by approximately 100 mm to 150 m (i.e., sloping towards the east) (Photo 5).

Photo 5 Tension crack on embankment fill (indicated by red dashed line) (WP 106) approximately 2 m below pavement elevation. Photo taken May 19, 2022, facing southwest.

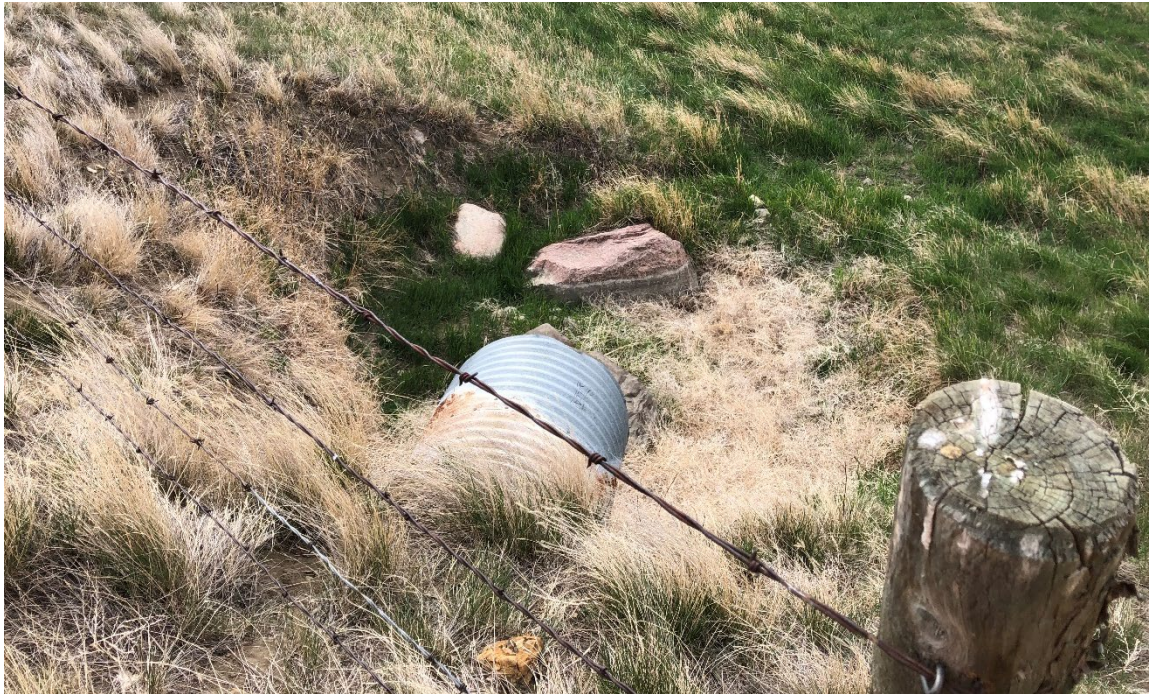
Photo 6 CSP culvert outlet near the left flank of the slide zone. The CSP culvert appears to be in good condition. Photo taken May 19, 2022, facing southeast.

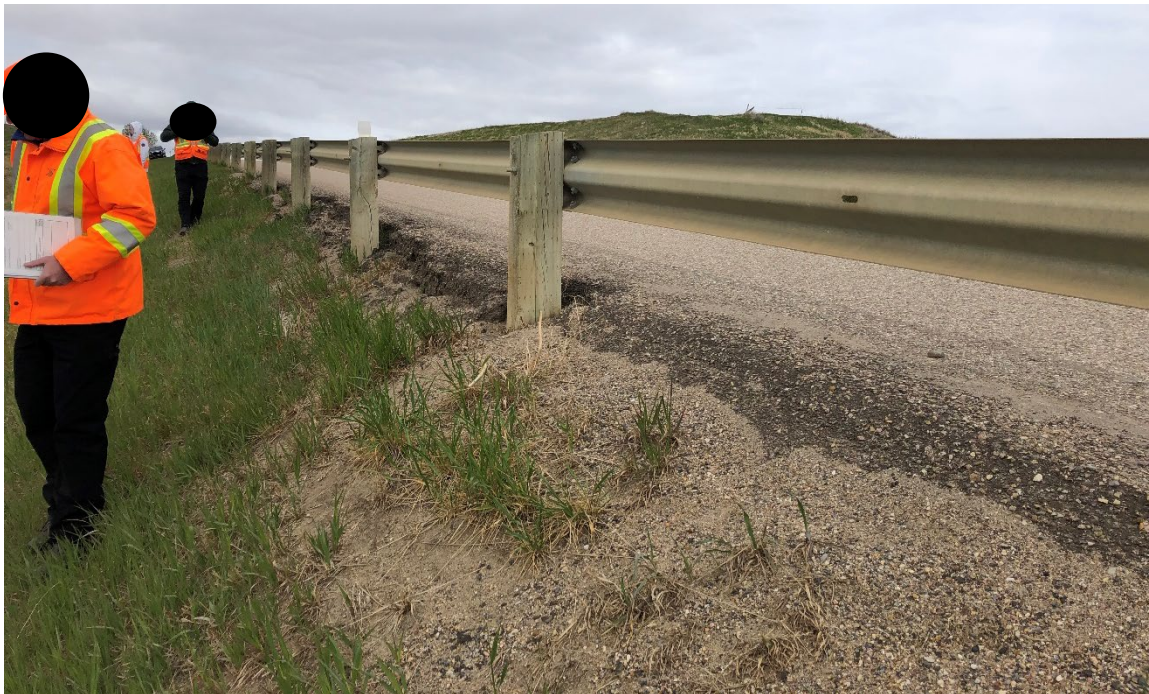
Photo 7 The head scarp at the edge of the pavement and is reducing the pavement support over approximately 18 m. Photo taken May 19, 2022, facing west.

- The site should be regularly inspected by AT's MCI and inspected every two-years as part of the Southern Region Section B inspections.
- Drainage improvements should be complete to divert survey water runoff away from the head scarp.
- Deeper-than-typical guardrail posts should be installed in this area to allow the guardrail to be at the typical/design guardrail height.
