SITE NUMBER AND NAME: <b>S049 Hoot and Howl Slide</b>		HIGHWAY & KM: 504:02, 5.090	PREVIOUS INSPECTION DATE: May 19, 2022	INSPECTION DATE: <b>May 29, 2024</b>
LEGAL DESCRIPTION: 03-17-04-16 W4M	NAD 83 COORDINATES: UTM Northing Easting 12 5460493 417931		RISK ASSESMENT: PF: 8 CF: 3 TOTAL: 24	
AVERAGE ANNUAL DAILY TRAFFIC (AADT): 180 (east) (Reference No. 7000054)			CONTRACTOR MAINTENANCE AREA (CMA): 24

SUMMARY OF SITE INSTRUMENTATION:  There is no instrumentation at the S049 site.  LAST READING DATE: N/A	INSPECTED BY: Chris Grapel (KCB) Peter Roy (KCB) Alex Frotten (TEC) Kristen Tappenden (TEC)
PRIMARY SITE ISSUE: Large translational earth slide on the south embankment of the highway. Approximately 20 m of guard rail on the south side of the highway is being undermined by the retrogressing head scarp.	
APPROXIMATE DIMENSIONS: Approximately 20 m of highway is being impacted by the head scarp. The landslide is approximately 50 to 70 m wide in the middle of the embankment.	
DATE OF ANY REMEDIAL ACTION: Unknown – guardrail was repaired

PROJECT SOUTHERN REGION GEOHAZARD RISK MANAGEMENT PROGRAM		
TITLE Site Plan S049 - Hoot and Howl Slide Hwy 504:02, km 5.090		
SCALE 1:800	PROJECT No. A

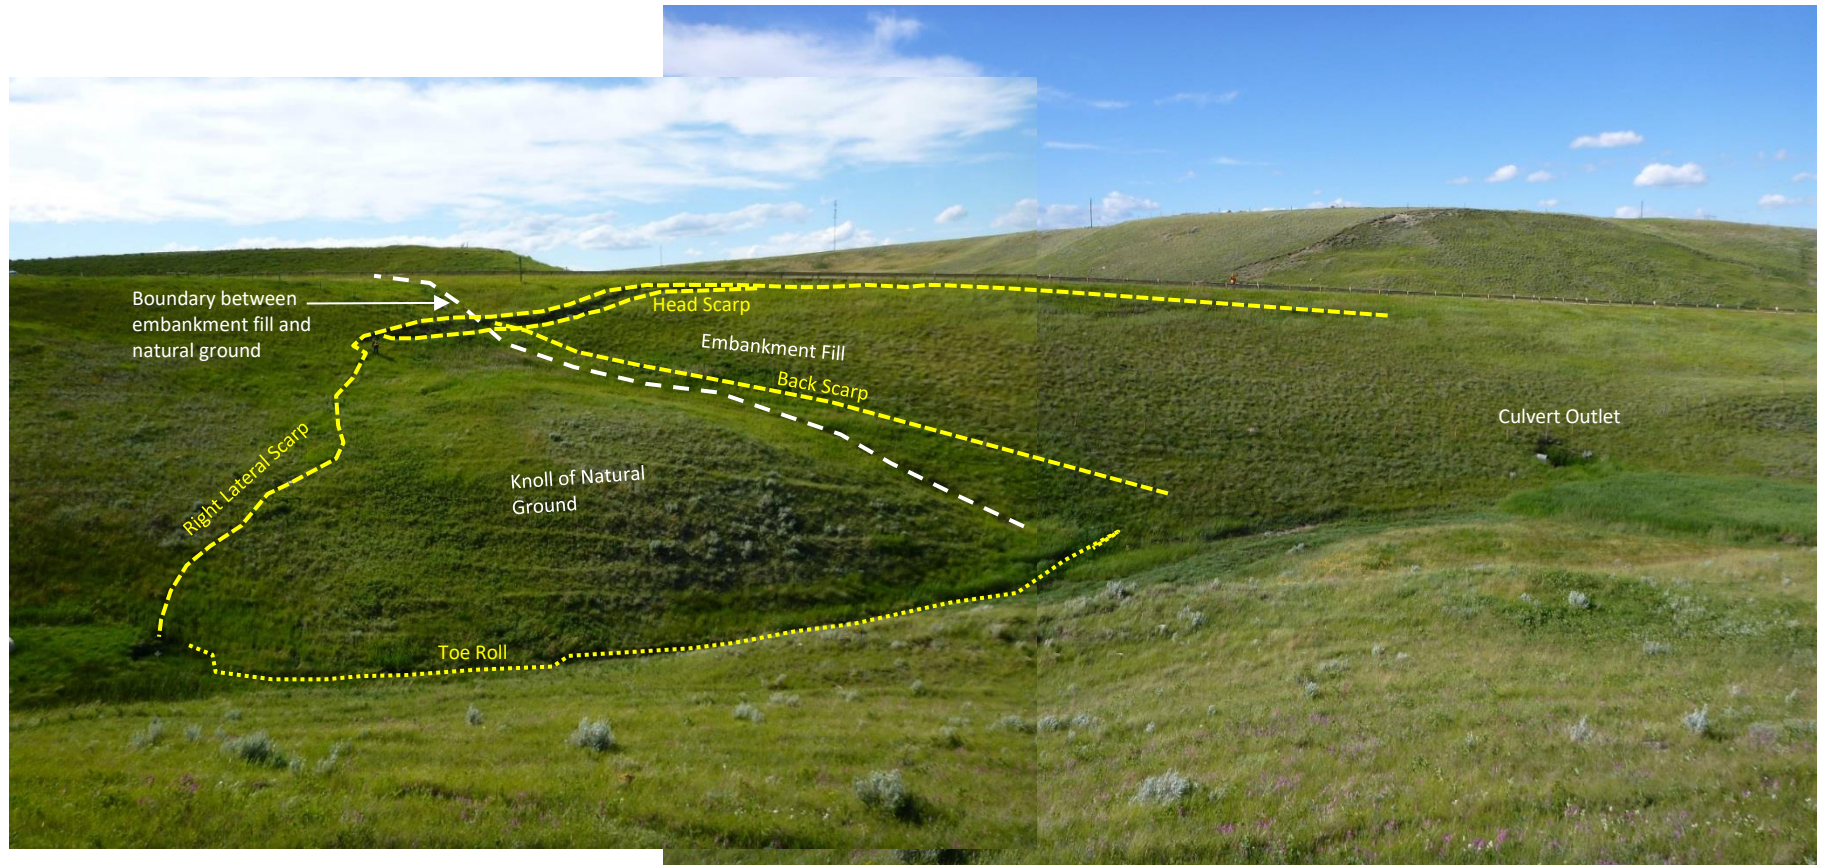
<b>COMMENTS</b>
No significant changes were observed between the 2022 and 2024 inspection. No significant changes have been observed at the site since 2018 (overall site shown in Photo 1)
The site is well vegetated.
Approximately 50 mm of settlement has been observed in the guardrail, where it is being undermined.
The pavement edge is cracking due to slope movement and asphalt pieces are rolling down the slope.
The CSP culvert (oriented approximately northwest-southeast) located west of the slide zone is in good condition without any signs of distress from the slide movement. The culvert inlet is slightly rusted and may have some debris inside. Minor erosion was noted at the outlet and standing water was observed during previous inspections.
During the 2024 inspection, a tension crack approximately 23 m long and 2 m below the pavement elevation appears to drop by approximately 100 mm to 150 mm (sloping towards the east).

**Photo 1** High embankment slope instability, translational slide. Presence of back scarp infers a reverse graben has formed which is evidence of translational slide movement usually along a horizontal weak layer at depth. Higher head scarp at west end indicates slide is exhibiting hinged movement, dropping more at the west end where more of the slide mass involves natural ground and a pre-existing basal rupture surface exists and is controlling movement. Photos taken June 16, 2016, facing northward.

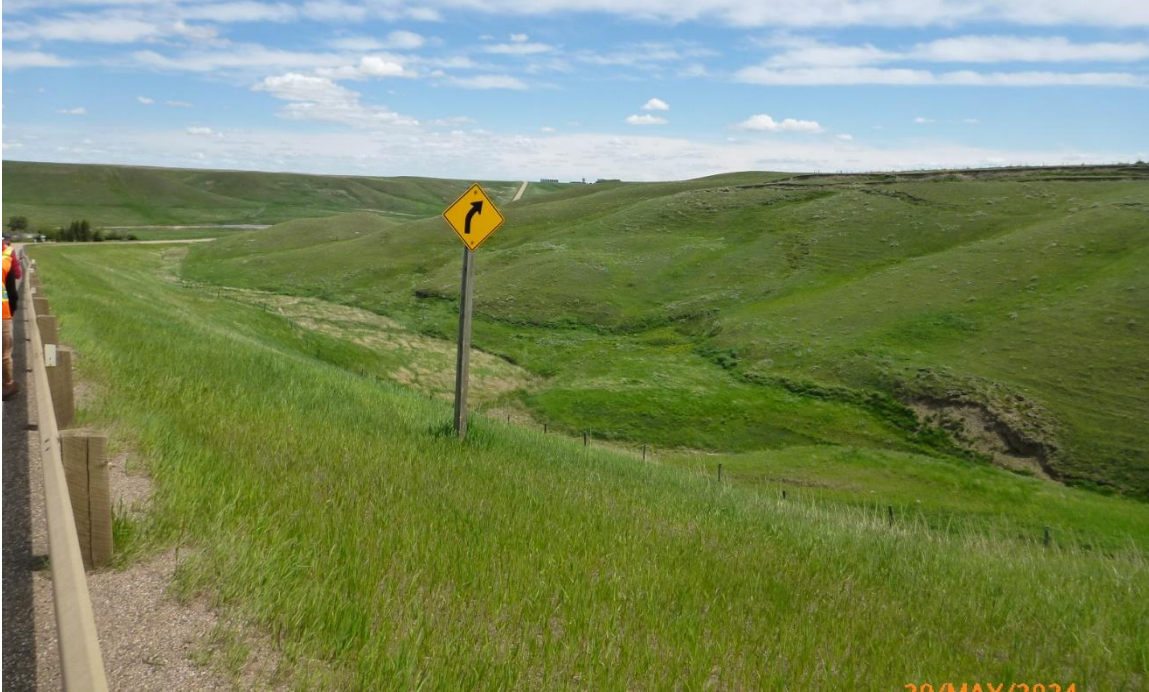
**Photo 2** View east across the slide zone. Tall grass is obscuring the visible slide features.  
Photo taken May 29, 2024, facing east.

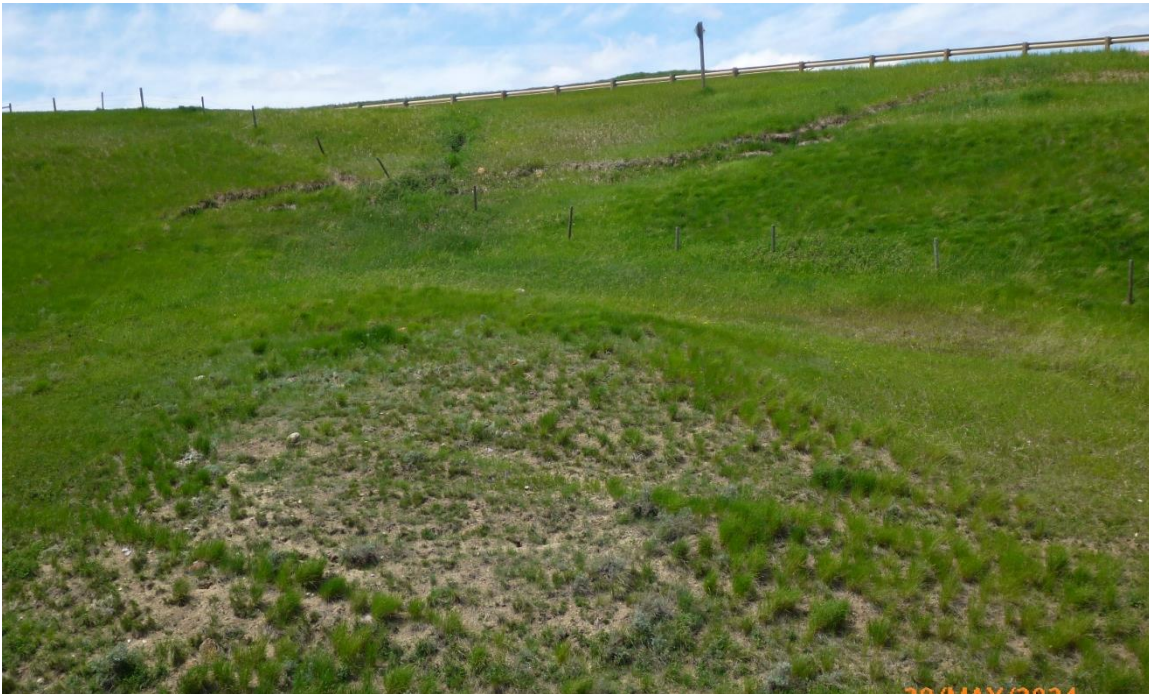
The right (west) flank of the scarp shows visible movement toward the creek and the slide appears to be extending further upslope. An erosion gully from the highway ditch is feeding into the right flank. There is no visible feature of

**Photo 3** Head scarp on right flank. Photo taken on May 29, 2024, facing northwest.

- The site should be regularly inspected by TEC's MCI and inspected every two-years as part of the Southern Region Section B inspections.
- Drainage improvements should be completed to divert surface water runoff away from the head scarp.
- Deeper-than-typical guardrail posts should be installed in this area to allow the guardrail to be at the typical/design guardrail height.

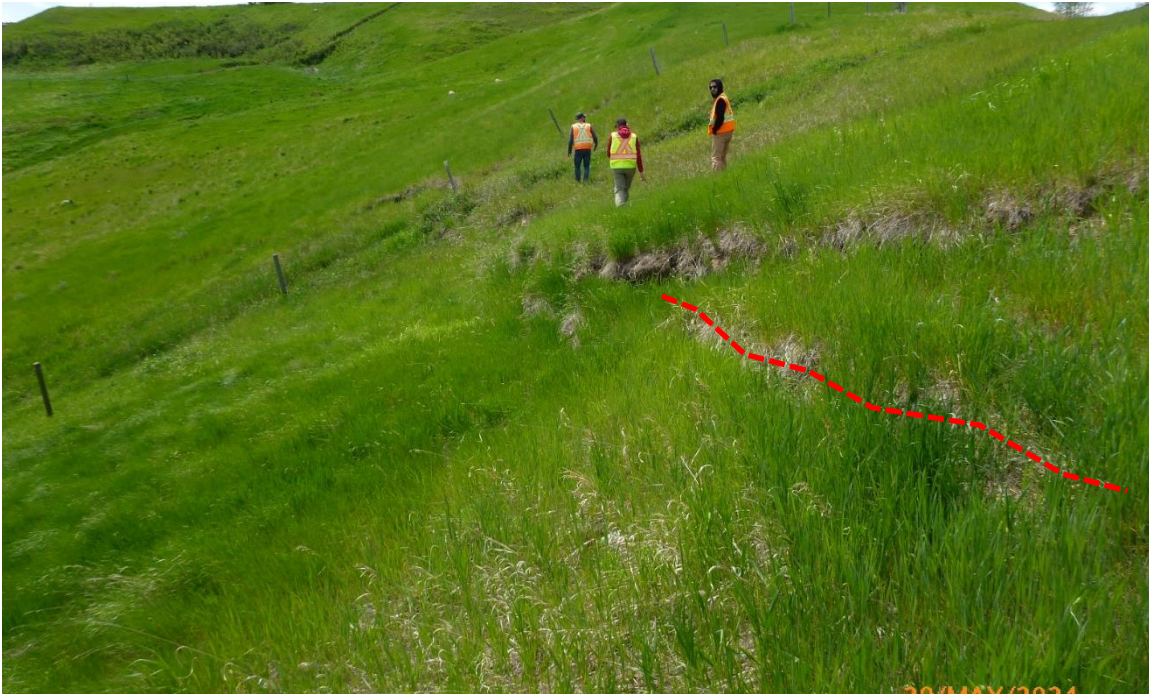
**Photo 4** Tension crack on embankment fill (indicated by red dashed line) approximately 2 m below pavement elevation. Photo taken May 29, 2024, facing southwest.

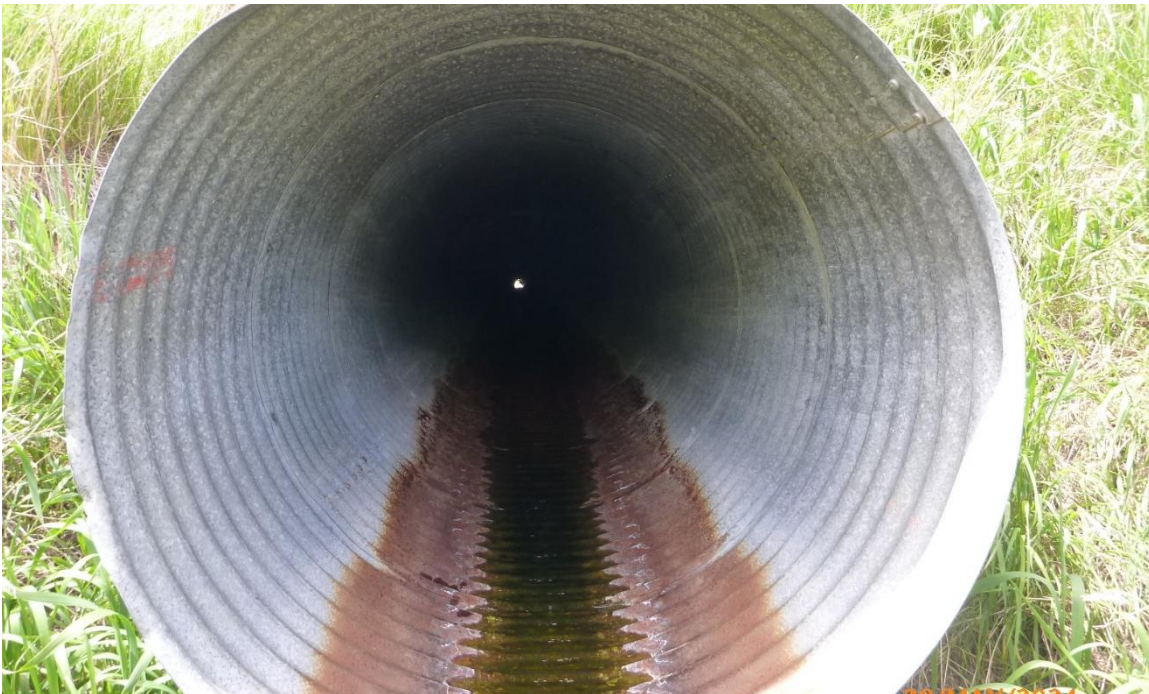
**Photo 5** CSP culvert outlet near the left flank of the slide zone. The CSP culvert appears to be in good condition. Photo taken May 29, 2024, facing northwest.

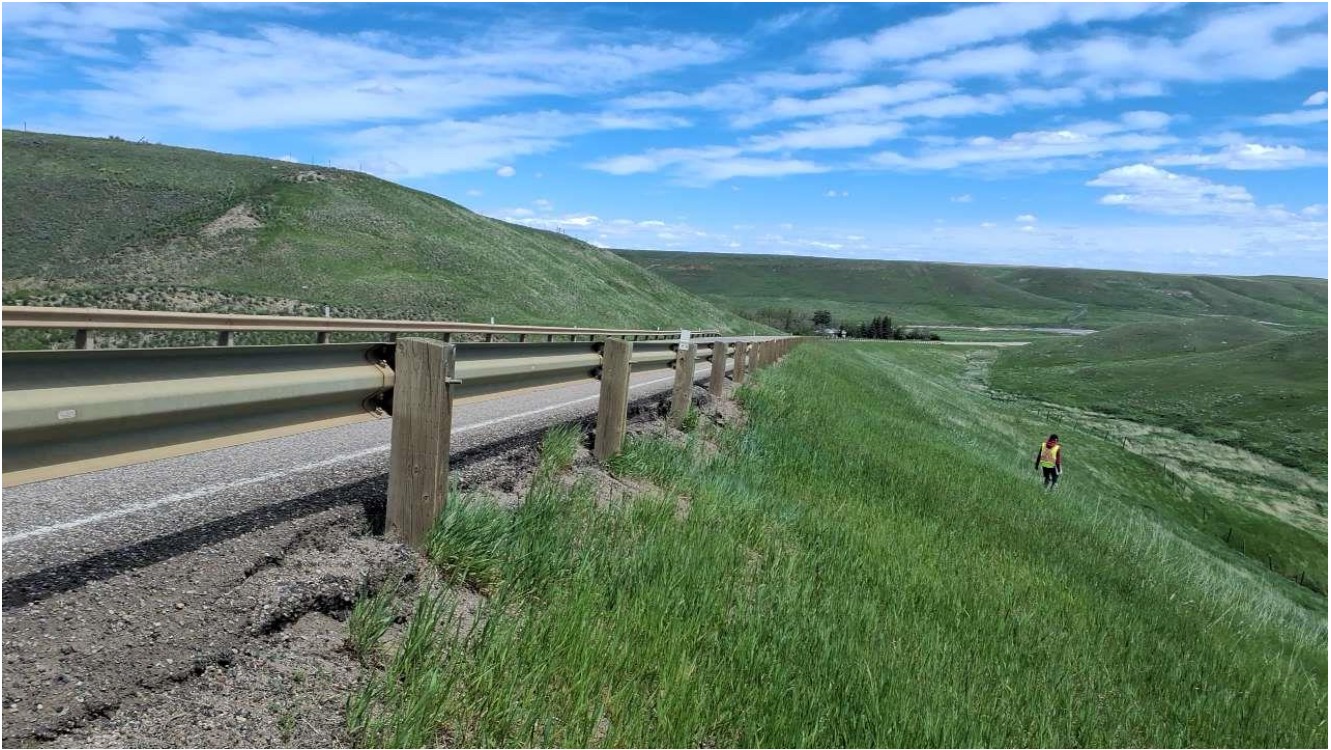
**Photo 6**      **Head scarp at the edge of the pavement. Loss of pavement support over approximately 20 m length. Photo taken facing west on May 29, 2024.**
