**HIGHWAY 505 – BULLRUSH HILL
CALL-OUT REPORT**

Submitted to:
Alberta Transportation
Calgary, Alberta

March 2016

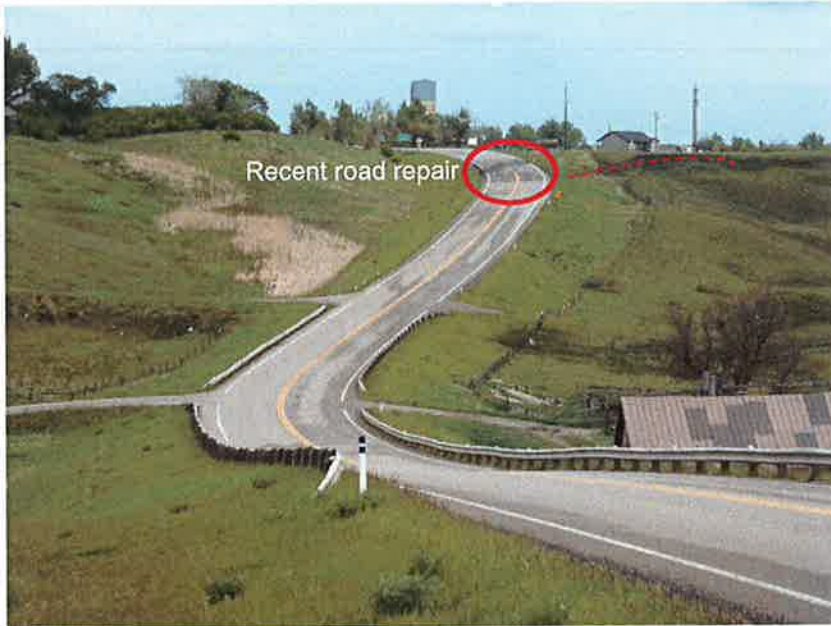
- ▶ The highway was aligned East-West and passed through a coulee at this site. Refer to Figure 1.
- ▶ A 60m stretch of highway has been damaged and recently patched. Refer to Photo 1. A possible old road was observed south of the current highway on the midslope bend.

- ▶ The scarp was observed across the road that had recently been patched. There was 300mm settlement noted, but no distinct cracks due to the recent patch work. The scarp aligned with the main scarp in the natural slope to the south.

Photo 1 - (May 2015) –
Site overview. Facing east
towards site. Main headscarp
marked with red dashed line.

- ▶ The MCI should continue road surface patching and overlays as required to mitigate the settlement and cracking along the shoulder and both the north and southbound lanes.
- ▶ Signage should be installed that indicates "slide area" and speed reductions should be considered to protect vehicles from potential road damage.
- ▶ This site should be added to the Southern Region Geohazard Monitoring Program for follow-up inspections.
- ▶ Slope inclinometers and piezometers should be installed to investigate ground movement and water levels in the slide area and on both sides of the highway. Borehole logs should be completed at the time of installation. Amec Foster Wheeler would be pleased to provide a cost estimate for this work.

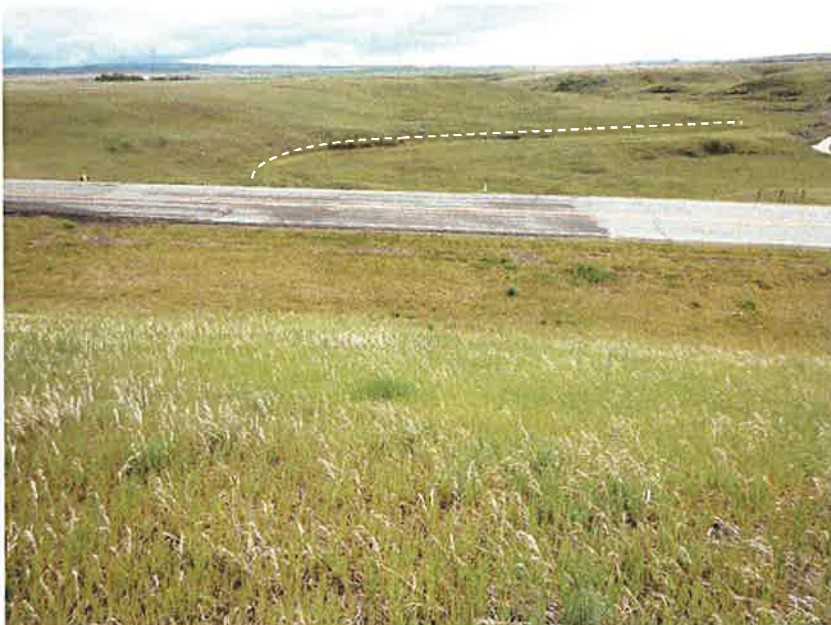
- ▶ The valley was broad with a meandering stream. An old meander was observed at the toe of the slide south of the damaged area at a slightly higher elevation than the current channel. The slide along the older riverbank was still active even though the creek has shifted position. Refer to Photo 2.

The cause of this slide is likely caused by groundwater seepage within the slope. The creek at the base of the slope currently makes a sharp westerly bend at the base of the slope area resulting in continued erosion of the toe and is contributing to the instability. An abandoned channel is visible both in the field and on aerial images meandering directly at the base of the slope on in which the slide is occurring. Refer to Figure 1 for a site plan. The slide at the old channel bank is still active even though the creek has shifted.

Photo 2 - (May 2015) –
On north slope facing south.
Abandoned creek channel
indicated with white dashed line.

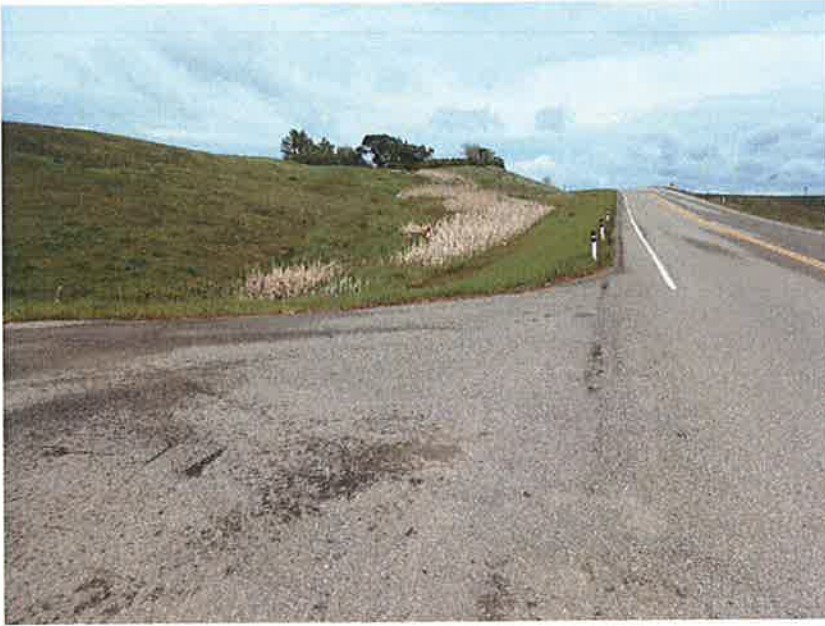
- ▶ A marshy area was observed north of the highway with flowing water. Vegetation including cat tails indicated consistent higher moisture. Refer to Photo 3 and Figure 1. This area smelled like sewage which could be related to a septic system at the house to the north of the site.

The presence of both flowing and ponded water on the slope north of the highway is suspected to be a result of springs in the area. Vegetation indicates water is accumulating on the north slope and that the soil may not be able to effectively drain.

Photo 3 - (May 2015) –
Facing east towards area of moist ground on north shoulder of Highway 505 indicated by cat tail vegetation.

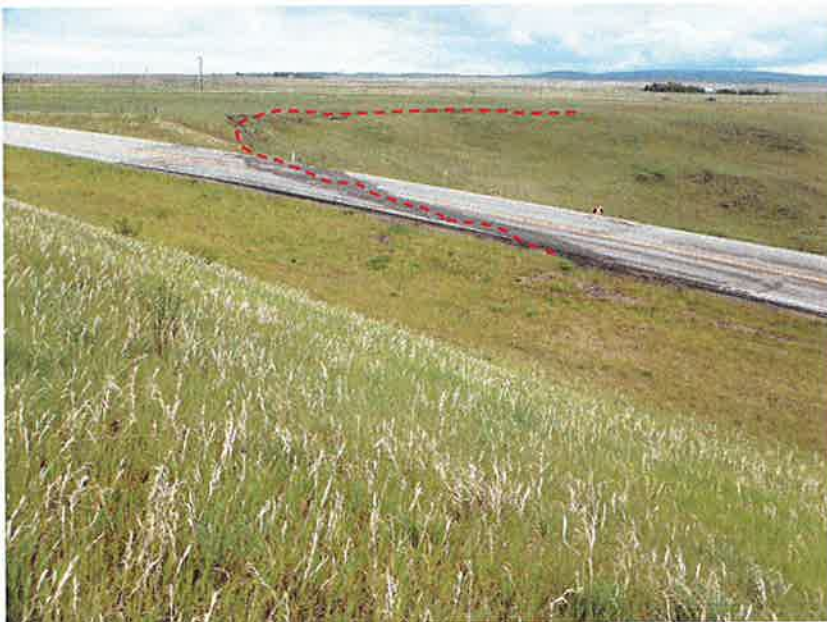
- ▶ The main scarp on the hillside has soil exposure indicating soil is likely a clay till (Cl-CH). Slide movement appeared to be to the south with potential compression to the west. Refer to Photos 4, 5 and 6. No additional cracks or toe bulge were observed on the slope.

Photo 4 - (May 2015) –
On north slope facing southeast towards headscarp and road damage. Extent of headscarp indicated by red dashed line.

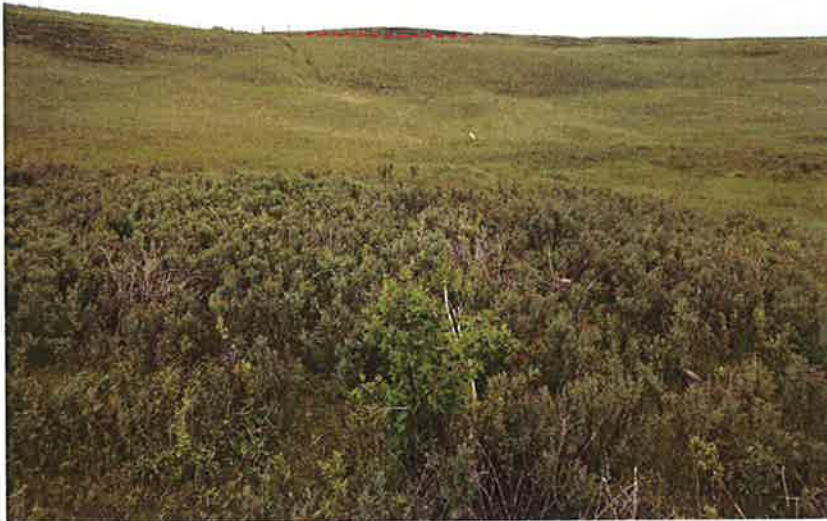
Photo 5 - (May 2015) –
In valley south of highway facing
upslope (east) towards
headscarp exposure, marked
with dashed line.

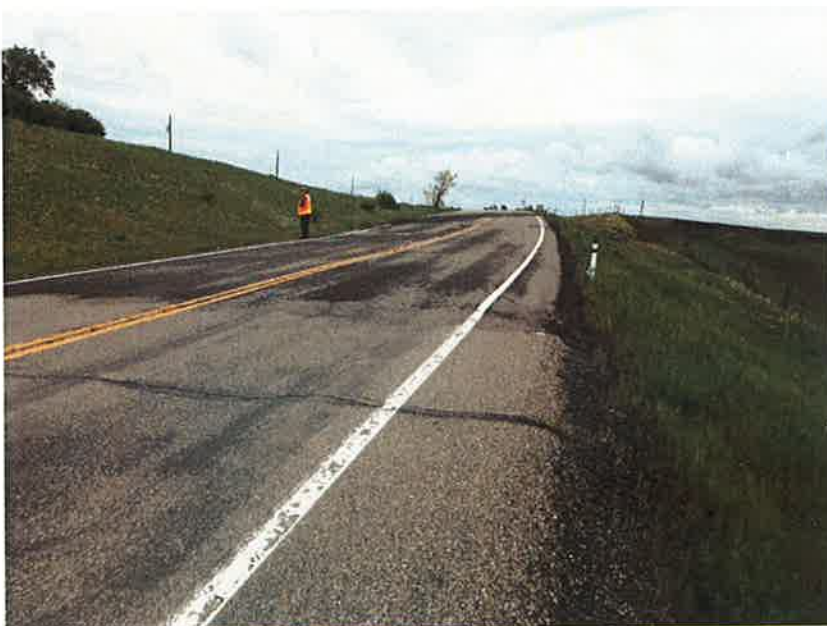
There is risk to both lanes of the highway at this site based on the ongoing cracking and settlement observed in the road surface. This damage appears to be due to an active landslide located on the south slope and crossing the highway. The extent and depth of sliding at this location is unknown however it is suspected to be a deep-seated landslide after the field visit.

Photo 6 - (May 2015) –
Facing east towards damaged
portion of highway.
