SITE NUMBER AND NAME: S058 Spring Hill		HIGHWAY & KM: 505:04, 21.110	PREVIOUS INSPECTION DATE: July 7, 2020	INSPECTION DATE: July 8, 2021
LEGAL DESCRIPTION: 15-29-004-23 W4M	NAD 83 COORDINATES: UTM Northing Easting 12 5466599 350117		RISK ASSESMENT: PF: 7 CF: 6 TOTAL: 42	
AVERAGE ANNUAL DAILY TRAFFIC (AADT): 570 (east) (Ref. No. 93050), 530 (west) (Ref. No. 99030)			CONTRACTOR MAINTENANCE AREA (CMA): 25

PRIMARY SITE ISSUE: Deep-seated earth slide within coulee side slope. The head scarp extends into the roadway and is impacting the pavement and south shoulder of the embankment.

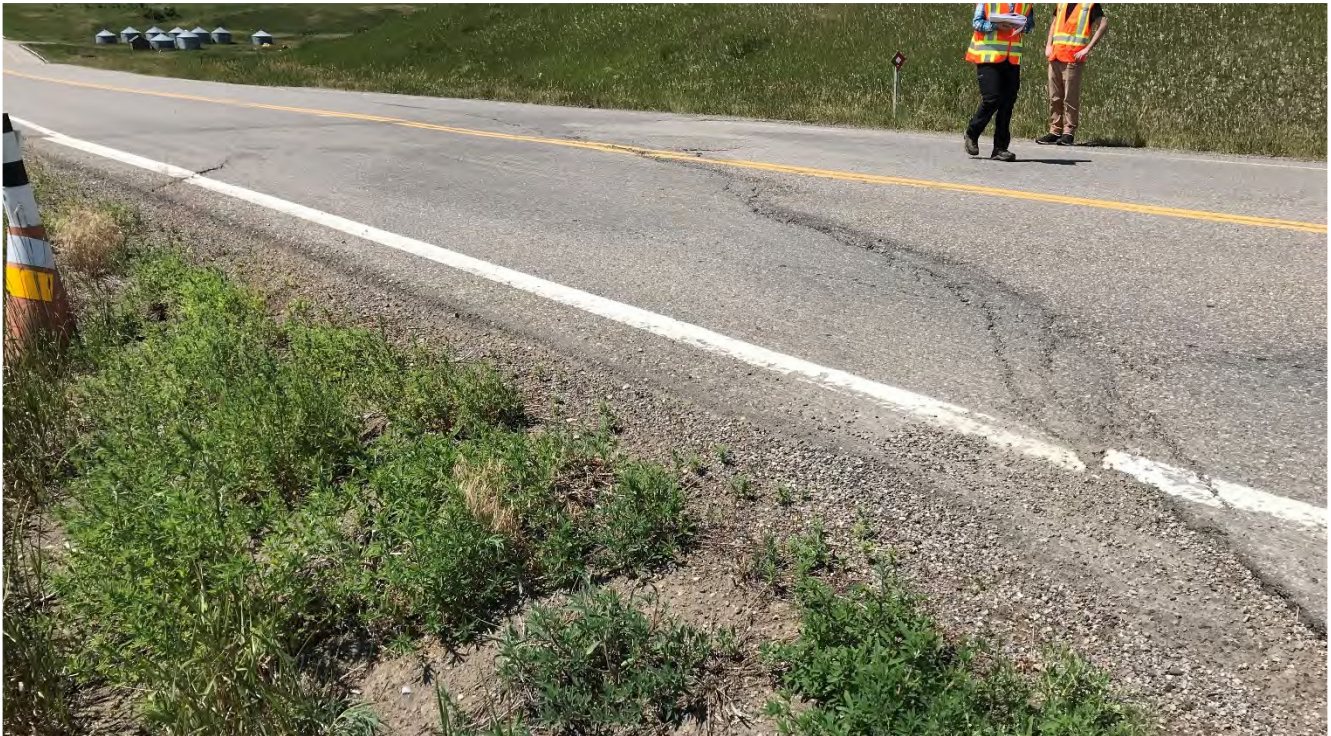
Photo 1 Pavement cracking and settlement due to head scarp of slide on coulee slope south of highway. Photo taken facing northwest on July 8, 2021.

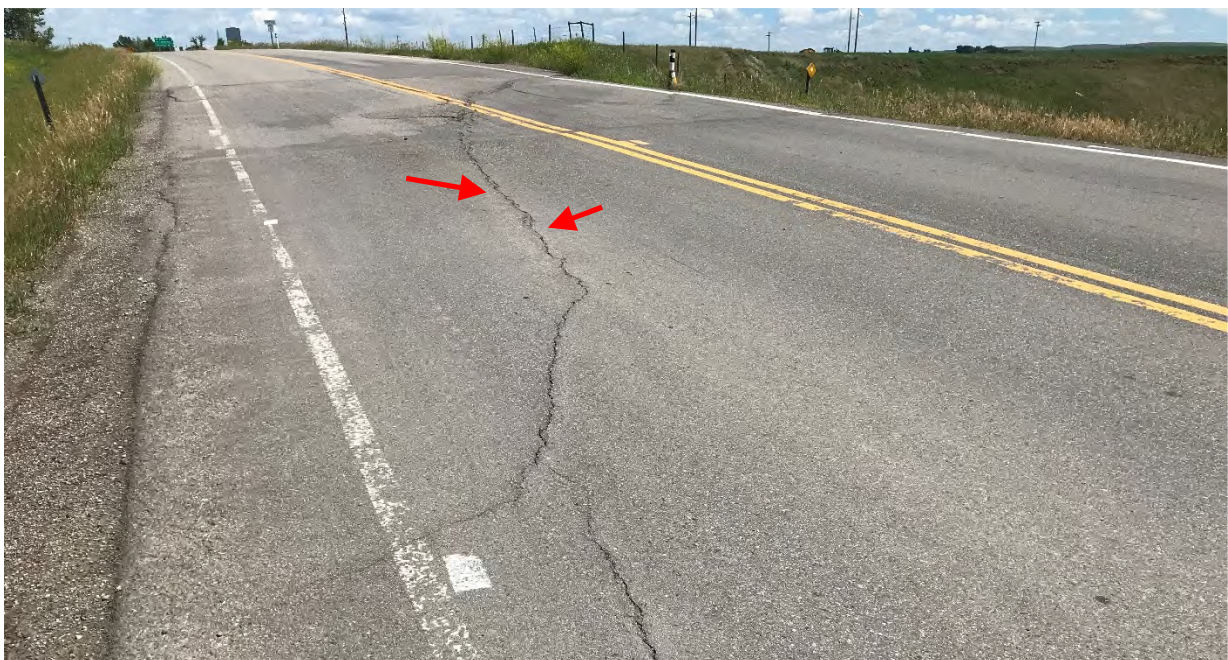
Photo 2 Pavement patching and milling due to ongoing slope movement. Cracking has extended through the recent overlay. Photo taken facing east on July 8, 2021.

- Investigating the drainage pipe and clearing the outlets to promote positive drainage.
- Paving and patching should include milling or excavation, to avoid adding weight to the crown of the slide.

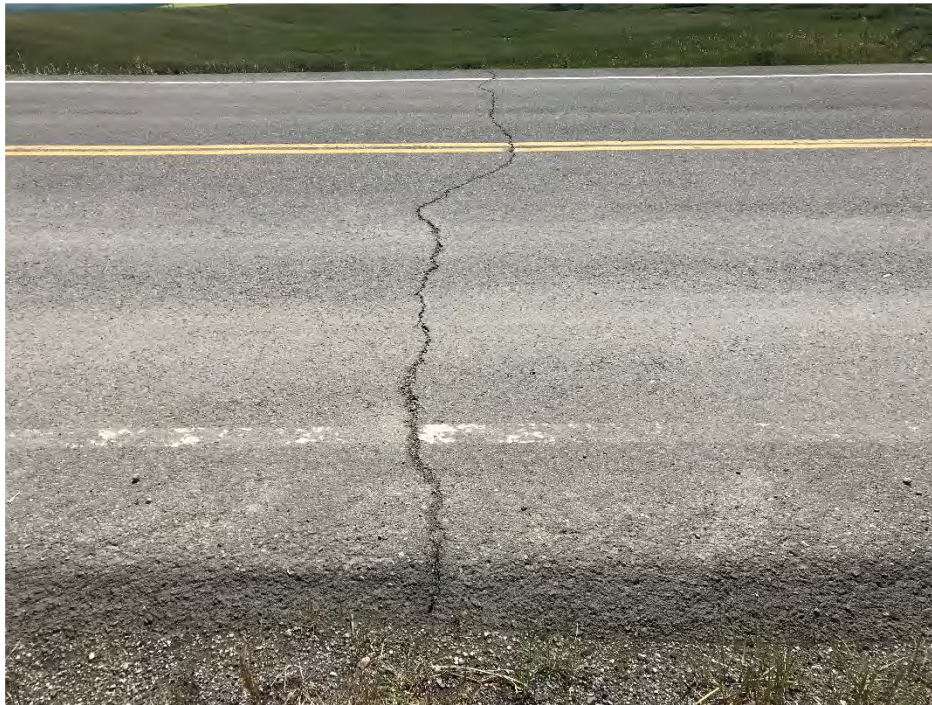
Photo 3 Transverse crack to the west of the pavement cracking and milling. Photo taken facing south on July 8, 2021.

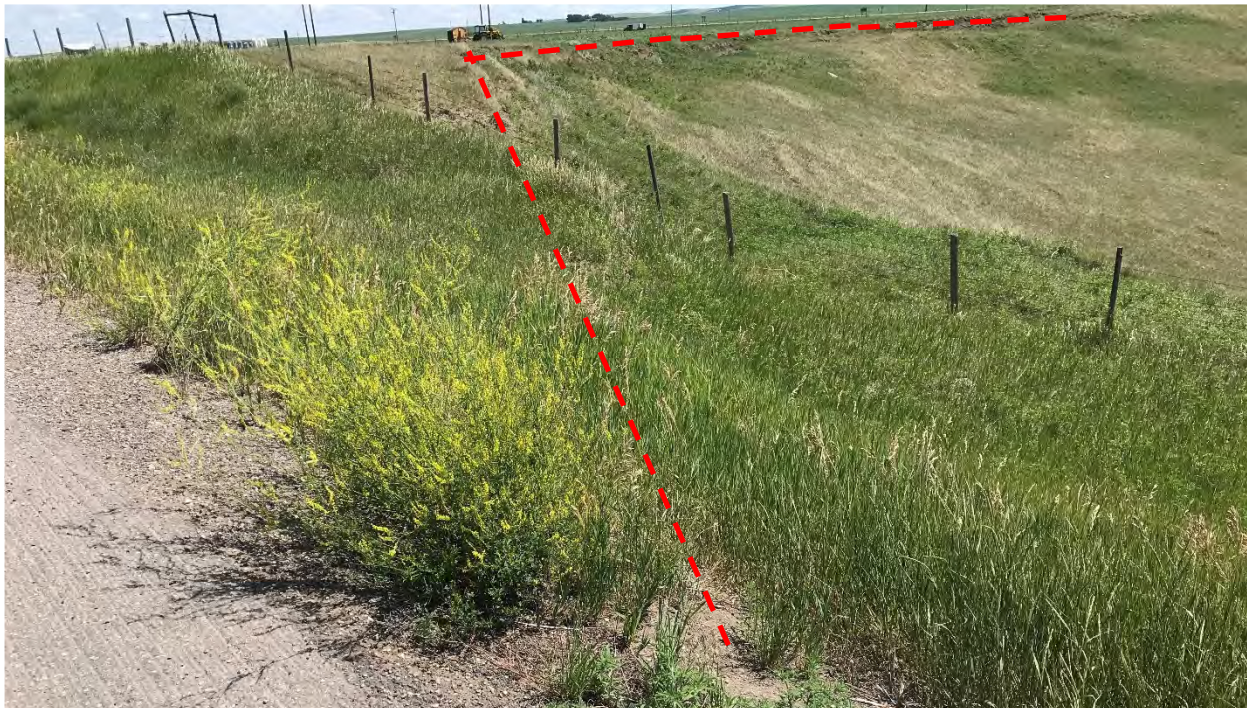
Photo 4 Head scarp of slide on coulee slope south of highway. Photo was taken facing southeast on July 8, 2021.

Candidate repair options for this site include a driven steel pile wall, drainage improvements, or a toe berm. Ground investigation and instrumentation monitoring would be required for design.
